PEAKE ARBORICULTURE

ARBORICULTURAL IMPACT ASSESSMENT

**Lot 7/5/DP6777
24 Beach Road
Collaroy, NSW 2097**

Prepared on: 30/10/2024

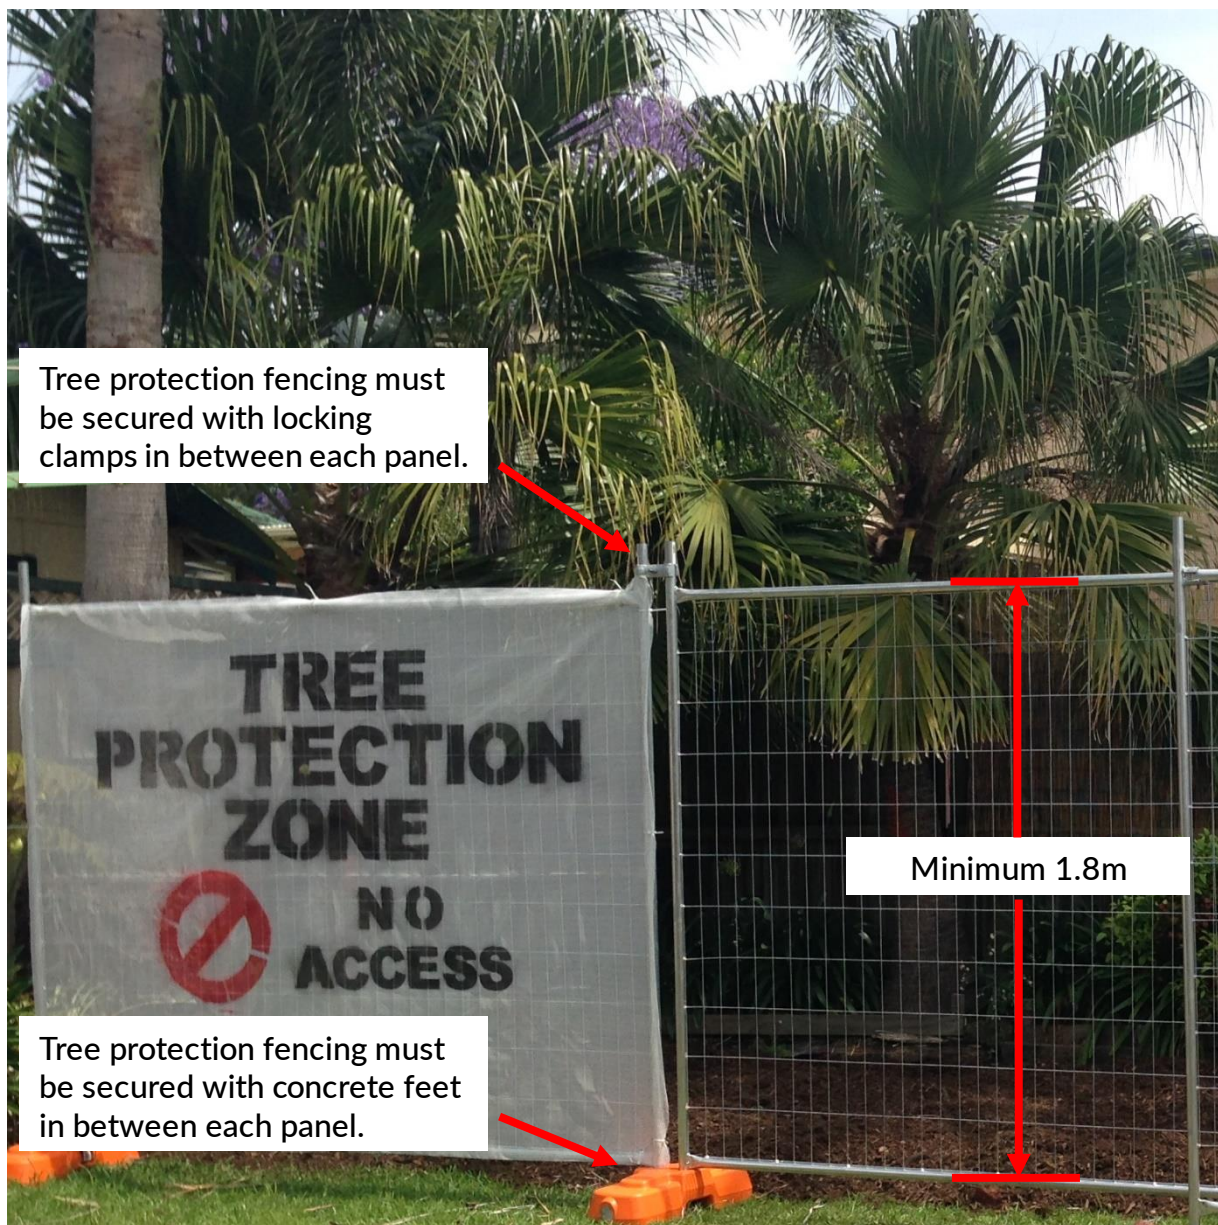
An Example of Temporary Fencing

Tree protection Fencing must be a minimum of 1.8 metres in height and be held in place with locking clamps and concrete feet between each panel, see Figure 2 below.
