J2784B. 20th October, 2021 Page 1.

GROUND TESTING: To accompany the existing Geotechnical Report **87 Alexandra Crescent, Bayview**

Preconstruction Meeting

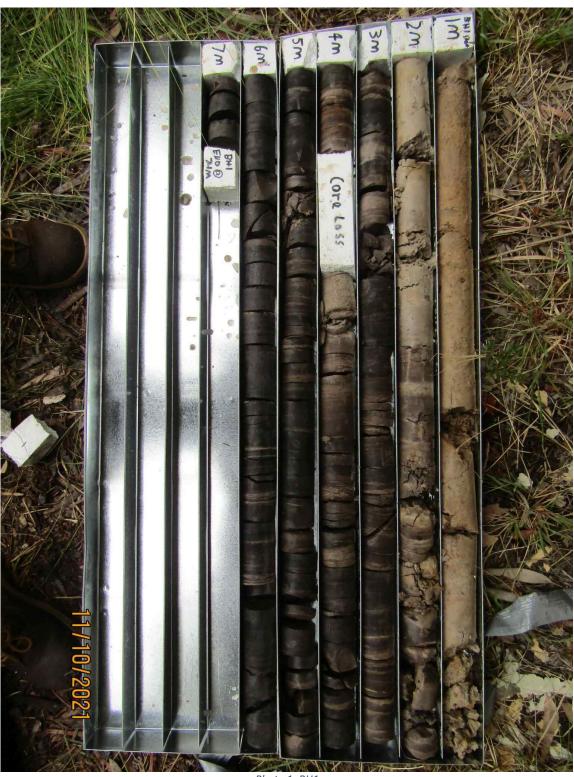
Photo 1: BH1

BORE HOLE 1 (~RL72.9) – BH1 (Photo 1)

Depth (m) Material Encountered
0.0 to 1.0 FILL.

Start of Bore Hole at 1.0m:

1.0 to 2.2	CLAY, brown orange and grey, stiff.
2.2 to 2.4	EXTREMELY LOW STRENGTH SHALE, grey.
2.4 to 3.0	VERY LOW STRENGTH SHALE, grey and black/dark brown.
3.0 to 4.14	LOW STRENGTH SHALE, black/dark brown, grey and orange, parting
	at variable intervals of between 2cm to 13cm.
4.14 to 4.31	CORE LOSS.
4.31 to 7.1	LOW STRENGTH SHALE, black/dark brown and grey, with grey
	sandstone laminite, parting at variable intervals of between 2cm to
	12cm.

End of hole @ 7.1m in Low Strength Shale. No watertable encountered.

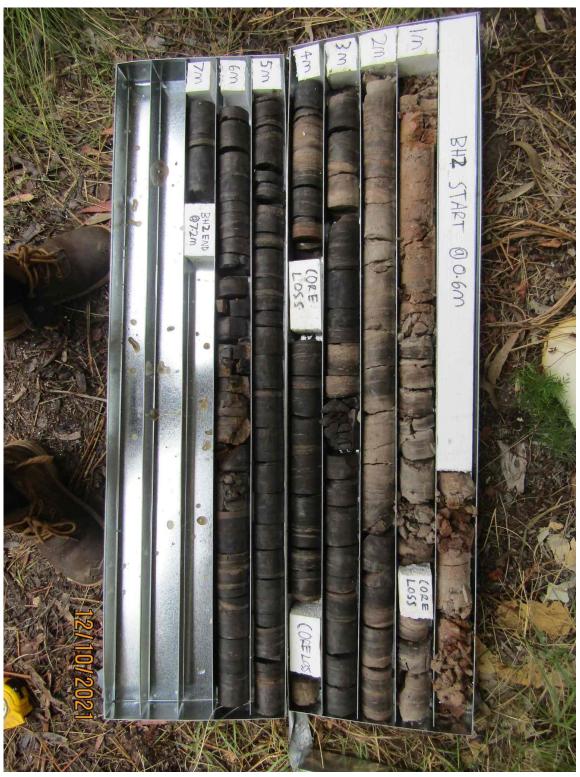
Photo 2: BH2

BORE HOLE 2 (~RL73.0) – BH2 (Photo 2)

Depth (m)	Material Encountered

0.0 to 0.6 **CLAY**.

Start of Bore Hole at 0.6m:

0.6 to 1.3	EXTREMELY LOW STRENGTH SHALE , grey, brown and
	orange.
1.3 to 1.76	VERY LOW STRENGTH SHALE, grey and black/dark brown.
1.76 to 1.83	CORE LOSS.
1.83 to 2.7	VERY LOW STRENGTH SHALE, grey, black/dark brown and orange,
	with thin grey sandstone laminite, parting at variable intervals of
	between 4cm to 12cm.
2.7 to 4.28	LOW STRENGTH SHALE, black/dark brown, grey and orange, parting
	at variable intervals of between 4cm to 12cm.
4.28 to 4.39	CORE LOSS.
4.39 to 4.84	LOW STRENGTH SHALE, black/dark brown and grey, parting at
	variable intervals of between 2cm to 8cm.
4.84 to 4.94	CORE LOSS.
4.94 to 7.2	LOW STRENGTH SHALE, black/dark brown, grey and orange, with thin
	grey sandstone laminite, parting at variable intervals of between 2cm
	to 8cm.

End of hole @ 7.2m in Low Strength Shale. No watertable encountered.
