Preliminary Site Investigation, Lot 1
DP1129384 at Stuart Street, Little Manly,
NSW.

P208072JR01V01
January 2021

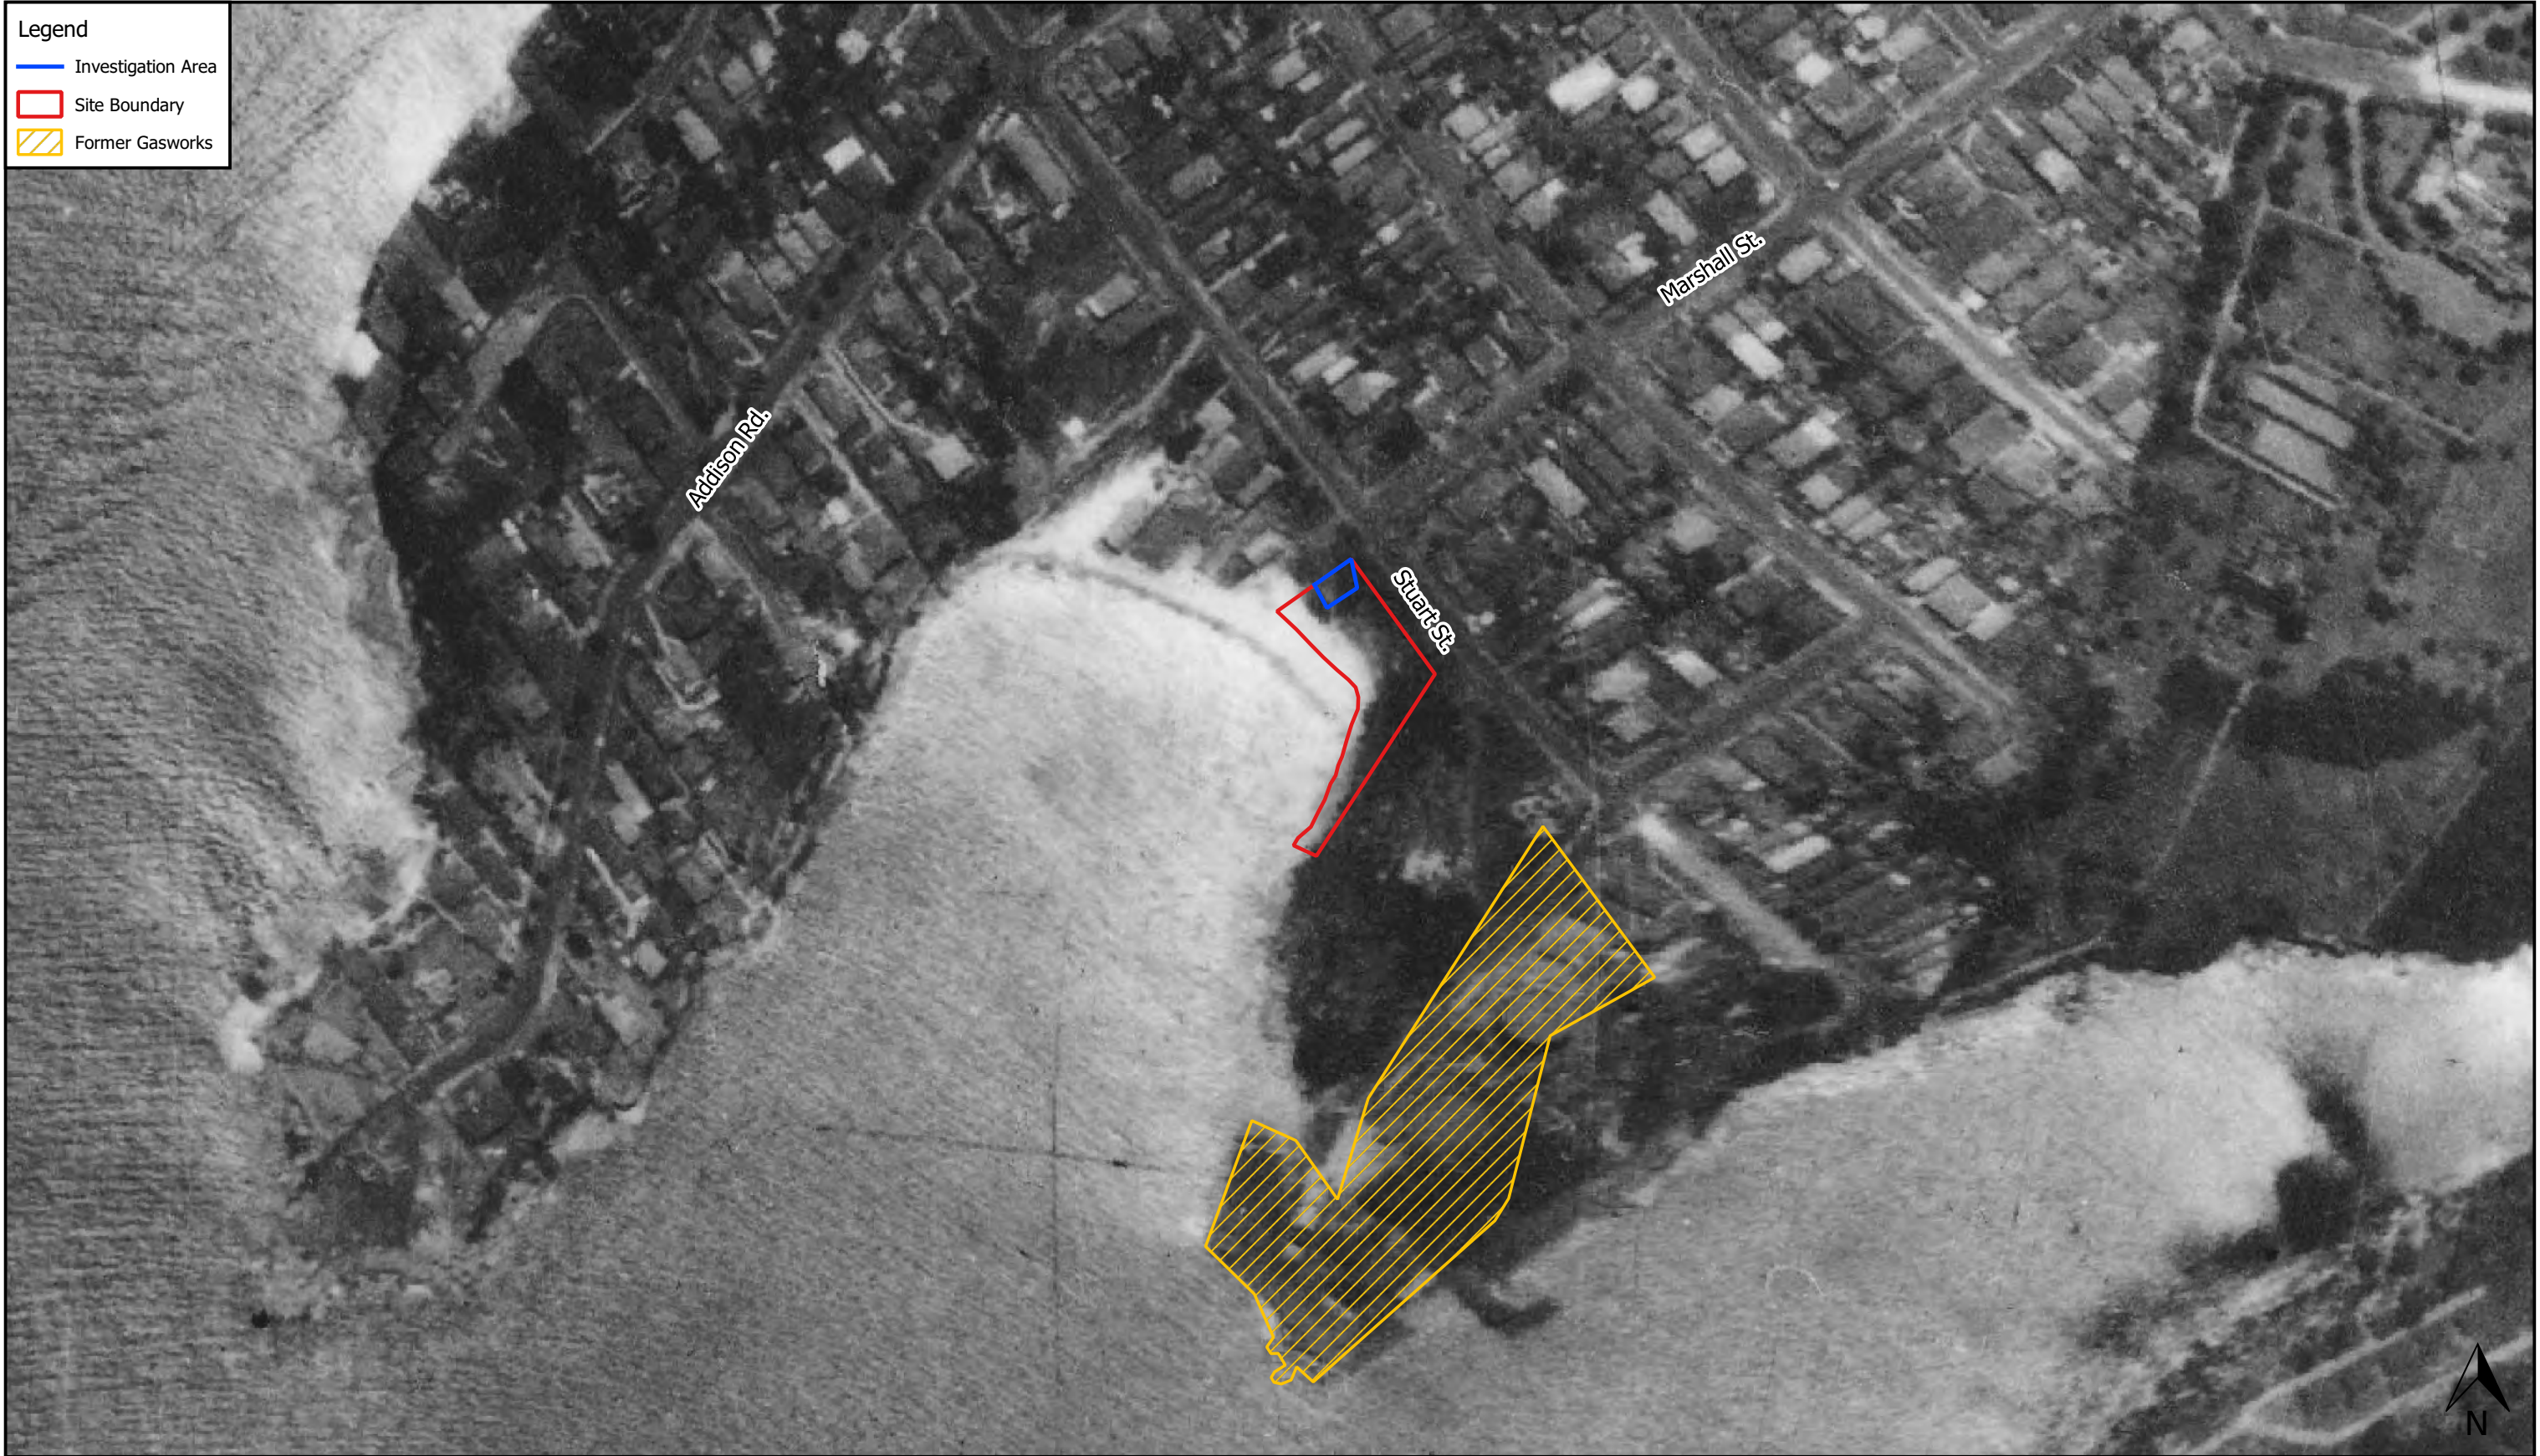
Historical Aerial - 1930

| Year | IA | Surrounding Land Use |
|---|--|--|
| 1930 | The IA is undeveloped. | Surrounding land is typically residential to the north and east. The former gasworks can be seen to the south of the site. |

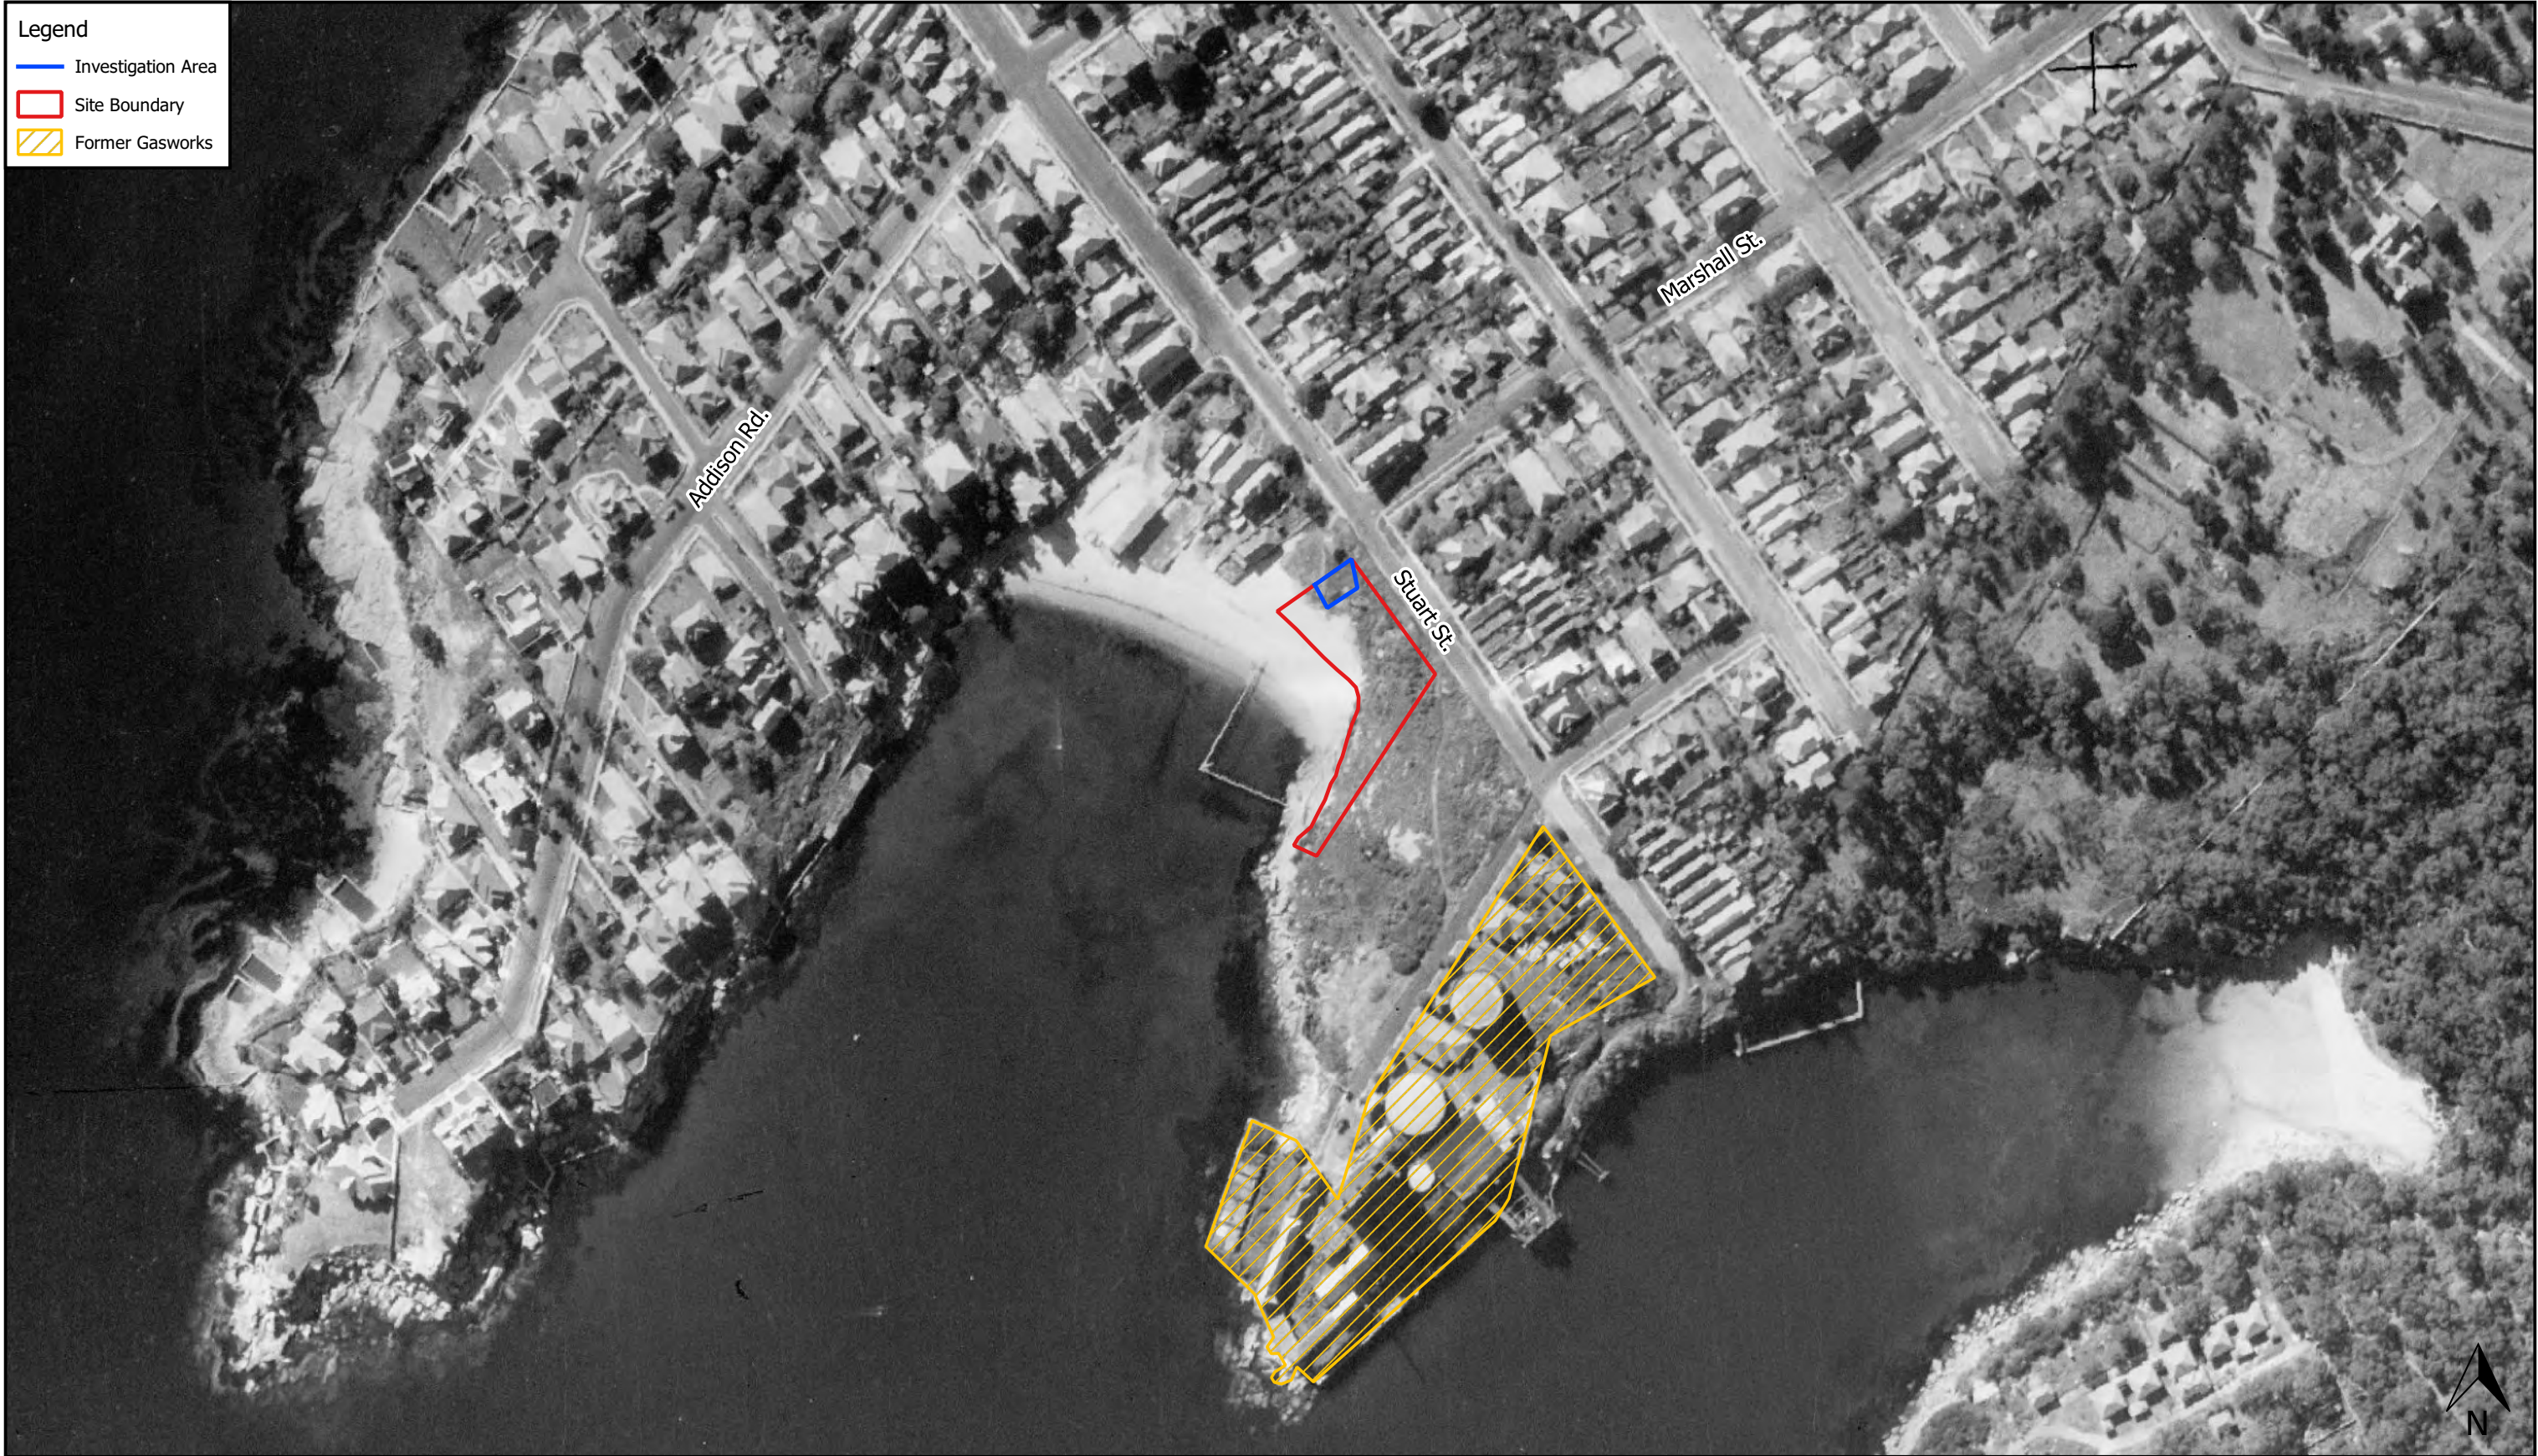
Map Title / Figure:
Historical Aerial - 1951

| Year | IA | Surrounding Land Use |
|---|--|--|
| 1951 | Little to no change from previous. | Little to no change from previous. |

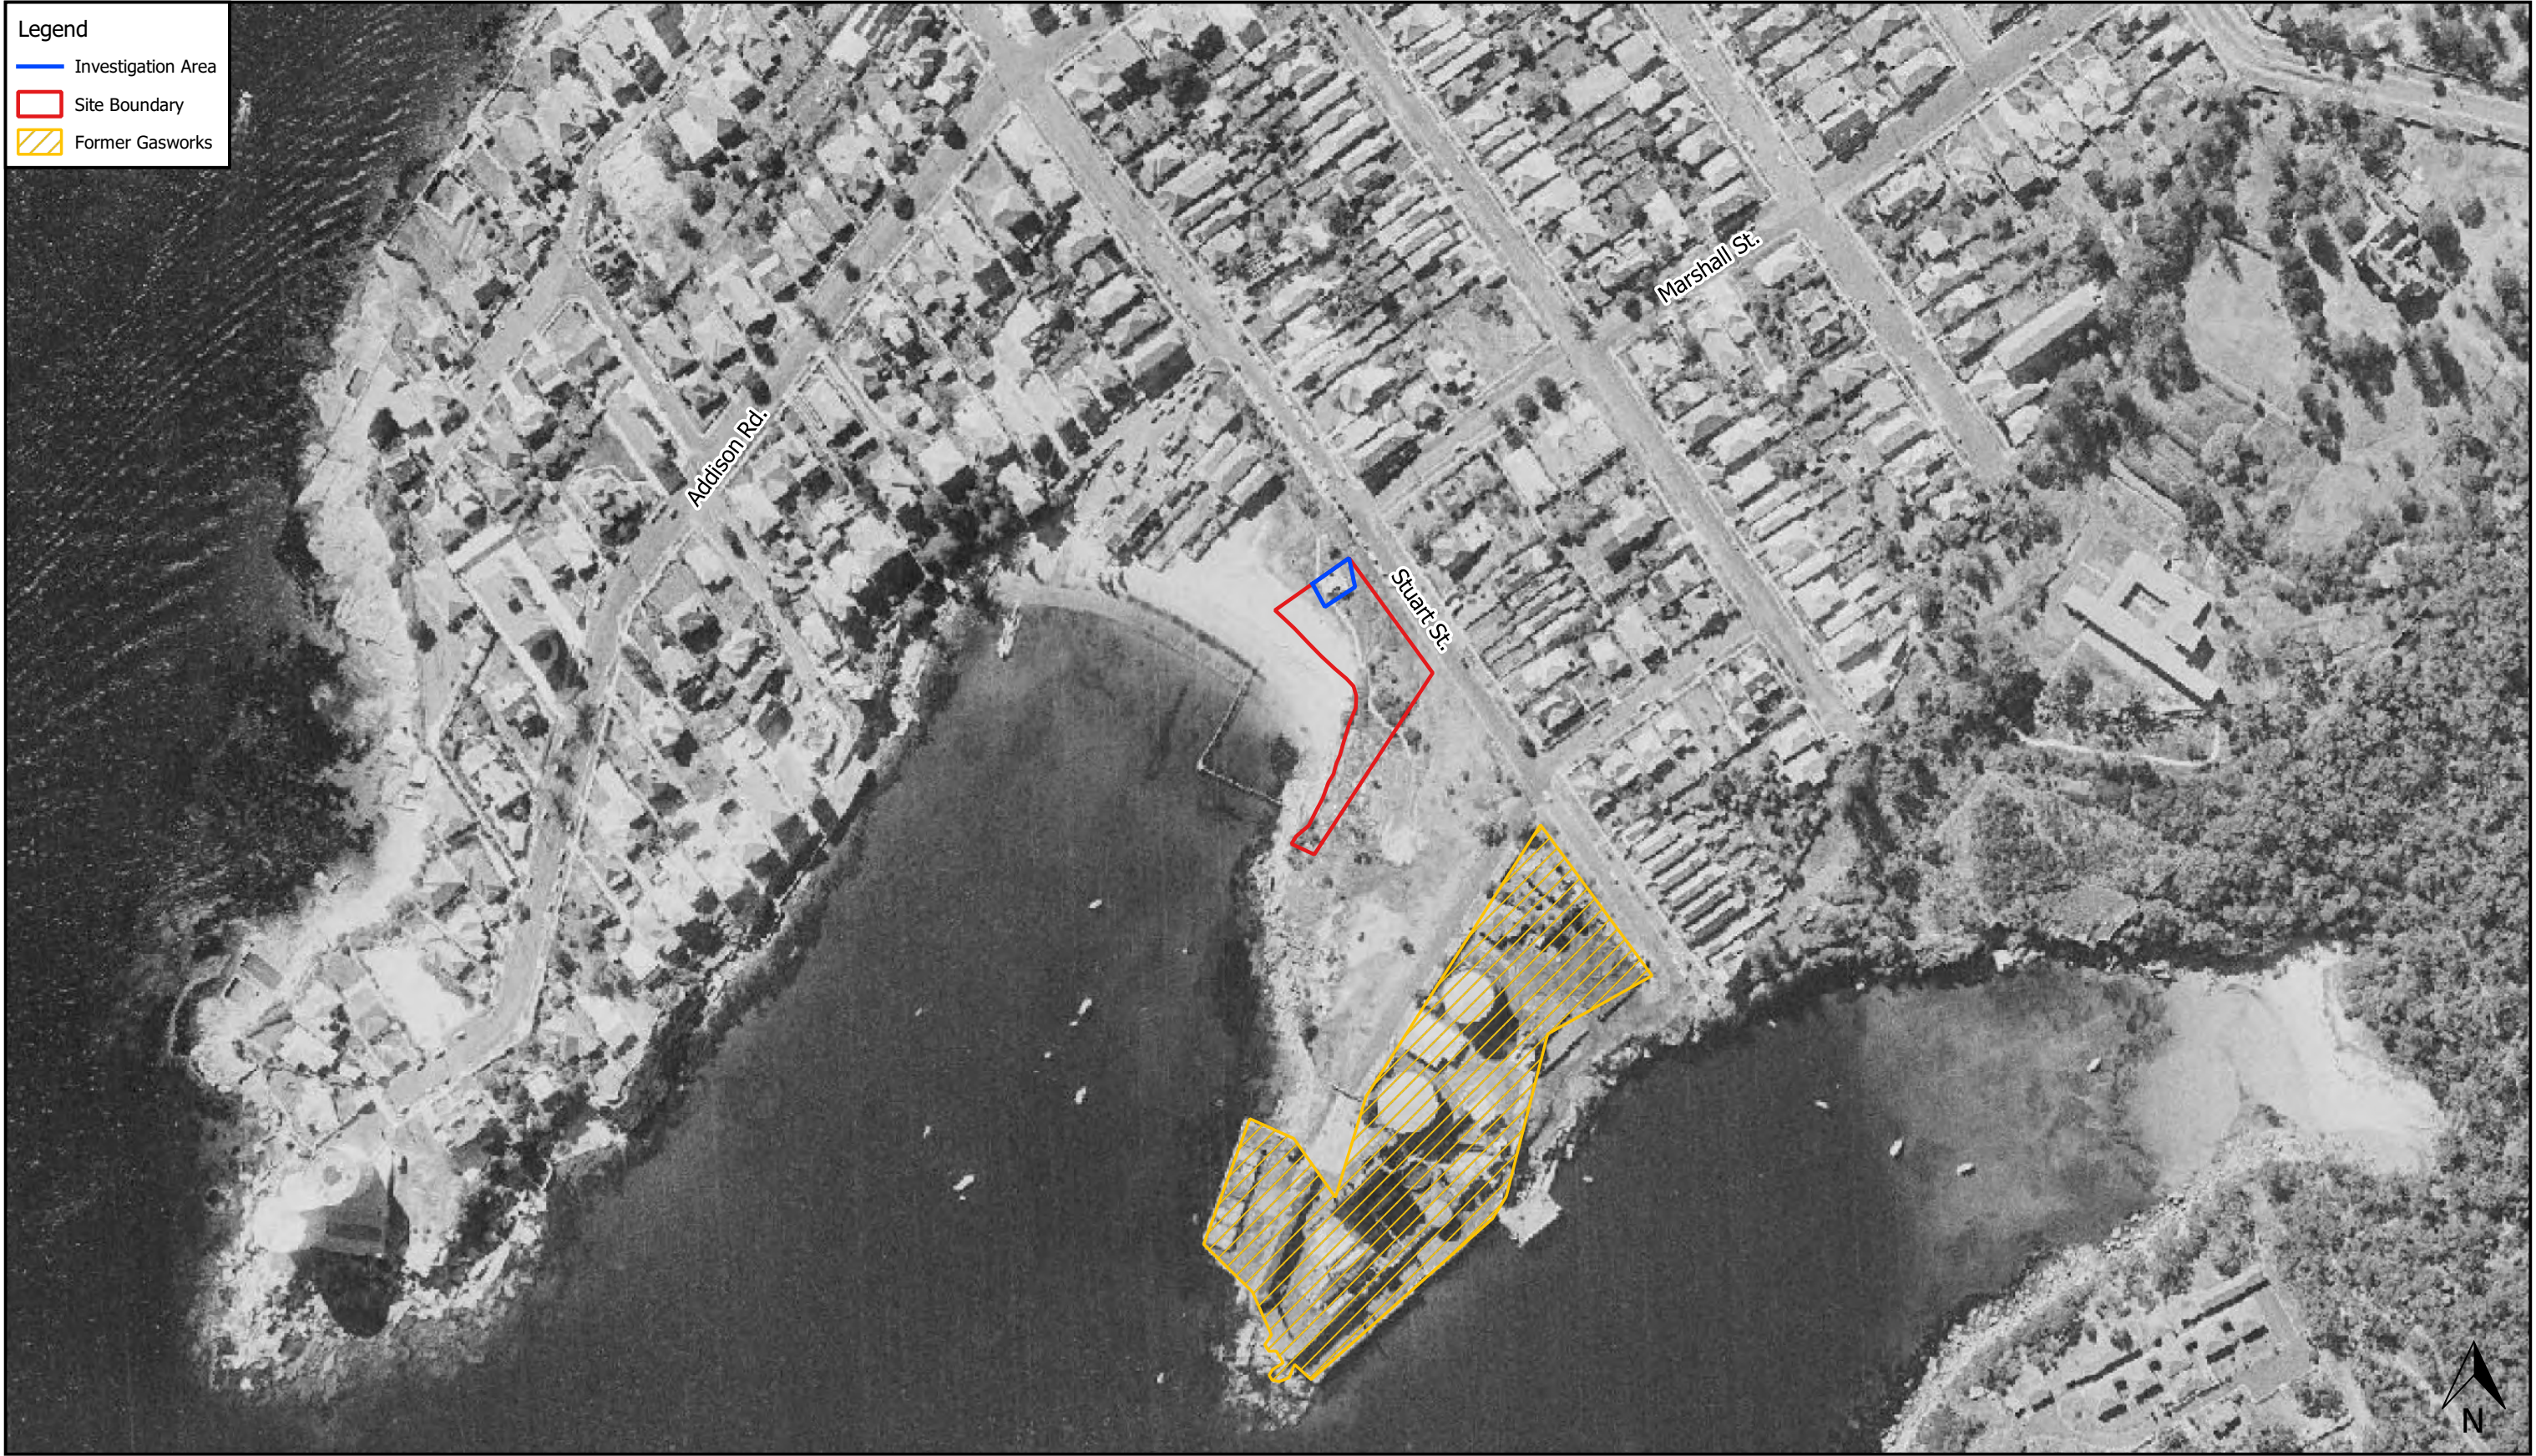
Map Title / Figure:
Historical Aerial - 1965

| Year | IA | Surrounding Land Use |
|---|--|--|
| 1965 | A structure has been constructed in the place of the existing café. A path has been constructed to the structure. | Little to no change from previous. |

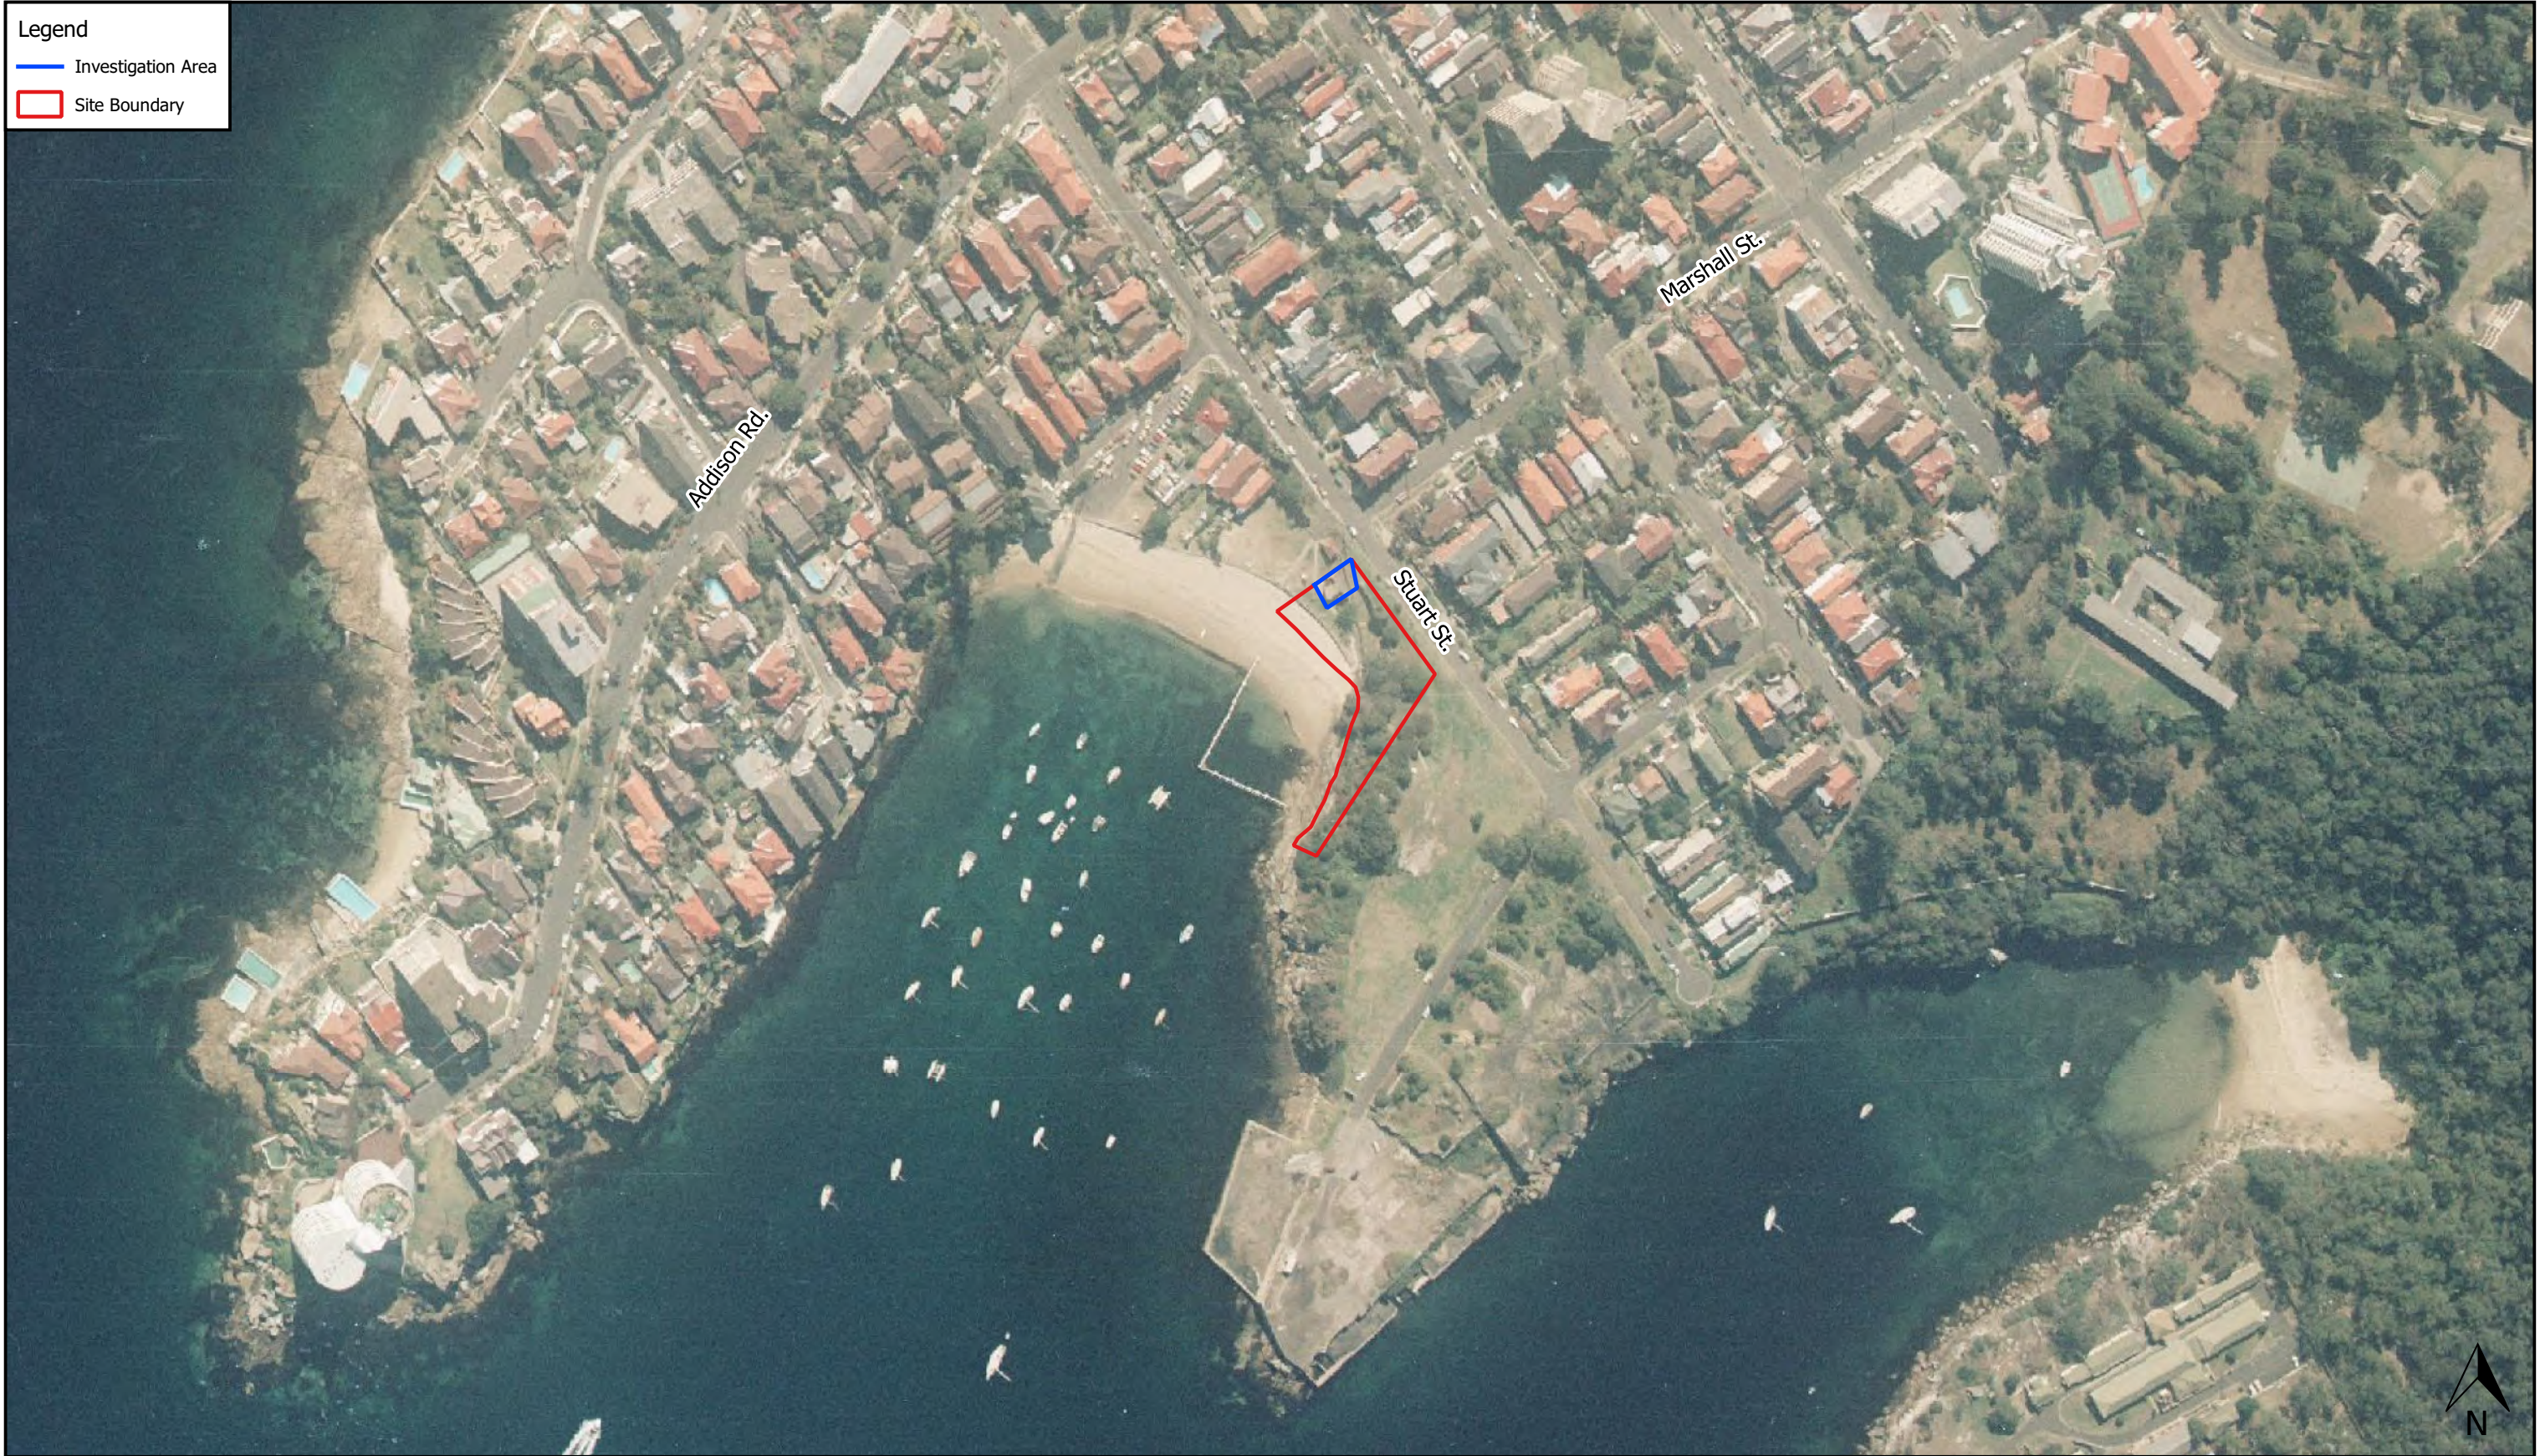
Map Title / Figure:
Historical Aerial - 1986

| Year | IA | Surrounding Land Use |
|---|--|--|
| 1986 | Little to no change from previous. | The former gasworks area has been redeveloped and landscaped into a park area. |

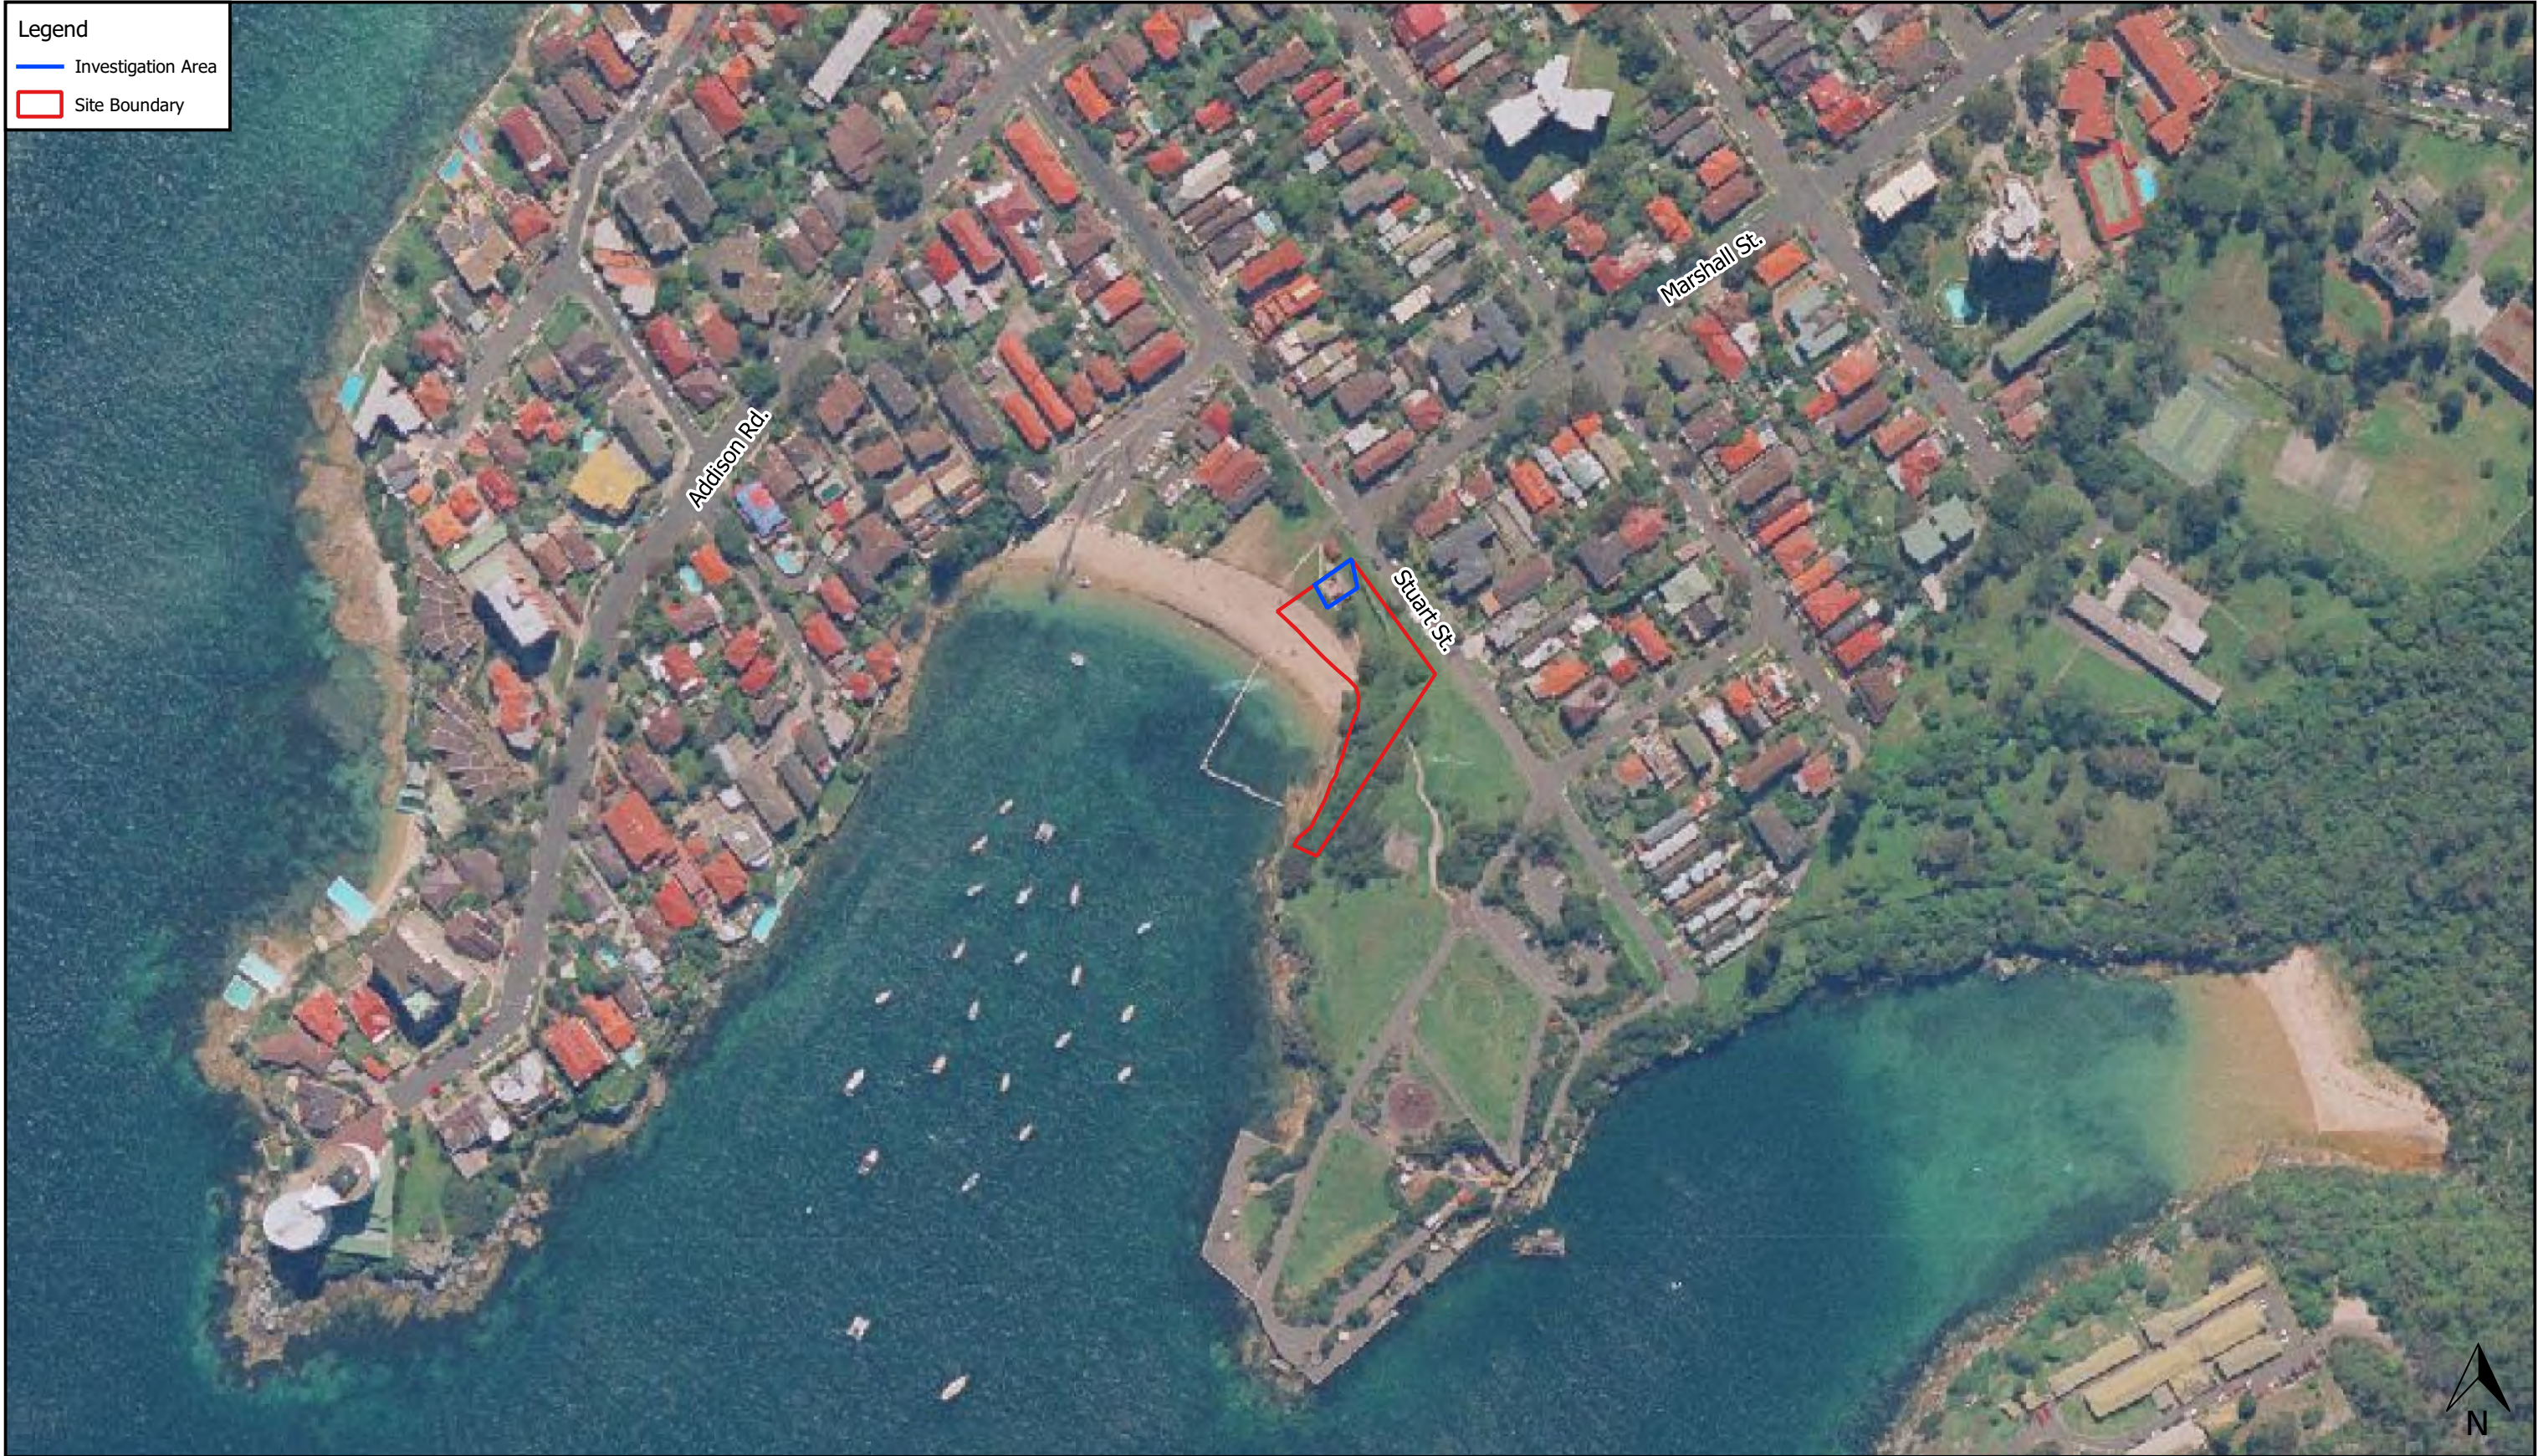
Map Title / Figure:
Historical Aerial - 1994

| Year | IA | Surrounding Land Use |
|---|--|--|
| 1994 | Little to no change from previous. | Little to no change from previous. |

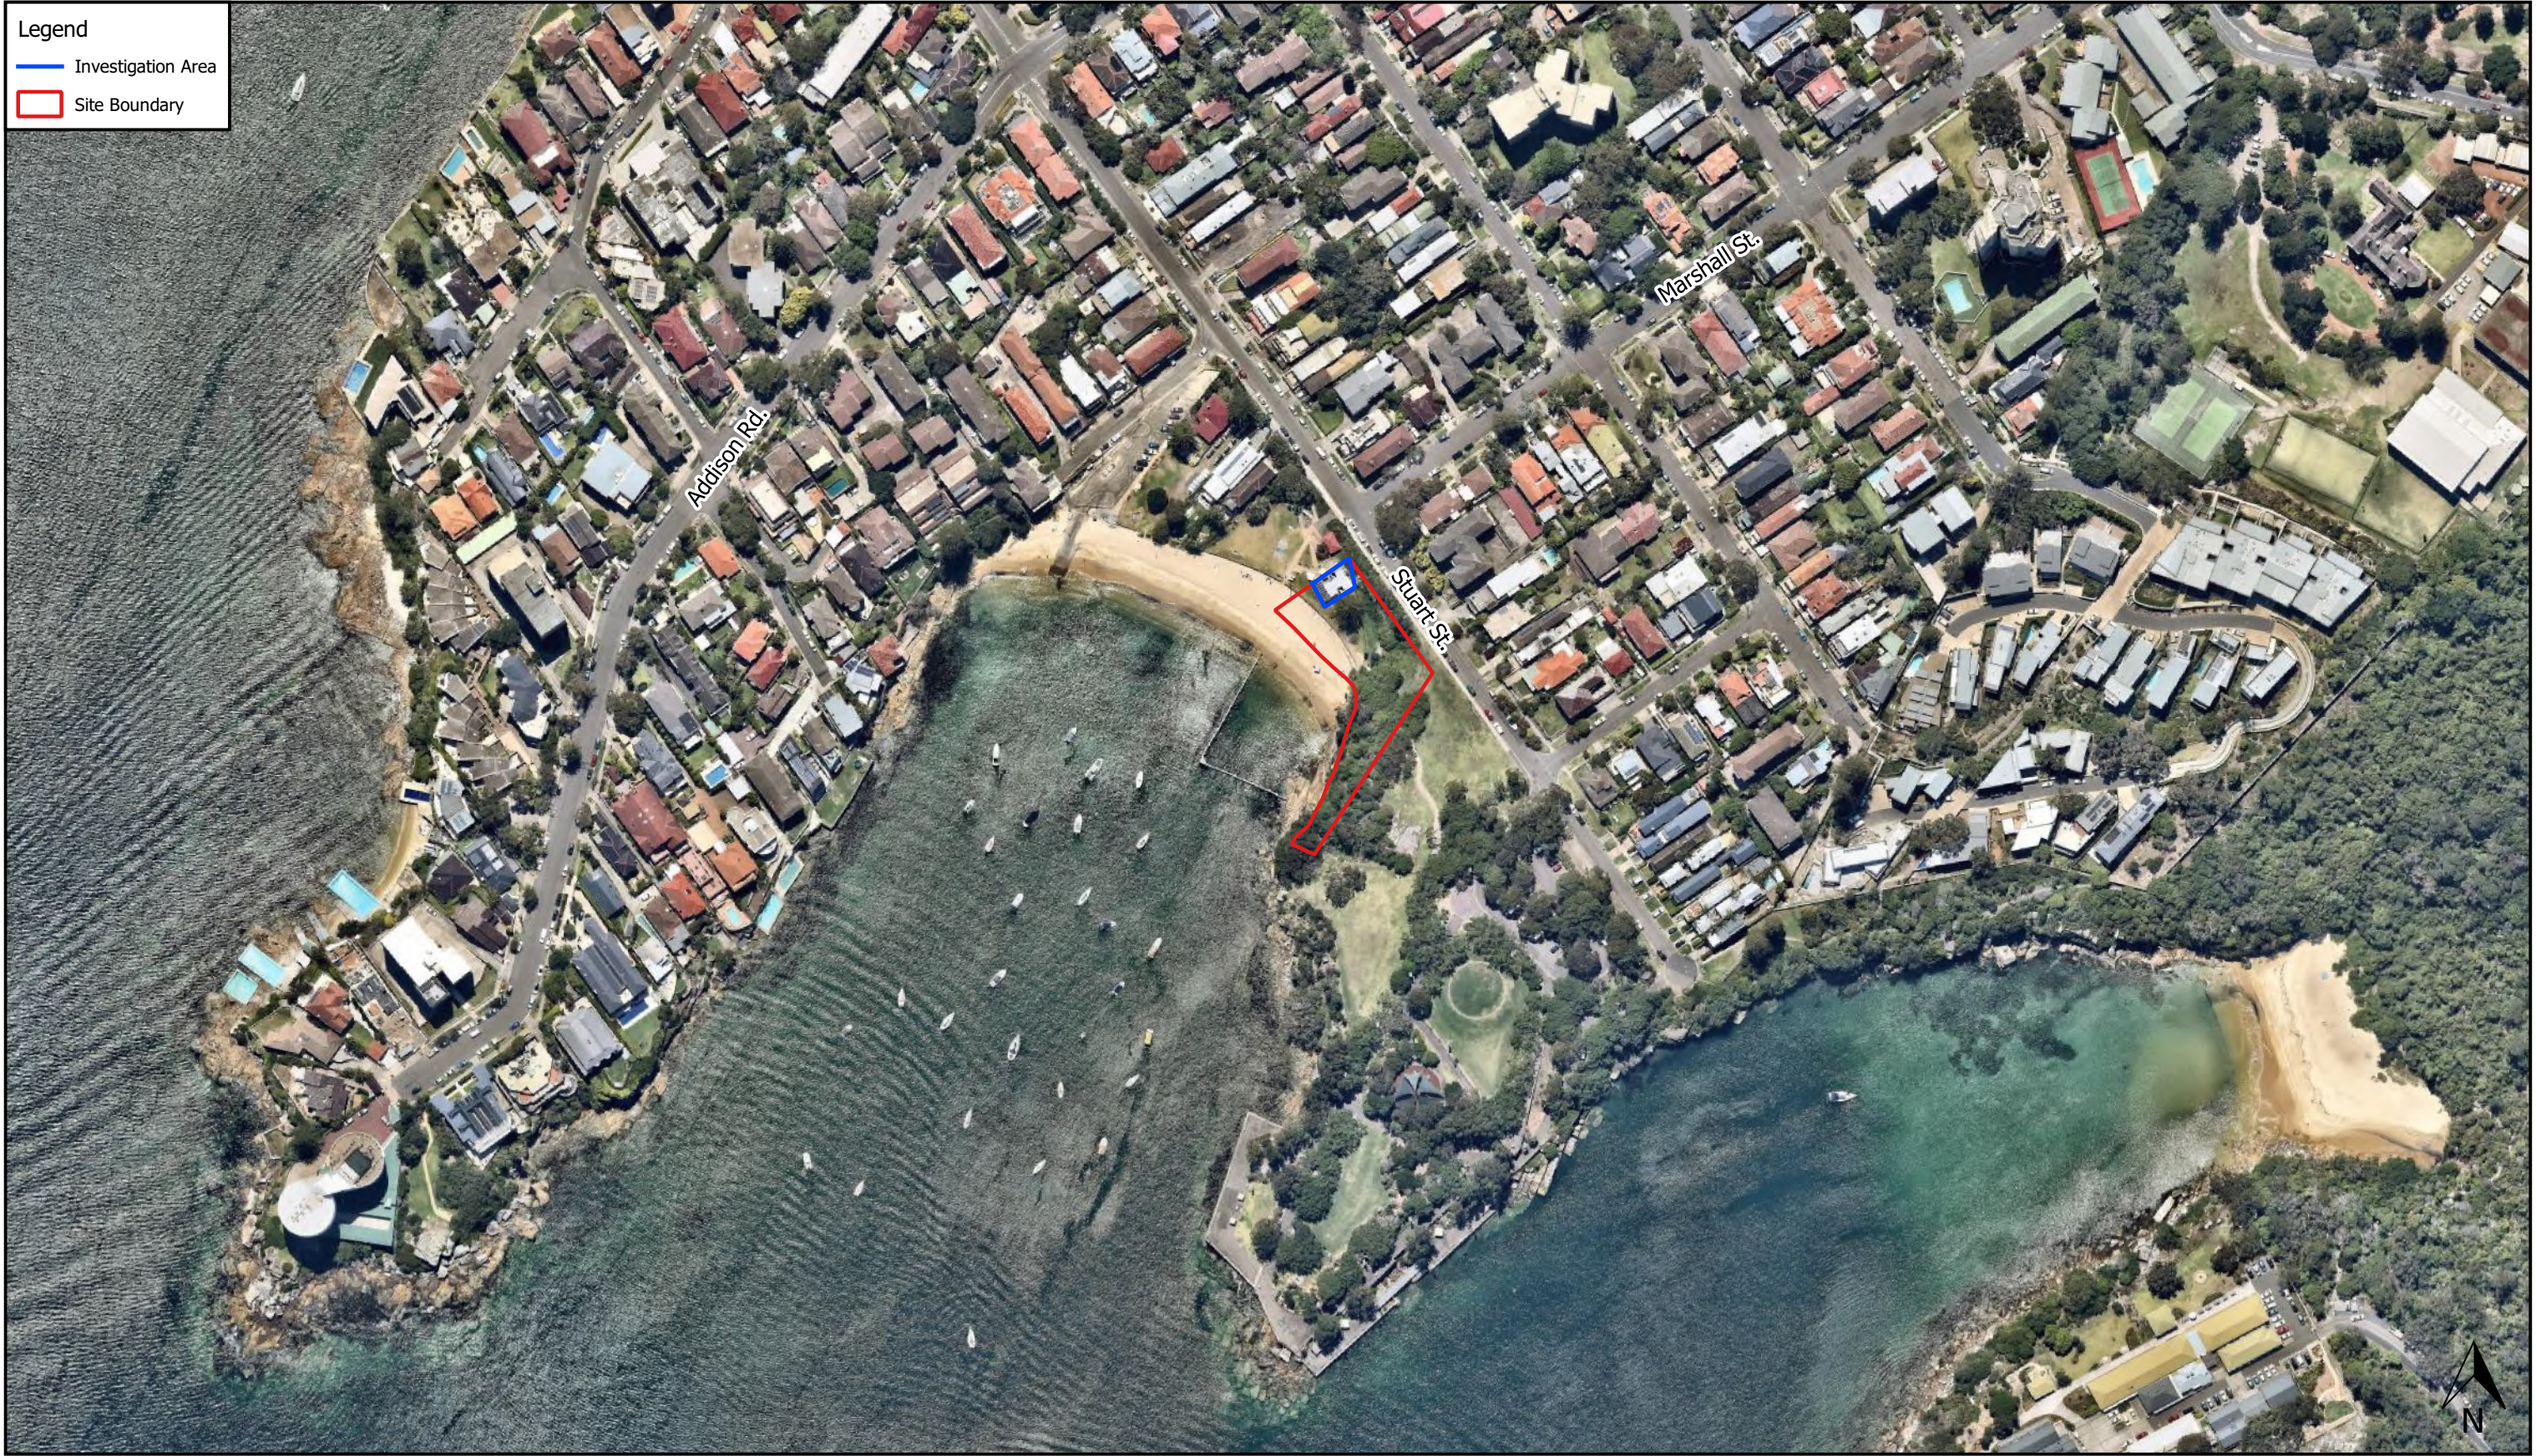
Map Title / Figure:
Historical Aerial - 2019

| Year | IA | Surrounding Land Use |
|---|--|--|
| 2019 | Little to no change from previous. | Little to no change from previous. |
