GEOTECHNICAL INVESTIGATION

NEW RESIDENTIAL DEVELOPMENT

53A & 53B WARRIEWOOD ROAD, WARRIEWOOD, NSW

Project No.: 2023-108

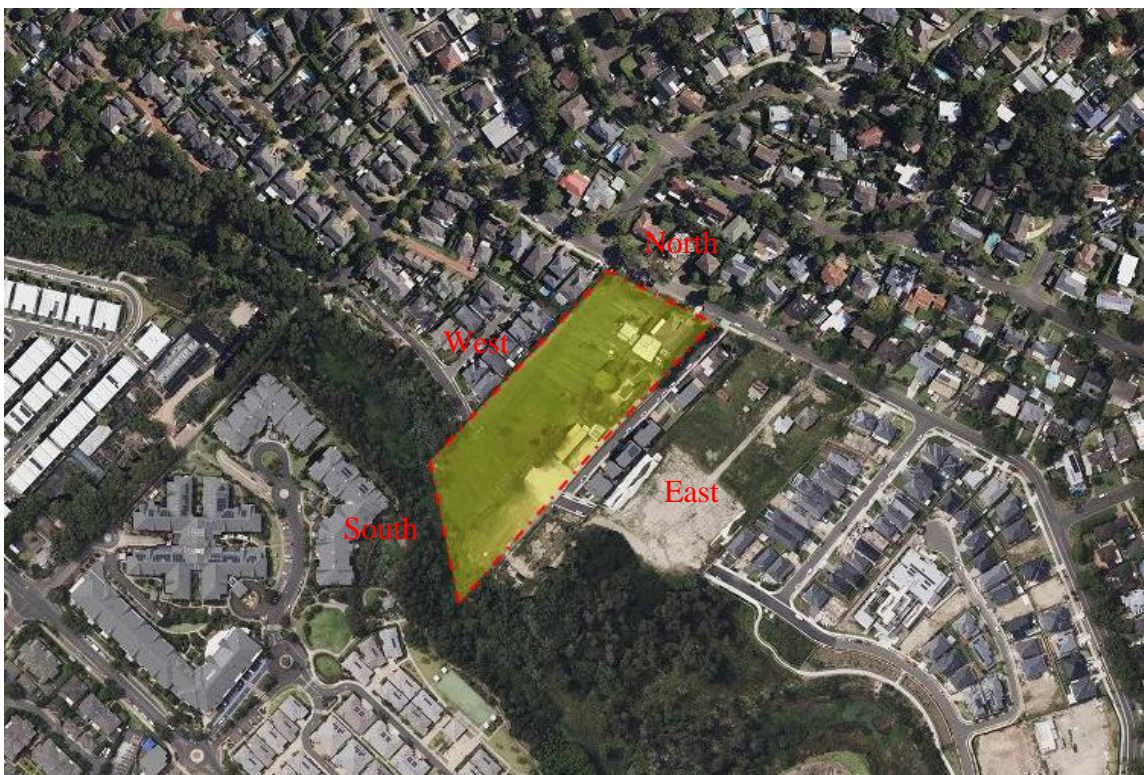
The combined site is a broadly trapezoidal shaped block on the southern side of Warriewood Road situated within gentle south to south west dipping topography that extends down to Narrabeen Creek which forms the southern site boundary. The site currently contains a two storey masonry dwelling towards the northern end of No. 53b, a single storey timber and weatherboard dwelling situated towards the northern end of 53a and a warehouse situated within the middle portion of No. 53b. A photograph of the site and surrounds is shown below in Photograph 1 with boundary designations.

Photograph 1: Aerial view of the site and surrounds (NSW Gov't Six Map Spatial Data)

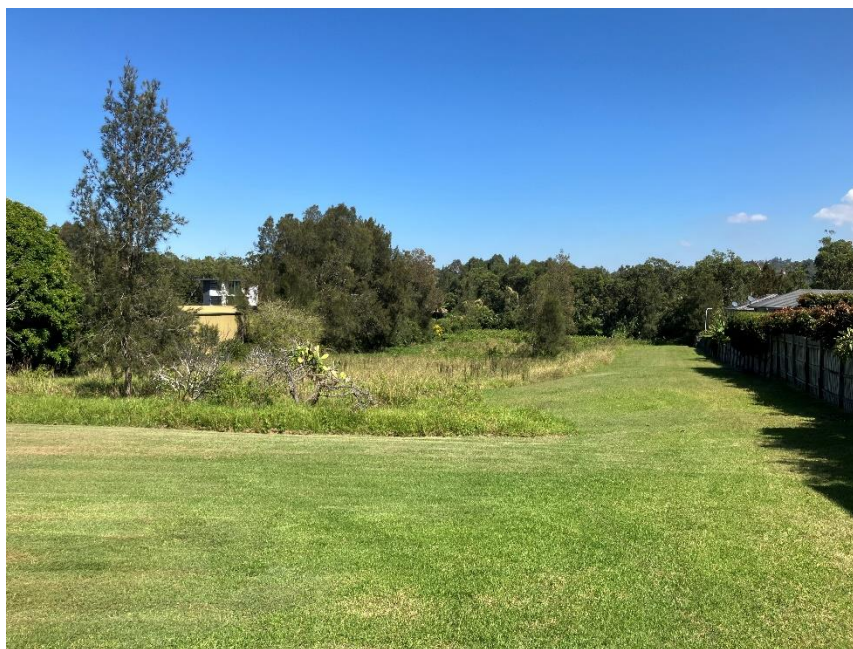
No. 53a, which comprises the western portion of the site contains a single storey timber and weatherboard dwelling situated towards the front northern end of the site and accessed by a gentle to moderate south west dipping driveway. The remainder of the site, with the exception of a few minor ancillary structures, is vacant and typically comprises an open, gentle south west dipping field. The western edge of the property adjacent to the western site boundary is slightly elevated with respect to the rest of the site, understood to be as a result of placed fill soils associated with the neighbouring development. Photograph 2 below provides a view of No. 53a.

Photograph 2: View of No. 53a, looking broadly south

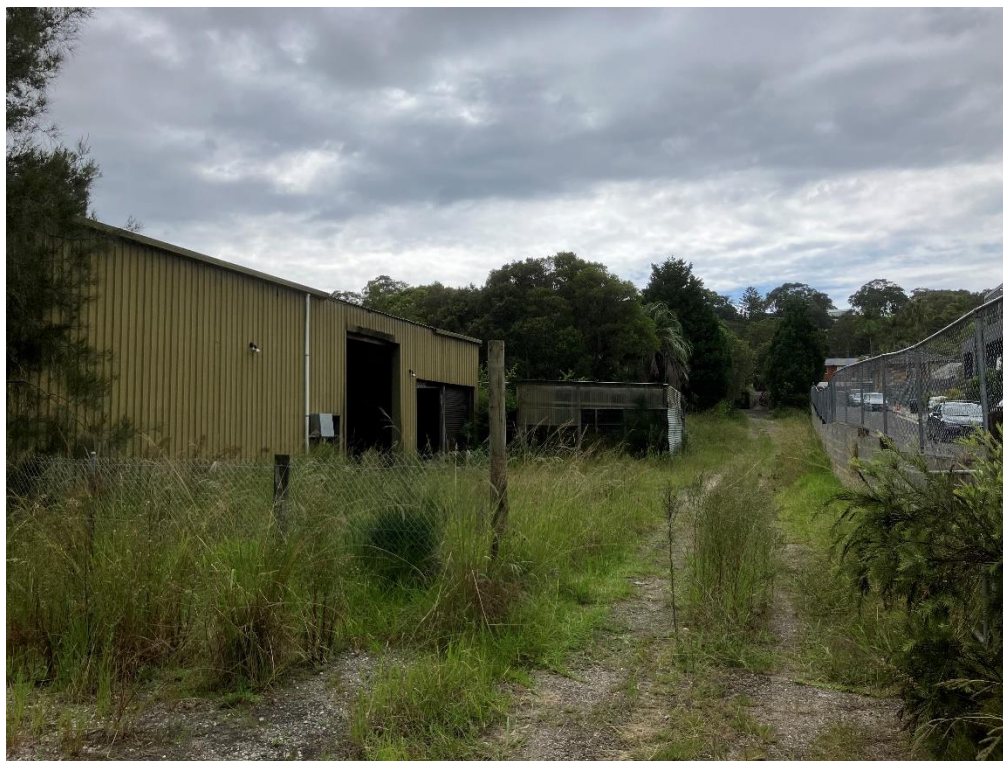
No. 53b, which comprises the eastern portion of the site contains a two storey masonry residential dwelling situated towards the northern end of the site with an in ground pool situated adjacent to the rear southern edge of the dwelling. A gently south west dipping driveway extends along the eastern site boundary and provides access to the rear portion of the site where a warehouse structure is situated along with a relatively flat cleared area, understood to have previously been used for vehicle storage. Photograph 3 below provides a view of No. 53b.

Photograph 3: View of No. 53b, looking broadly north from the rear portion of the property

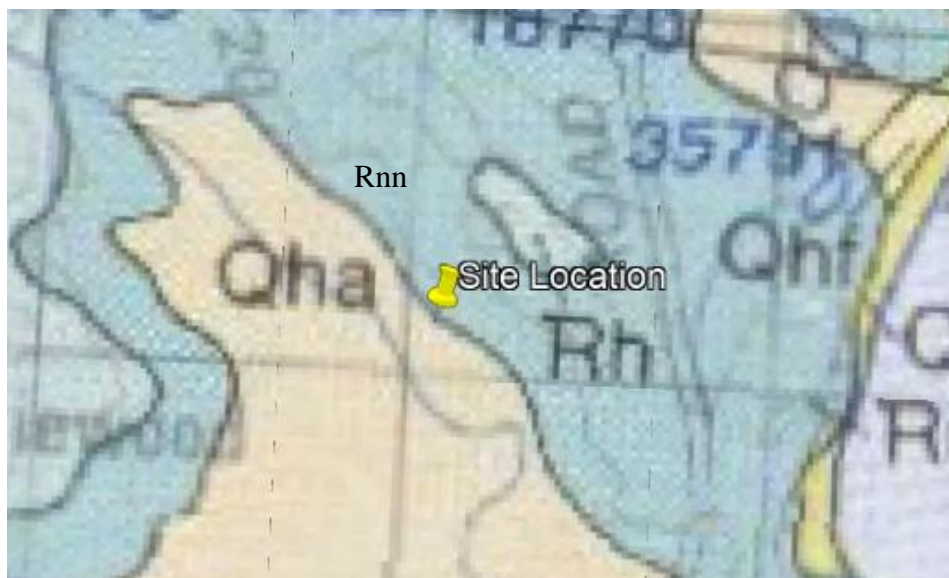
Reference to the Sydney 1: 100,000 Geological Series sheet (9130) indicates that the site is situated near the boundary of The Newport Formation (Upper Narrabeen Group) rock (Rnn) and Quaternary Sands (Qha). The rock unit is of middle Triassic age and typically comprises interbedded laminite, shale and quartz to lithic quartz sandstones and pink clay pellet sandstones and tends to weather to a significant depth. The sands typically comprise silty to peaty quartz sand silt and clay.

Extract 1: Sydney (9130 Geology Series Map): 1: 100000 – Geology underlying the site

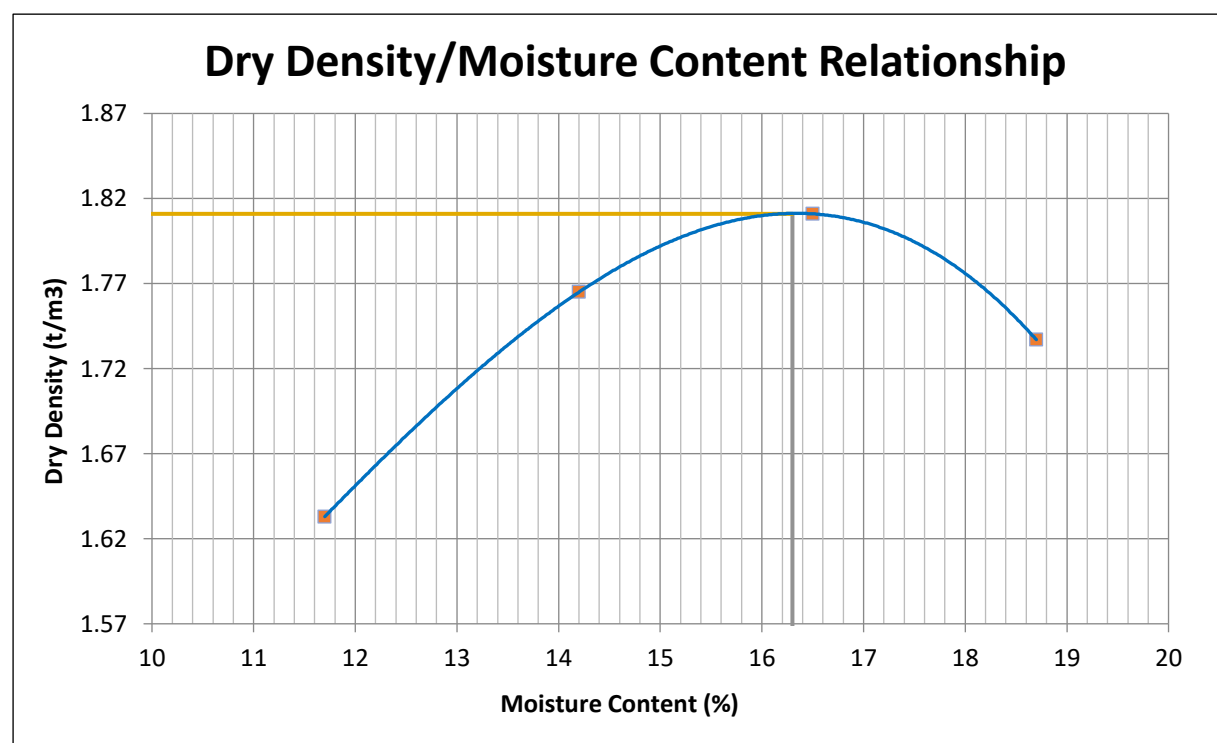
DRY DENSITY / OPTIMUM MOISTURE CONTENT REPORT

Maximum Dry Density (t/m ³)	1.81
Optimum Moisture Content (%)	16.3
Oversize Retained on 19mm sieve (%)	0
Oversize Retained on 37.5mm sieve (%)	0
Curing Time	69 hrs
Liquid Limit Determination	Technician Assessment

One bulk soil sample was tested to determine laboratory moisture density relationship (Standard) for assessment of maximum dry density (MMD) and the optimum moisture content. The results of the testing are summarised in the table below.

Sample Location	Description	Maximum Dry Density (t/m ³)	Optimum Moisture Content (%)
BH3a, 0.50m	Sandy Silty Clay	1.81	16.3

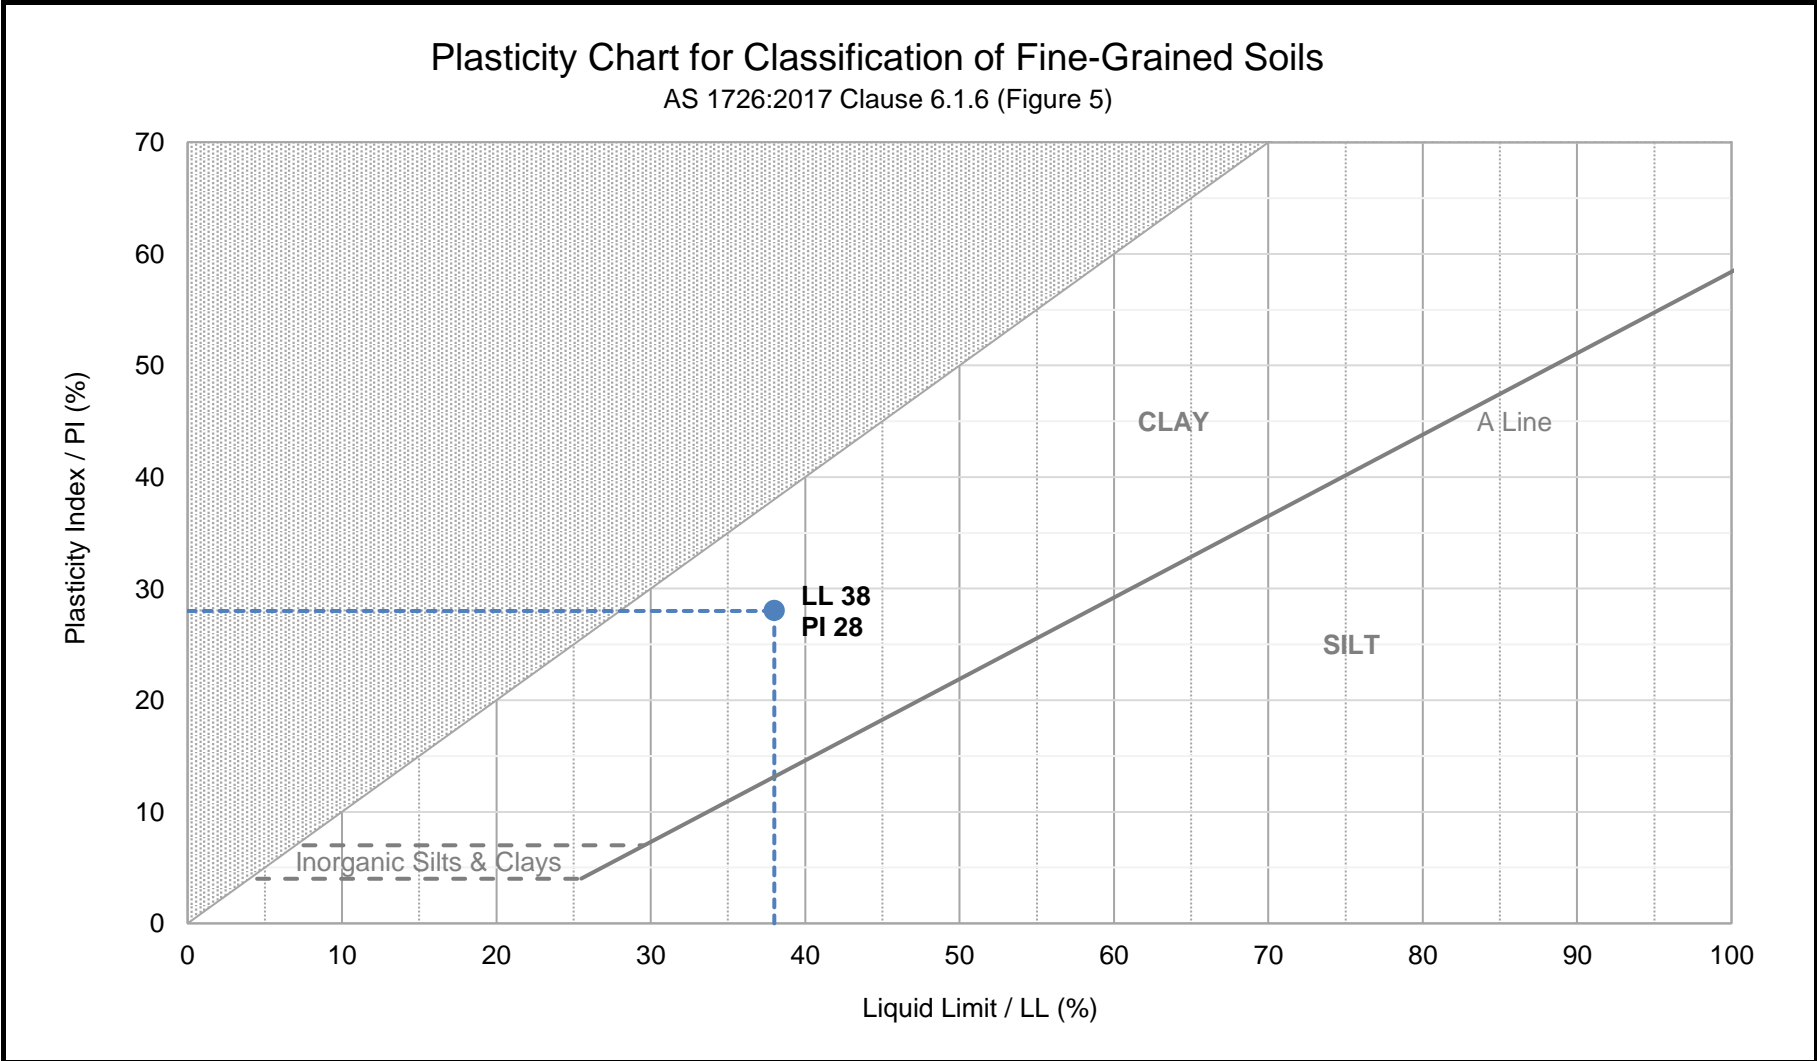
SOIL CLASSIFICATION REPORT

Client	Crozier Geotech	Source	BH2 2.50m
Address	Unit 12/ 42-46 Wattle Street Brookvale NSW 2100	Sample Description	Silty CLAY
Project	53a & 53b Warriewood Road (2023-108)	Report No.	S95382-PI
Job No.	S24155-1	Lab No.	S95382
Test Procedure	<div><div><input type="checkbox"/> AS1289 3.1.1</div><div>Liquid Limit - Four point Casagrande method</div><div><input type="checkbox"/> AS1289 3.1.2</div><div>Liquid Limit - One point Casagrande method</div><div><input checked="" type="checkbox"/> AS1289 3.2.1</div><div>Plastic Limit - Standard method</div><div><input checked="" type="checkbox"/> AS1289 3.3.1</div><div>Calculation of the Plasticity Index</div><div><input type="checkbox"/> AS1289 3.4.1</div><div>Linear Shrinkage - Standard method</div></div>		
Sampling	Sampled by Client - results apply to the sample as received	Date Sampled	28/03/2024
Preparation	Prepared in accordance with the test method	Date Tested	15/04/2024

Dry Sieved	38
Air Dried	10
	28
