Hydrogeology Assessment and Groundwater Dewatering Management Plan

1-3 Gondola Road, North Narrabeen, NSW

Final Report

P2310036JR05V01

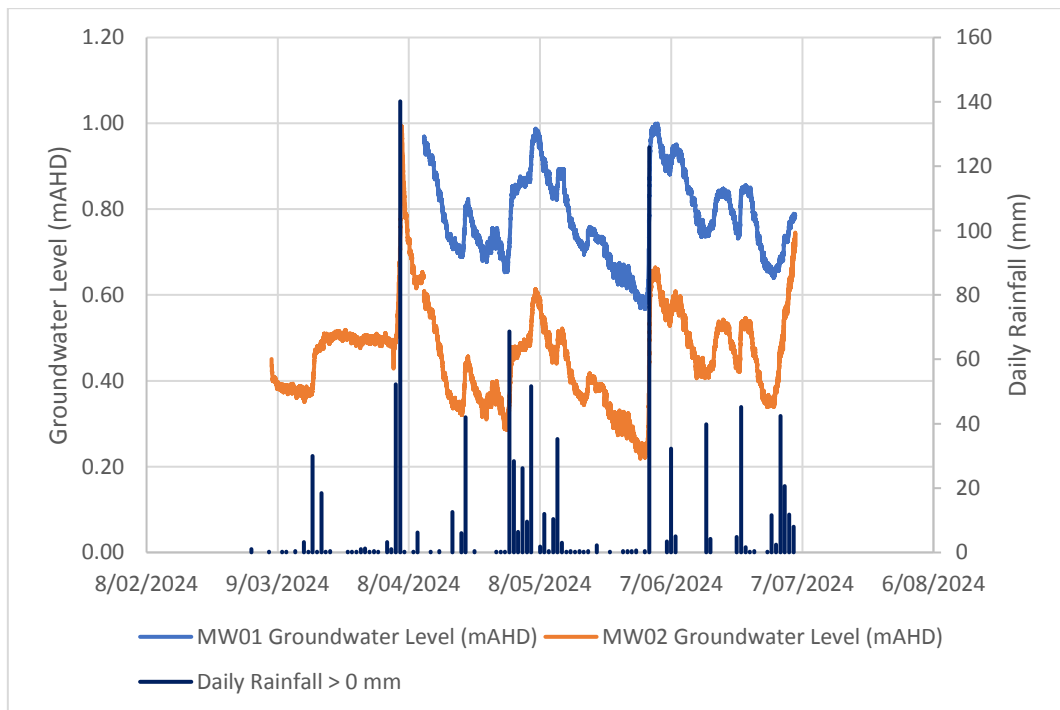
Figure 1: Plot of groundwater level data.

Some amount of groundwater level variation was recorded throughout the monitoring period. Rapid groundwater level response was observed during heavy or prolonged rainfall with increases in groundwater levels closely reacting to rainfall recharge. It is noted that the monitoring period was conducted during a period of consistent and at times heavy rainfall which is likely the reason for observed groundwater level variance. During dry periods with little to no rainfall, Site groundwater levels would be expected to remain generally stable.

The groundwater gradient across the Site was observed to be relatively flat with a slight gradient to the east (noting only two monitoring wells).

Dip meter measurements and continuous data logger recordings are summarised in Table 2 and Table 3 respectively, and a graphical plot of collected groundwater level data is provided in Figure 1.

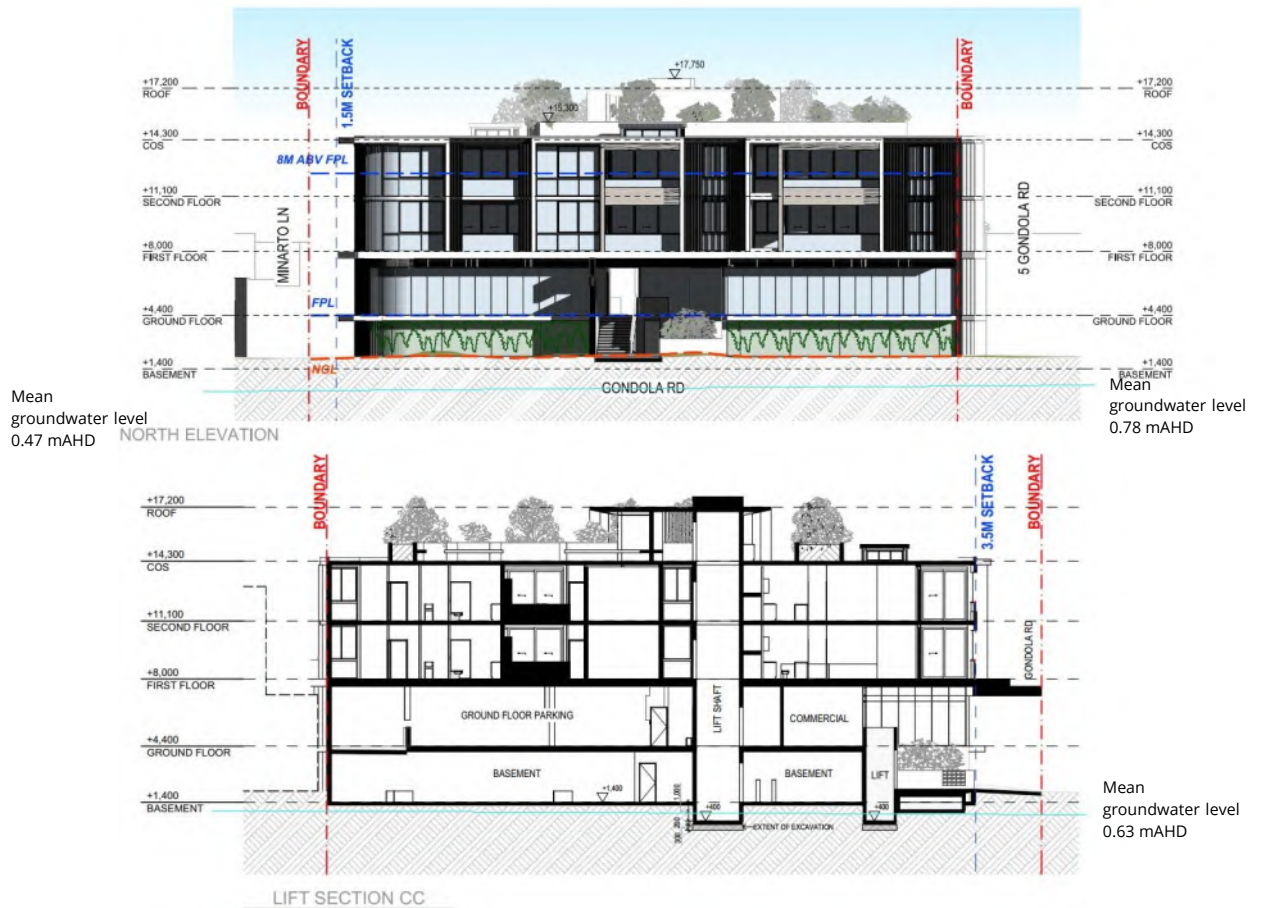
Figure 2: Expected mean groundwater level.

Based on Site construction plans, bulk excavation for construction of the basement will be across the Site is to be taken to 1.1 mAHD, with excavation of lift wells expected to be to -0.1 mAHD. Analysis of rainfall and groundwater levels indicated bulk excavation is only expected to intercept groundwater with occurrences of high rainfall with groundwater quickly returning to Site averages in the following days (Figure 1). Excavation of lift wells is expected to intercept approximately 0.73 m into the groundwater table.

A diagram showing approximate mean groundwater elevations across the Site is provided in Figure 2.

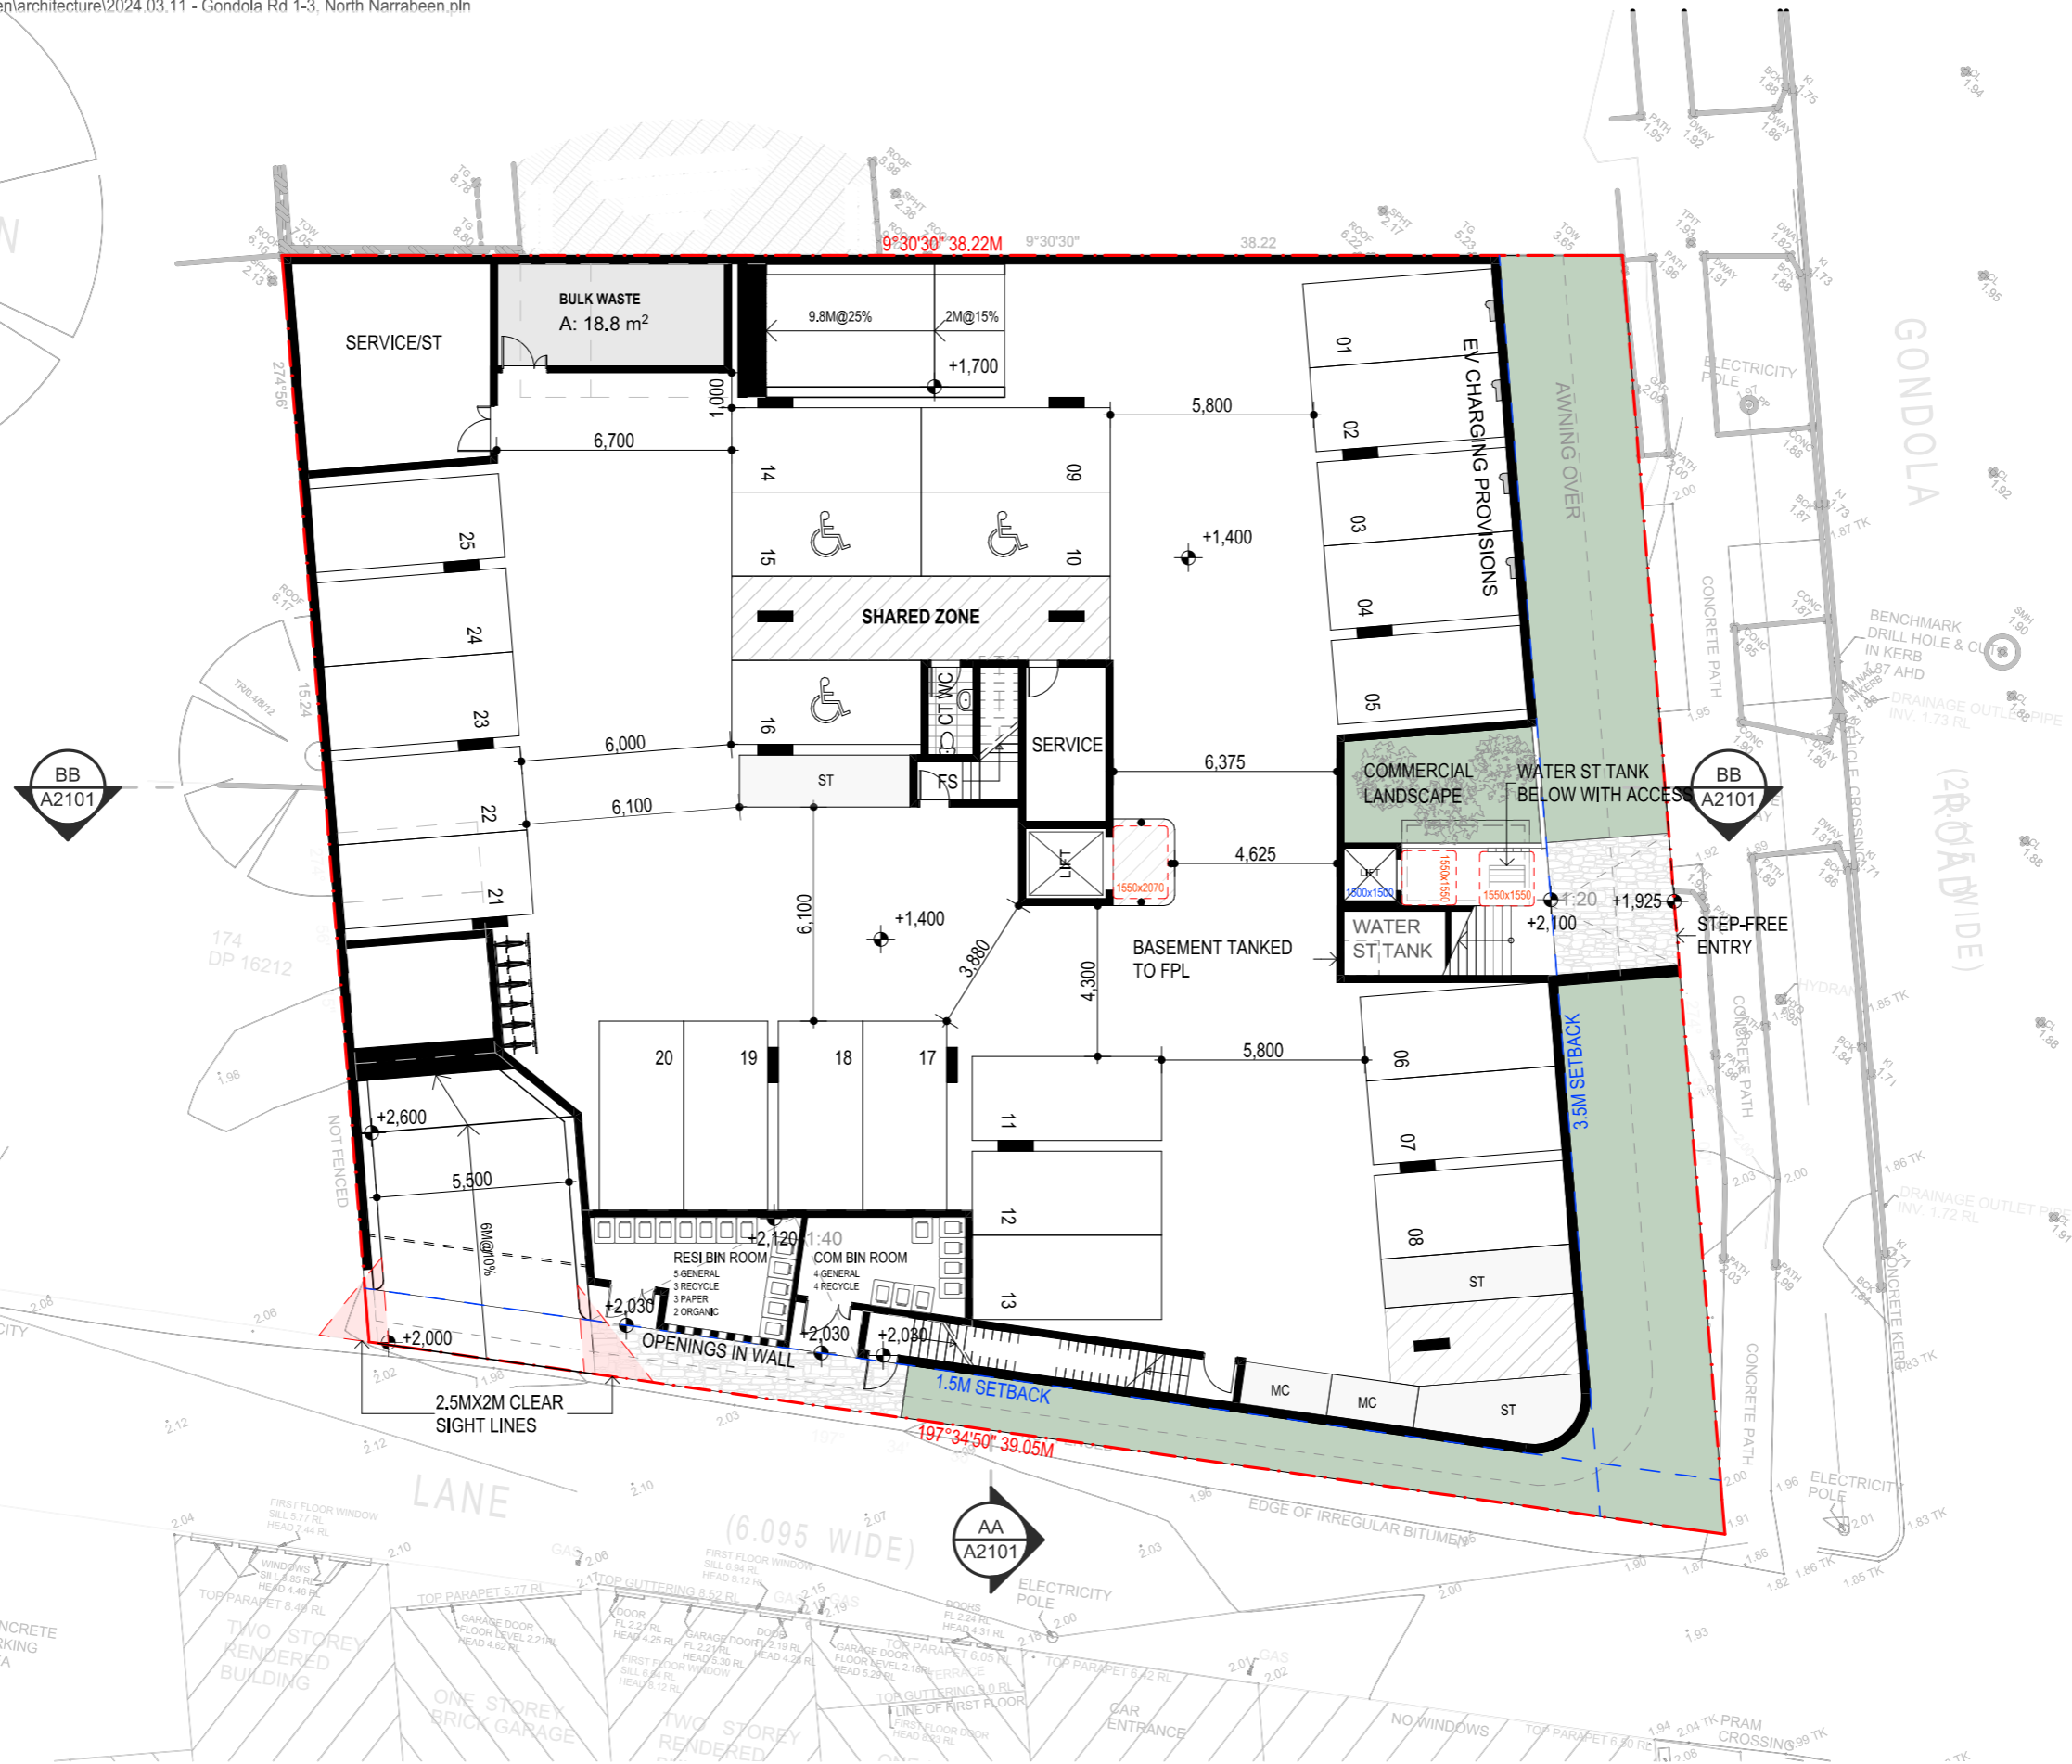
DRAWING: BASEMENT PLAN			
DRAWN BY	SCALE:	DRAWING NO.:	ISSUE:
J.E	1:200@A3	A1001	A
CHECKED BY			
D.M

The proposal includes a single level basement with a finished floor level of 1.4 m AHD, equivalent to a bulk excavation of up to approximately 1.2 m below existing ground level (**mbgl**) to allow for a 300 mm slab to be constructed. The eastern portion of the basement contains a garage ramp from Minarto Lane, grading from a proposed level of 2 m AHD to the basement finished floor level at 1.4 m AHD. Two lifts are proposed as part of the development are expected to have lift well base levels of approximately -0.1 m AHD.

Development plans and the approximate extent of the proposed basement is shown in Appendix B.
