Burley Katon Halliday Pty Ltd

Geotechnical Assessment: 9 Thyra Road, Palm Beach, NSW

P1806622JR02V03 March 2022

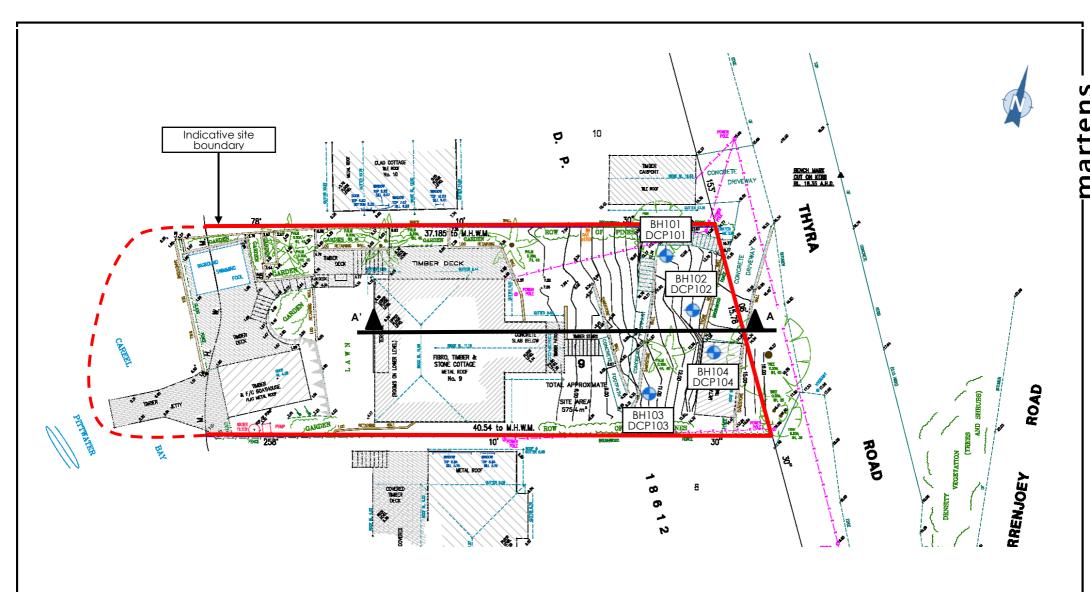
Martens & Associates Pty Ltd ABN 8	5 070 240 890	Environment Water Wastewater Geotechnical Civil Management						
Drawn:	AG		Drawing:					
Approved:	SK	EXISTING SITE SURVEY AND GEOTECHNICAL TESTING PLAN	FIGURE 1					
Date:	13.08.2021	9 Thyra Road, Palm Beach, NSW						
Scale:	NA	Source: BL, 2006	Job No: P1806622JR02V02

Item	Details
	presented in MA's report referenced P1806622JR01V02, dated March 2019. Results of the assessments have been reproduced in this report.
	MA's engineer performed the site investigation on 5 May 2021. From the site investigation, it is observed that the site seems to be in similar condition as when previous geotechnical investigation was completed in 2018. The previous scope of geotechnical investigations are considered relevant for the site including recommendations since changes to the proposed development are minor.
	Investigation locations are shown in Figure 1, Attachment A.

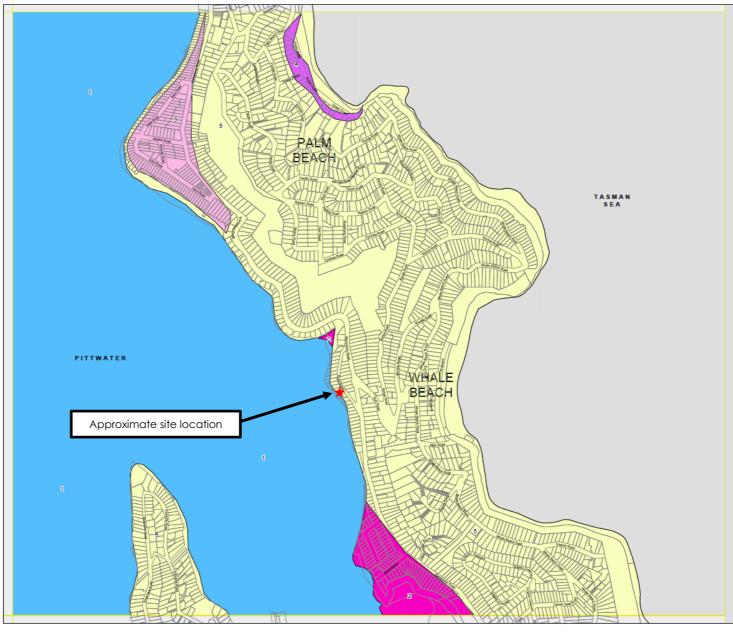
Martens & Associates Pty Ltd ABN 85 070 240 890	Environment Water Wastewater Geotechnical Civil Management						
Drawn: AG		Drawing:					
Approved: SK	SITE LOCATION RELATIVE TO ASS RISK MAP	FIGURE 3					
Date: 06.05.2021	9 Thyra Road, Palm Beach, NSW						
Scale: NA	Source: Pittwater Council LEP, 2014	Job No: P1806622JR02V01

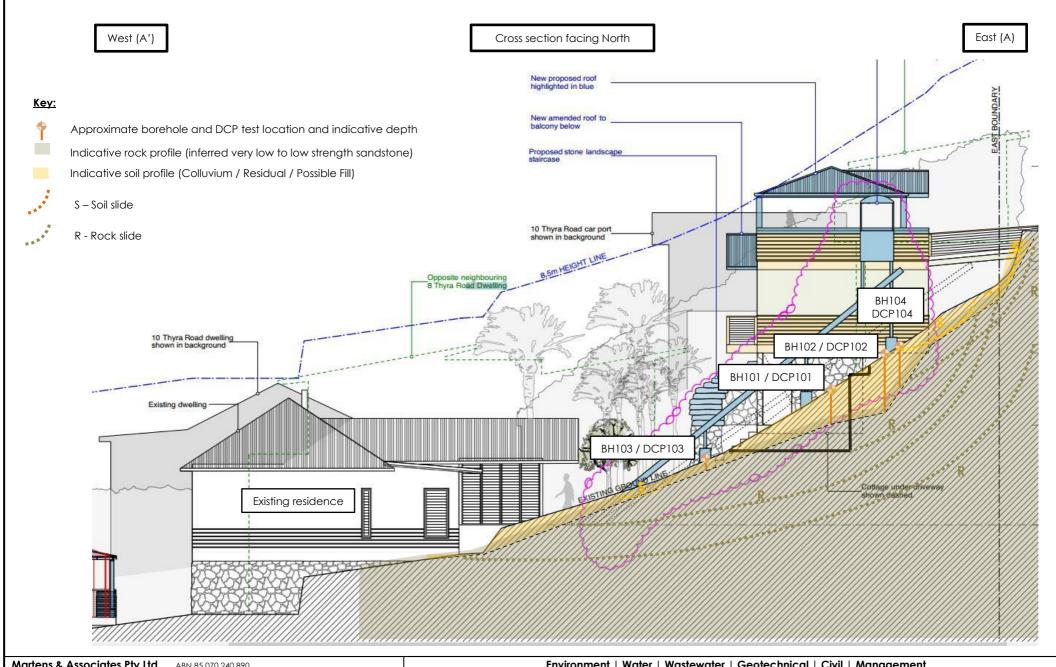
Geological cross section (Figure 3)

Mariens & Associates Fly Lia ABN 85	0/0 240 890	Environment water wastewater Geolectrinical Civil Management						
Drawn:	AG		Drawing:					
Approved:	SK	INFERRED GEOLOGICAL CROSS SECTION SHOWING POSSIBLE INSTABILITY RISKS	FIGURE 2					
Date:	13.08.2021	9 Thyra Road, Palm Beach, NSW						
Scale:	NA	Source: Modified from BKH, 2021	Job No: P1806622JR02V02

Comment
Within highly undulating terrain, approximately at the base of a southwest facing slope.
South westerly aspect with grades up to approximately 30%. Site elevation ranges between approximately 1.5 mAHD (western site boundary) and 16.5 mAHD (south eastern site corner along Thyra Road).
The existing development include: Single storey fibro, timber and stone residence with associated timber decking, corrugated roof. In-ground swimming pool, timber boat house and jetty, Carport, retaining / garden walls and concrete pathway and steps in good working condition.
Grass, landscaped gardens, shrubs and trees. Eastern portion of the site is heavily vegetated with small shrubs.
Via overland flow into Careel Bay, located along the western site border.
Narrabeen Group comprising interbedded sandstone, siltstone and shale (Sydney 1:100 000 Geological Sheet 9130, 1^{st} edition).
 Unit A: Topsoil comprising very soft and soft sandy silt / clayey silt up to approximately 0.3 mBGL. Unit B: Colluvium (possible fill from upslope road cuts) comprising silty clay with consistencies generally between very soft and soft, and firm up to approximately 0.55 mBGL. Unit C: Residual clay, silty clay and sandy clay, generally firm grading to very stiff to hard near the transition into rock and hand auger refusal depths of up to 1.7 mBGL. Unit D: Weathered and inferred very low to low strength sandstone / siltstone / shale below DCP refusal between 1.25 mBGL (DCP103) and investigation termination depth of 2.05 mBGL (DCP104). For the purpose of this report, rock below DCP refusal depths is assumed to be of very low to low strength, with possible lower and / or higher strength bands, which should be confirmed / revised by further assessment, as necessary. Top of weathered rock is expected to step down towards the south west across the site.
