Report Title: Geotechnical Report 94 Whale Beach Road, Whale Beach
Report Date: 21/12/21

GEOTECHNICAL INVESTIGATION:

New Deck and Gym at **94 Whale Beach Road, Whale Beach**

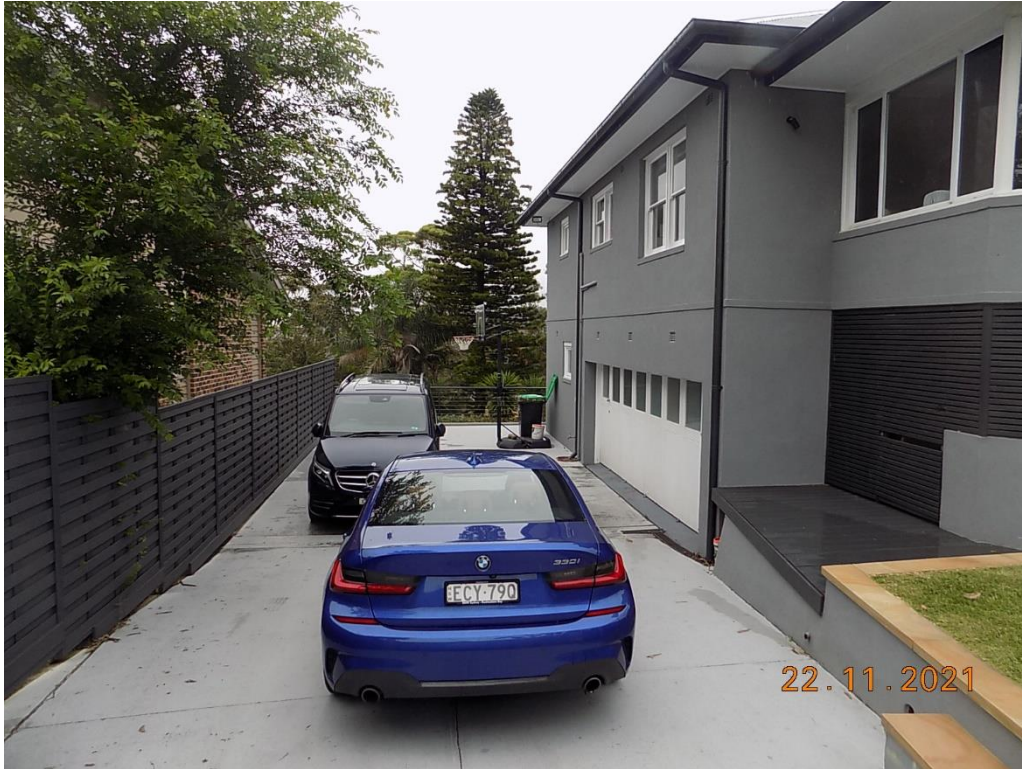
Photo 1

- 2.3** At the road frontage, a concrete driveway runs down the slope to a garage underneath the E side of the house (Photo 1). In between the road frontage and the house is a level lawn area (Photo 2). The part-two storey rendered brick house is supported on rendered brick walls and brick piers (Photo 3). The brick walls show no significant signs of movement and the brick piers stand vertical. A cut to create the level platform for the house is supported by a stable ~1.3m high concrete retaining wall (Photo 4). A pool has been cut into the slope on the downhill side of the property (Photo 5). No significant signs of movement were observed in the concrete shell of the

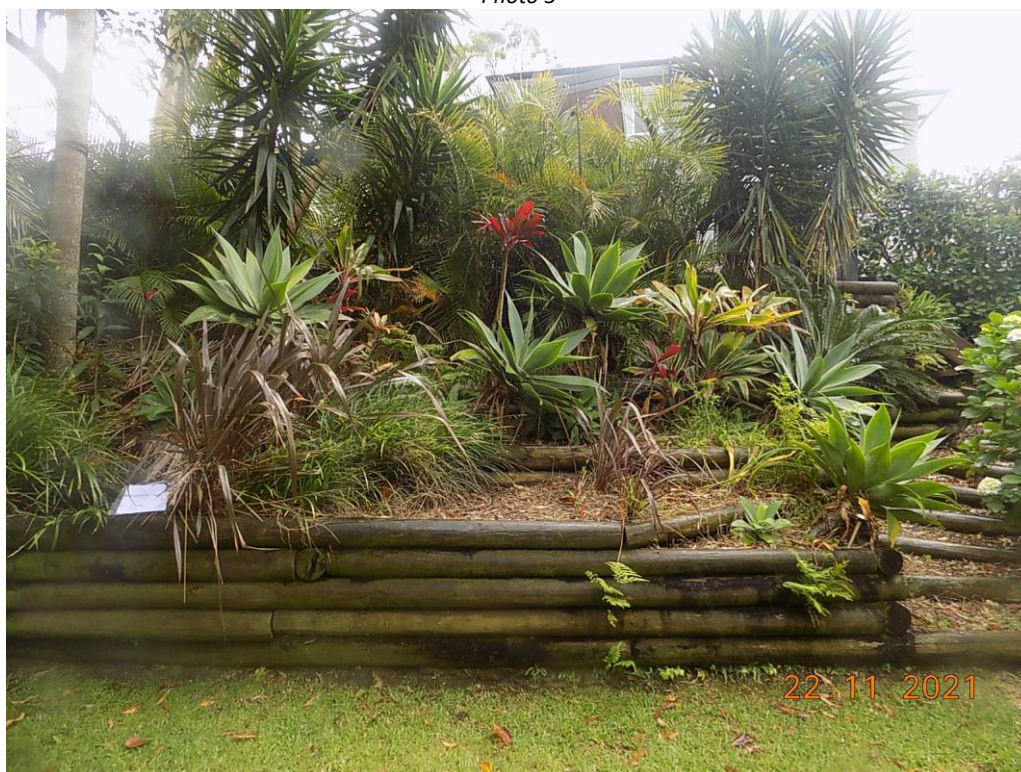
Photo 6

pool. Immediately below the pool deck, a series of timber log retaining walls reaching up to ~1.5m in height terrace the slope to the lower common boundary (Photos 6 & 7). Several of these retaining walls are tilting to a maximum angle of ~15°. These timber log retaining walls are to be demolished and rebuilt as part of the proposed works. A moderately sloping lawn extends to the lower common boundary (Photo 8).

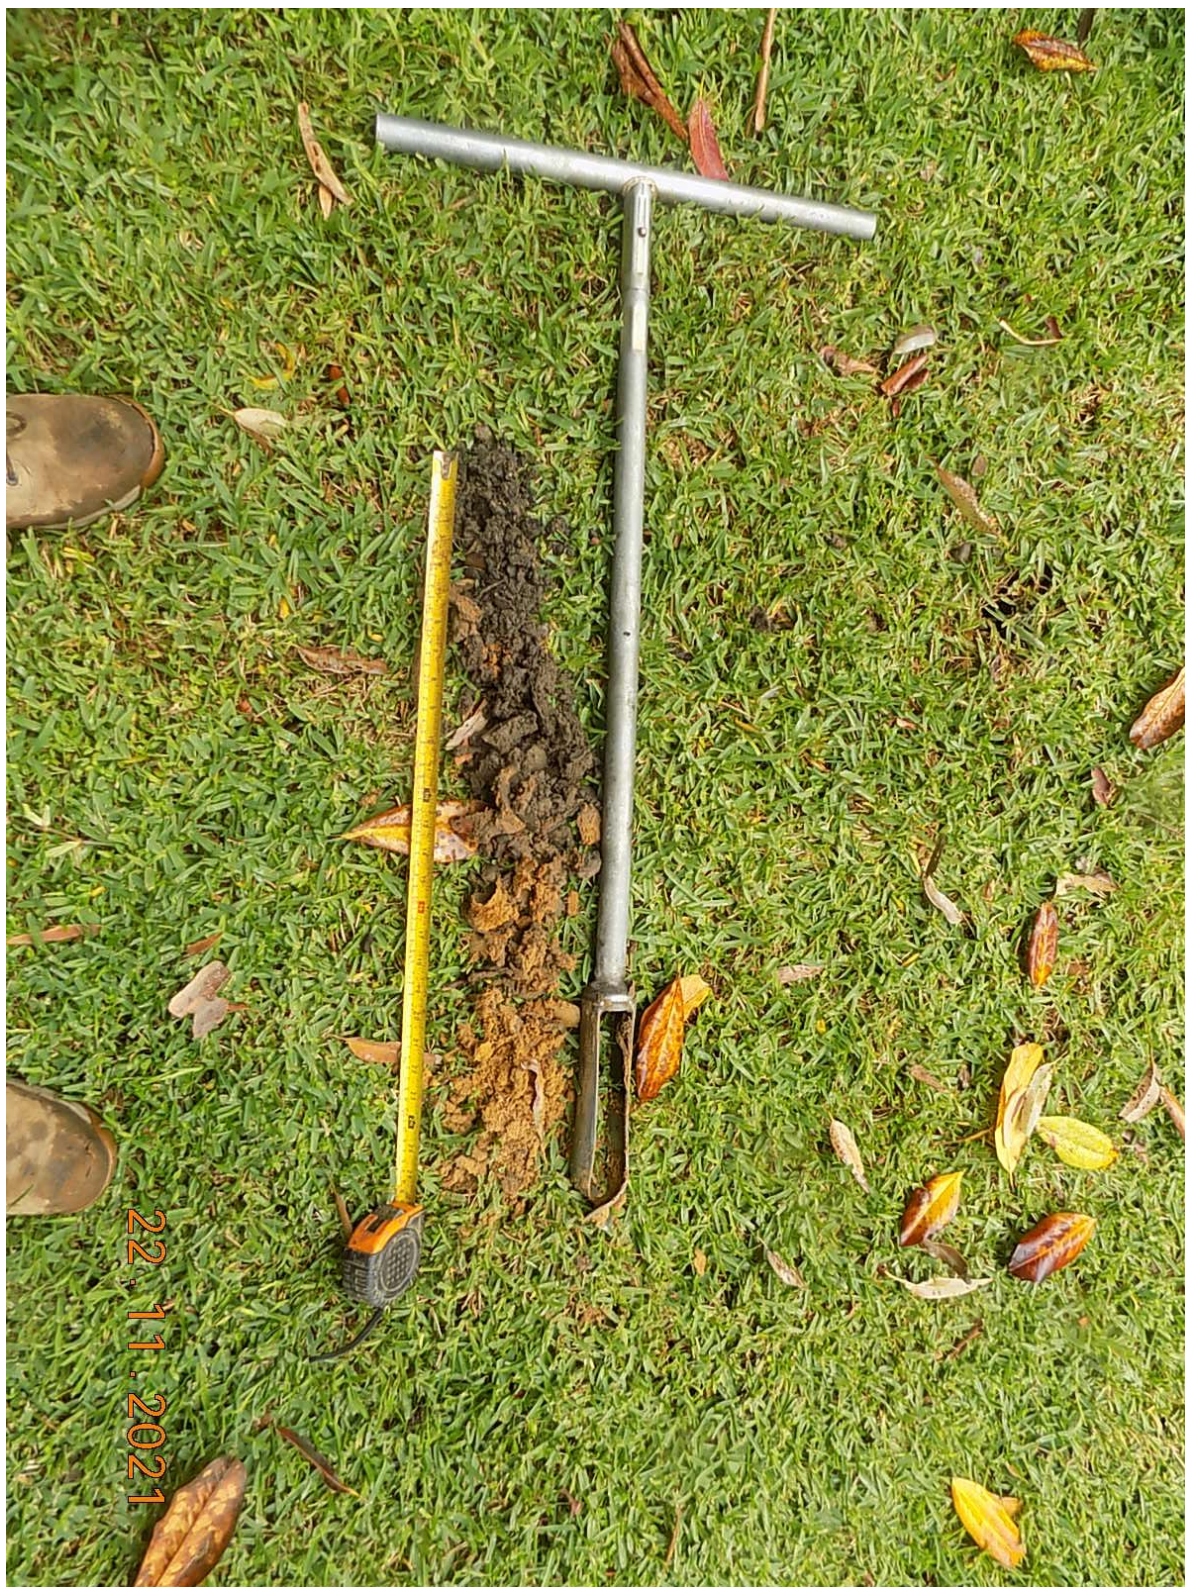
Photo 9 (Top to Bottom)

AUGER HOLE 1 (~RL41.5) – AH1 (Photo 9)

Depth (m)	Material Encountered
0.0 to 0.1	FILL, dark brown clayey soil, fine to medium grained, loose, fine trace of organic matter, dry.

- 0.1 to 0.3 **FILL**, orange and brown clay, fine grained, firm, pebbles present throughout, dry.
- 0.3 to 0.5 **CLAY**, orange, fine grained, firm to stiff, dry.
- 0.5 to 0.7 **CLAY**, sandy, orange, fine to coarse grained, stiff, dry.

End of test @ 0.7m. No water table encountered.
