PRELIMINARY ASSESSMENT: Acid Sulfate

New House at **13 Garden Street, North Narrabeen**

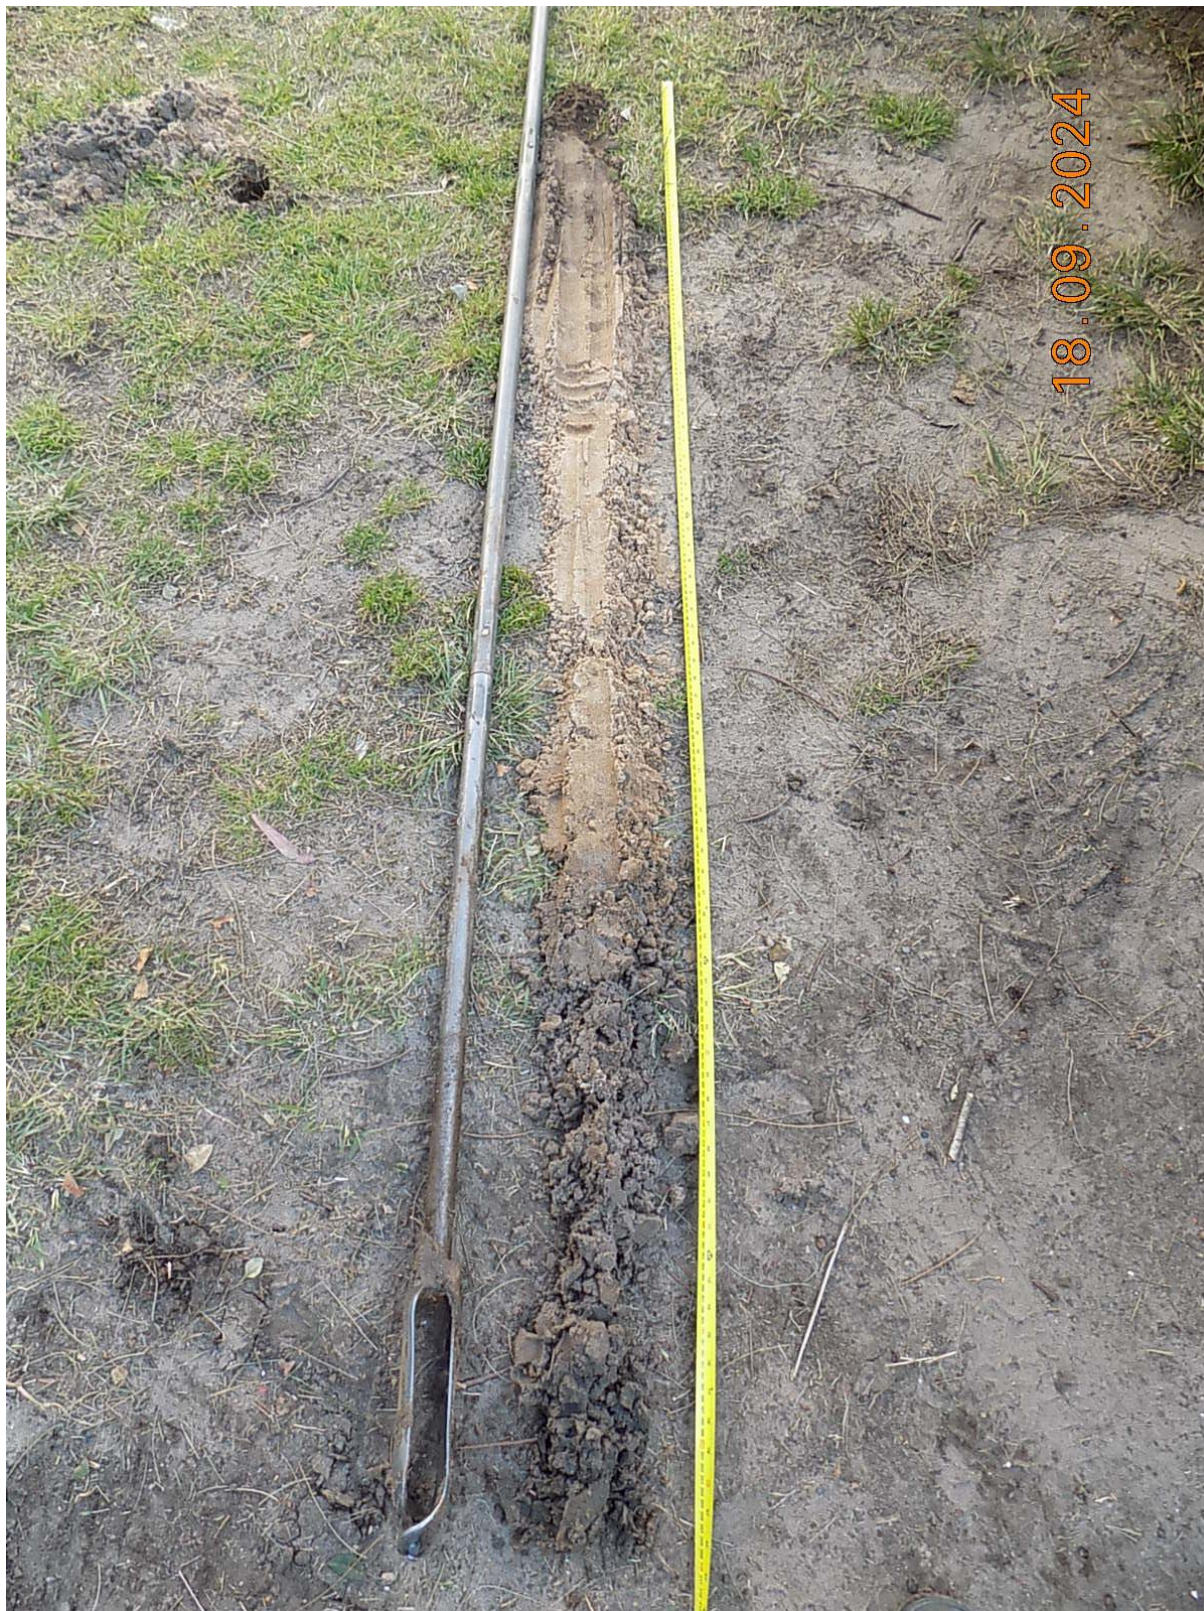
Photo 1: AH1 – Downhole is from top to bottom

AUGER HOLE 1 (~RL2.1) – AH1 (Photo 1)

Depth (m)	Material Encountered
0.0 to 0.3	TOPSOIL , sandy soil, dark brown to brown, dry, fine to medium, shells and shell fragments, and fine organic matter (roots) present.
0.3 to 1.4	ALLUVIAL SEDIMENT , sand, light brown to yellow, dry to damp, shells and shell fragments present.
1.4 to 2.1	ALLUVIAL SEDIMENT , clayey sand, grey, damp to wet, fine to coarse grained.

End of hole @ 2.1m in alluvial sediment. Hole collapsing due to presence of water. Water table encountered at ~1.7m.

TEST: AH1	FIELD pH & PEROXIDE RESULTS				
Sample depth (m)	pH _F	30% Peroxide reaction	pH _{FOX}	pH _F - pH _{FOX}	SS=Shell J=Jarosite R=Roots
0.3	7.5	L	7.4	0.1	<5% R & SS
0.7	7.7	M	7.6	0.1	<5% SS
1.2	8.0	M	7.8	0.2	<5% SS
1.7	8.0	M	7.8	0.2	<5% SS
2.1	7.6	M	7.0	0.6	<5% SS

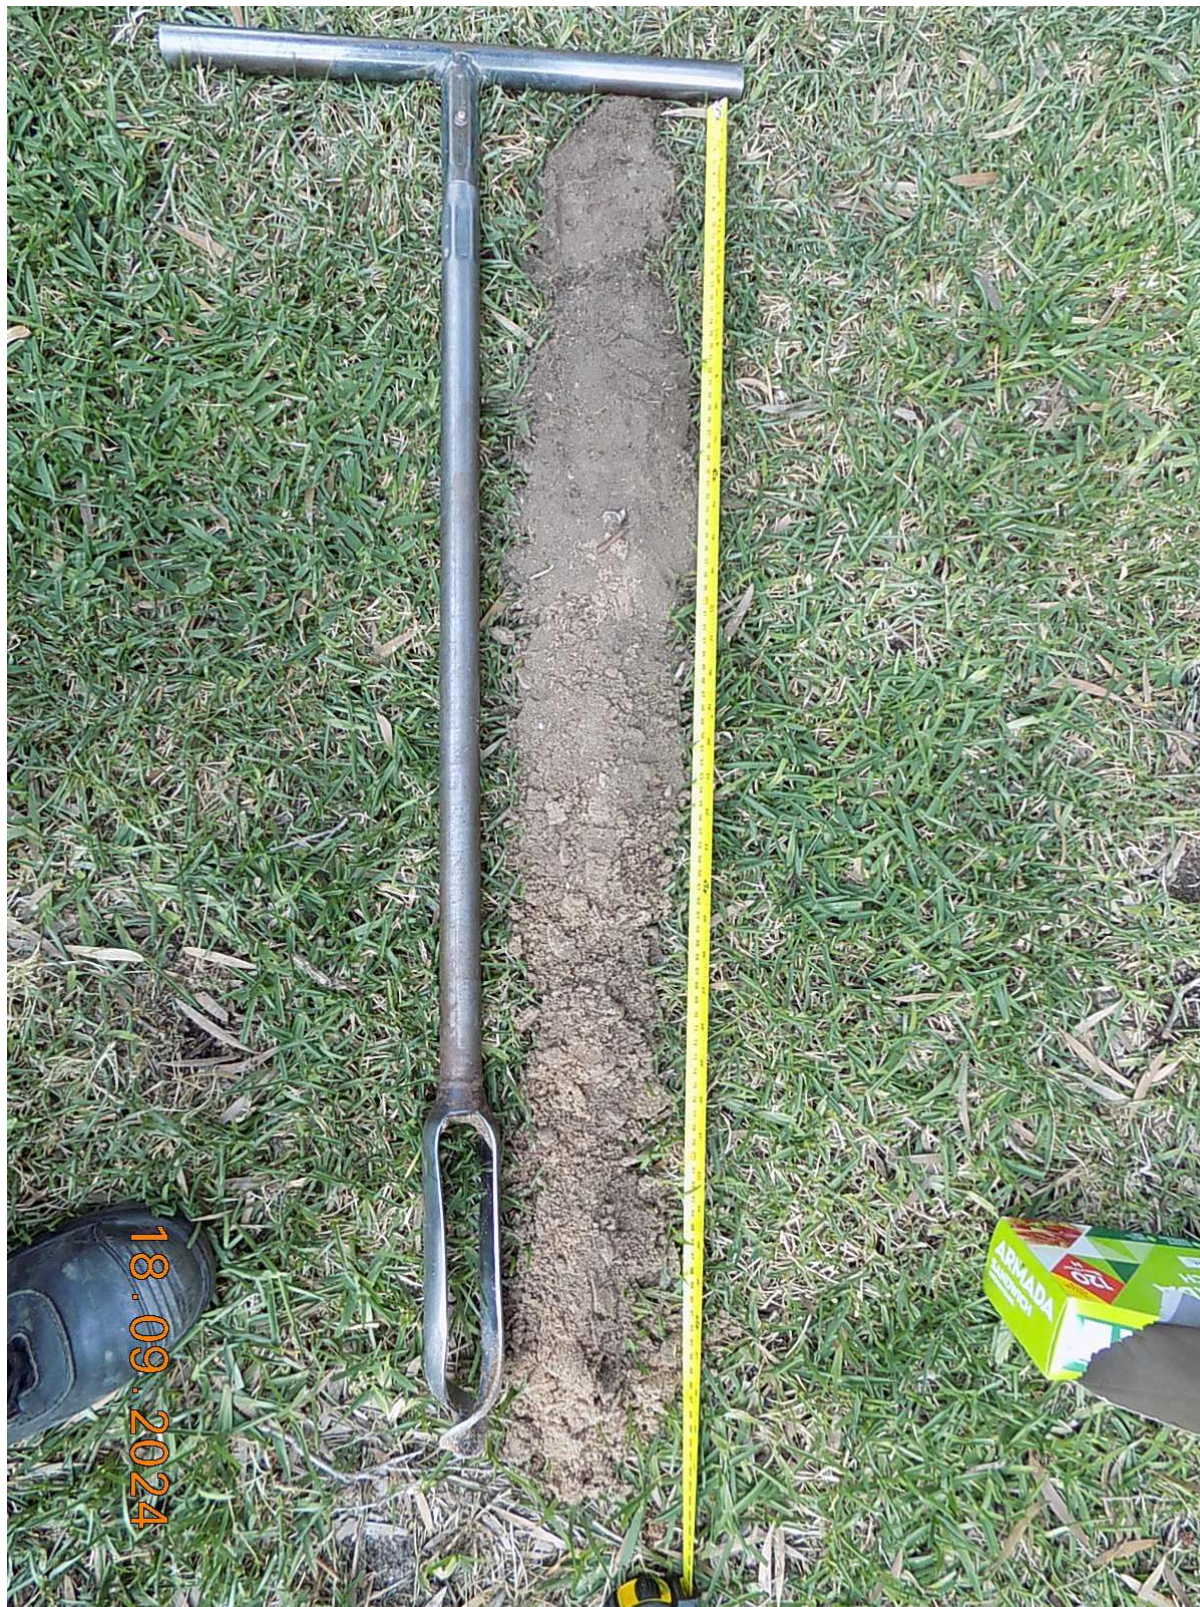
Photo 2: AH2 – Downhole is from top to bottom

AUGER HOLE 2 (~RL2.2) – AH2 (Photo 2)

Depth (m)	Material Encountered
0.0 to 0.5	TOPSOIL , sandy soil, dark brown to brown, dry, fine to medium, shells and shell fragments, and fine organic matter (roots) present.
0.5 to 1.0	ALLUVIAL SEDIMENT , sand, light brown to yellow, dry to damp, shells and shell fragments present.

End of Hole @ 1.0m in alluvial sediment (sand). No water table encountered.

TEST: AH2	FIELD pH & PEROXIDE RESULTS				
Sample depth (m)	pH _F	30% Peroxide reaction	pH _{FOX}	pH _F - pH _{FOX}	SS=Shell J=Jarosite R=Roots
0.4	7.6	M	7.5	0.1	<5% R & SS
0.9	7.7	L	7.7	0	<5% SS

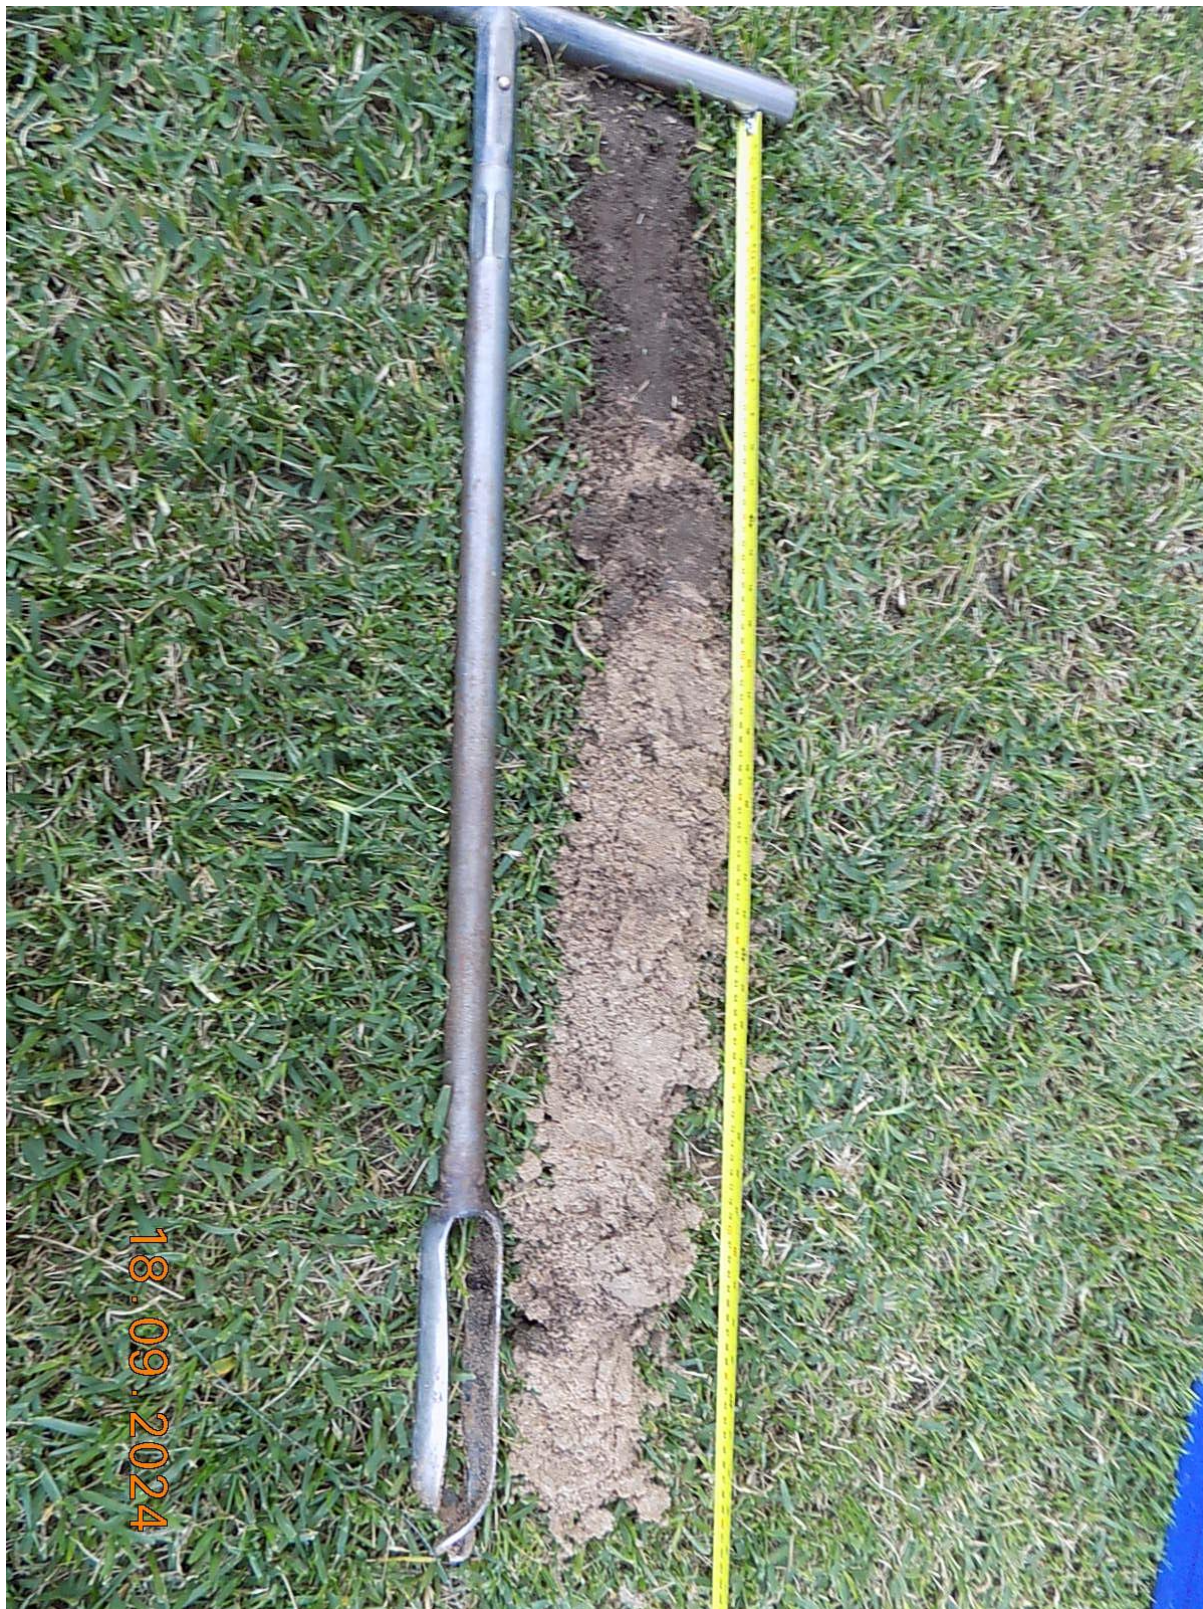
Photo 3: AH3 – Downhole is from top to bottom

AUGER HOLE 3 (~RL2.2) – AH3 (Photo 3)

Depth (m)	Material Encountered
0.0 to 0.4	TOPSOIL , sandy soil, dark brown to brown, dry, fine to medium, shells and shell fragments, and fine organic matter (roots) present.
0.4 to 1.0	ALLUVIAL SEDIMENT , sand, light brown to yellow, dry to damp, shells and shell fragments present.

End of Hole @ 1.0m in alluvial sediment (sand). No water table encountered.

TEST: AH3	FIELD pH & PEROXIDE RESULTS				
Sample depth (m)	pH _F	30% Peroxide reaction	pH _{FOX}	pH _F - pH _{FOX}	SS=Shell J=Jarosite R=Roots
0.4	7.6	M	7.5	0.1	<5% R & SS
0.9	8.0	L	7.8	0.2	<5% SS

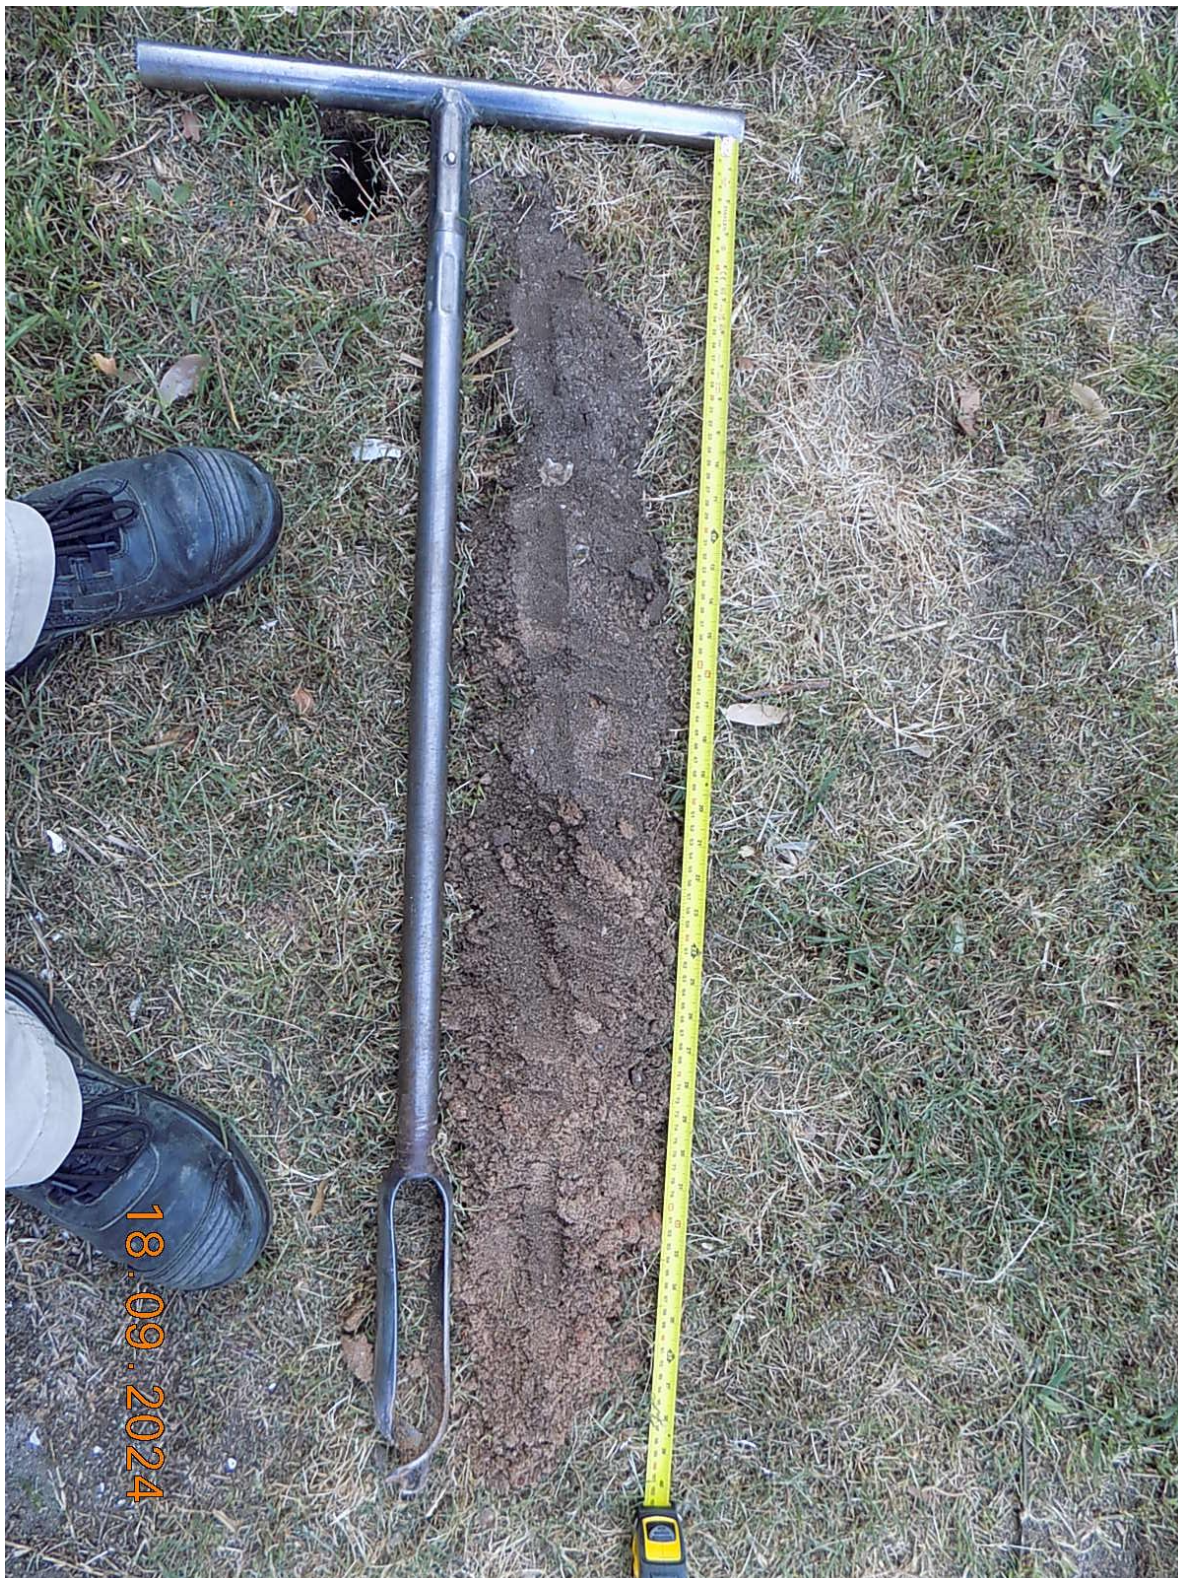
Photo 4: AH4 – Downhole is from top to bottom

AUGER HOLE 4 (~RL2.2) – AH4 (Photo 4)

Depth (m)	Material Encountered
0.0 to 0.5	TOPSOIL , sandy soil, dark brown to brown, dry, fine to medium, shells and shell fragments, and fine organic matter (roots) present.
0.5 to 1.0	ALLUVIAL SEDIMENT , sand, light brown to yellow, dry to damp, shells and shell fragments present.

End of Hole @ 1.0m in alluvial sediment (sand). No water table encountered.

TEST: AH4	FIELD pH & PEROXIDE RESULTS				
Sample depth (m)	pH _F	30% Peroxide reaction	pH _{FOX}	pH _F - pH _{FOX}	SS=Shell J=Jarosite R=Roots
0.5	7.9	M	7.8	0.1	<5% R & SS
1.0	8.1	H	8.0	0.1	<5% SS
