Bayview Gardens Retirement Living, 36-42 Cabbage Tree Road, Bayview, NSW _____

Report Title: Geotechnical Investigation and Stability Assessment	
Report Date: 20 February 2025	Report Ref No: 37080Yrpt2Rev1
Author: Ben Sheppard/Woodie Theunissen	
Author's Company/Organisation: JK GEOTECHNICS

REPORT TO
AVEO GROUP
ON

**GEOTECHNICAL INVESTIGATION AND STABILITY
ASSESSMENT**
(In Accordance with Pittwater Council Risk
Management Policy)

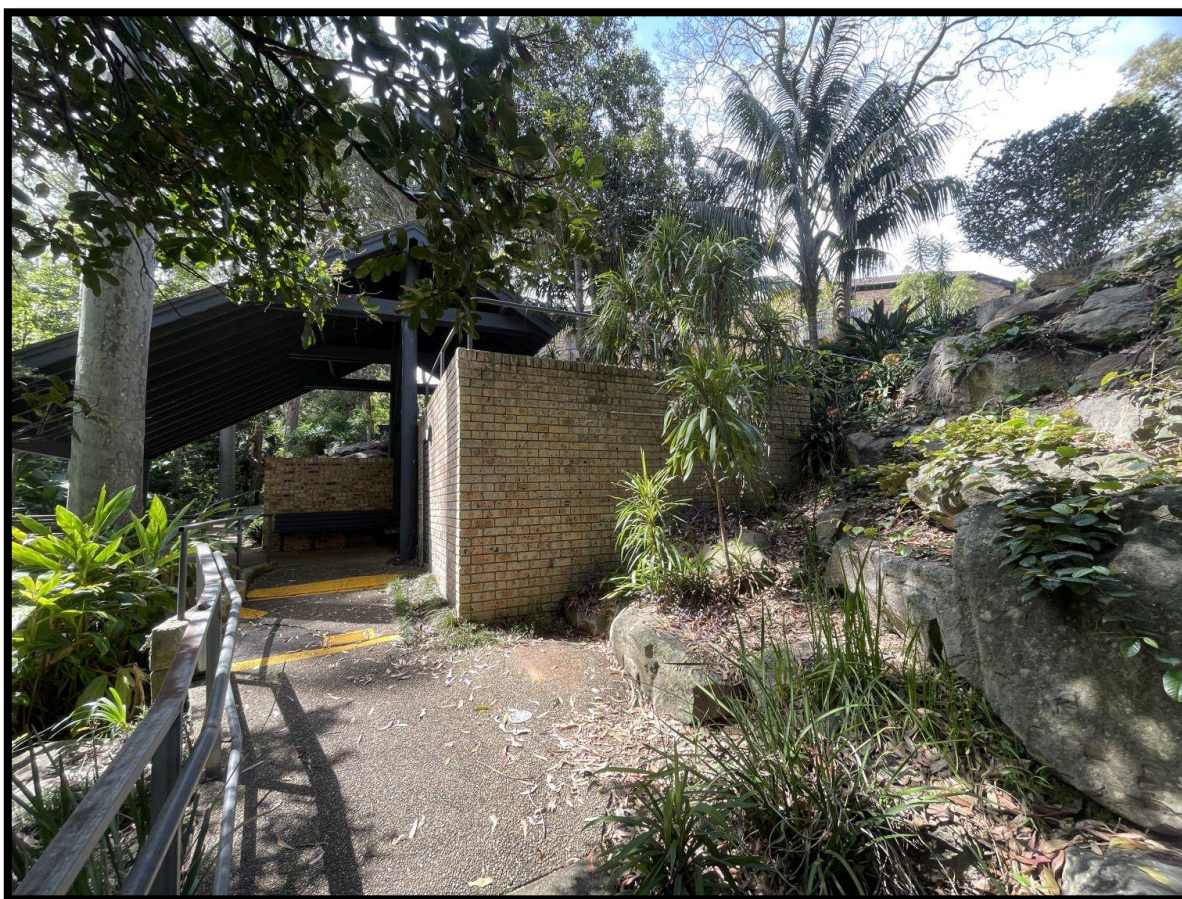
Plate 1 – Existing Site Conditions, looking north-east

For the purpose of this report, the 'site' is limited to the area to the south-east of the existing storeroom, as shown in the below Plate 1. The site comprises several elevation changes, with an overall slope to the south-west at about 30°.

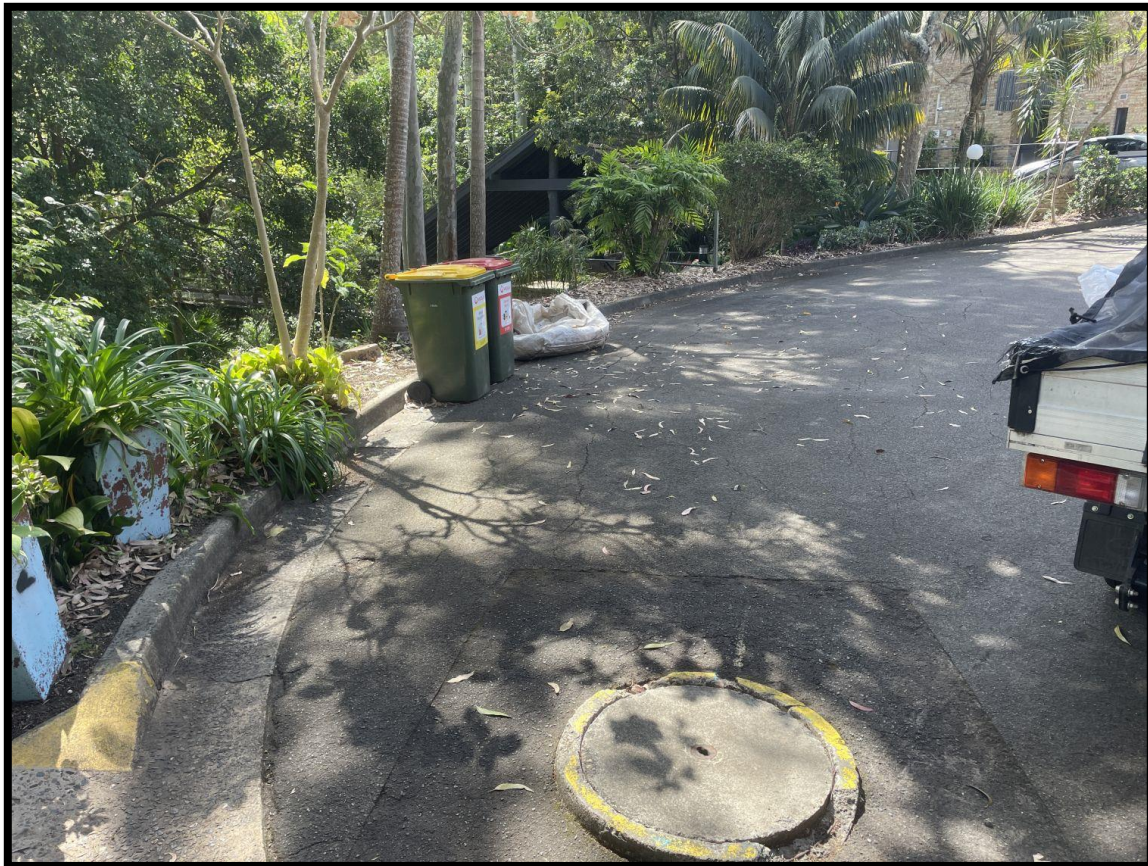
Plate 2 – Above Boulder wall, Looking north-west

The site generally comprises a sandstone boulder wall, which has a total height of about 3.8m and an average slope of about 30° down to the south-west. The sandstone boulders were generally 'lenticular' in shape and have an average size of about 1m x 0.8m x 0.5m, although some larger and smaller boulders were also evident. Along the crest of the boulder wall is an AC surfaced road, which generally appears to be in good condition, with the exception of some longitudinal cracking (parallel to the embankment), as shown in the below Plate 2. A sewer manhole and subsequent spray paint marking on the road indicates the presence of a sewer which runs near the edge of the boulder wall at depth of about 2.9m below existing road levels

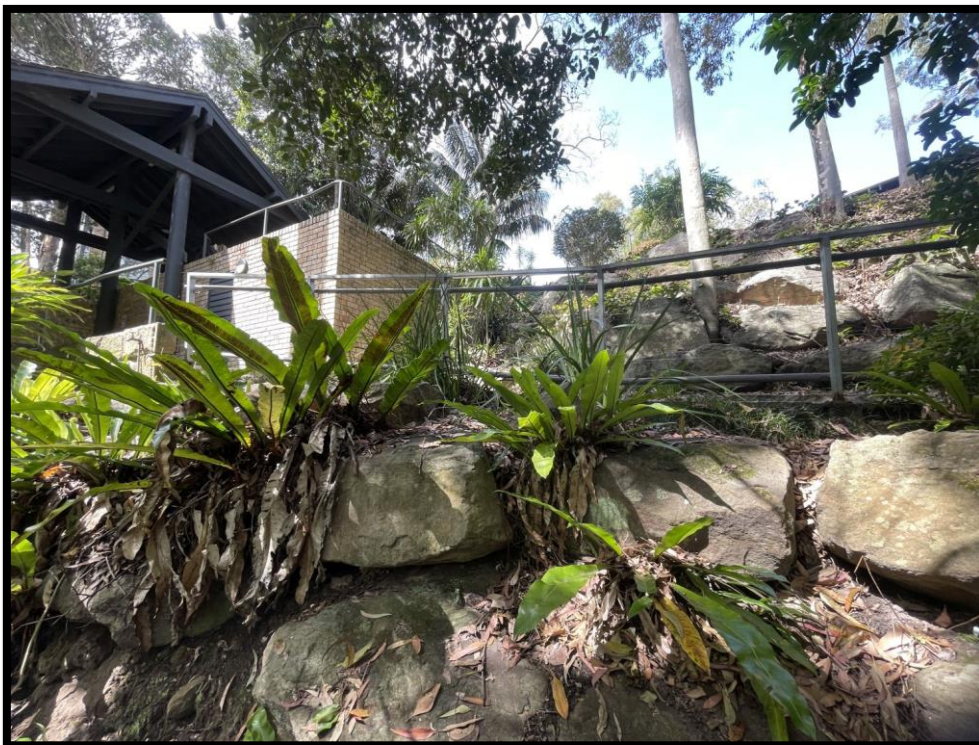
Plate 3 – Lower boulder wall, looking north-east

A single storey brick storeroom is located along the north-western side of the boulder wall, and appears to have been built into the hillside along its eastern edge. Above the storeroom and extending to the north-west is the 'bridgehouse', which forms the landing structure for the timber bridge which traverses the creek located at the toe of the slope. Along the toe of the boulder wall is a concrete footpath, which is generally level and appears to be in fair condition. The south-western edge of the footpath is supported by a sandstone boulder wall, which is about 1.2m high and slopes to the south-west at between about 40° to near vertical, as shown in the below Plate 3. The pathway was undermined by up to about 0.2m in some sections. Some erosion/washing of the soils between the boulders was evident. To the north of the lower boulder wall was a sandstone block retaining wall, which varies in height between about 0.8m and 2m, and generally appeared to be in good external condition.

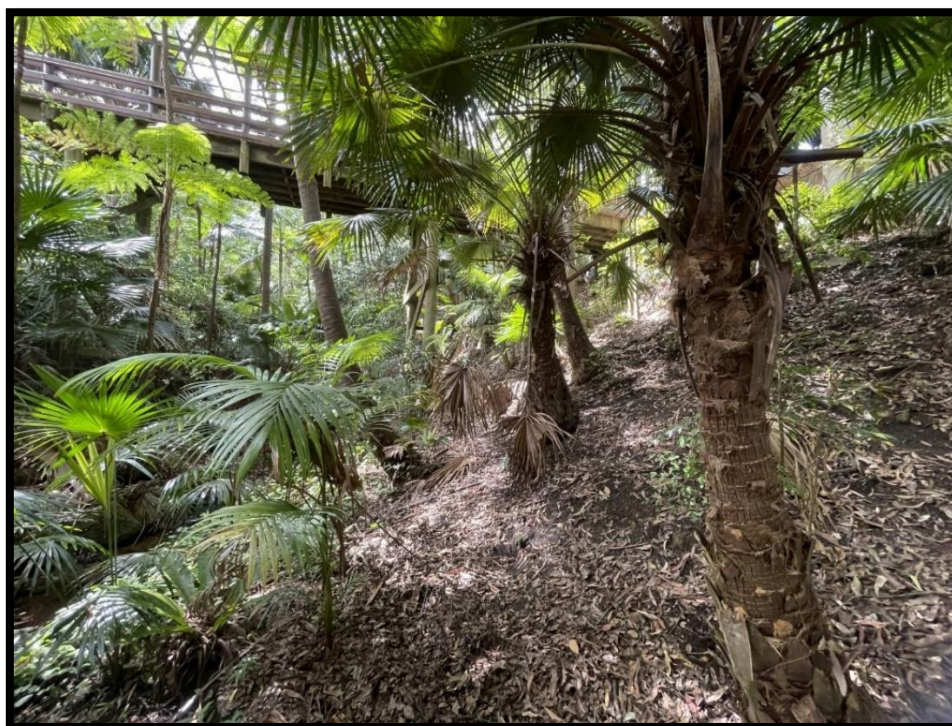
Plate 4 – Hillside adjacent to creek, looking north-west

At the toe of the lower boulder wall was a vegetated hillside which slopes at about 20° to 30° towards a creek. Towards the lower reaches of the slope, adjacent to the creek, medium to large trees appeared to exhibit signs basal curvature, with one large tree curving at up to about 40° from the horizontal near its base, as shown in the below Plate 4.
