- Swept Path Statement Alterations & Additions for the development at No. 577-579 Sydney Rd, Seaforth.

Reference No.: 202045-SWEPT

Swept Path Statement - No. 577-579 Sydney Rd, Seaforth

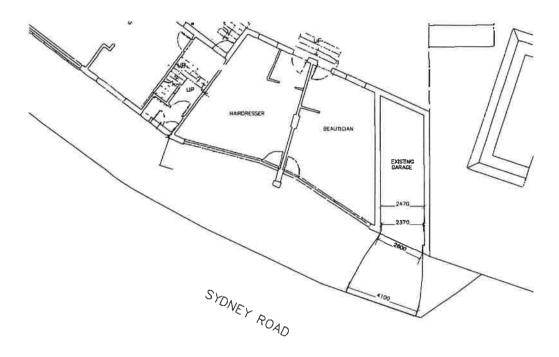
Figure 3 – Architectural Plan Source: Architectural Plans by BAXTER & JACOBSON dated May 24, 2017

The existing driveway layback fronting the Sydney Rd is 4.1m wide and the garage entrance is 2.6m wide. The internal width of the existing garage is 2.47m and internal width at entrance is 2.37(See Figure 3 - Figure 5).

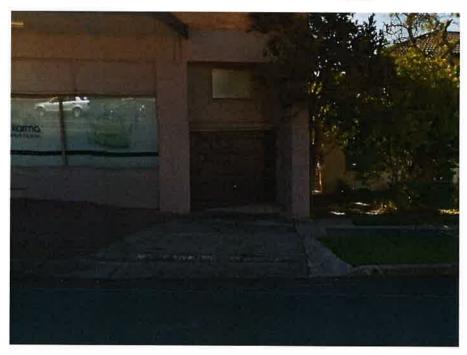
Figure 5 – Existing Garage at No.577-579 Sydney Rd, Seaforth

A swept path analysis has also been carried out to determine the B85 vehicle size able to enter/exit the site adequately. As per AS2890.1 Off Street Parking Facilities, the overall internal width of a single vehicle garage shall be minimum 3.0mm. The internal width of the existing garage is 2.47 which is less than minimum garage width and is not compliant. With reference to the swept designs displayed (See Figure 6 – Figure 8) it has been shown

In conclusion, it is noted that the size and geometric layout of the existing garage is not adequate, and the occupants of the subjected site has never had use this garage for parking. Swept path analysis shows inadequate manoeuvrability. It is our opinion to incorporate the existing garage into shop 1.

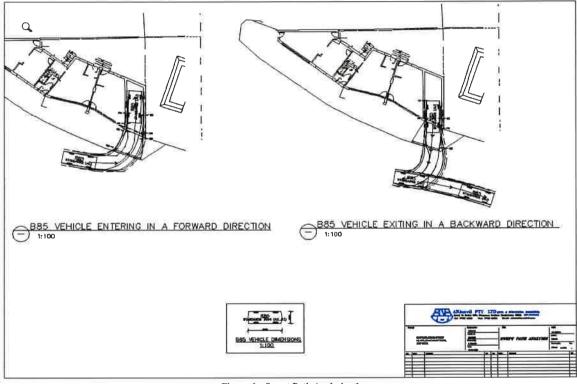
Figure 6 – Swept Path Analysis - 1 Source: Swept Path Analysis by ANA Civil Pty Ltd dated February 27, 2020

A swept path analysis has been carried out by ANA Civil to show a B85 vehicle parking in a forward direction and exiting the garage in a backward direction and is deemed to be not compliant with AS2890.1 Off Street Parking Facilities.

that the size and orientation of existing garage is not adequate for a B85 vehicle to enter/exit without scrap.

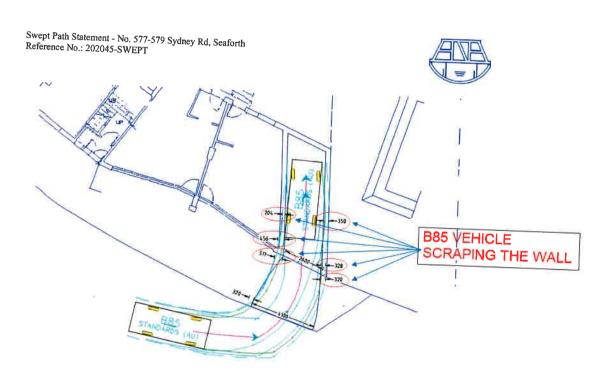
Figure 8 – Swept Path Analysis - 3
Source: Swept Path Analysis by ANA Civil Pty Ltd dated February 27, 2020

The geometric layout and turning swept path of the existing garage has been checked and are not in accordance with the requirements of AS2890.1 (Parking Facilities-Off Street Parking).

B85 VEHICLE ENTERING IN A FORWARD DIRECTION
