J5956. 11th April, 2025. Page 1.

GEOTECHNICAL INVESTIGATION:

New Dual-Occupancy House at 54 Gardere Avenue, Curl Curl

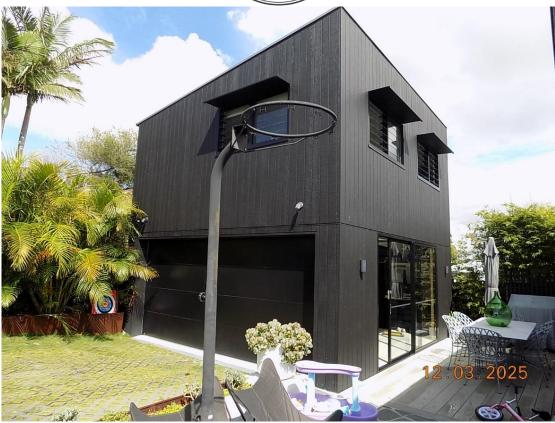
Photo 1

- **2.1** The site was inspected on the 12th March, 2025.
- 2.2 This residential property is on the corner of Gardere Avenue and Cooksey Avenue; it is on the high side of Gardere Ave and is level with Cooksey Ave. The property has a N aspect. It is located on the gently graded upper reaches of a hillslope. The natural slope falls/rises across the property at an average angle of <5°. The slope above the property eases at the crest of the hill, the slope below the property gradually increases in grade.
- **2.3** At the Cooksey Avenue frontage, a concrete and permeable driveway run to a stable two-storey timber clad garage on the uphill side of the property (Photo 1). Fill

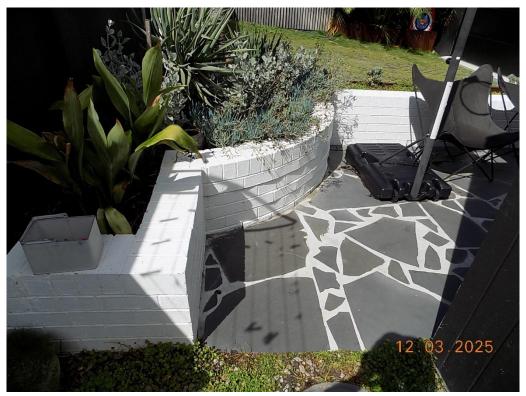
Photo 2

for the driveway and a cut for a level area between the garage and the house is supported by a stable low brick retaining wall (Photo 2). The single-story timber clad and brick house (Photo 3) is supported on brick and sandstone block walls and brick piers. No significant signs of movement were observed in the visible supporting walls, and the supporting piers stand vertical. Between the downhill side of the house and the lower common boundary fill has been laid for a level lawn and garden beds. The fill is supported by a stable low sandstone log retaining wall which approximates the lower boundary (Photo 3). A stable brick and concrete block retaining wall runs along the W common boundary. It reaches a height of ~1.3m and supports a cut for the W neighbouring property (Photos 4 & 5).

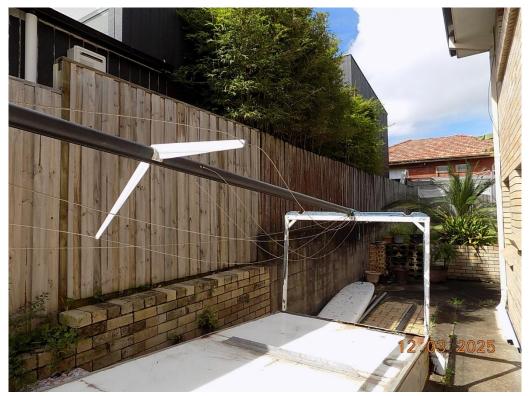
Photo 4

| HAZARDS | Hazard One | Hazard Two | Hazard Three | |
|---|---|--|--|--|
| TYPE | The vibrations produced during the proposed excavations impacting on the surrounding structures. | The excavations collapsing onto the work site before retaining structures are in place. | The proposed excavations undercutting the footings for the W neighbouring brick and block retaining wall (Photo 4 & 5) causing damage or failure. | |

The basement excavation for Lot 2 will reach a maximum depth of ~3.1m and be set back ~0.4m from the W common boundary and the brick and concrete block retaining wall which supports a cut for the W neighbouring property (Photo 4).

Where the W boundary wall falls within the zone of influence of the excavations, exploration pits along the wall will need to be put down by the builder to determine the foundation depth

- The exploration pits to determine the foundation material along the W boundary wall (Photos 4 & 5) are to be inspected by the geotechnical consultant to determine if underpinning is necessary. This is to occur before the bulk excavation for the basements commence.

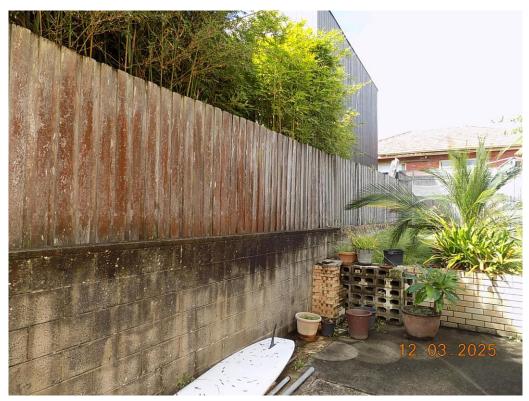
Photo 5

• The basement excavation for Lot 1 will reach a maximum depth of ~3.3m and be set back ~0.4m from the W common boundary and the low brick retaining wall which supports a cut for the W neighbouring property (Photo 5).

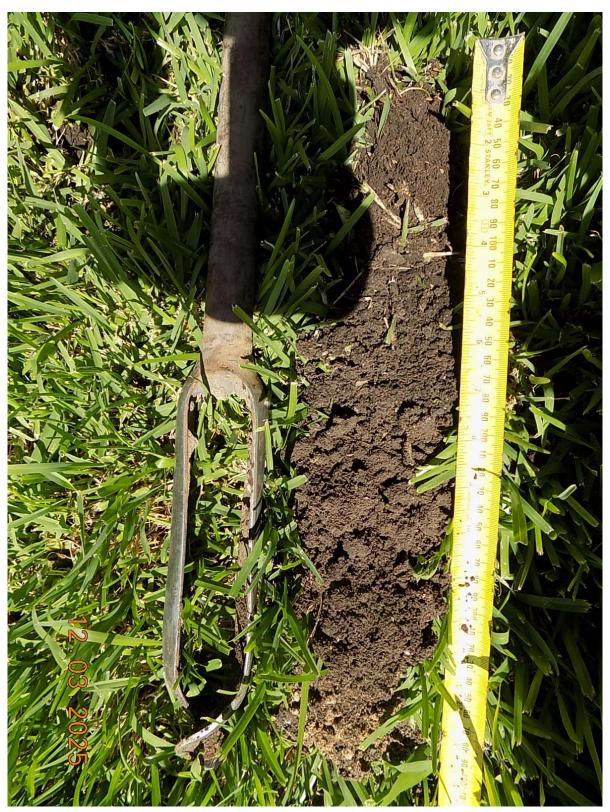
Photo 6 – downhole is top to bottom

AUGER HOLE 1 (~RL40.4) – AH1 (Photo 6)

0.0 to 0.4 FILL, sandy fill, brown, Medium Dense, dry, fine to coarse grained,

crushed sandstone at base of auger.

Refusal @ 0.4m, auger grinding in fill. No water table encountered.

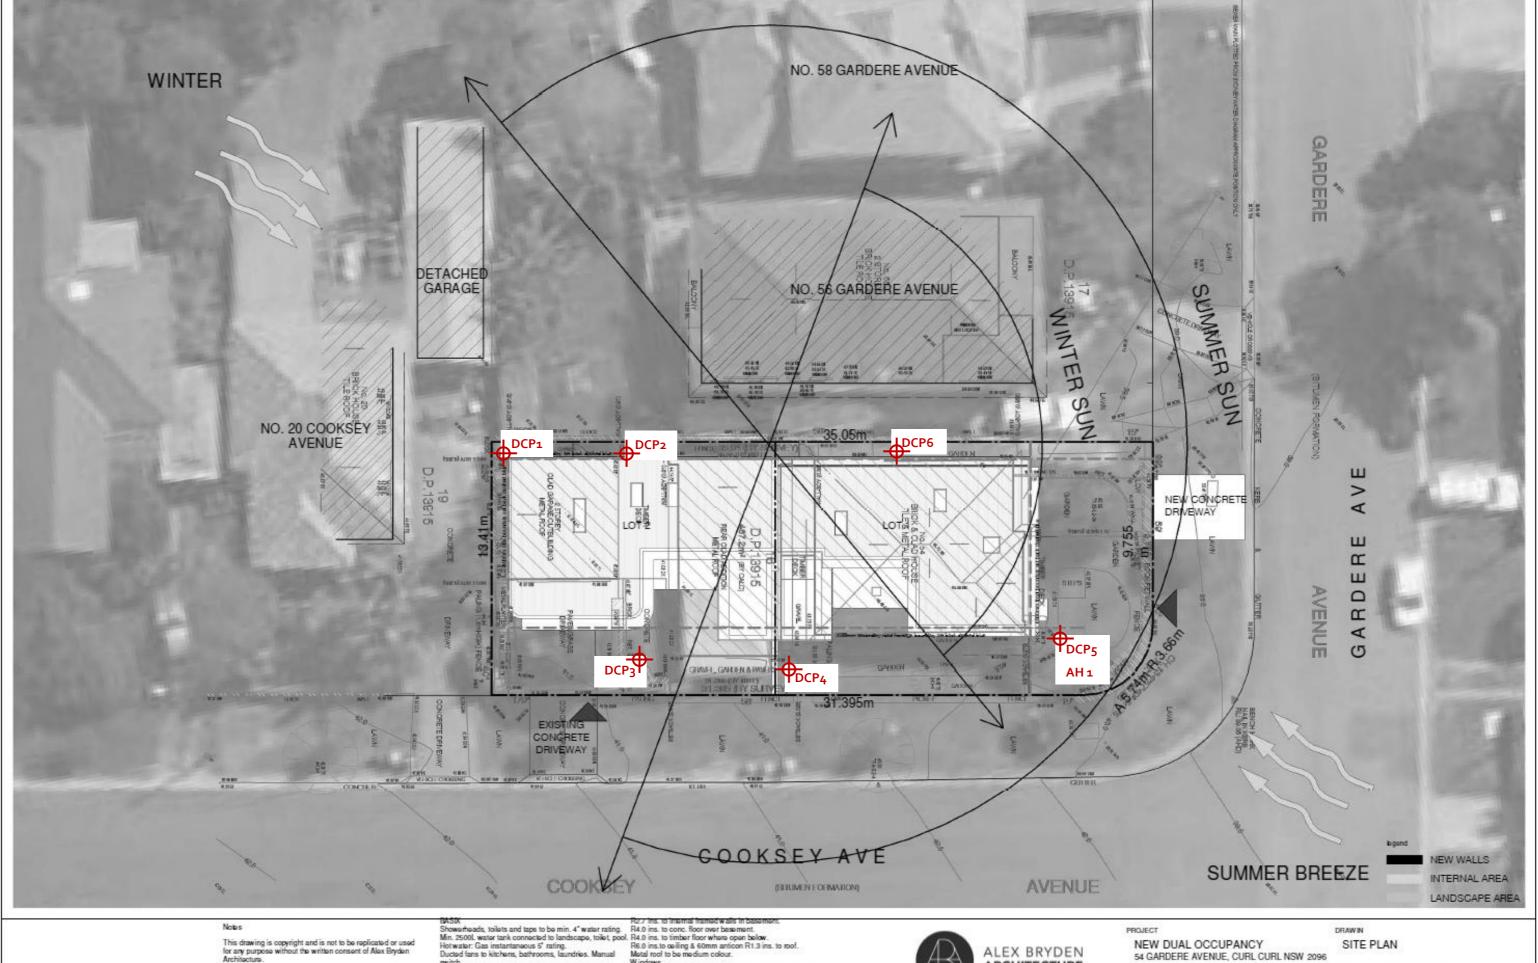
SITE PLAN – showing test locations

One hand Auger Hole (AH) was put down to identify the soil materials. Six Dynamic Cone Penetrometer (DCP) tests were put down to determine the relative density of the overlying soil and the depth to bedrock. The locations of the tests are shown on the site plan attached. It should be noted that a level of caution should be applied when interpreting DCP test results. The test will not pass through hard buried objects so in some instances it can be difficult to determine whether refusal has occurred on an obstruction in the profile or on the natural rock surface. This is not expected to have been an issue for this site. But due to the possibility that the actual ground conditions vary from our interpretation there should be allowances in the excavation and foundation budget to account for this. We refer to the appended "Important Information about Your Report" to further clarify. The results are as follows:

plan attached for the minimum extent of the required exploration pits/underpinning.

batters are not left unsupported. See the site plan attached for the minimum extent of the
