Report Title: Geotechnical Report 11 Hilltop Road, Avalon

Report Date: 23/11/20

## **GEOTECHNICAL INVESTIGATION:**

### **New House & Pool at 11 Hilltop Road, Avalon**

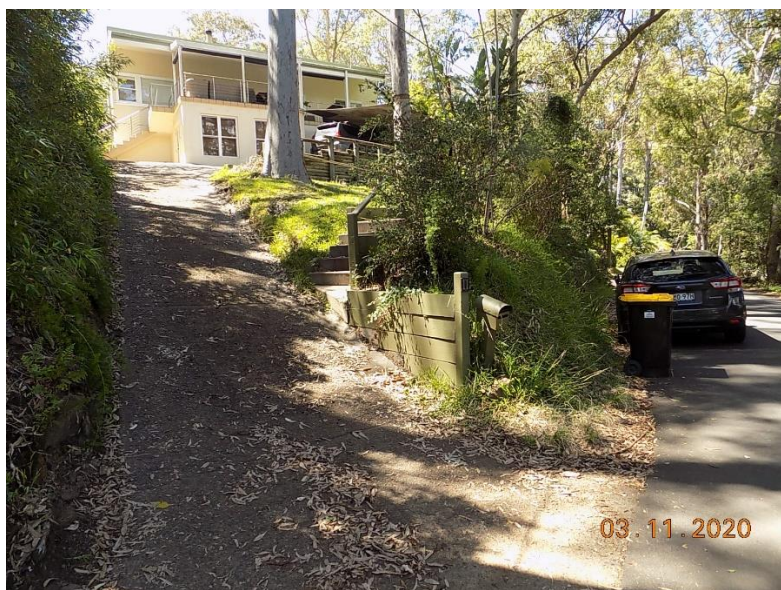
Photo 1

- 2.3** At the road frontage, a concrete driveway runs up the slope to a parking area on the downhill side of the house (Photos 1 & 2). The fill for the parking area is supported by a treated timber retaining wall reaching ~1.3m high (Photo 3). The slope on the uphill side of the house has been terraced with a series of treated timber and stack rock retaining walls (Photo 4). The part two-storey rendered brick and timber framed and clad house will be demolished and the site will be cleared as part of the proposed works (Photo 5).

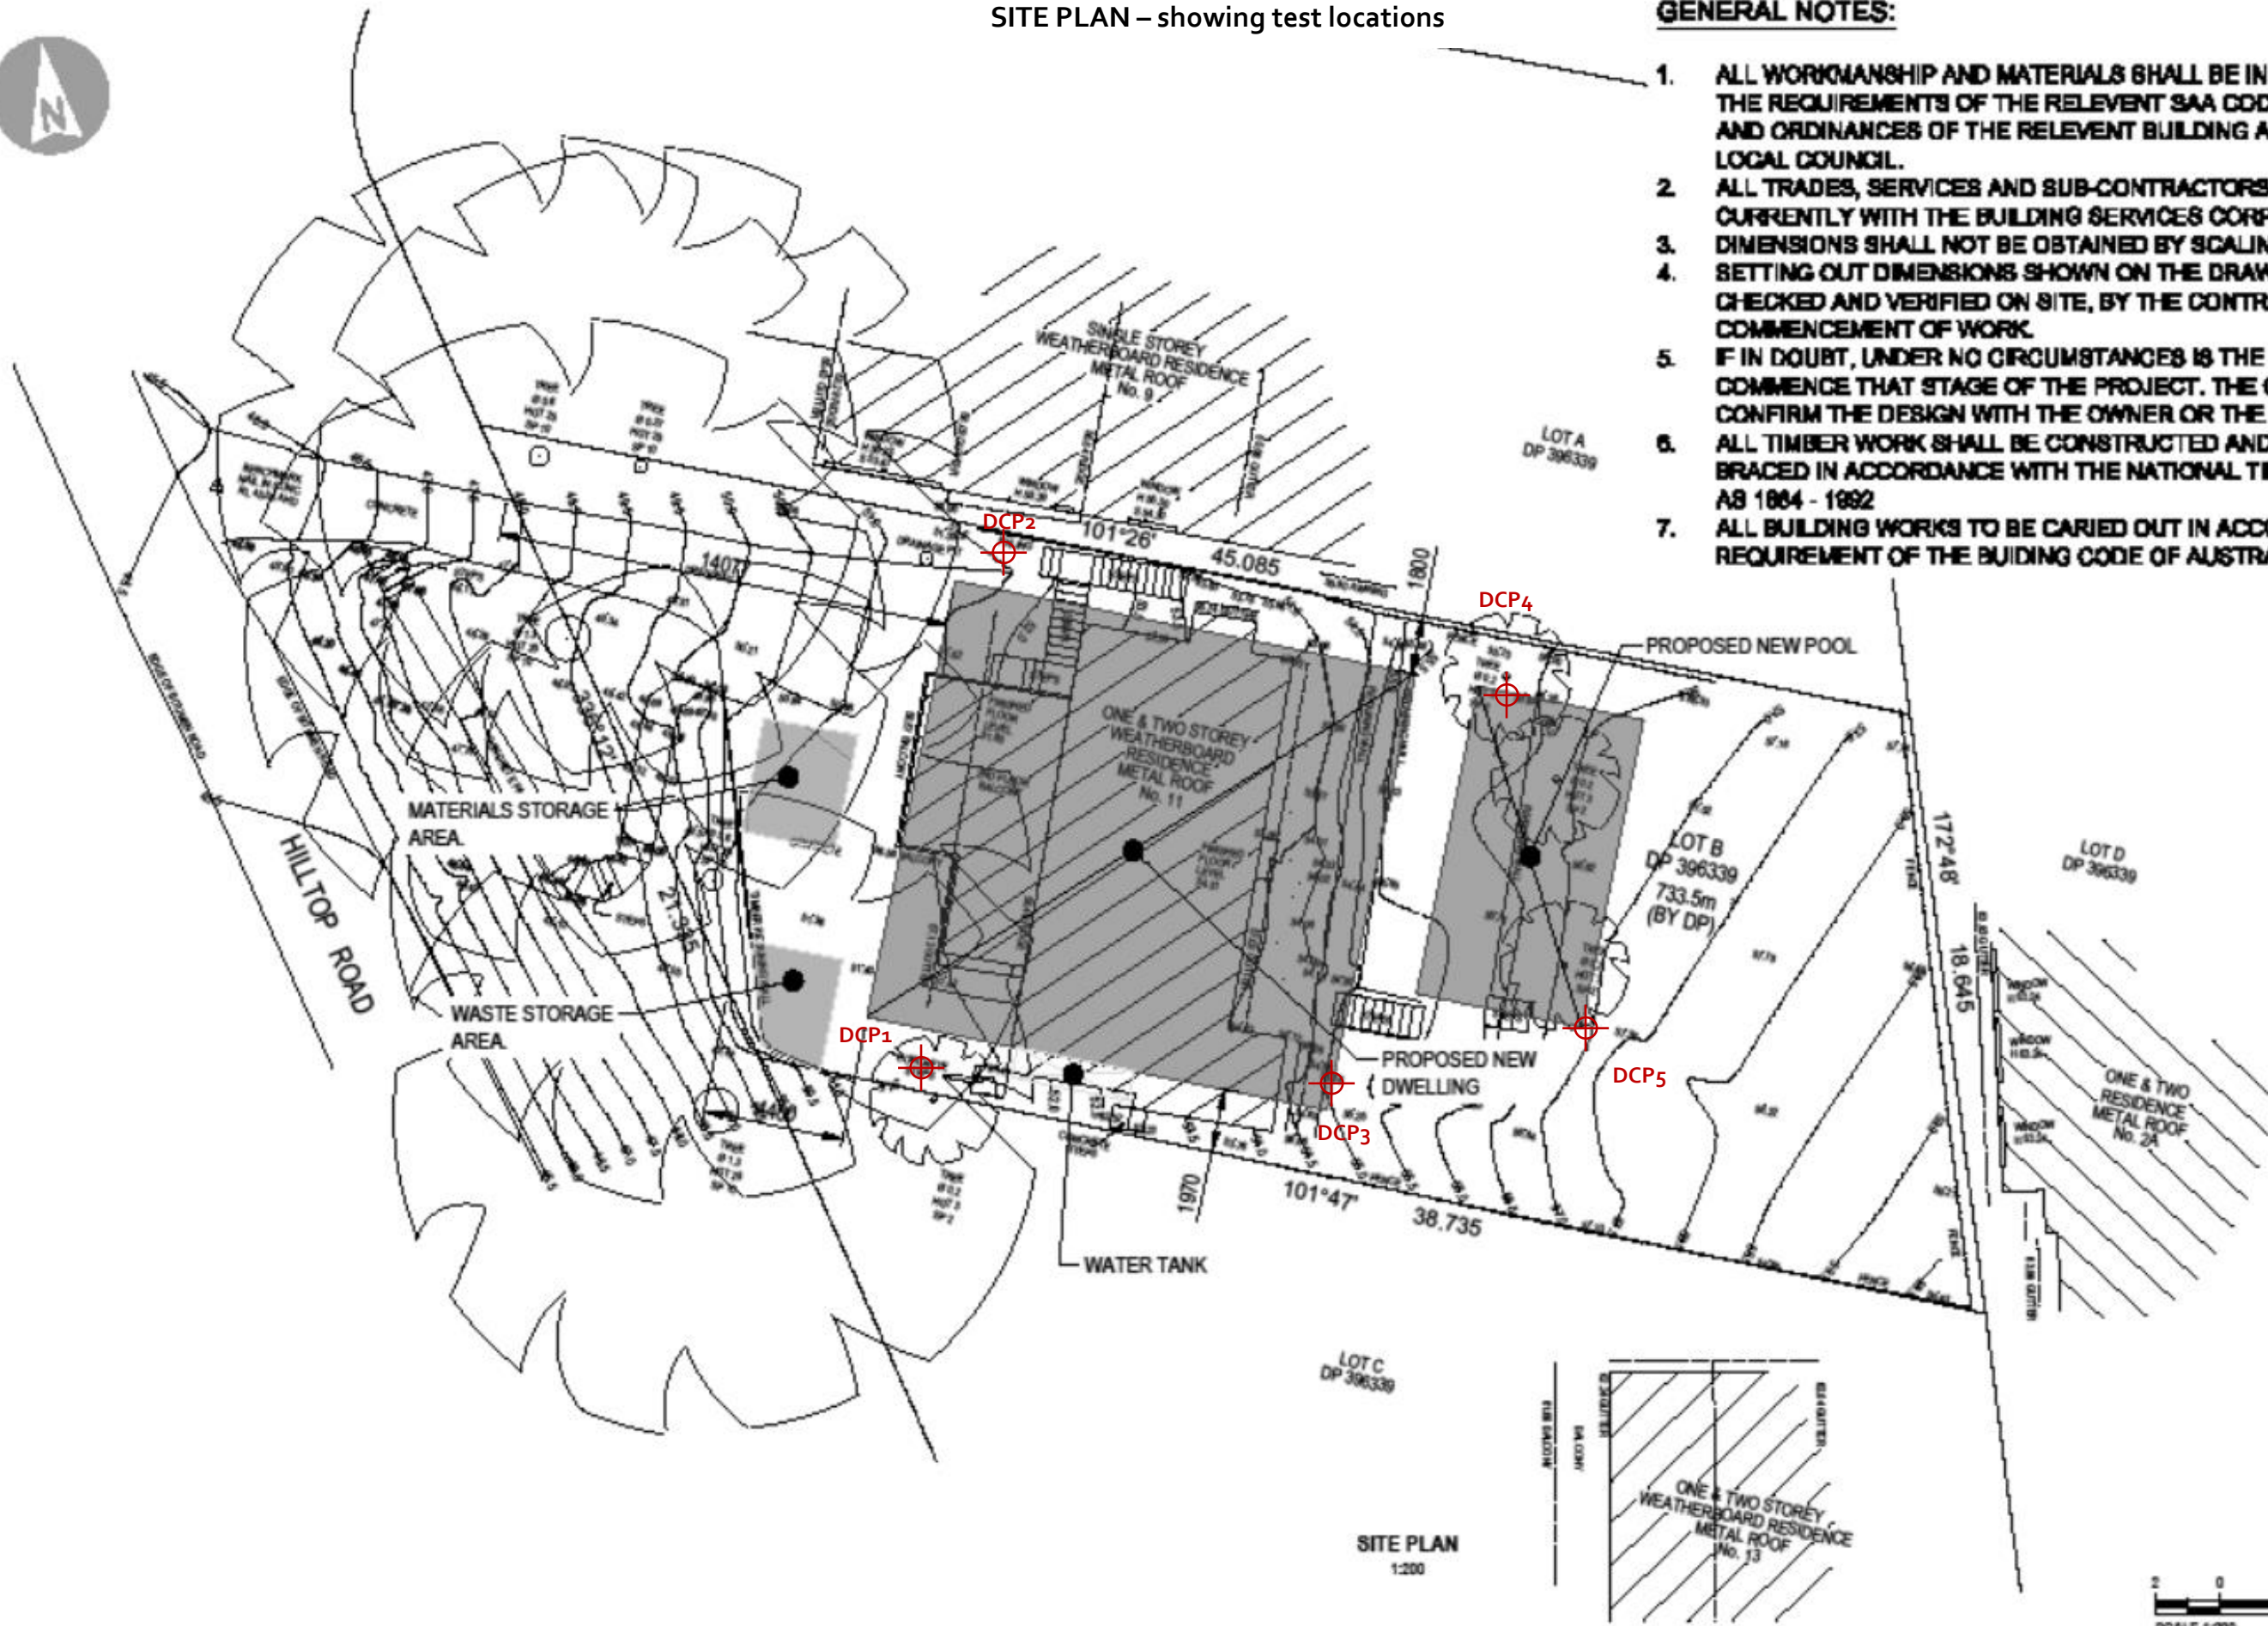
# SITE PLAN – showing test locations

Five Dynamic Cone Penetrometer (DCP) tests were put down to determine the relative density of the overlying soil and the depth to weathered rock. The locations of the tests are shown on the site plan attached. It should be noted that a level of caution should be applied when interpreting DCP test results. The test will not pass through hard buried objects so in some instances it can be difficult to determine whether refusal has occurred on an obstruction in the profile or on the natural rock surface. This is not expected to be an issue for the testing on this site. However, excavation and foundation budgets should always allow for the possibility that the interpreted ground conditions in this report vary from those encountered during excavations. See the appended "Important information about your report" for a more comprehensive explanation. The results are as follows:

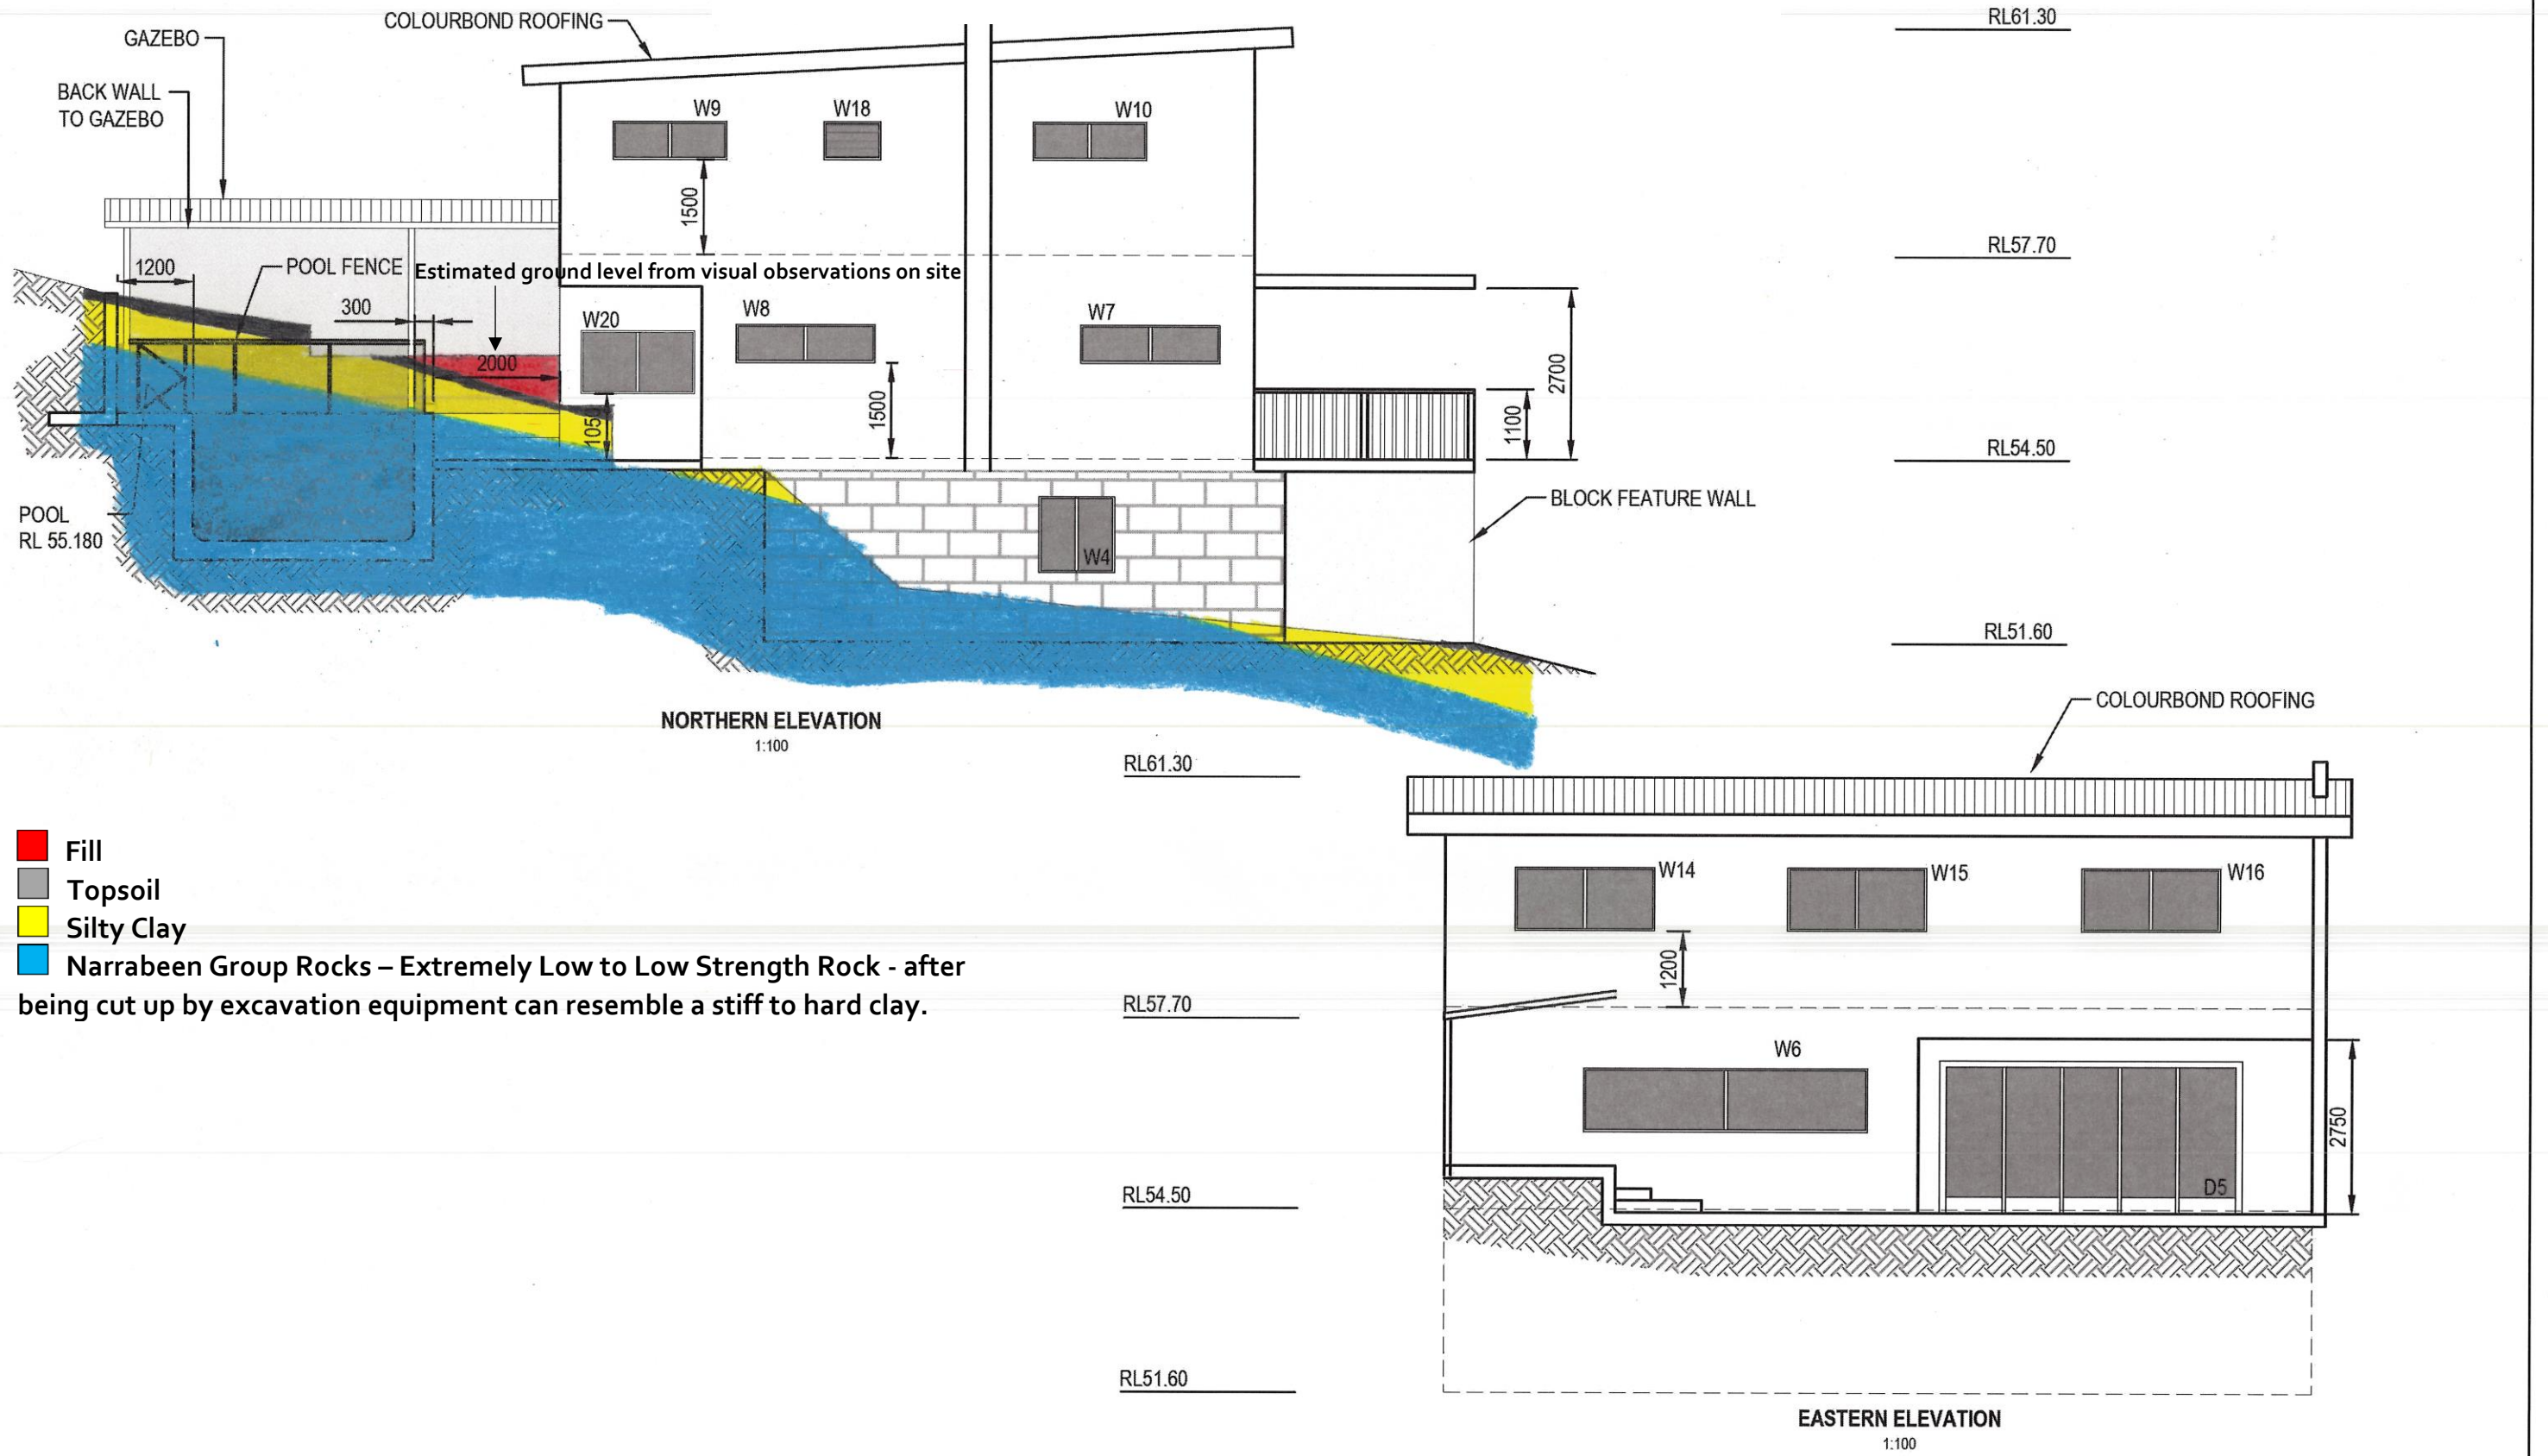
# TYPE SECTION – Diagrammatical Interpretation of expected Ground Materials

In the test locations, the ground materials consist of a shallow topsoil over firm to very stiff clays. Filling has been placed on the slope below the house for the parking area. The clays merge into the underlying weathered rock at depths of between 0.4 to 1.5m below the current surface, being deeper where filling has been placed in the location of DCP1. The weathered zone is interpreted to be Extremely Low to Low Strength Rock. The rock is expected to slowly become progressively stronger with depth. Three of the Five DCP tests encountered refusal on the underlying rock. These tests may have encountered some isolated bands of sandstone. The extents of the bands are not known. The only method to prove the extent of the bands is to perform core drilling. Our office can be contacted if core drilling is desired. See Type Section attached for a diagrammatical representation of the expected ground materials.
