# CONSERVATION MANAGEMENT PLAN

Newport SLSC  
394 Barrenjoey Road  
Newport

**June 2022**

**Job No: 9546**

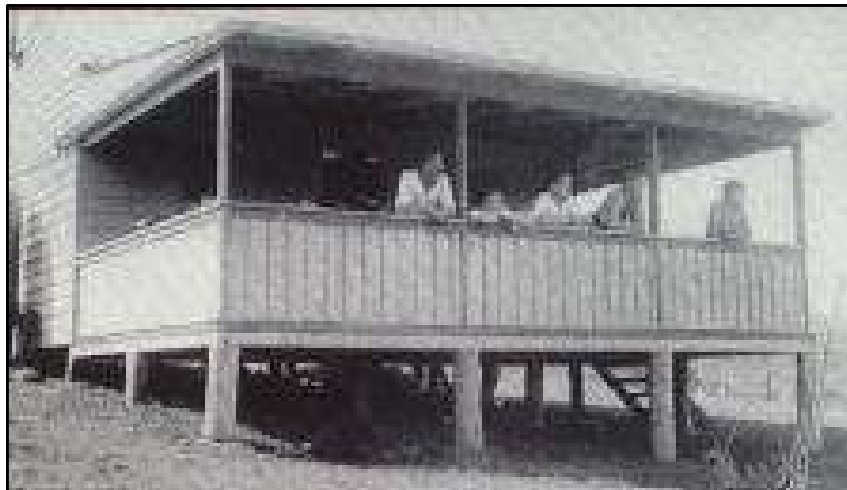
Figure 15. First Newport Surf Clubhouse, "La Solitaire", built in 1909. Photo taken 1925<sup>47</sup>.

The Newport Surf Life Saving Club was founded in 1909 by young surfers who rode their bikes every weekend from Mosman, in search of an isolated beach (Figure 16). In 1909, at the time of the establishment of the Newport Surf Life Saving Club, Warringah Shire Council and local residents of the area were in talks regarding acquiring six acres of land belonging to Johnny Farrell for a public reserve and recreation grounds. This area was called Farrell's Beach at the time. After lengthy negotiations and support from the Minister for Lands, Mr Neilsen, the Government resumed the six acres of Johnny Farrell's land for a public reserve, dressing sheds and the Surf Club.<sup>43</sup> In that same year, the first Clubhouse (Figure 15) was erected on Neptune Street on a land belonging to off Snell.

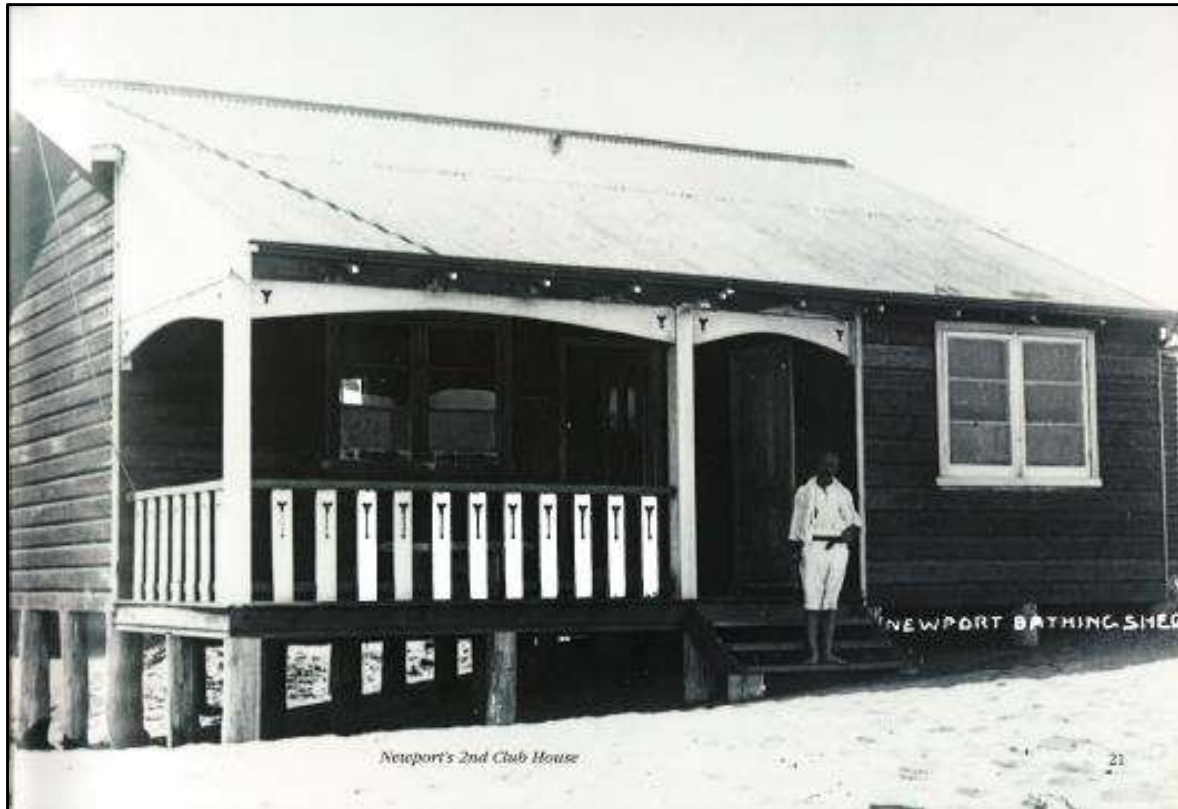
Figure 21. The Second Newport Clubhouse opened in 1915<sup>57</sup>.

In 1912, the Warringah Shire Council approved a proposal by the Surf Bathing Committee for the design of a clubhouse for surf clubs. The basic clubhouse would have capacity for 50 members and include a club room, veranda, casualty room and a tower. By 1915, the weatherboarded clubhouses were built by the Council with the help of grants from the State Government. However, due to monetary restrictions by Council, only the North Narrabeen club included the tower in their clubhouse utilising their own funds. On 30 January 1915, the Newport Clubhouse was opened by Mr Quirk.<sup>56</sup>

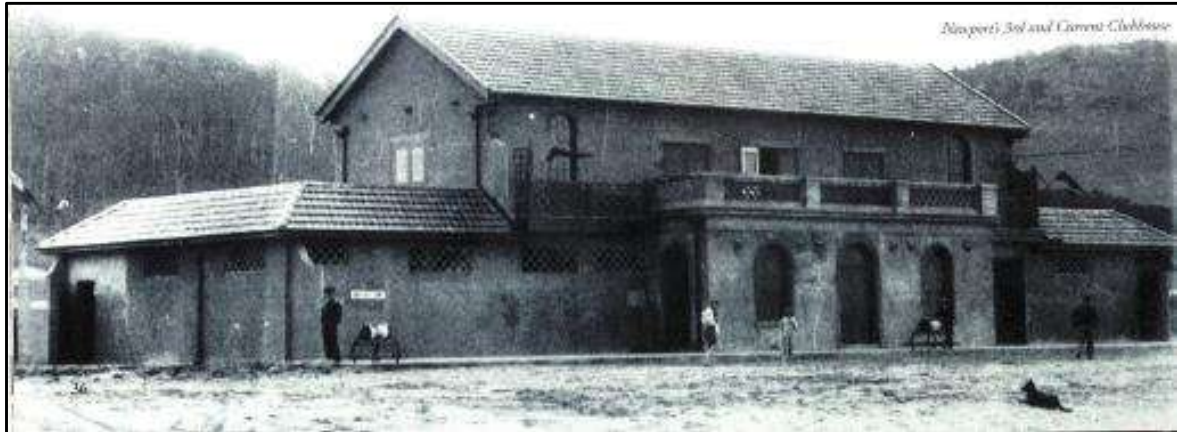
Figure 27. Third and current Newport Clubhouse, built in 1933.<sup>71</sup>

Photographic evidence demonstrates that during the 1930s, both wings of the Clubhouse were open to the sky, incorporating pitched roofs. It is evident from these photographs that the existing Clubhouse, with the added public toilet, first floor additions to the northern and southern wings, the staircases as well as the flat roof of the northern wing were not part of the original plans.

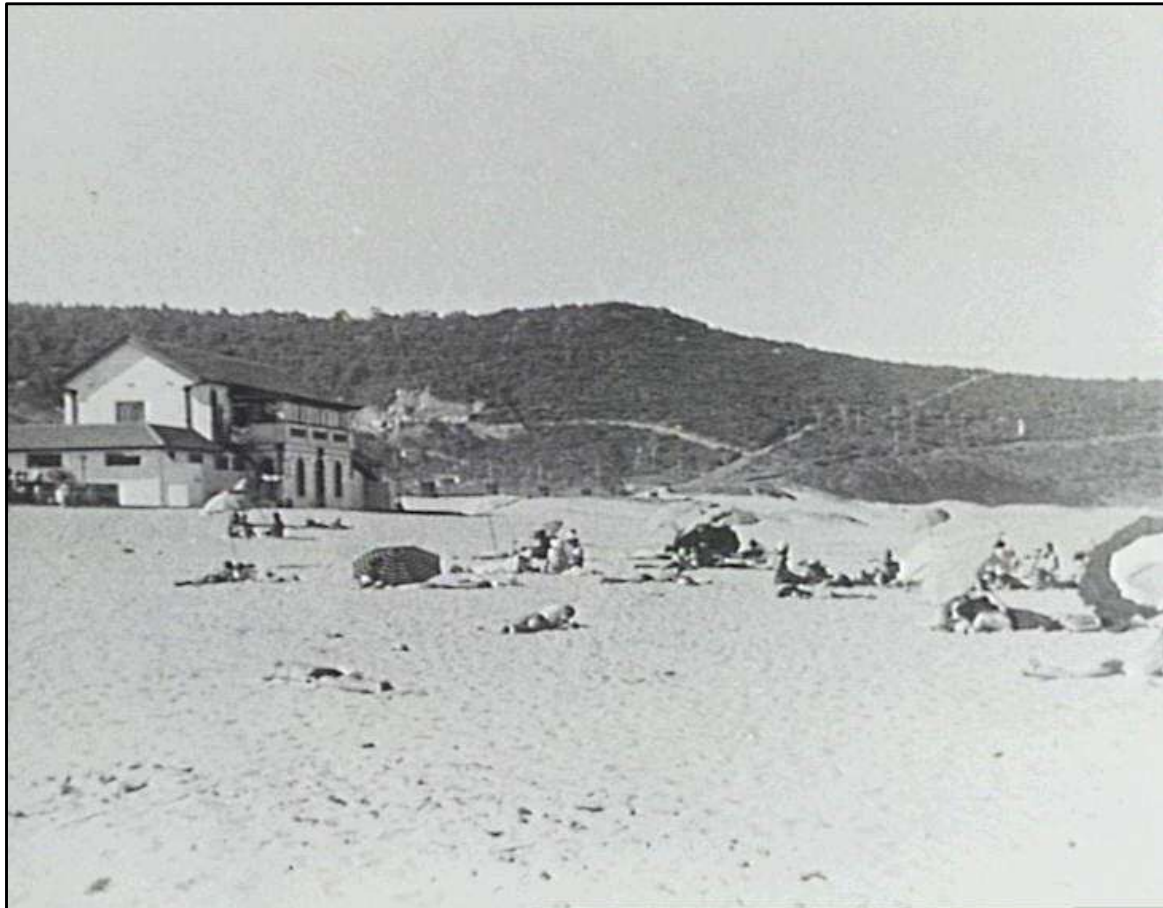
Figure 31. 'Newport Beach Surf Club House', c. 1937.<sup>78</sup>

By 1937, additions had been made to the original 1933 Clubhouse. These included an external staircase introduced to the northern wing of the Clubhouse, on the eastern façade, providing direct access to the beach.

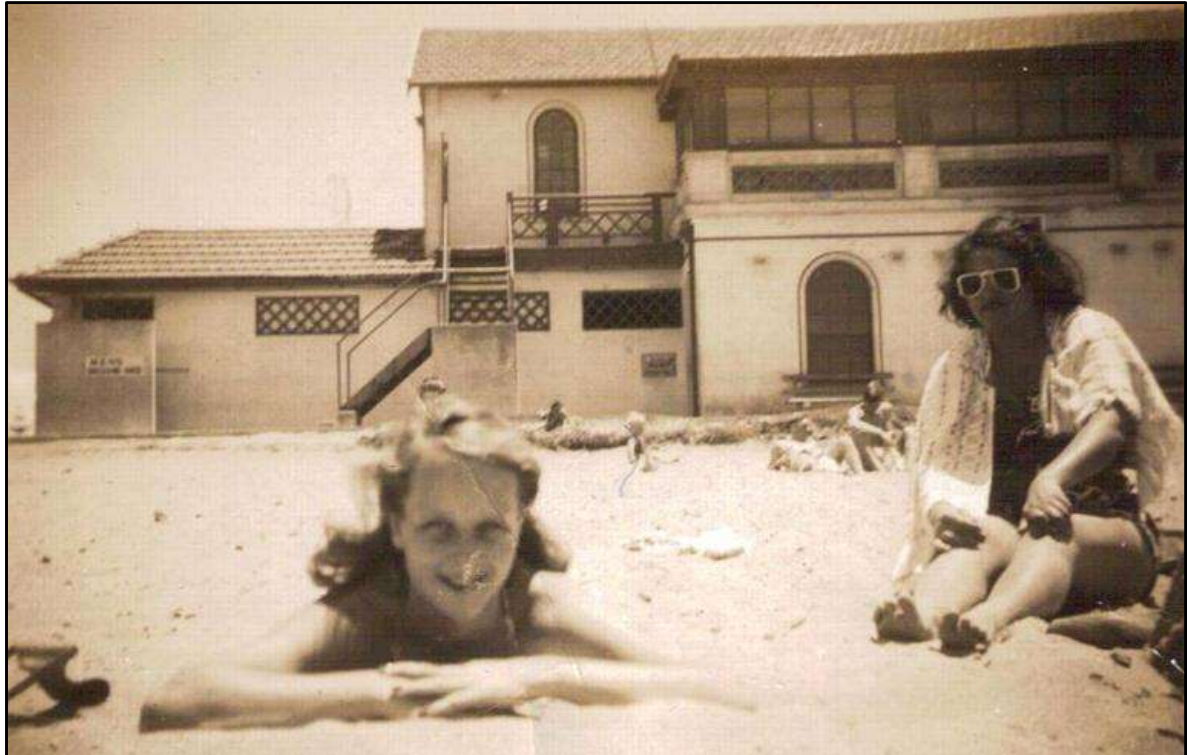
Figure 33. Image of eastern façade of the Newport Clubhouse, c. 1948. The photo shows the removal of a portion of the balustrade for the addition of emergency stairs. 'Ann Kristensen on sand at Newport Beach'.<sup>83</sup>

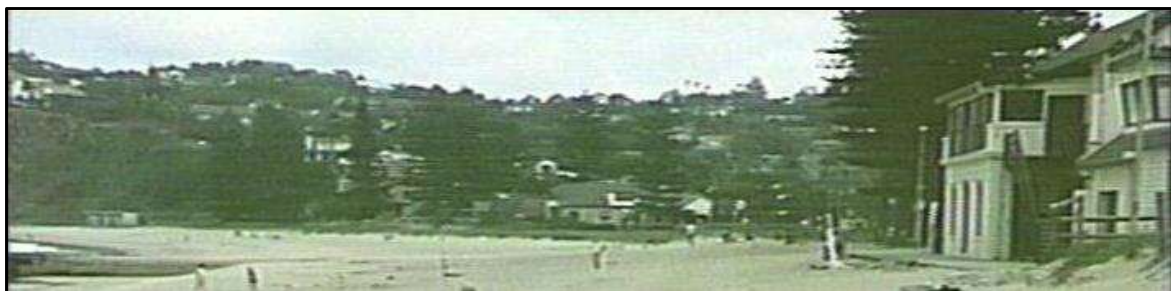
Figure 39. 'Newport Beach and Surf Club, 1986'<sup>100</sup>.

By 1986, further additions and modifications had been made to the Clubhouse. The pitched roof of the northern wing had been removed and replaced by a flat roof. Additionally, a tower with glazing had been added on top of the flat room, in order to provide views of the beach from the Clubhouse.

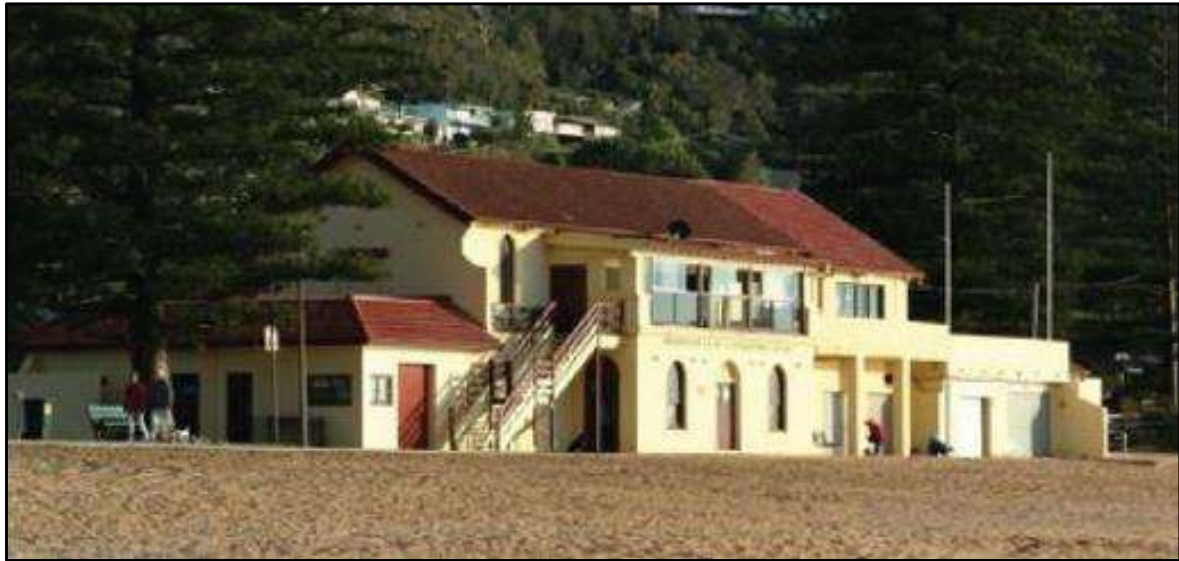
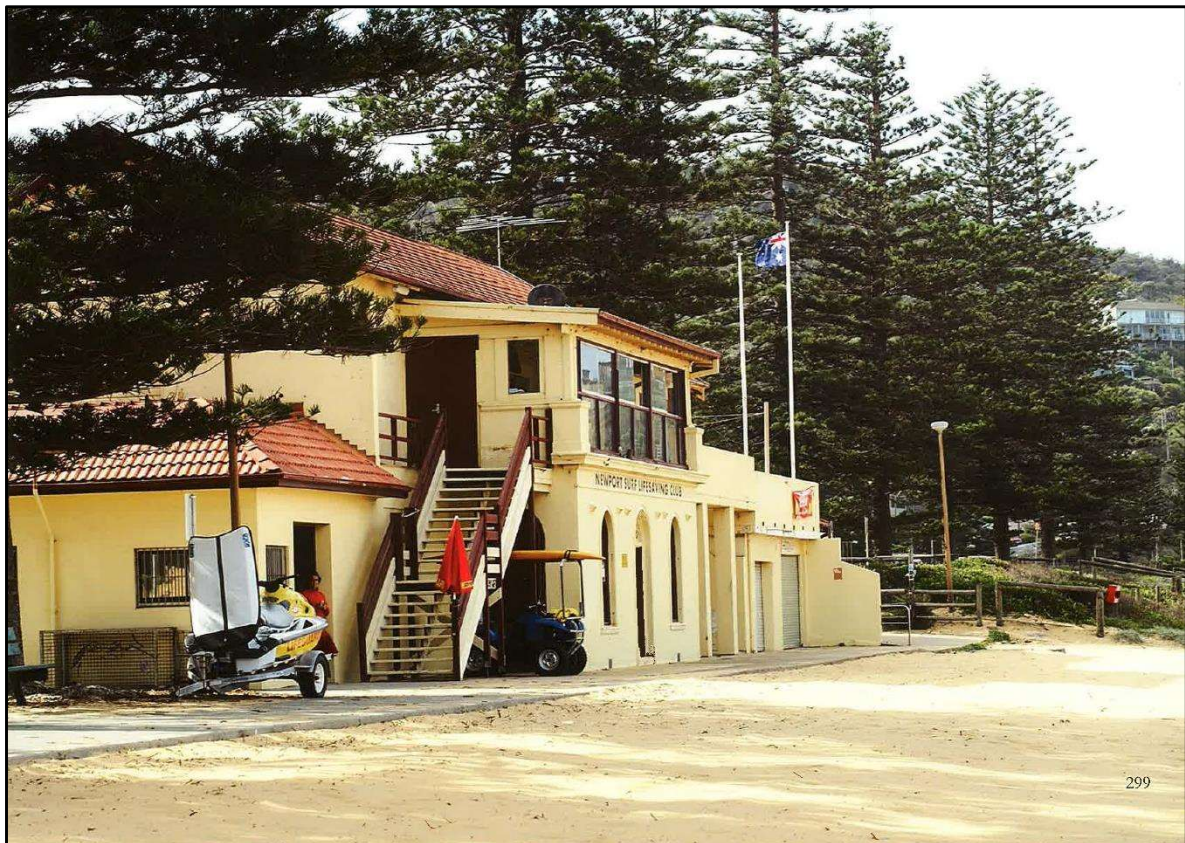
Figure 44. Newport Surf Life Saving Club, c. 2000. Photograph by Max Nippard<sup>107</sup>.

Figure 45. Newport Surf Life Saving Club, c. 2000<sup>108</sup>.

Figures 44 and 45 below demonstrate that by the 2000s, various alterations and additions had been made to the Clubhouse. These included the extension of the northern wing, incorporating a skillion roof and the addition of a public bathroom, the removal of the glazed tower located in the northern wing, and first floor additions to the northern wing. The modifications made substantially altered the roof line and form of the northern wing. Additionally, the alterations also included the removal of the external staircase located on the southern wing, and the installation of a new staircase in its place.

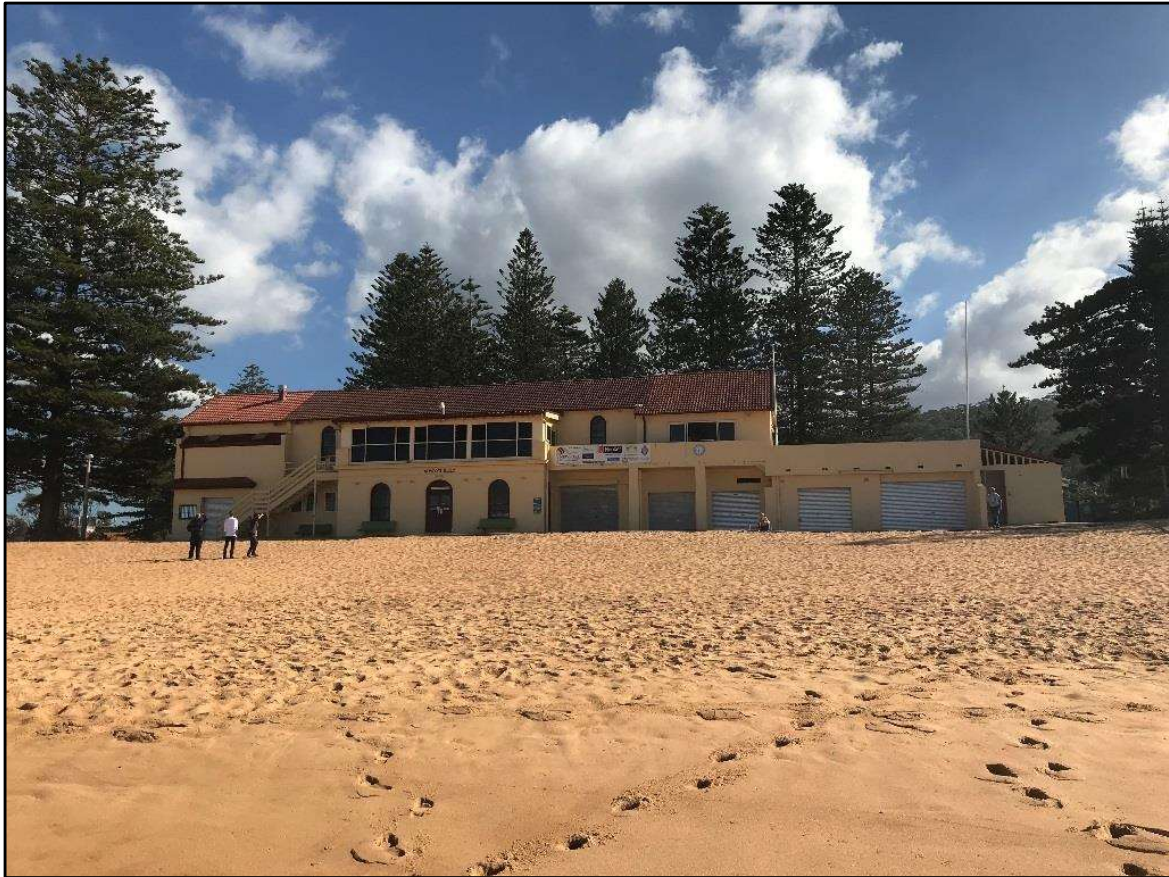
Figure 46. Eastern elevation of the Clubhouse. (Source: Photo taken by Heritage 21, 23.05.18)

The eastern façade facing the Tasman Sea and Newport beach presents itself as a two-storey single building with an extended entrance podium and a single storey extension at the northern end. Fenestrations along the extended podium on ground floor have been retained while the veranda on first floor has been enclosed with aluminium windows. Two doors on either side of the podium have been left in original condition. An access staircase in timber leads to the beach along the southern end of the building. The extension along the southern end presents itself as a three-tiered structure, with the ground floor tier punctured by a large roll-up door and a small aluminium framed window; the second tier comprises the kitchen with skylights inserted in a narrow skillion roof that has been added at a later stage; the third tier matches the roofline of the original building. The single storey extension at the northern end comprises of a high parapet wall indicating that the entire first-floor of the extension is used as an outdoor seating area while the ground floor is penetrated with five inconsistently sized garage roll-up doors that house the club's larger sized equipment. A small lean-to with a skillion roof is further added on as a secondary extension along the northern end containing the public female washrooms.

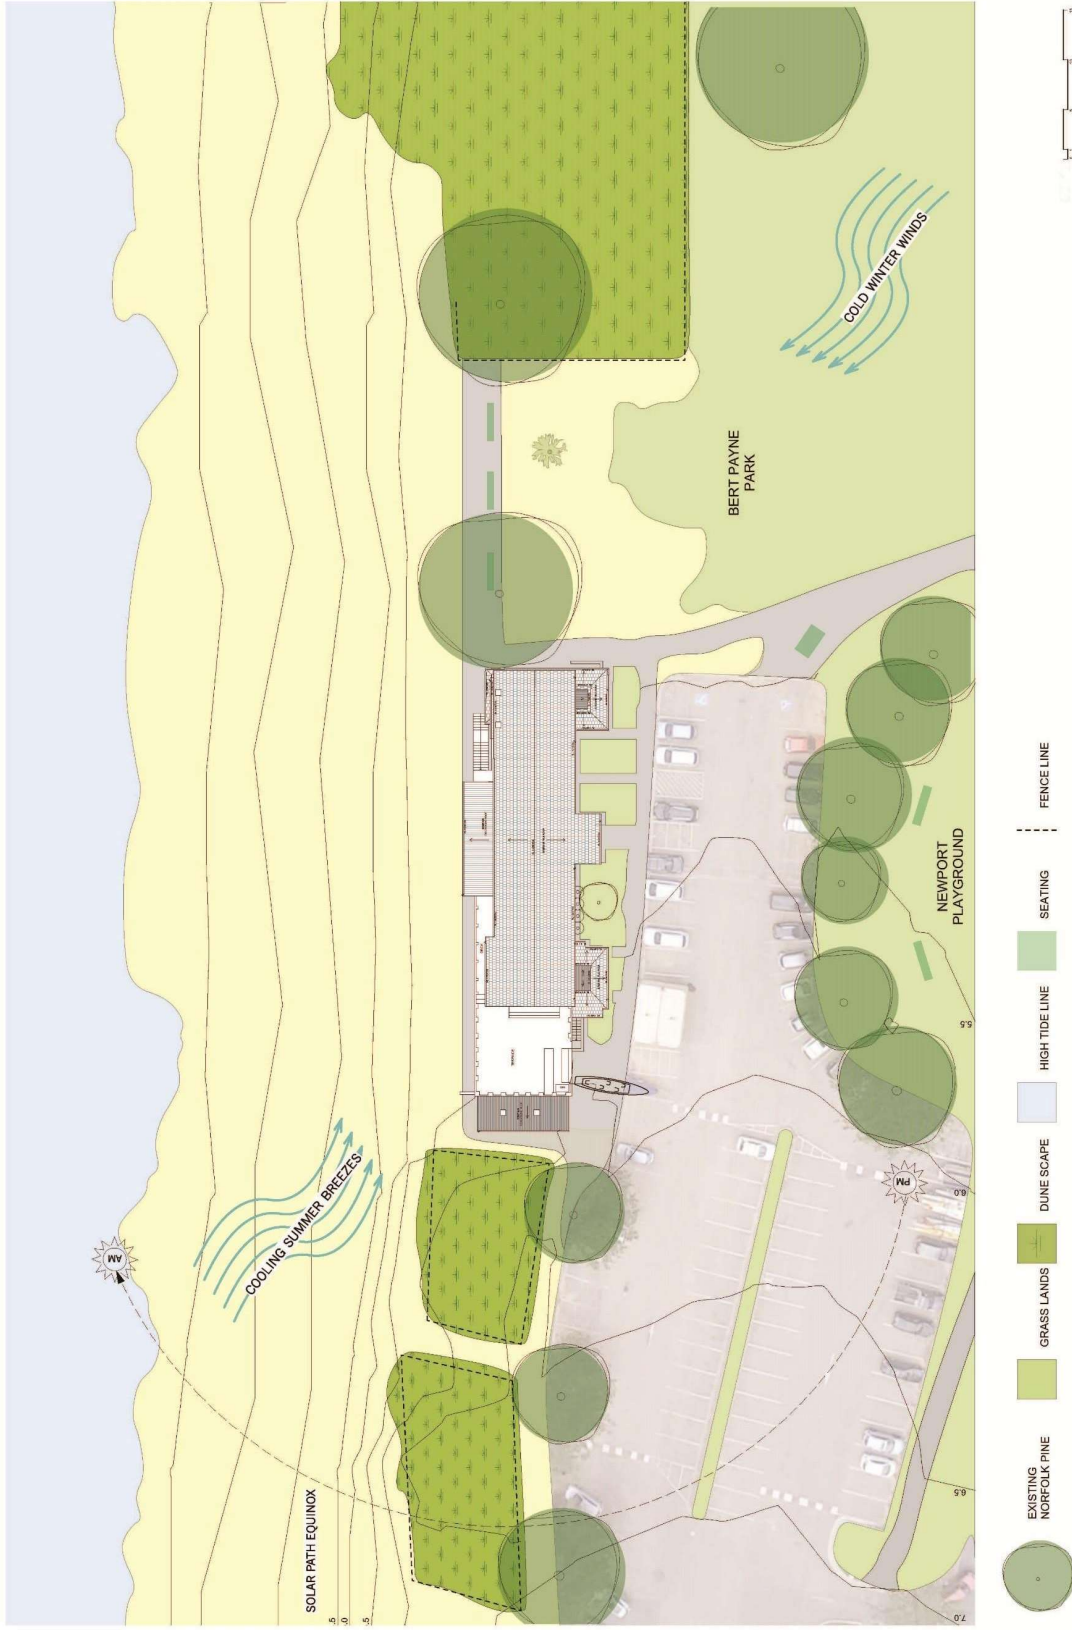
Site Analysis: Climate and Landscape Elements

Concept Design - Newport Surf Life Saving Club - June 2018

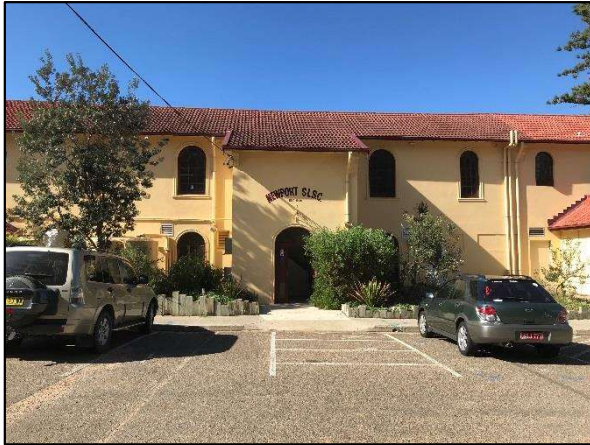
Figure 50. View to the entrance portico along the Western Elevation (Source: Heritage 21, 23.05.18)

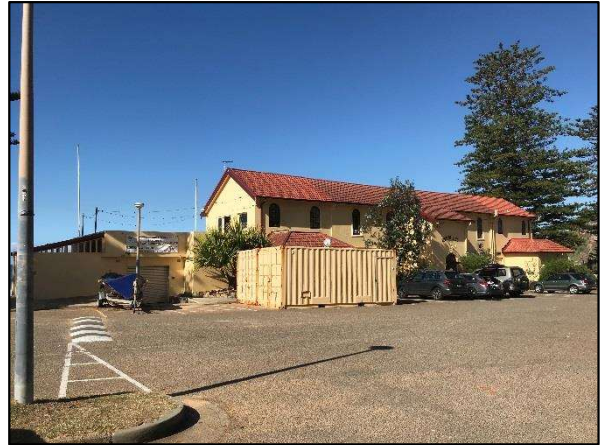
Figure 51. View from the north western corner of the parking lot looking towards the subject building. (Source: Heritage 21, 23.05.18)

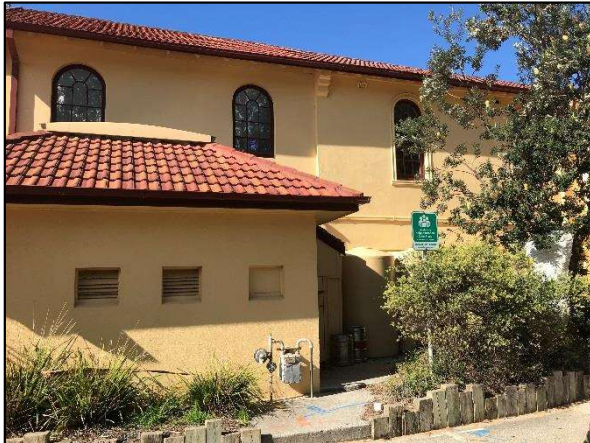
Figure 52. View of the Northern wing. Note the recessed wall between the original and the later addition northern extension. (Source: Heritage 21, 23.05.18)

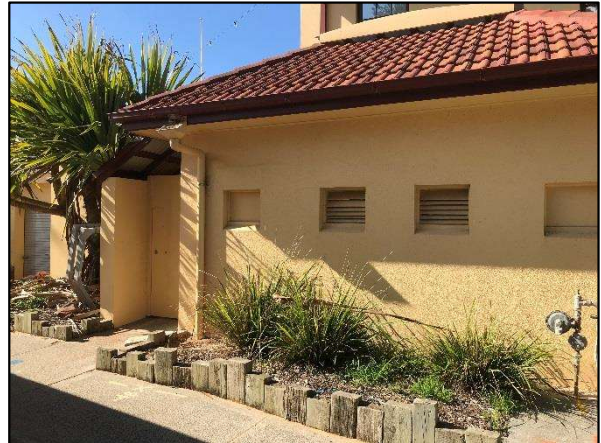
Figure 53. View of the northern wing and side wall that may leads may have led to an earlier entrance to change rooms. (Source: Heritage 21, 23.05.18)

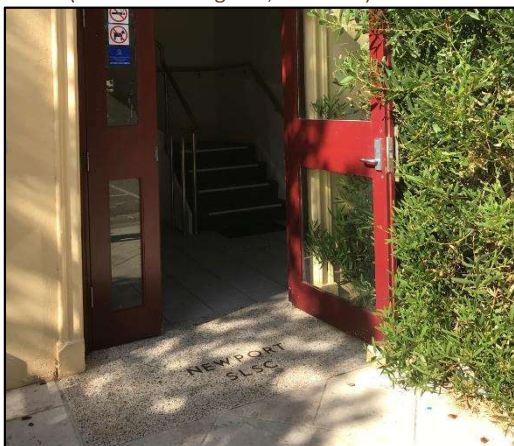
Figure 54. Detail of main entrance, featuring entry threshold with metal letters. (Source: Heritage 21, 23.05.18)

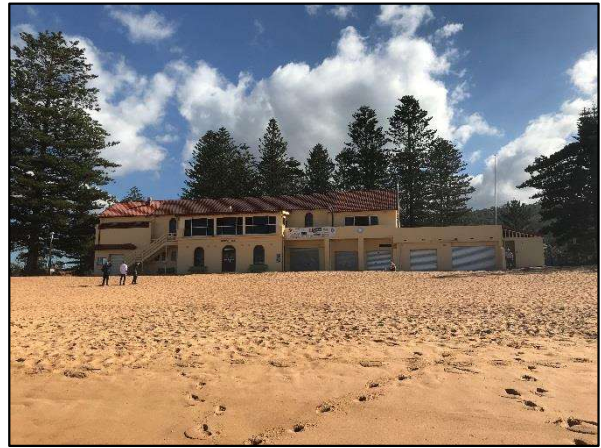
Figure 57. View of the eastern elevation as seen from Newport beach. (Source: Heritage 21, 23.05.18)

The exterior of the building, built in the Mediterranean Clubhouse style, is in a fair condition. However, considerable alterations have been undertaken over the years. The original building footprint included a two-storey central section with an entrance portico along the western façade and an extended podium entrance along the east. Two single storey wings flanked the main building

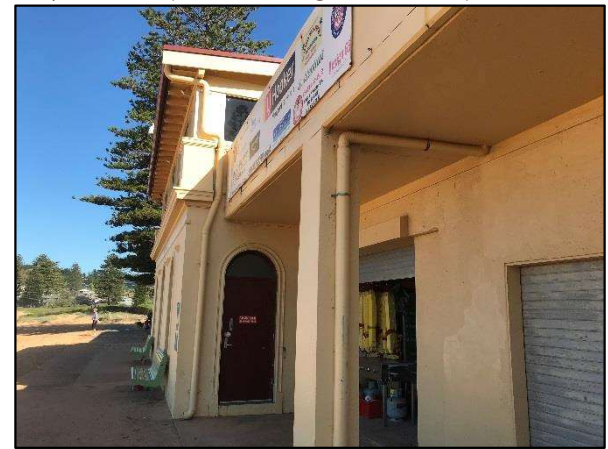
Figure 59. View of the door leading into the first aid room on ground floor and verandah extension in front of storage yards. (Source: Heritage 21, 23.05.18)

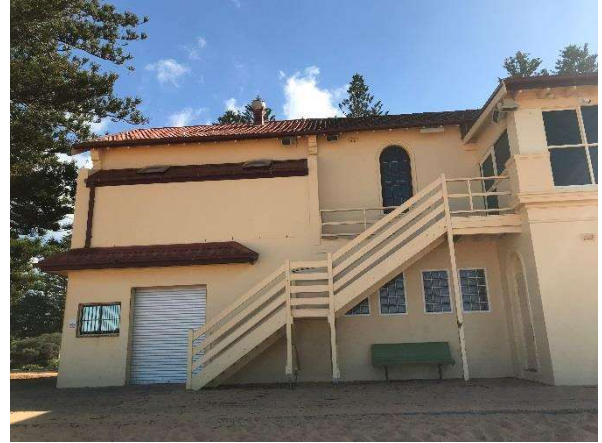
Figure 63. View of the Southern wing extension. Note the three-tiered roof extension. (Source: Heritage 21, 23.05.18)

- The existing roof is clad in terracotta tiles with timber ridge and hip capping.
- The tiles of the original central section vary from the later first floor wing extensions.
- The roof tiles of the ground floor wings also differ in colour from the central section indicating that they may also be a later addition.
- The roof cladding is in fair condition.

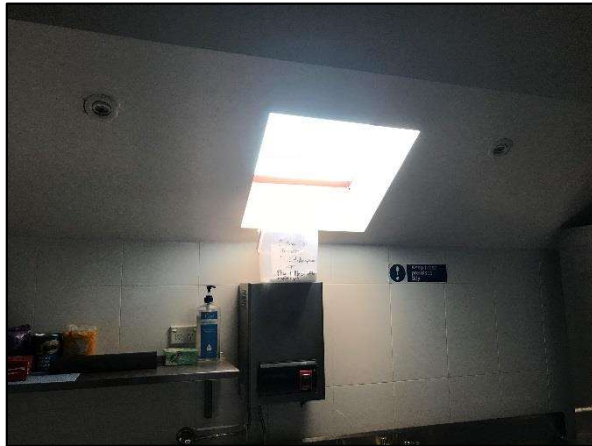
**Figure 98.** View of the later addition extension covering open to sky areas to facilitate the kitchen. Note modern skylights. (Source: Heritage 21, 23.05.18)

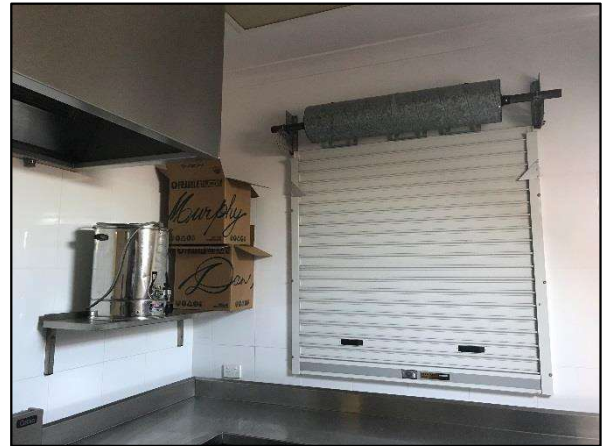
**Figure 99.** Service window from kitchen that opens into the main club room. The door can be viewed on the club room end in Figure 48. (Source: Heritage 21, 23.05.18)

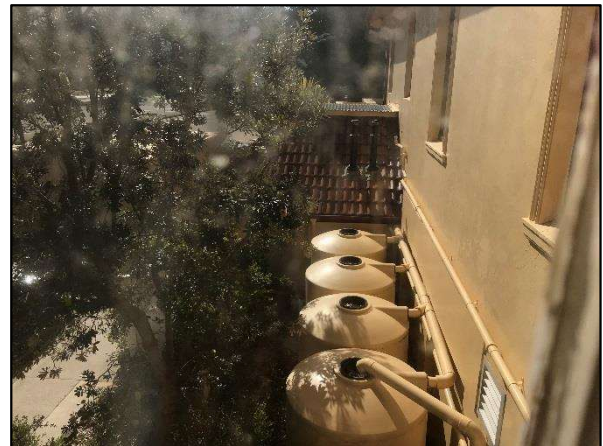
**Figure 101.** View to the Western elevation from a window in the office above the entry portico. Note water storage tanks and northern wing beyond. (Source: Heritage 21, 23.05.18)

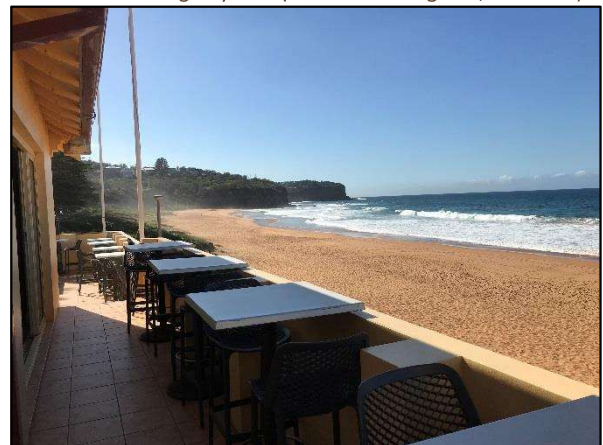
**Figure 103.** View of the open terrace extended beyond northern wing looking towards the main beach. (Source: Heritage 21, 23.05.18)

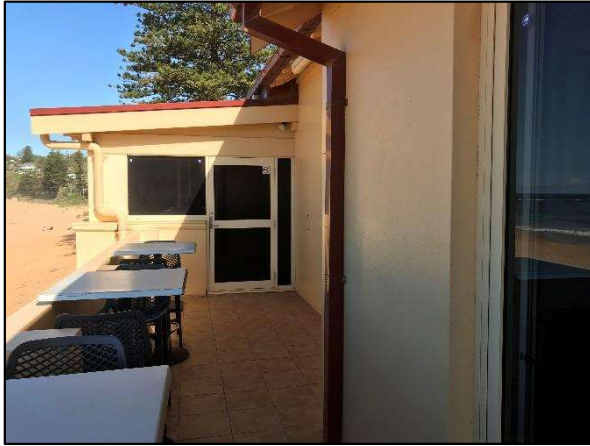
**Figure 104.** View of the open to sky terrace extended east from the Northern Wing. Note enclosed veranda extension behind the seating area. (Source: Heritage 21, 23.05.18)

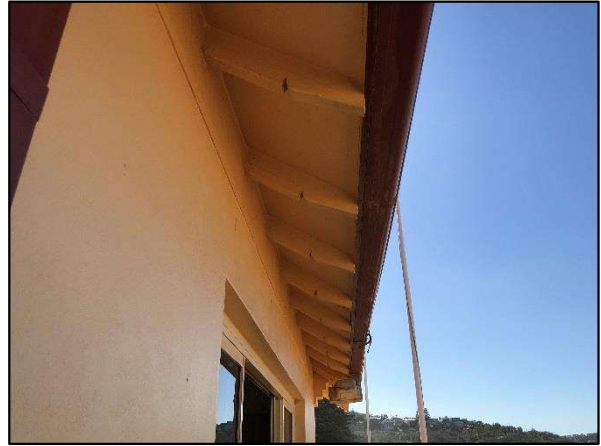
**Figure 105.** Note timber batons along roof line of original building in the centre. (Source: Heritage 21, 23.05.18)

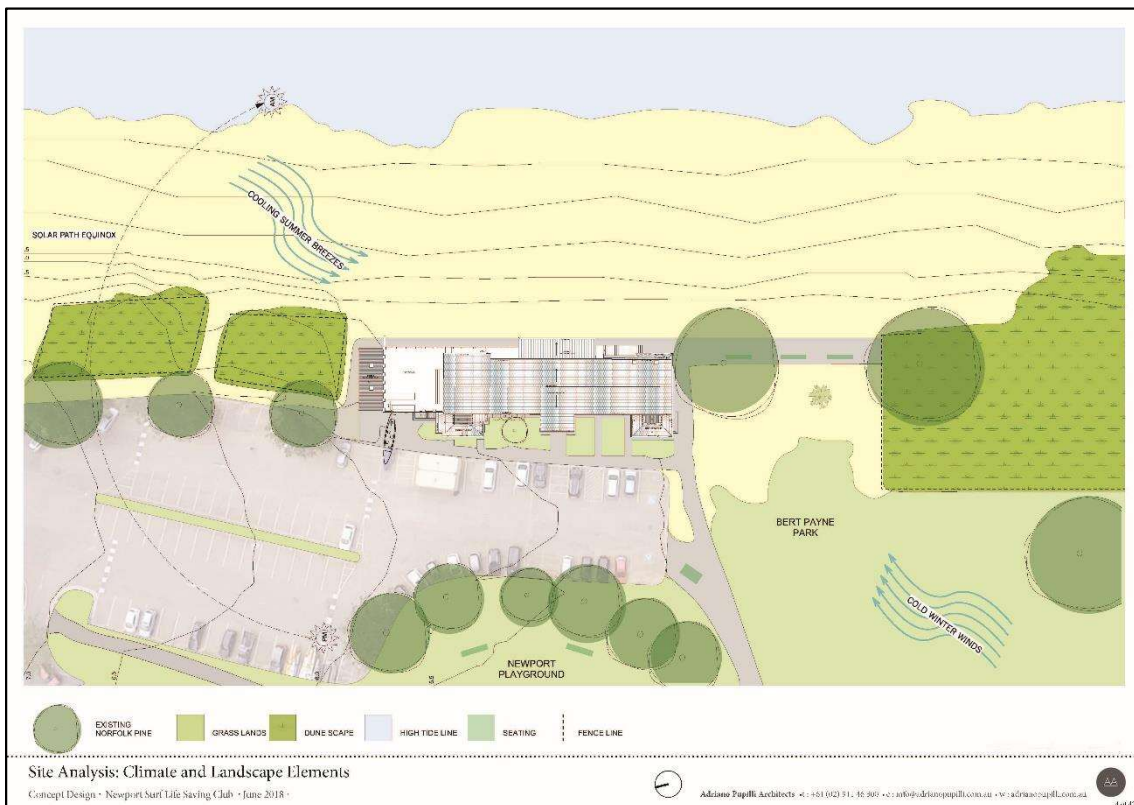
The following Curtilage Map illustrates the subject site and its surrounding areas. The sandy Newport beach runs 1.3 km facing the east extending from Newport Head to the lee of the sandstone Newport Reef. Barrenjoey Road runs along the northern half of the beach with a substantial reserve containing the club, parking and picnic facilities. The Bert Payne Reserve named after a Life Member of Newport SLCS runs between Barrenjoey Road and the Newport SLSC. The following drawing indicates the curtilage around the subject site.

Figure 106. The existing site plan showing the curtilage of the subject site.<sup>109</sup>

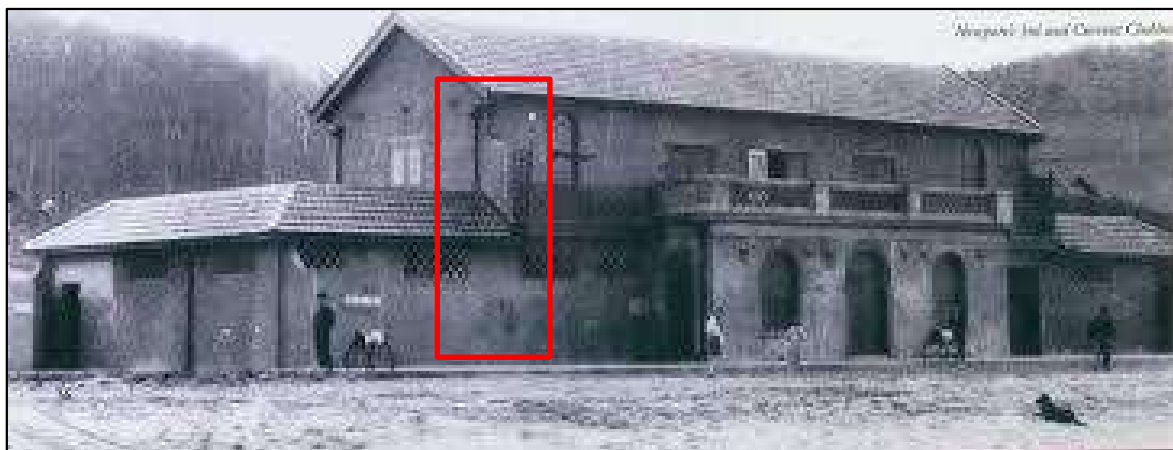
Figure 107. Photograph indicating original single storey wing alignment with two-storey section walls

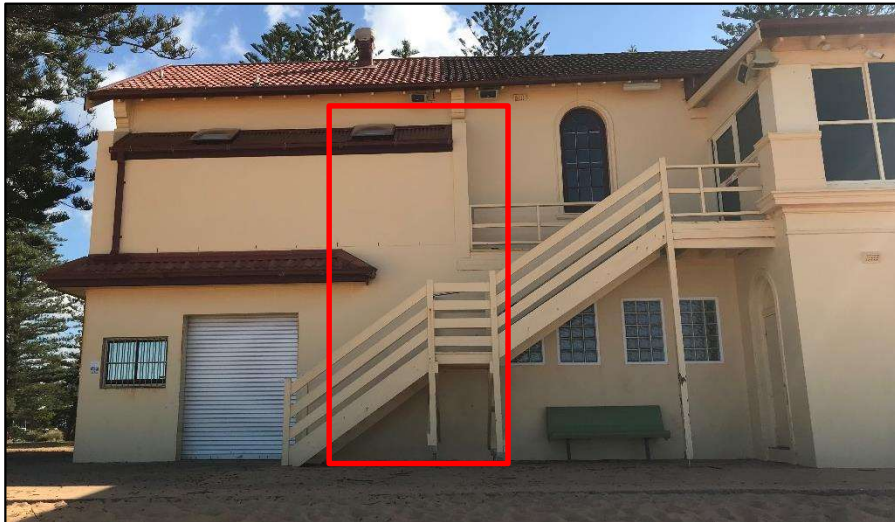
Figure 108. Current alignment of wing and central section walls.

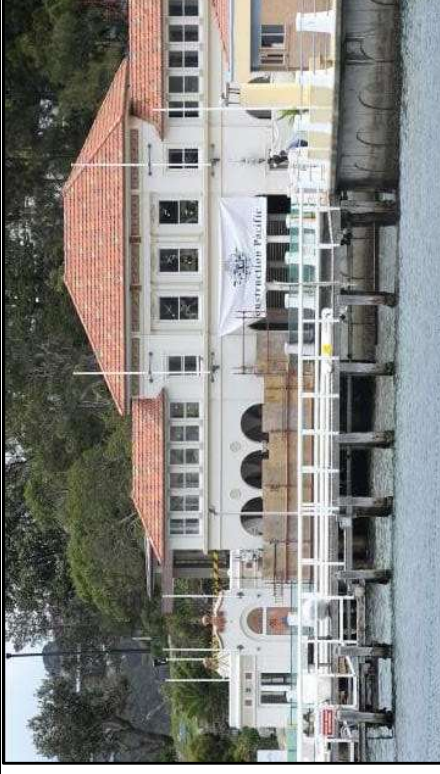
| Item Name | Address | Listing | Construction Date | Images |
|--|---|---|---|--|
| <p><b>Description</b></p> <p>Largely intact exterior retaining the ambience of the interwar Mediterranean style; white painted rendered brick, decorative ceramic tile insets and arched colonnade. (Anglin 1990:1047) Ferro-concrete two storey tiled roof pavilion built on pier. Colonnade to ground floor. Capitals to columns have fish, shell and acanthus leaf decoration; original wrought iron balustrading between columns beside water. Pavilion walls have decorative tile inlays using burnt orange and ultramarine ceramic tiles. A Greek key motif pattern is surmounted by semi-circular tiles which is in turn surmounted by ceramic decoration in scrolls and by urns. There is a strong Spanish</p> | | | | |

**Figure 112.** Manly Cove Pavilion. (Source: Welling, K. *Famous Manly harbour front site available after years of sitting idle*. The Daily Telegraph. May 21, 2015. Retrieved from: <https://www.dailytelegraph.com.au/newslocal/northern-beaches/>)
