Report Title: Geotechnical Report 18 Grenfell Avenue, North Narrabeen
Report Date: 30/6/21

GEOTECHNICAL INVESTIGATION:

Alterations and Additions at 18 Grenfell Avenue, North Narrabeen

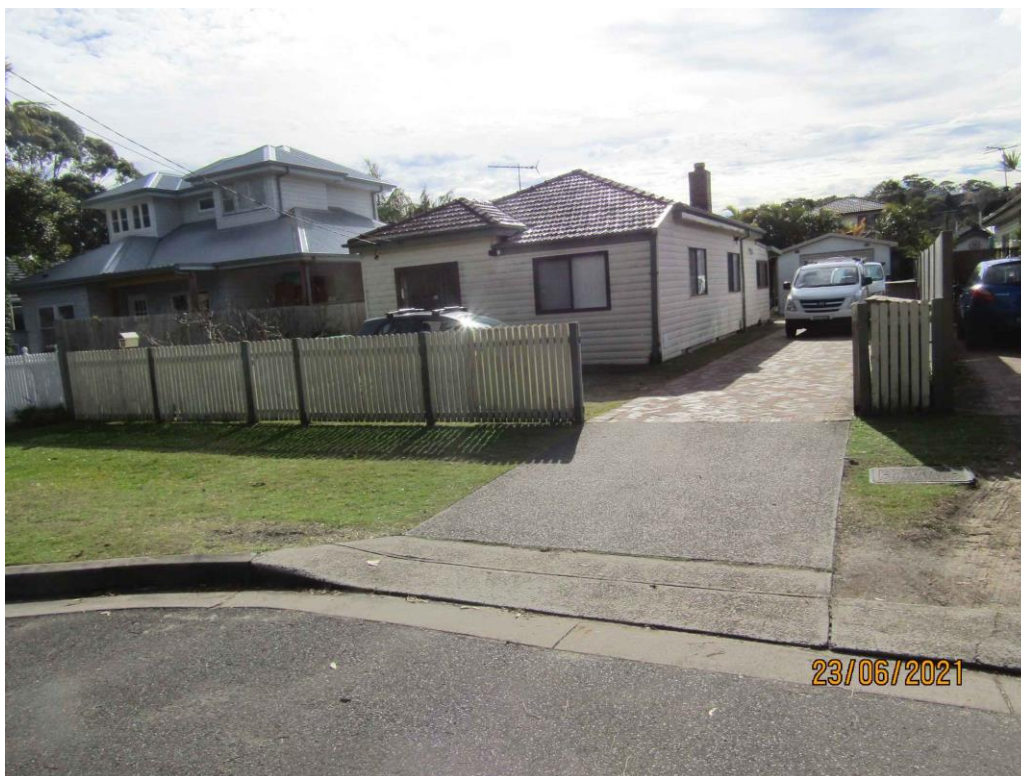
Photo 1

AUGER HOLE 1 (~RL2.2) – AH1 (Photo 1)

Depth (m)	Material Encountered
0.0 to 0.5	SILTY SAND , brown, moist, fine to medium grained with fine trace organic matter.
0.5 to 0.9	SAND , light yellow/brown, moist, fine to medium grained.
0.9 to 1.0	PEATY SAND , dark grey and black, damp.
1.0 to 1.5	SAND , grey, wet to very wet, medium grained.

End of Hole @ 1.5m. Watertable encountered at ~1.1m.

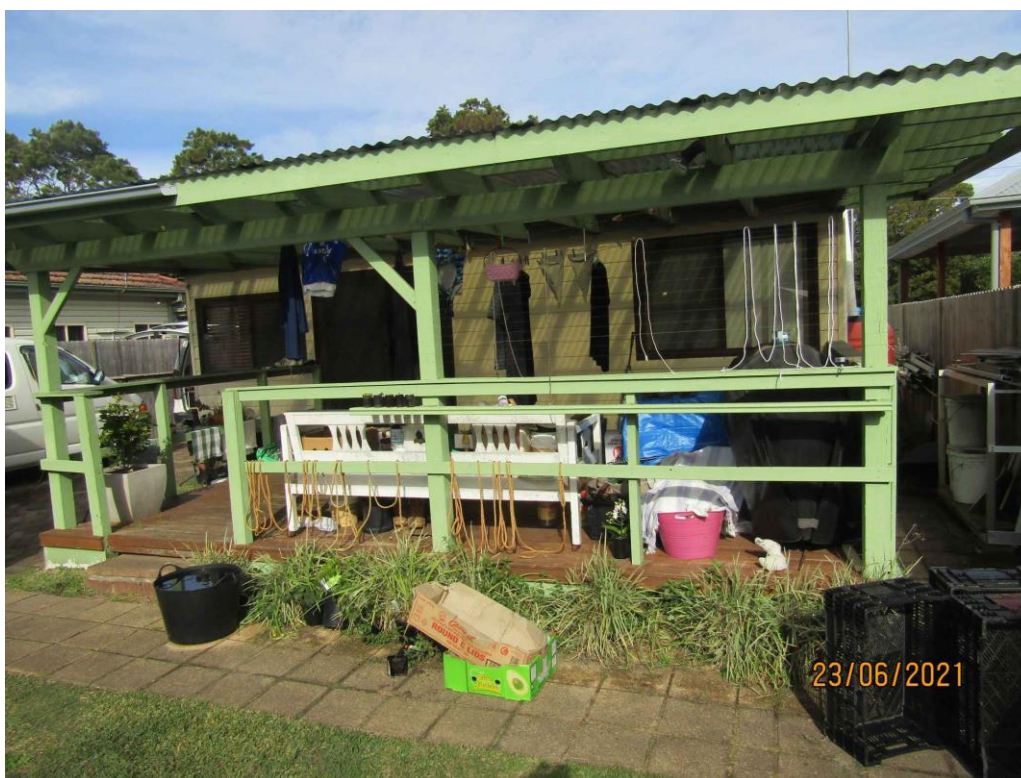
Photo 2

AUGER HOLE 2 (~RL2.1) – AH2 (Photo 2)

Depth (m)	Material Encountered
0.0 to 0.3	SANDY SOIL , brown, moist, fine to medium grained with fine trace organic matter.
0.3 to 0.8	SAND , with shell fragments, light yellow/brown, moist, fine to medium grained.
0.8 to 0.9	PEATY SAND , with shell fragments, dark grey and black, damp.
0.9 to 1.4	SAND , with shell fragments, grey, wet to very wet, medium grained.

End of Hole @ 1.4m. Watertable encountered at ~1.0m.

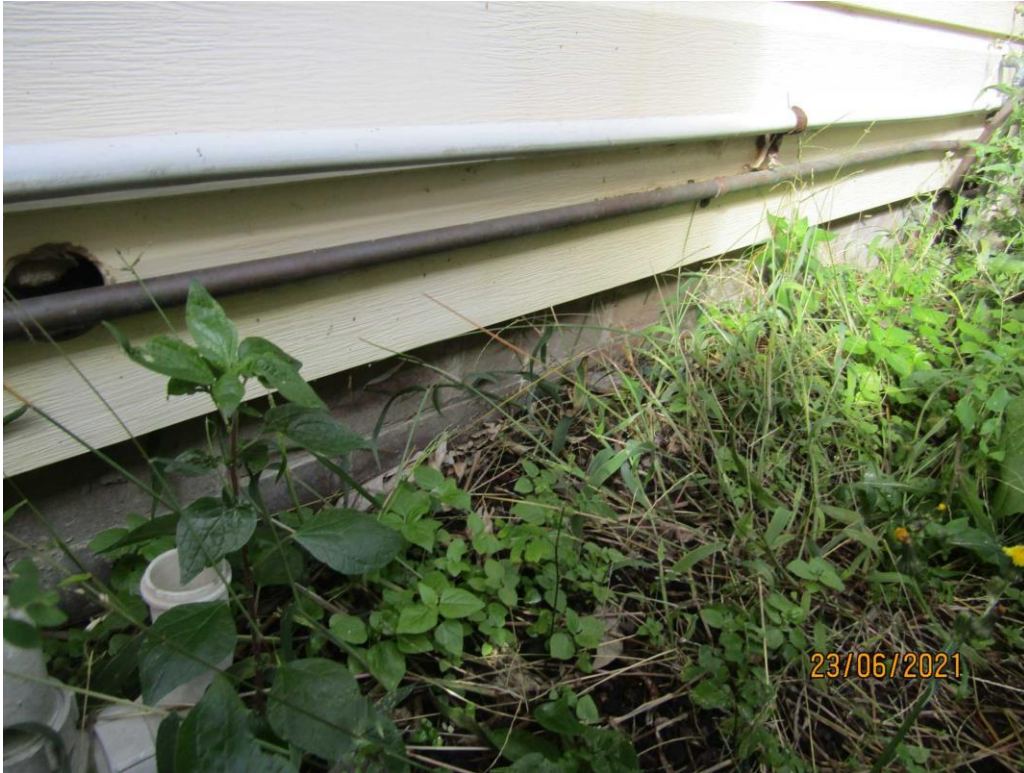
Photo 3

AUGER HOLE 3 (~RL2.1) – AH3 (Photo 3)

Depth (m)	Material Encountered
0.0 to 0.3	SANDY SOIL , brown, moist, fine to medium grained with fine trace organic matter.
0.3 to 0.8	SAND , with trace shell fragments, light yellow/brown, moist, fine to medium grained.
0.8 to 0.9	PEATY SAND , with trace shell fragments, dark grey and black, damp.
0.9 to 1.4	SAND , with trace shell fragments, grey, wet to very wet, medium grained.

End of Hole @ 1.4m. Watertable encountered at ~1.0m.

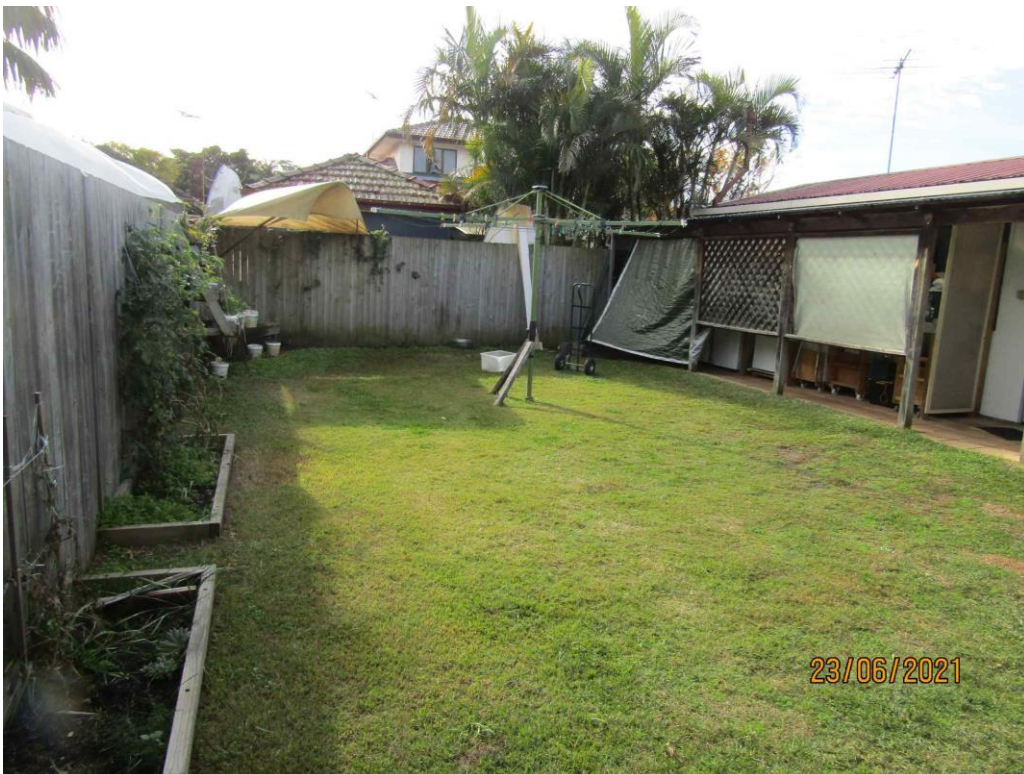
Photo 4

AUGER HOLE 4 (~RL2.0) – AH4 (Photo 4)

Depth (m)	Material Encountered
0.0 to 0.6	SANDY SOIL , brown, moist, fine to medium grained with fine trace organic matter.
0.6 to 0.8	SAND , with trace shell fragments, light yellow/brown, moist, fine to medium grained.
0.8 to 0.9	SAND , grey, wet, medium grained.
End of Hole @ 0.9m. No watertable encountered.

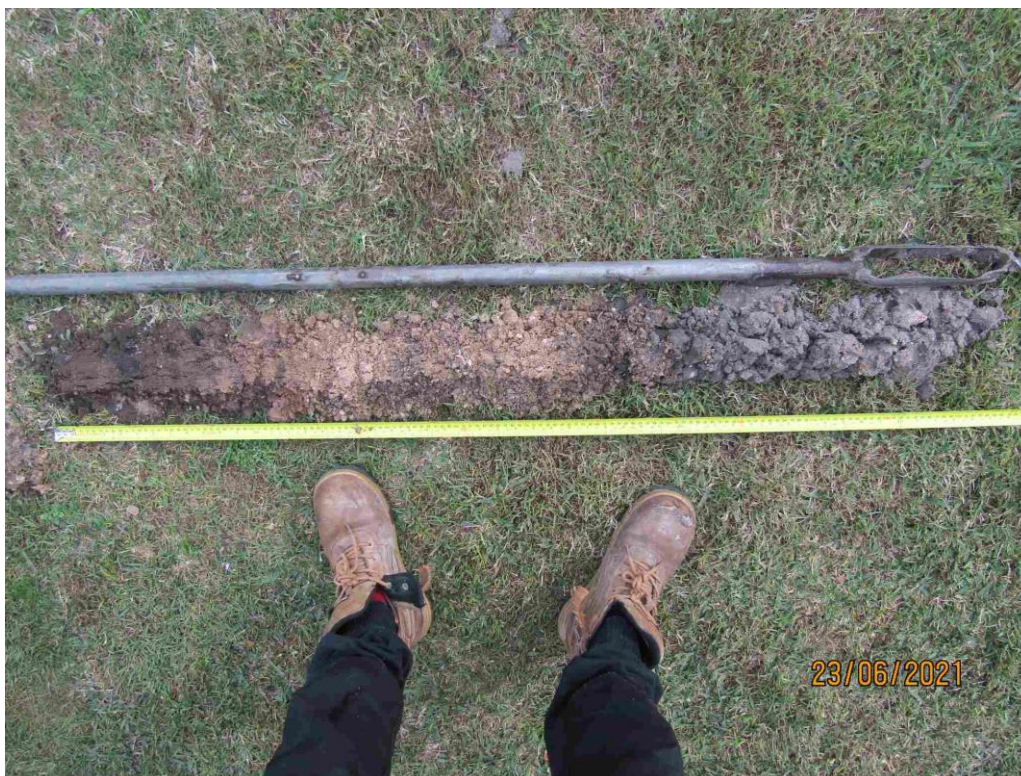
Photo 6: AH2 – Downhole is from left to right.

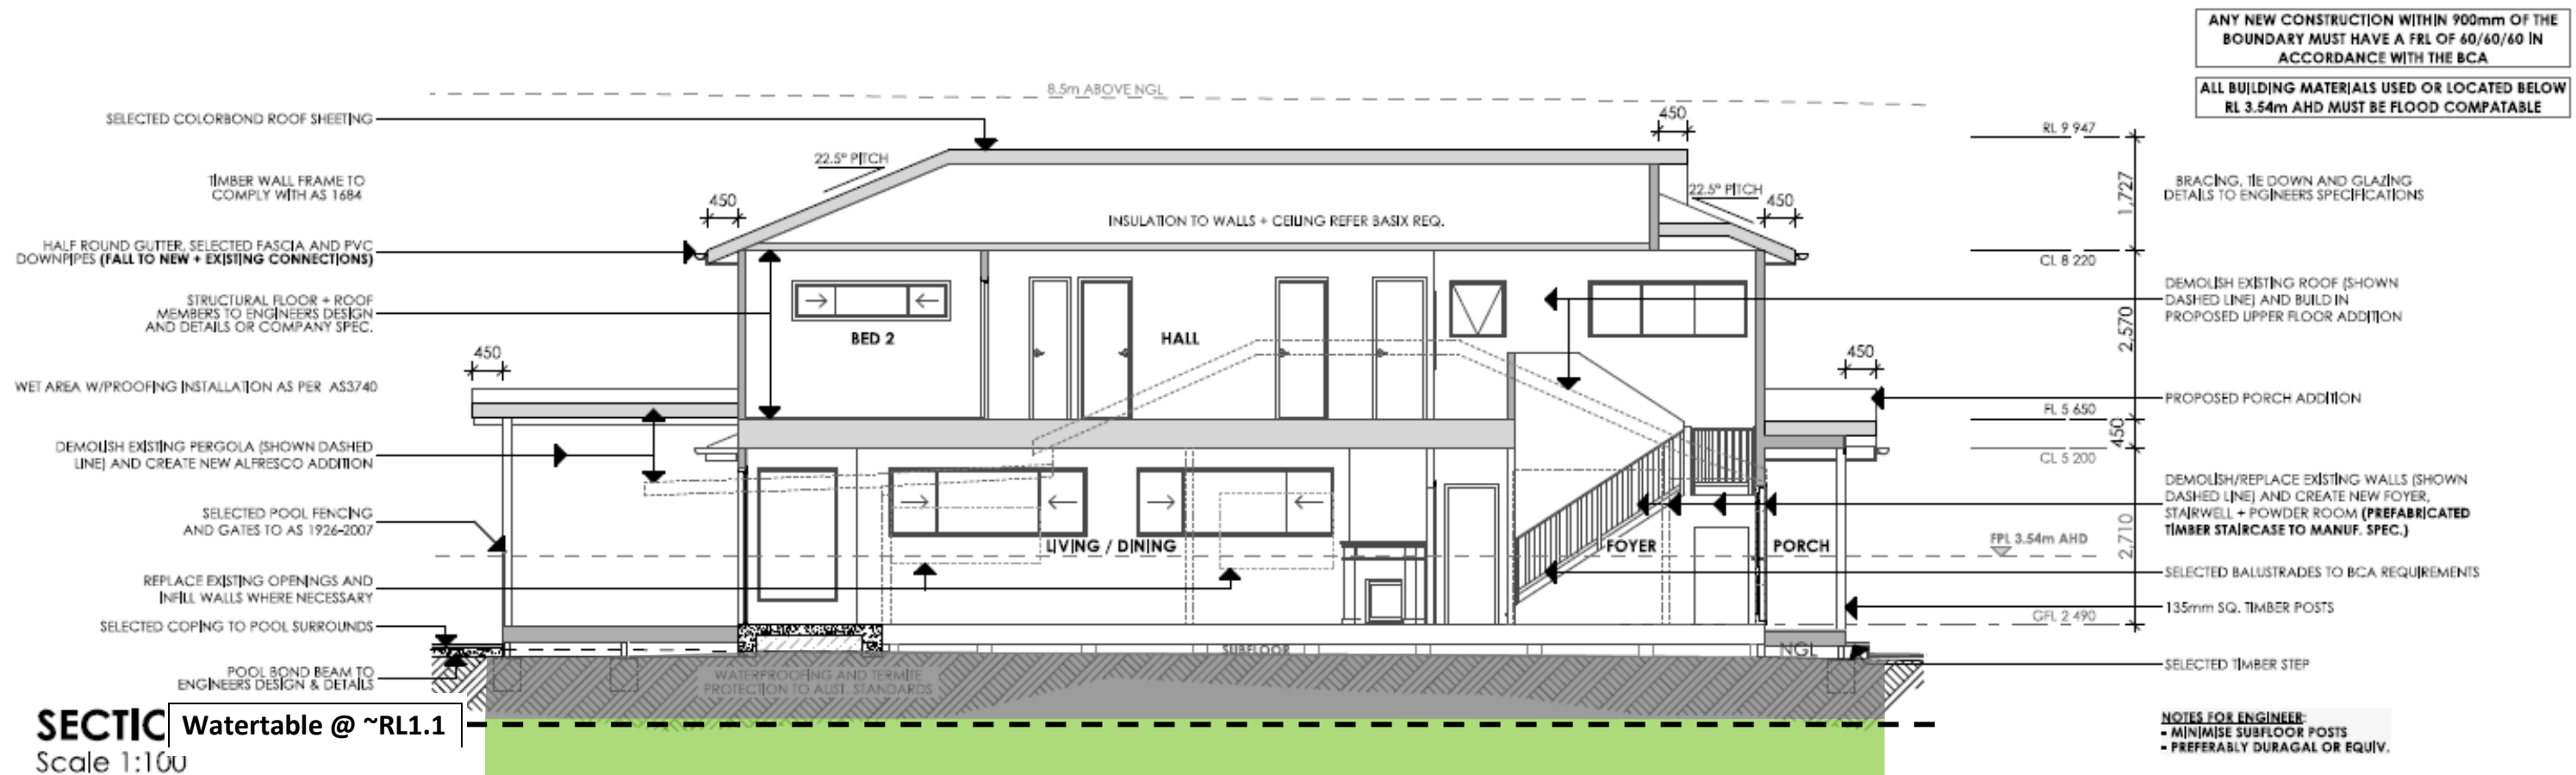
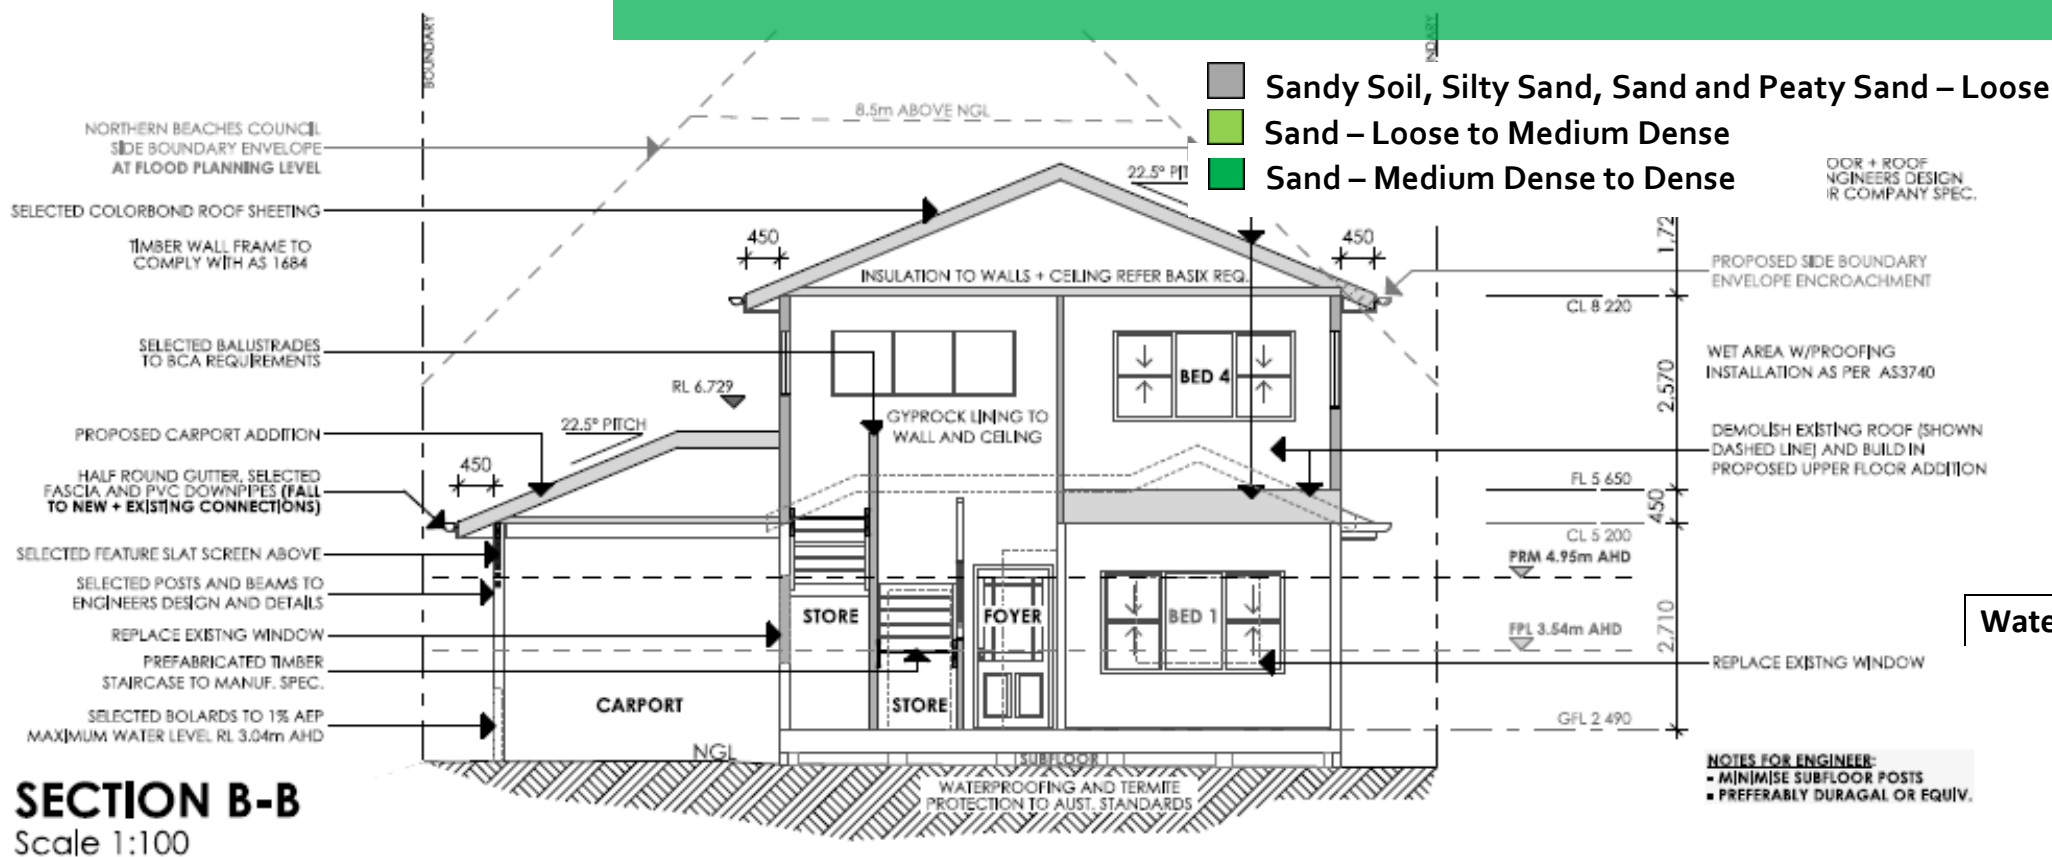
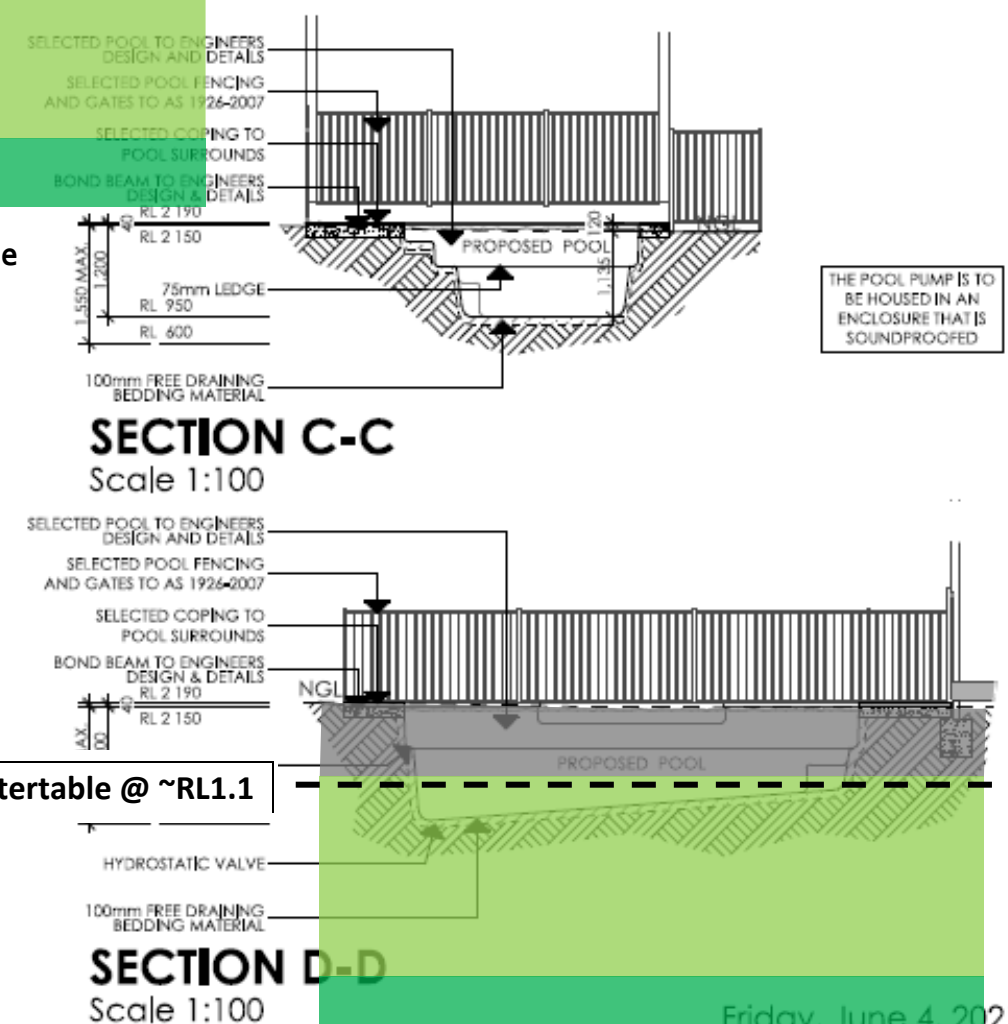
TYPE SECTION – Diagrammatical Interpretation of expected Ground Materials

The site is underlain by alluvial sediment that extends to the extent of the testing at 4.5m. To summarise the test results, Loose silty sand and sandy soil overlies Loose sand to a depth of ~0.9m. These overlie a thin ~0.1m layer of Loose peaty sand. The peaty sand overlies sands that vary in density between Loose to Medium Dense that extend to a depth of 3.6m. These overlie Medium Dense to Dense Sands to at least the extent of the testing at 4.5m. See the Type Section attached for a diagrammatical representation of the expected ground materials.
