Report on  
Geotechnical Investigation

Narrabeen Education Precinct  
Namona Street, North Narrabeen

Prepared for  
NSW Department of Education  
c/- Johnstaff Pty Ltd

Project 86973.00  
March 2020

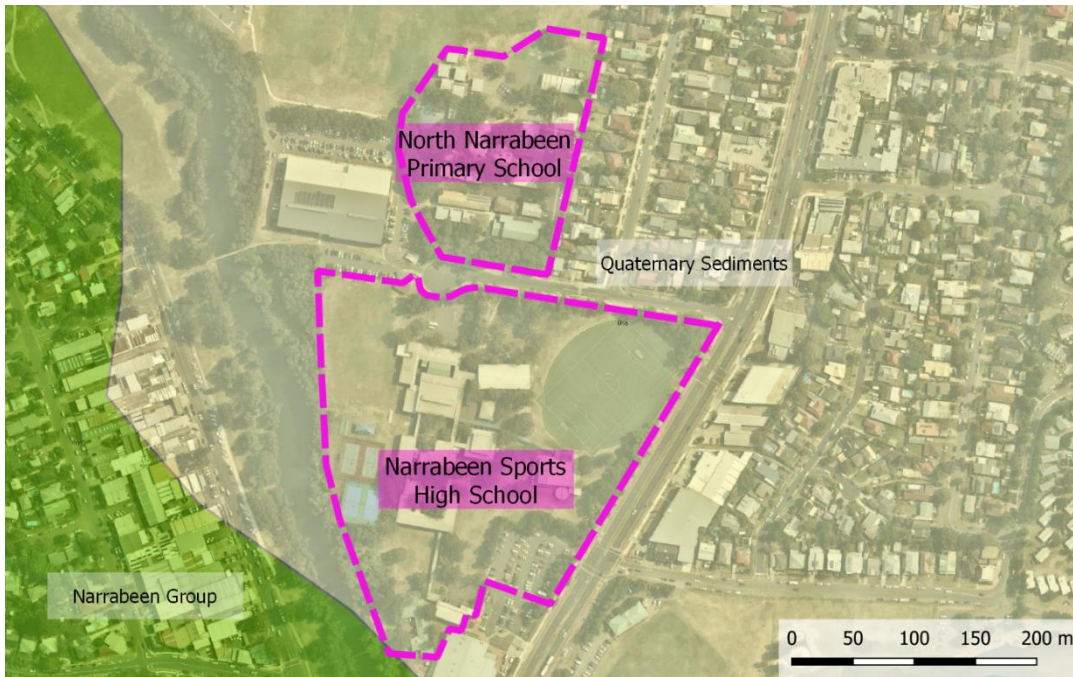
**Figure 1: Excerpt from Sydney 1:100 000 Geology Series Sheet 9130**

Reference to the Sydney 1:100 000 Geological Series indicates that the sites are in an area underlain by Quaternary Period stream alluvial and estuarine sediments. These sediments comprise silty to peaty quartz sand, silt and clay, ferruginous and humic cementation in places, and common shell layers. The mapping indicates that the area to south-west of the sites is underlain by the Narrabeen Group of the Triassic Period, which comprises interbedded laminite, shale and quartz, to lithic quartz sandstone. An excerpt from the Sydney 1:100 000 Geological Series Sheet 9130 is shown in Figure 1.

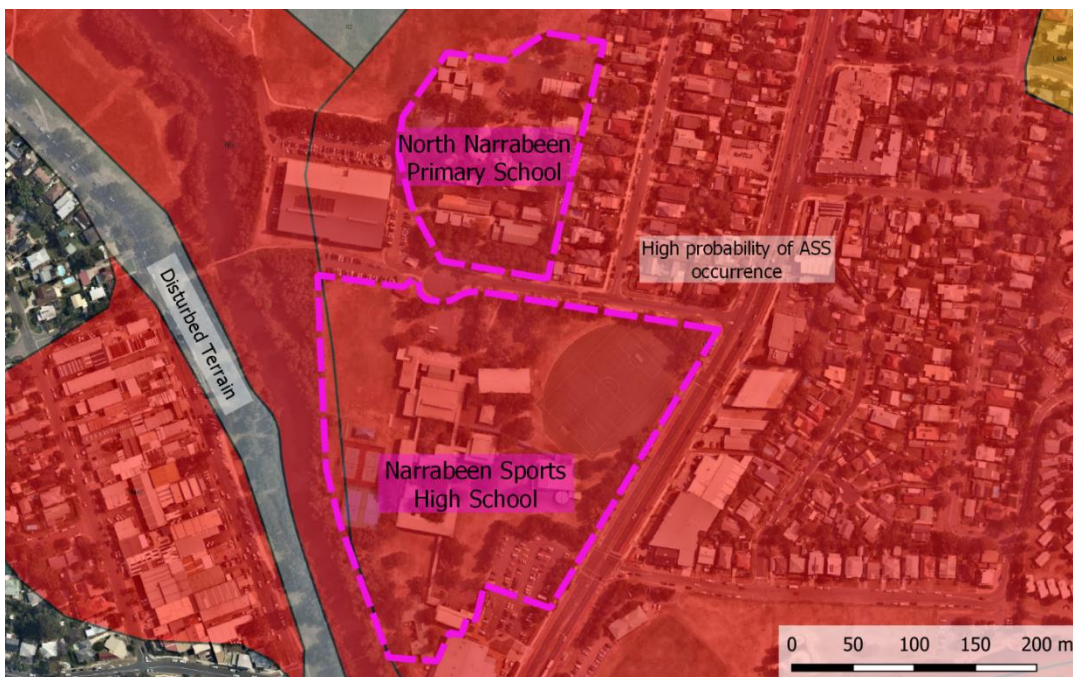
**Figure 2: Excerpt from Sydney 1:25 000 Acid Sulphate Soils (ASS) Risk Map**

Reference to the 1:25 000 Acid Sulphate Soils (ASS) Risk map indicates that the sites are located within an area of high probability of occurrence of ASS below 1 - 3 m depth. An excerpt from the ASS Risk map is shown in Figure 2.

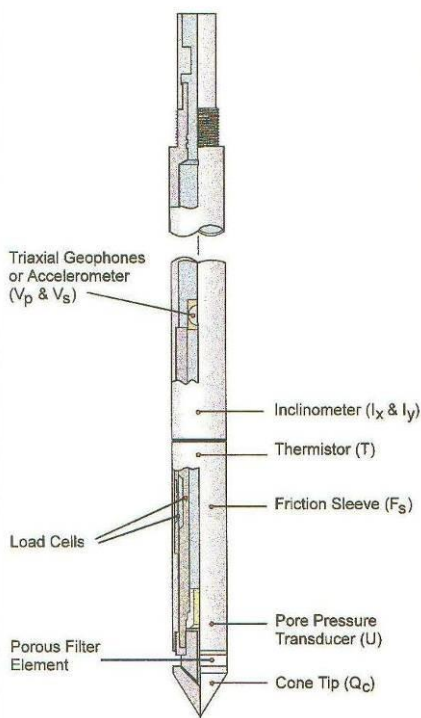
Figure 1: Cone Diagram

The soil parameters measured depend on the type of cone being used, however they always include the following basic measurements

- Cone tip resistance  $q_c$
- Sleeve friction  $f_s$
- Inclination (from vertical)  $i$
- Depth below ground  $z$

The inclinometer in the cone enables the verticality of the test to be confirmed and, if required, the vertical depth can be corrected.

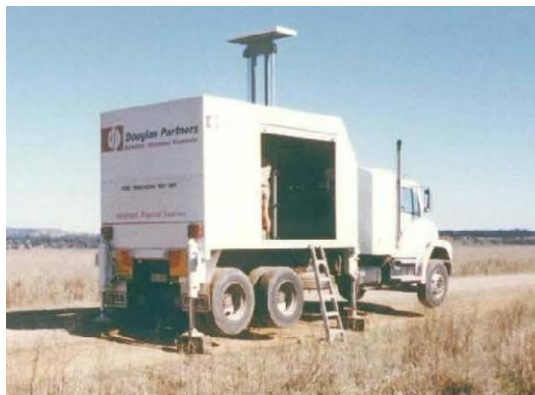
Figure 2: Purpose built CPT rig

The cone is thrust into the ground at a steady rate of about 20 mm/sec, usually using the hydraulic rams of a purpose built CPT rig, or a drilling rig. The testing is carried out in accordance with the Australian Standard AS1289 Test 6.5.1.

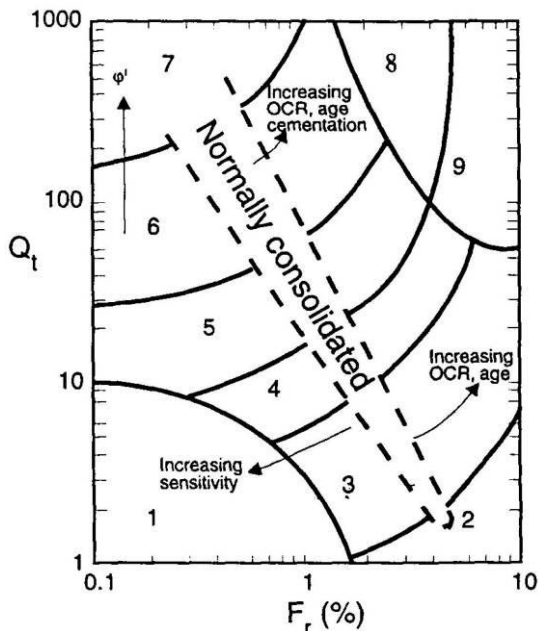
Figure 3: Soil Classification Chart

The CPT parameters can be used to infer the Soil Behaviour Type (SBT), based on normalised values of cone resistance ( $Q_t$ ) and friction ratio ( $F_r$ ). These are used in conjunction with soil classification charts, such as the one below (after Robertson 1990)

DP's in-house CPT software provides computer aided interpretation of soil strata, generating soil descriptions and strengths for each layer. The software can also produce plots of estimated soil parameters, including modulus, friction angle, relative density, shear strength and over consolidation ratio.

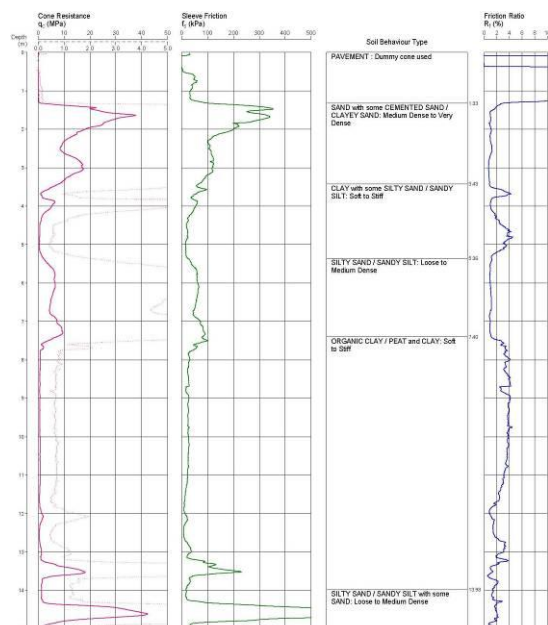
Figure 4: Sample Cone Plot

Other applications of CPT include ground improvement monitoring (testing before and after works), salinity and contaminant plume mapping (conductivity cone), preloading studies and verification of strength gain.

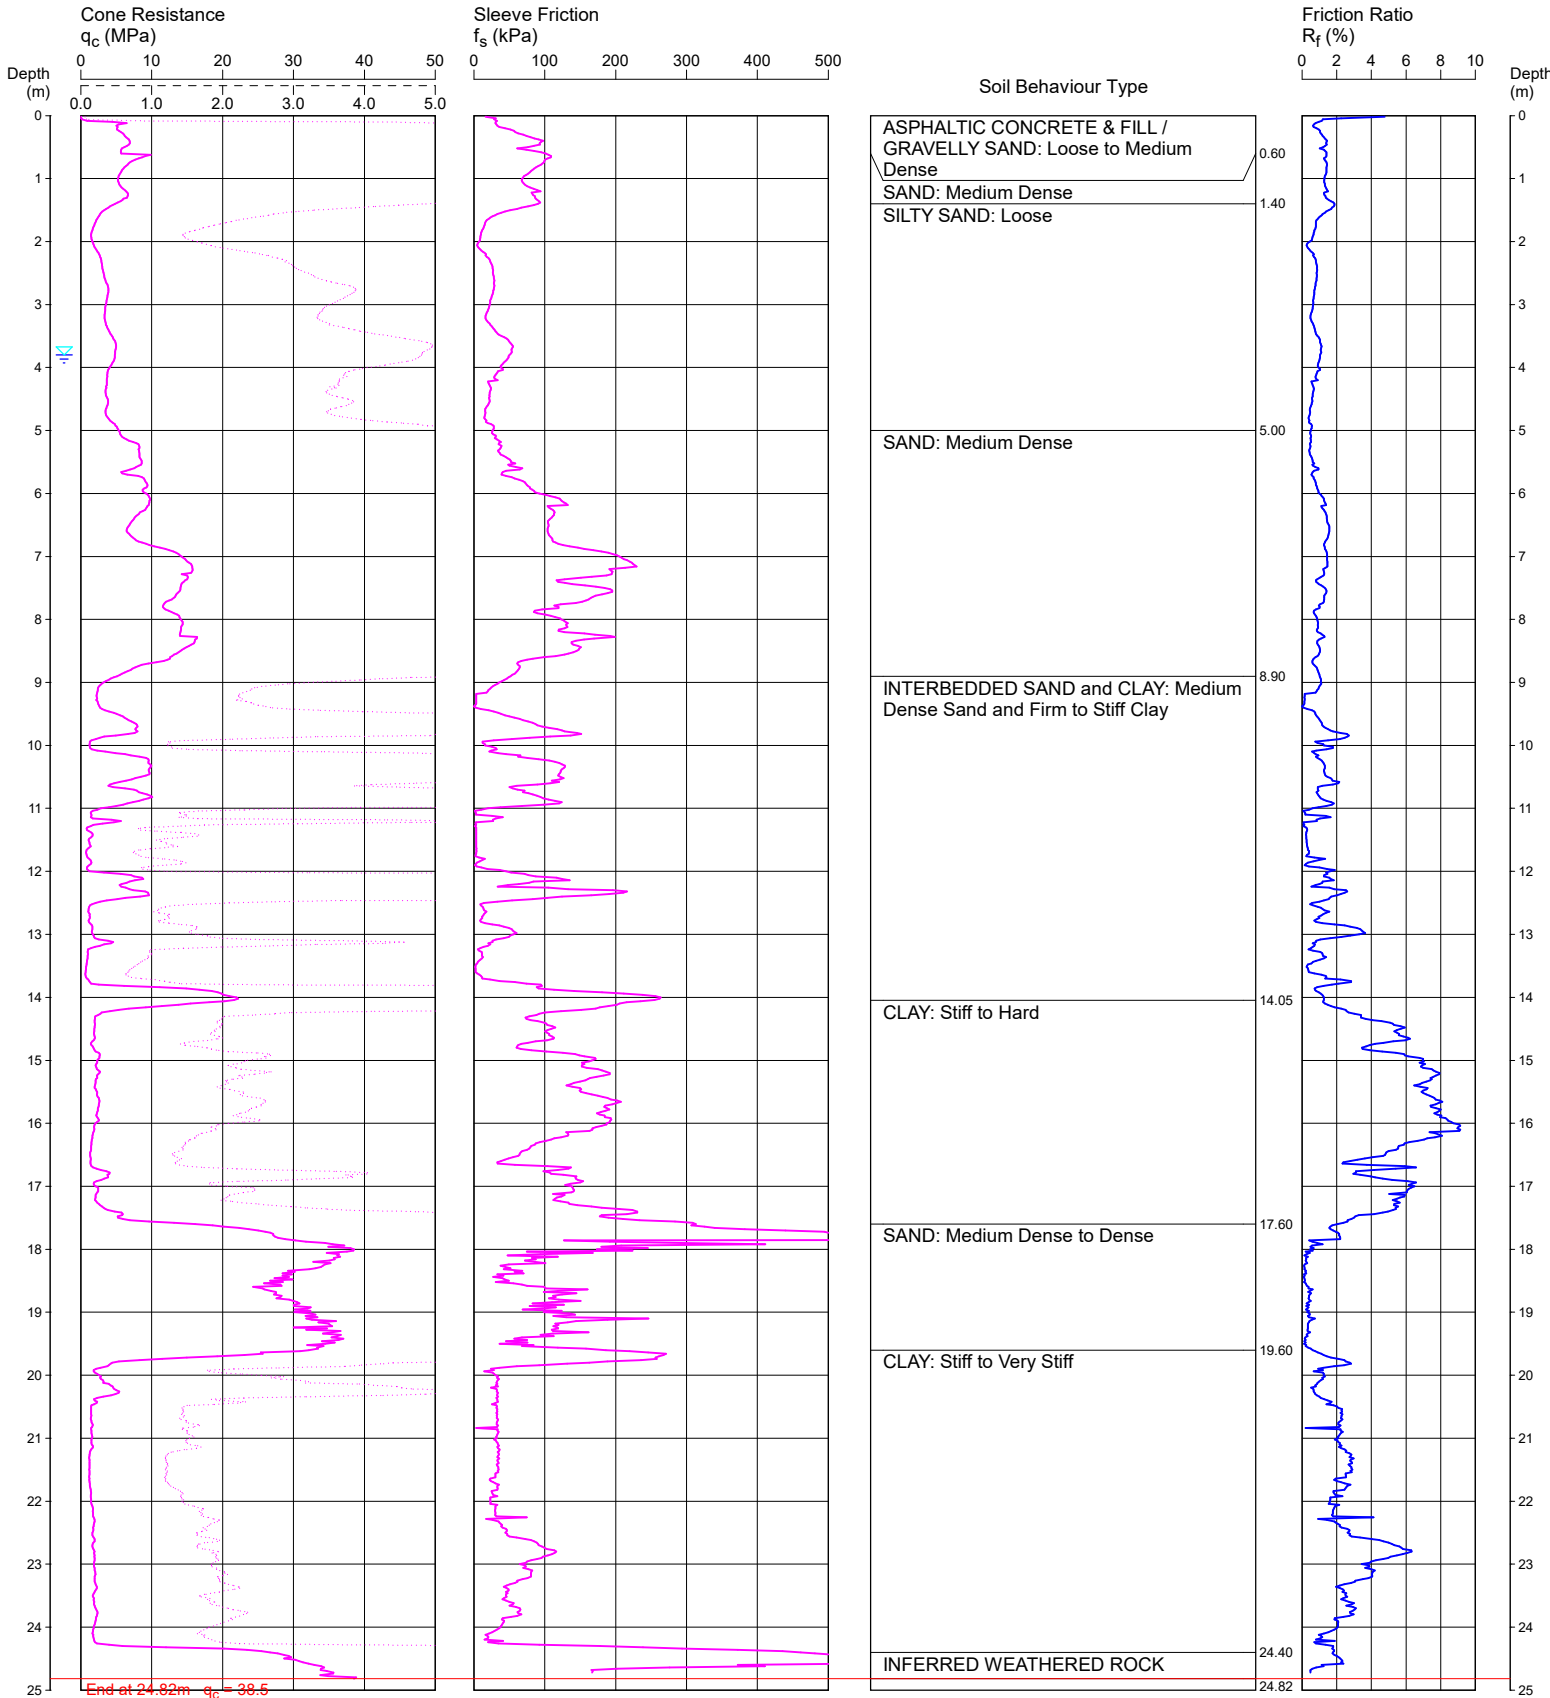
REMARKS: DIACORE TO 0.06m; TEST DISCONTINUED DUE TO CONE TIP REFUSAL  
GROUNDWATER MEASURED AT 3.8m AFTER REMOVAL OF RODS

Water depth after test: 3.80m depth (measured)

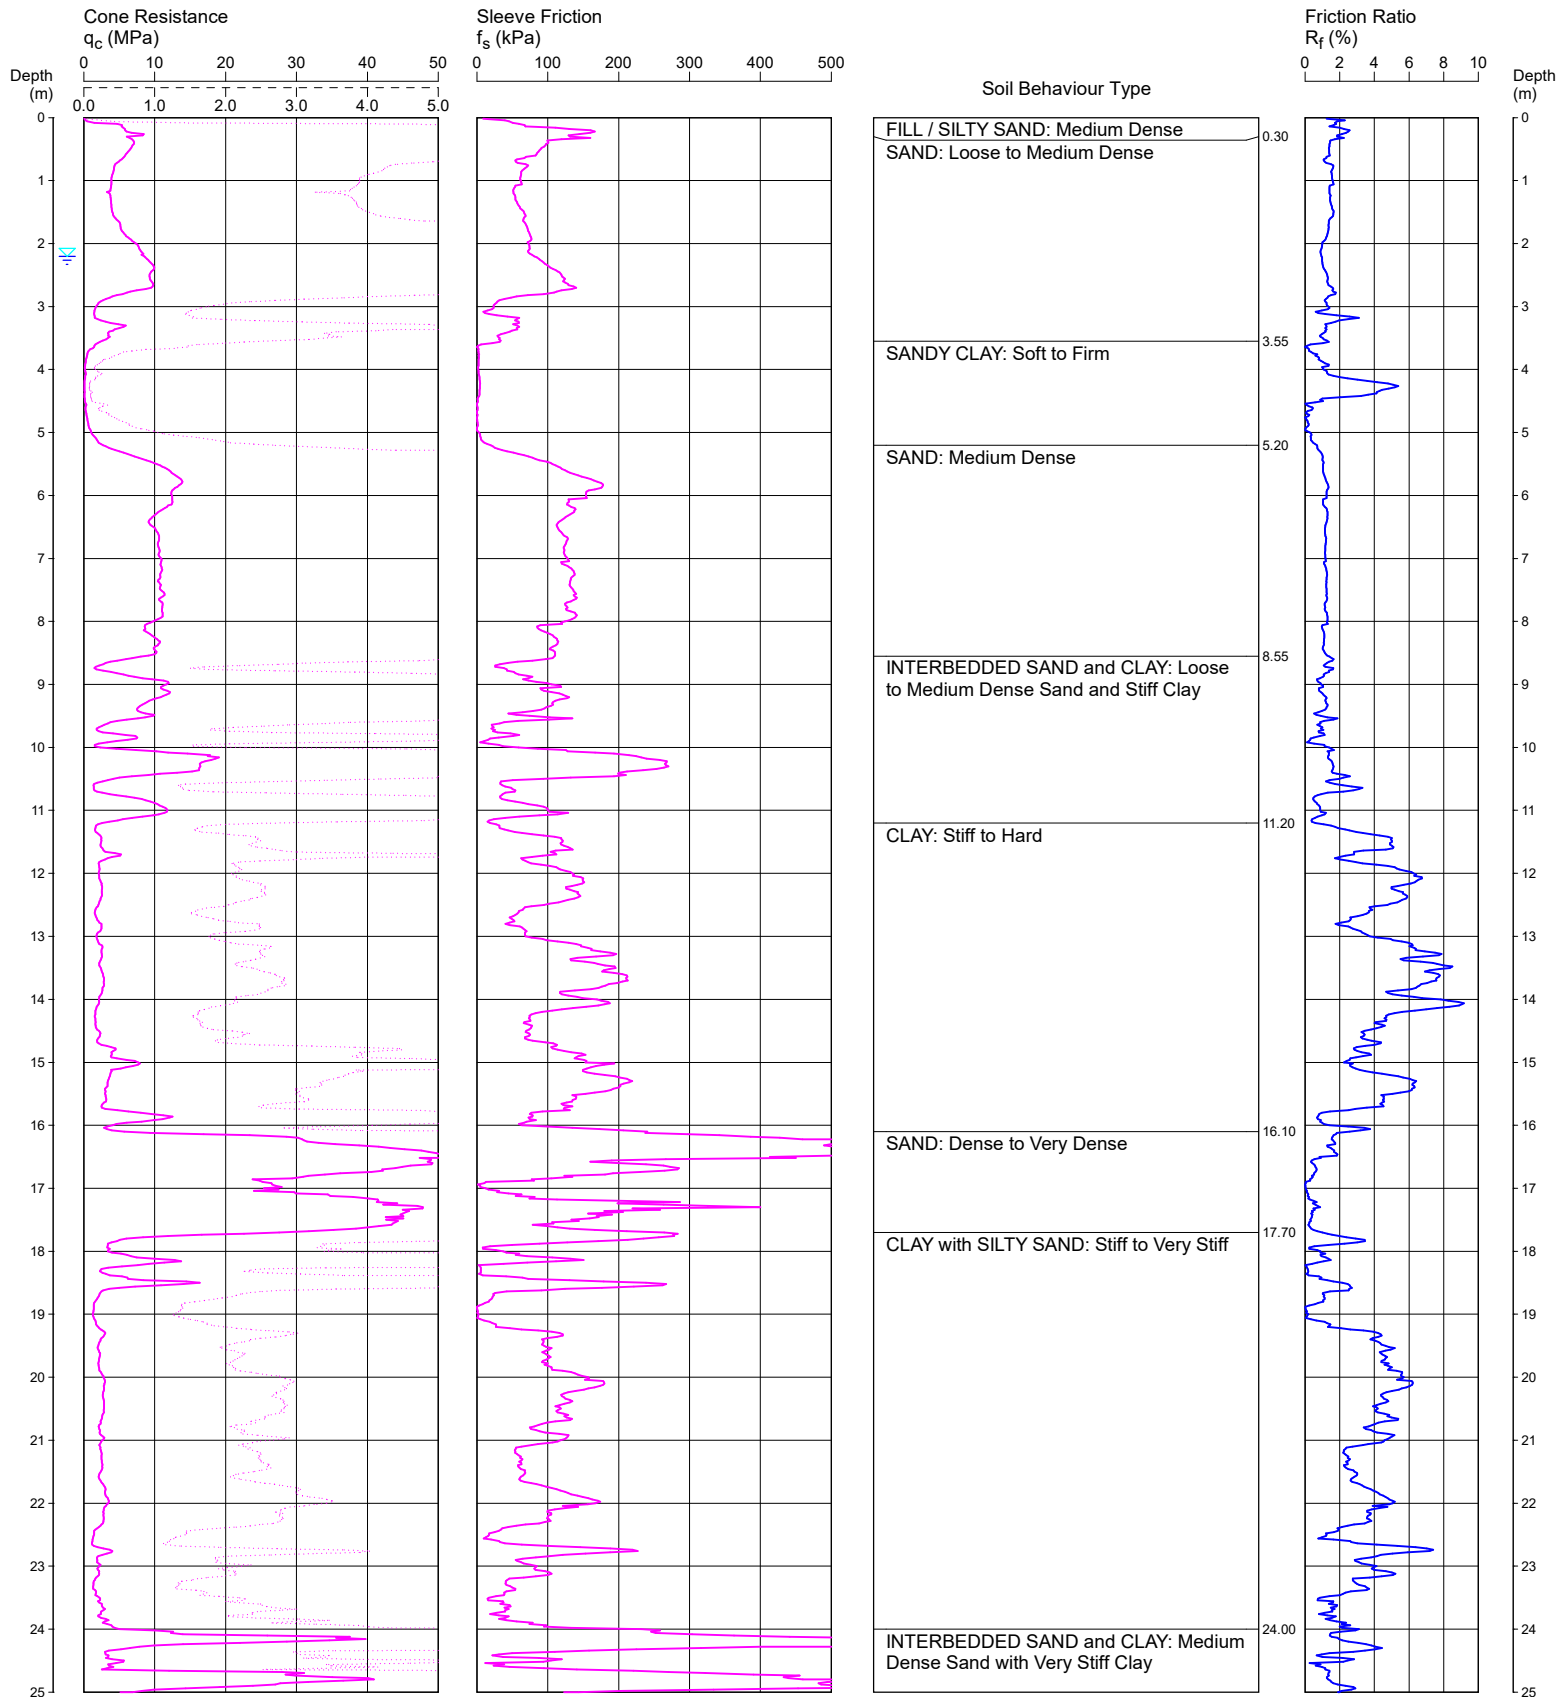
REMARKS: TEST DISCONTINUED DUE TO EXCESSIVE BENDING NEAR REFUSAL  
GROUNDWATER MEASURED AT 2.2m AFTER REMOVAL OF RODS

Water depth after test: 2.20m depth (measured)

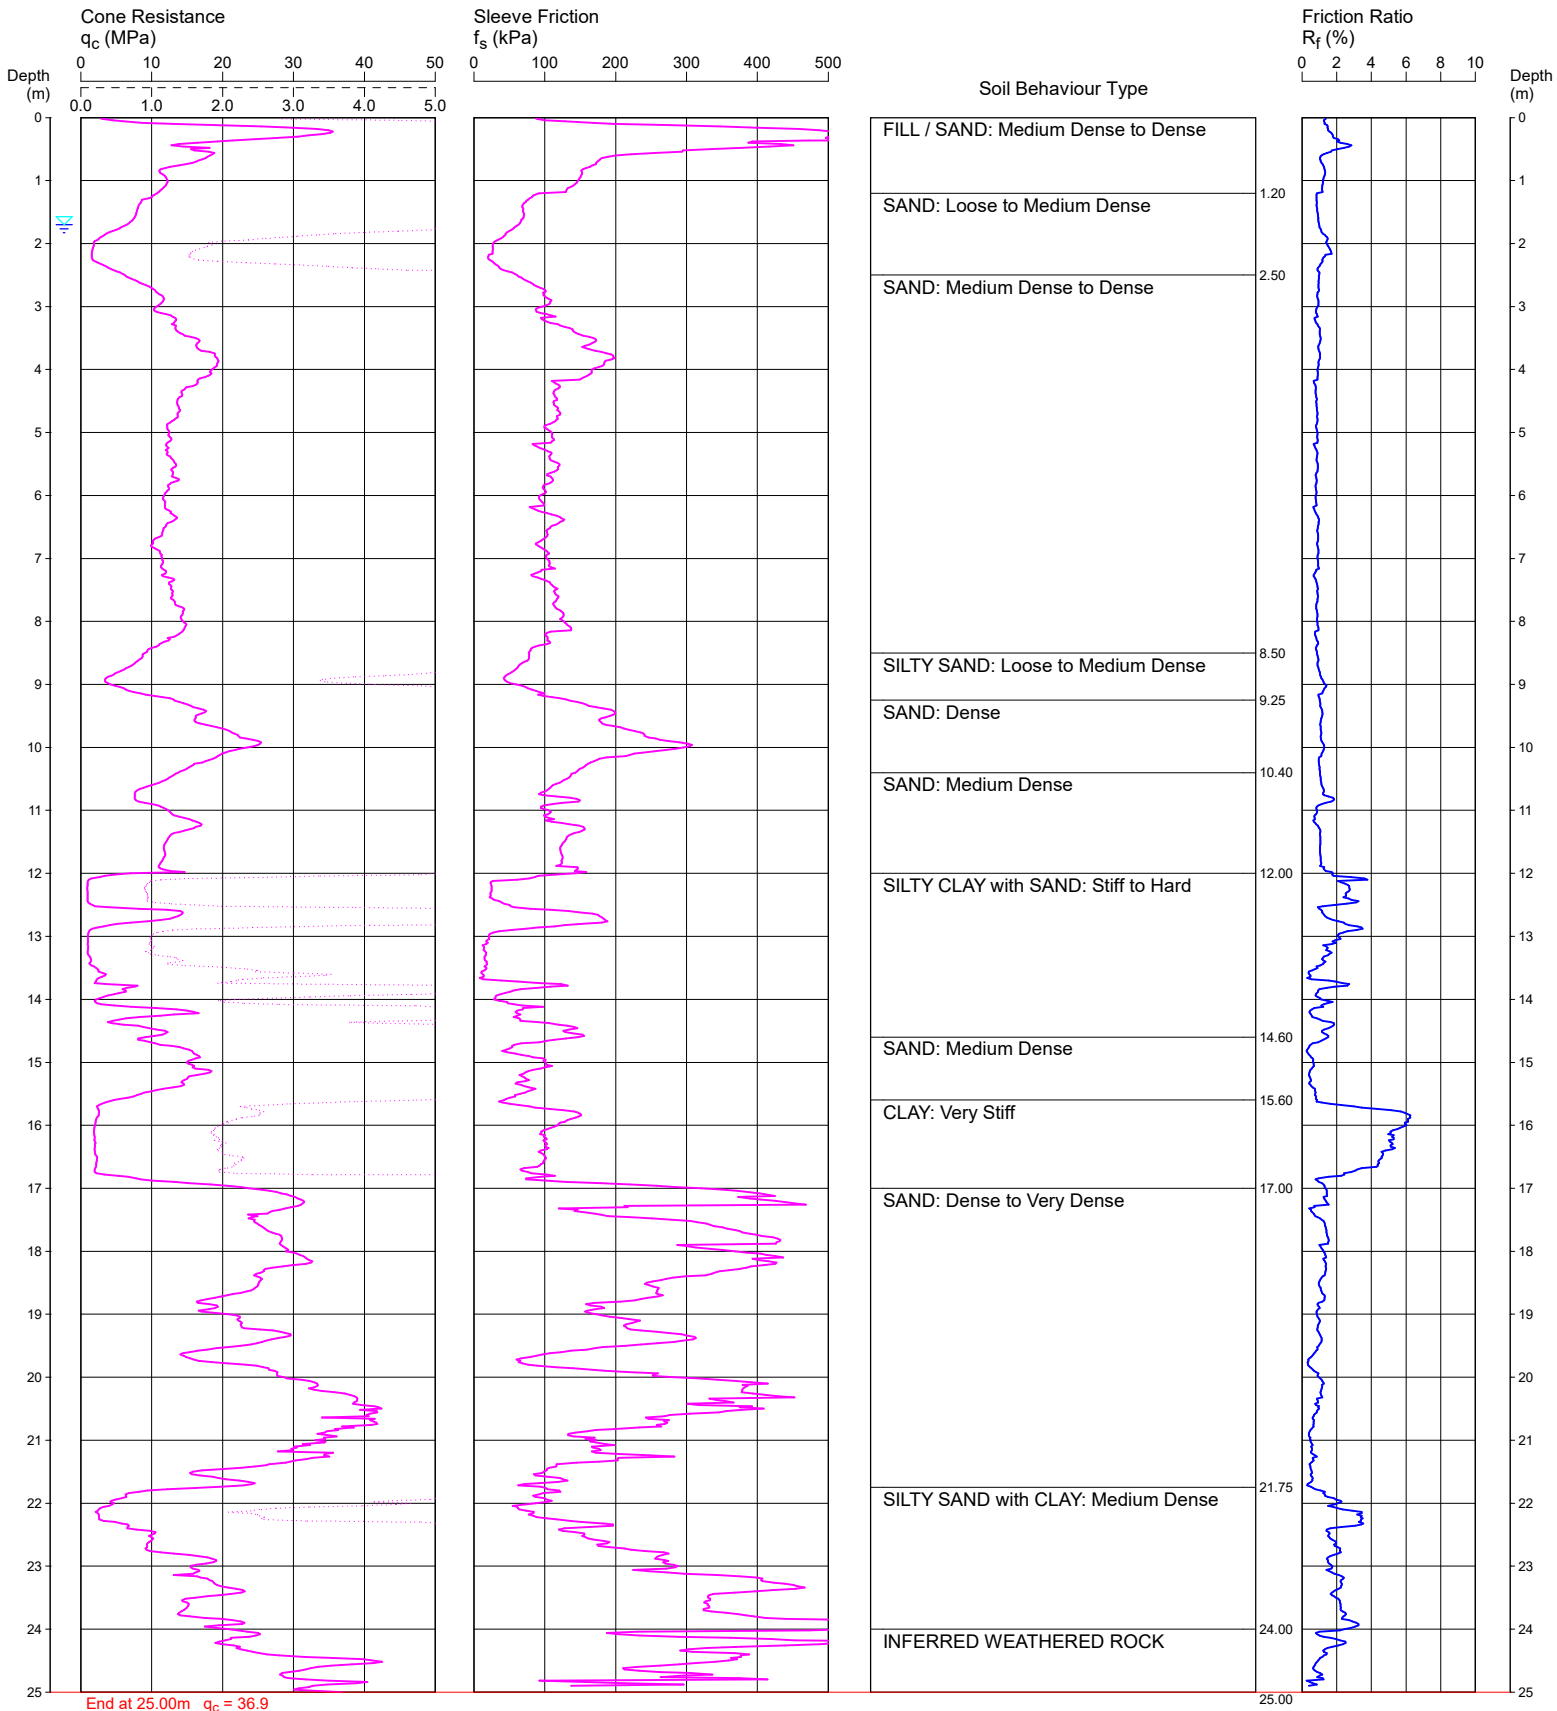
REMARKS: TEST DISCONTINUED AT TARGET DEPTH  
GROUNDWATER MEASURED AT 1.7m AFTER REMOVAL OF RODS

Water depth after test: 1.70m depth (measured)
