### GEOTECHNICAL REPORT INTO ACID SULFATE SOILS

### 9-11 BIRDWOOD AVENUE, COLLAROY

#### **Birdwood Projects Pty Ltd**

Project No.: 2019-139.1 February, 2020

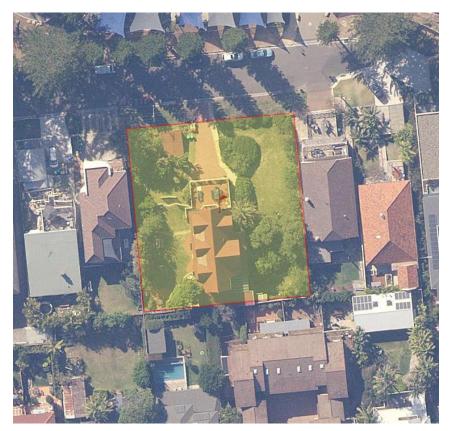
*Photograph:* 1 – *Aerial photo of site and surrounds.*

An aerial photograph of the site and its surrounds is provided below, as sourced from NSW Government Six Map spatial data, as Photograph 1.

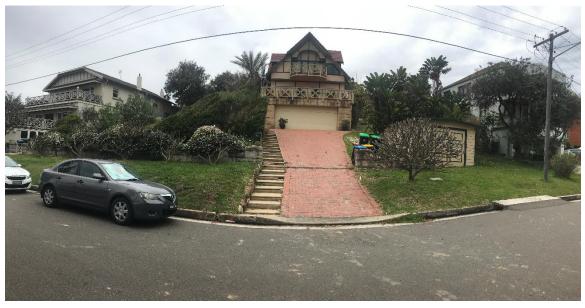
*Photograph: 2 – Front view of the site, facing south.*

The site is currently occupied by a two storey rendered house at the centre of the block with a moderate sloping front yard. A front view of the site is provided in Photograph 2 below.

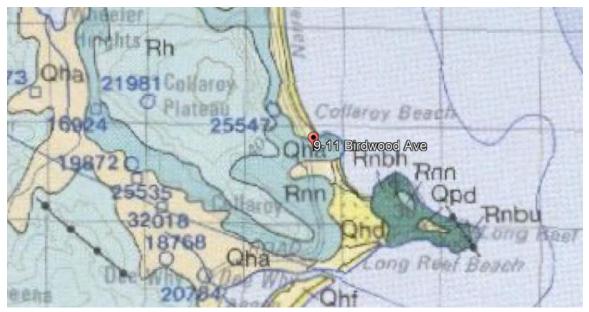
Reference to the Sydney 1:100,000 Geological Series sheet (9130) indicates that the site is underlain by Newport Formation (Upper Narrabeen Group) rock (Rnn) which is of middle Triassic Age. The Newport Formation typically comprises interbedded laminite, shale and quartz to lithic quartz sandstones and pink clay pellet sandstones.

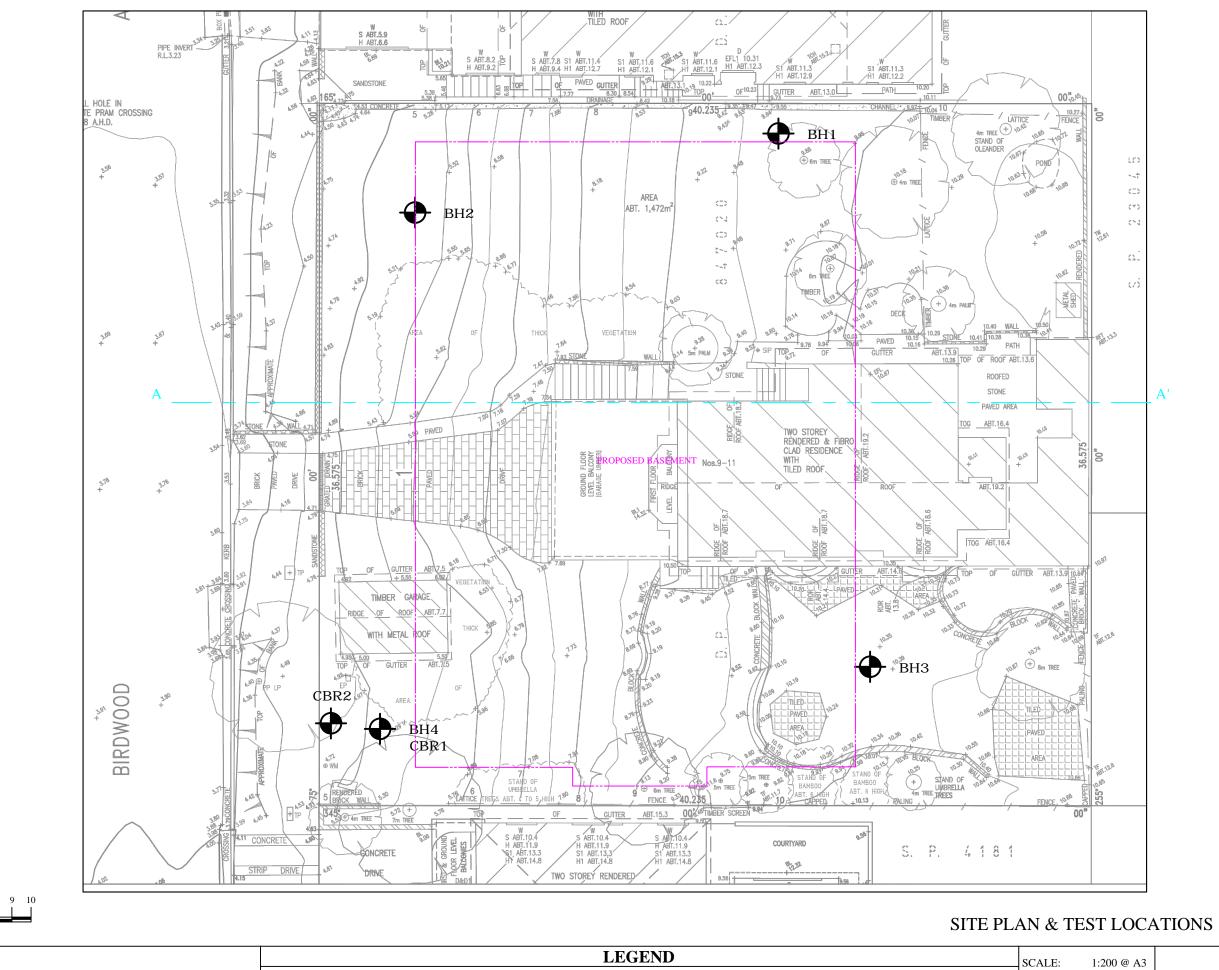
BOREHOLE LOCATIONS

Explanatory notes are included in Appendix: 1. Mapping information and test locations are shown on Figure: 1, along with detailed log sheets in Appendix: 2.

The boreholes (BH1 to BH4) were drilled approximately at the corners of the proposed basement. BH1 was discontinued at 9.23m depth in extremely weathered siltstone. BH2 and BH3 were drilled to 7.80m and 10.50m depth, respectively, in low strength siltstone. BH4 encountered auger refusal at 5.70m depth on interpreted low strength siltstone. SPT testing was undertaken at regular intervals during augering.
