Project Name	John Fisher Park Telecommunications Device - Waterways Impact Statement
Project Number	19SUT-12623
Project Manager	Elizabeth Hannon
Prepared by	Claire Wheeler
Reviewed by	Dr Peter Hancock
Approved by	Beth Medway
Status	Final
Version Number	1
Last saved on	23 July 2019

This report should be cited as 'Eco Logical Australia 2019. *John Fisher Park Telecommunications Device - Waterways Impact Statement.* Prepared for Urbis.'

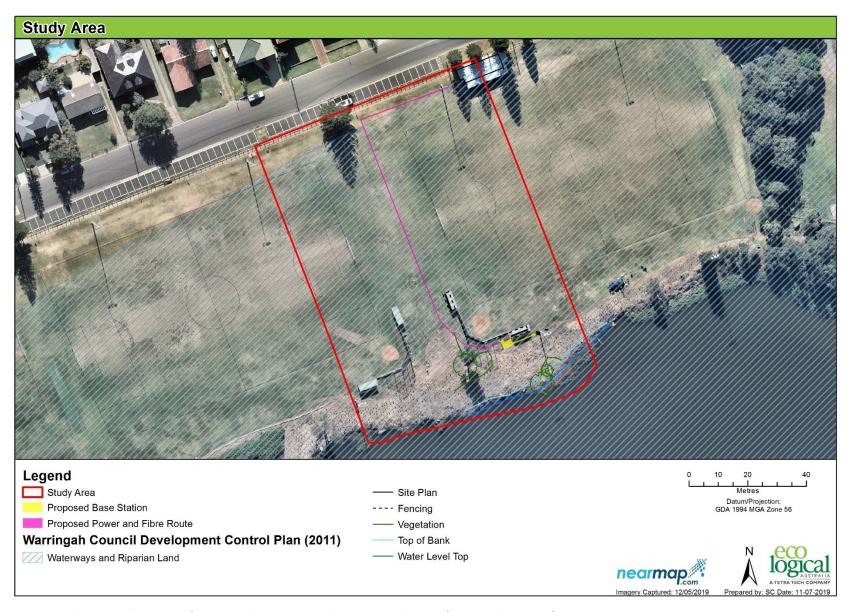
Figure 1: Study area with proposed footprint and Waterways and Riparian Land extent (Warringah DCP 2011)

The footprint of the proposed base station and power and fibre route is shown in Figure 1. The proposed equipment shelter is to be constructed approximately 17 m from the top of the Curl Curl Lagoon bank,

The development footprint is shown in Figure 1 and is located within riparian and waterways lands as mapped in the WDCP. Earthworks are proposed for the construction of the equipment shelter and monopole, but these would be minor and have a localised footprint. No mature trees require removal as part of the proposed works, but approximately 15 tubestock plants will need to be removed (see Flora and Fauna Assessment, Eco Logical Australia 2019, for more information).

The study area is located within Waterways and Riparian Lands (Figure 1). As per the WDCP control E8, the following requirements apply to the proposed works:

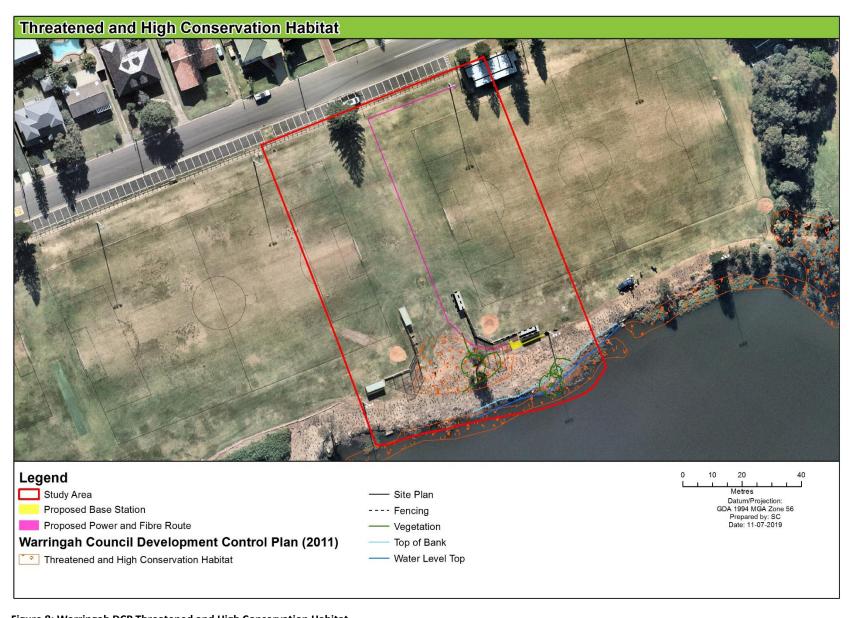
Figure 8: Warringah DCP Threatened and High Conservation Habitat

According to WDCP, the study area is mapped as containing *Threatened and High Conservation Habitat* (Figure 8). The Flora and Fauna Assessment prepared for the proposed works (Eco Logical Australia 2019) found that no habitat for threatened species existed within the study area due to the recent clearing of the site and the fact that the revegetated natives were too young to provide any habitat.

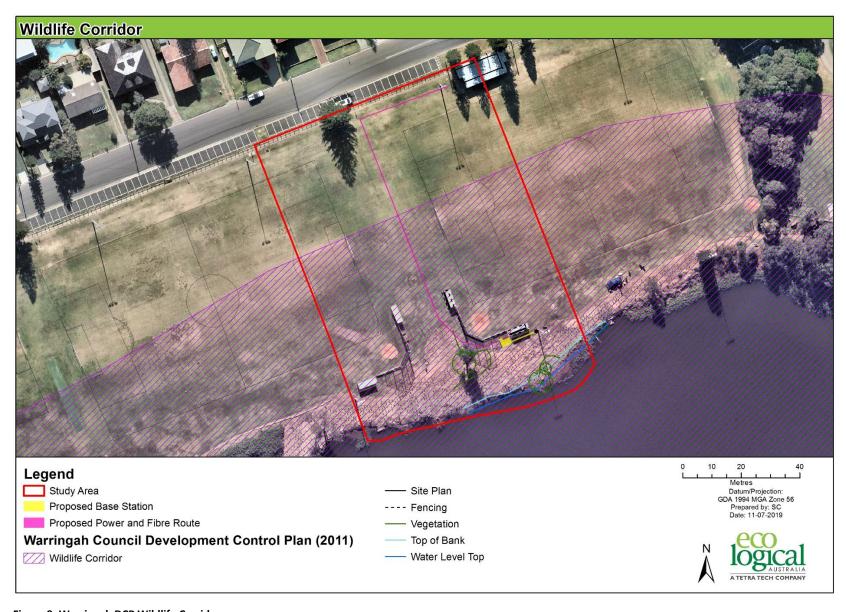
Figure 9: Warringah DCP Wildlife Corridor

The proposed development is located within a Wildlife Corridor (Figure 9). A Flora and Fauna Assessment and Biodiversity Management Plan have been prepared (ELA, 2019) as per the requirements of this DCP control. Due to the recently cleared nature of the study area and the fact that vegetation to be removed as part of the proposed works is currently tubestock-sized that does not yet provide any habitat for fauna, the likelihood of an immediate impact on the mapped wildlife corridor in this area as a result of the proposed works is unlikely.

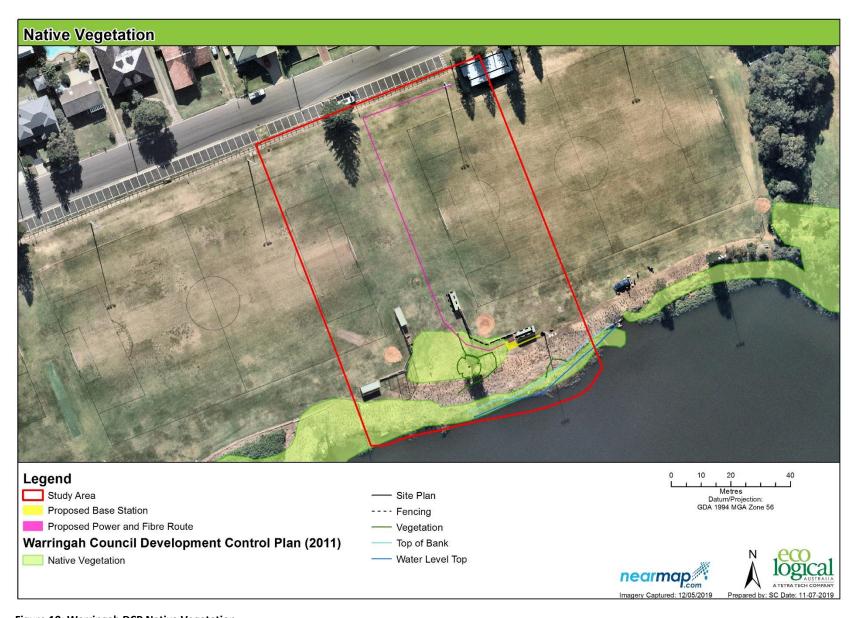
Figure 10: Warringah DCP Native Vegetation

According to Council's WDCP mapping, the study area contains Native Vegetation (Figure 10). As previously outlined, the study area has been recently cleared of exotic vegetation and replanted with native tubestock. No remnant native vegetation exists in the study area and the area of vegetation to be cleared as part of the proposed works is less than 100 m².
