J2597. 31st March, 2020. Page 1.

GEOTECHNICAL INVESTIGATION:

Alterations and Additions at 29 Wandeen Rd, Clareville.

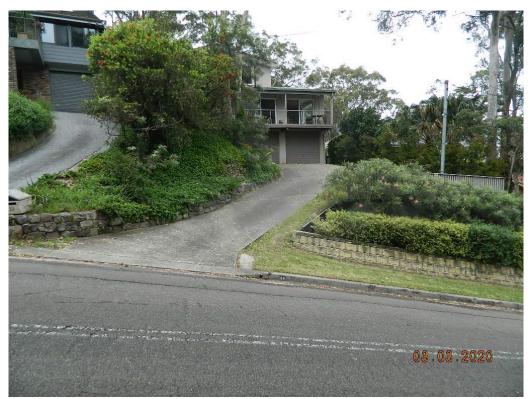
Photo 1

2.3 At the road frontage a concrete driveway cuts across the slope and leads to a double garage under the house. Low stable sandstone stack rock and keystone retaining walls line the slope either side of the driveway (Photo 1). The part three storey rendered masonry house is supported by masonry walls and a concrete slab

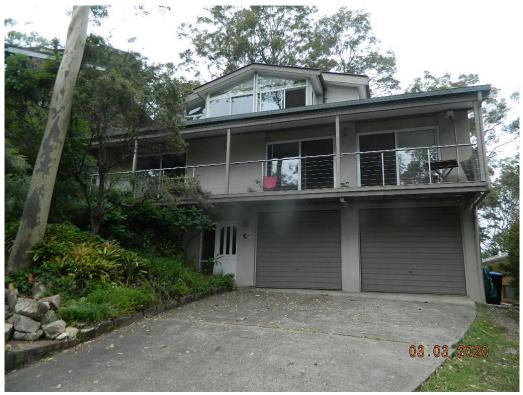
Photo 2

(Photos 2 & 3). The external supporting walls are in good condition and show no significant signs of movement.

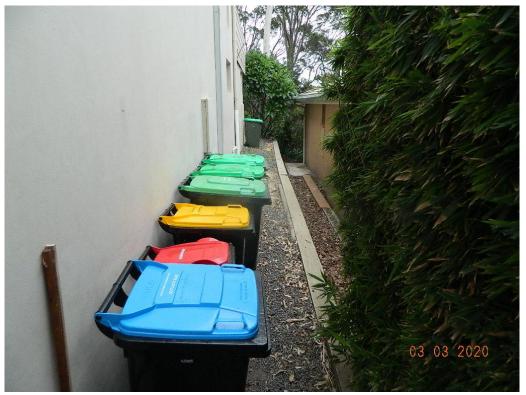
Photo 4

A ~0.6m high timber retaining wall supports a cut for the downhill property to the W along part of the W common boundary (Photo 4). A ~1.6m high timber retaining wall supports a cut in the slope next to the house along part of the E common boundary. Where the wall changes direction and extends onto the neighbouring property the supporting soldier post is tilting (Photos 5 & 6) some 10° from vertical. Due to its location the wall poses no significant threat to life or property. See 'Section 16 Remedial Works'.

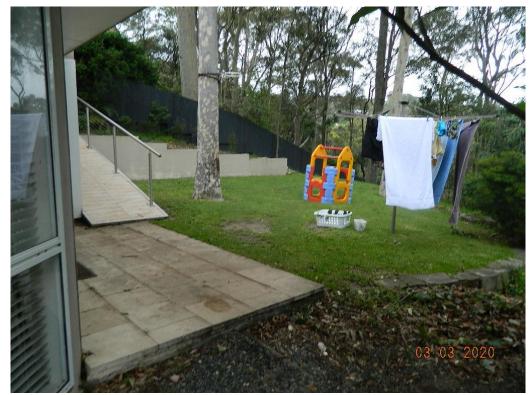
Photo 7

A cut and fill in the slope provides a near level lawn which extends from the S side of the house (Photo 7). Above the lawn a stable masonry retaining wall up to ~1.4m high supports the cut (Photo 8). The lawn drops away to the S where the fill batter merges into the natural slope (Photos 9 & 10).

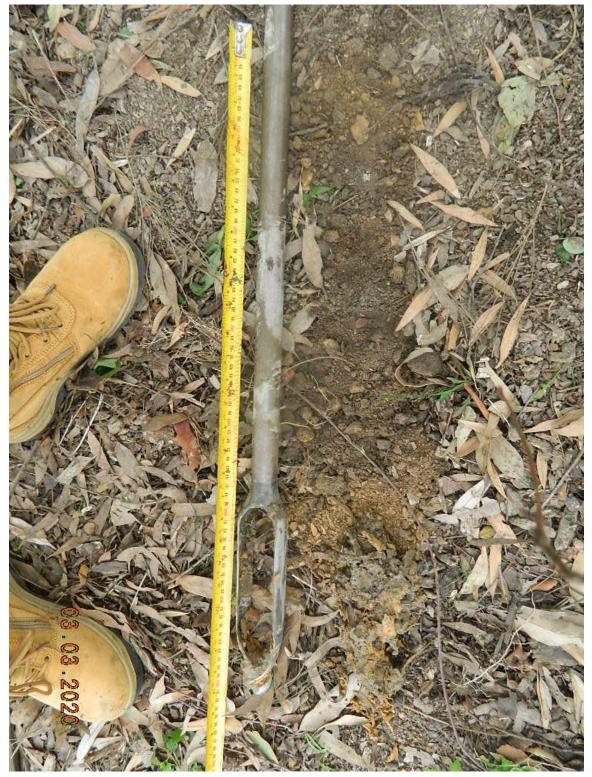
AUGER HOLE 1 (~RL58.4) – AH1 (photo 11)

Depth (m)	Material Encountered	
0.0 to 0.5	CLAYEY SOIL, brown and orange, dry.	
0.5 to 0.7	CLAY, orange, firm to stiff, dry.

End of Hole @ 0.7m in Clay. No watertable encountered.

Photo 11: AH1 – Downhole is from top to bottom
