**32 GOLF AVENUE, MONA VALE, NSW**

## **ARBORICULTURAL IMPACT ASSESSMENT**

**Date** 23 February 2024 **UPDATED 25 JUNE 2024**

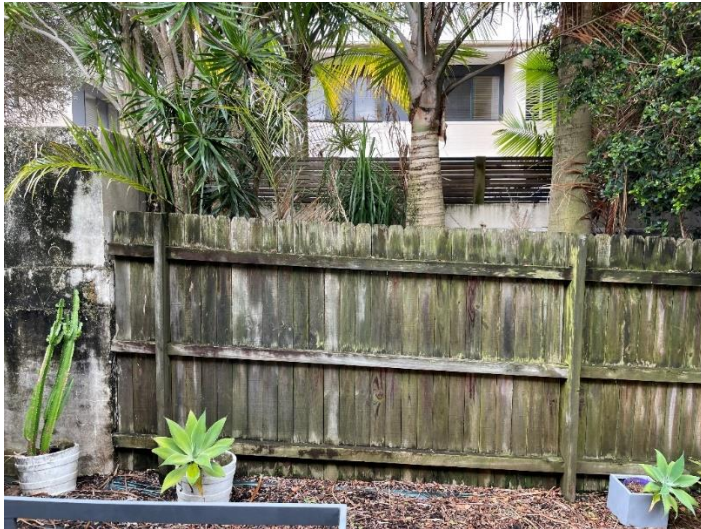
Figure 2: Tree 1, Majestic Palm located within neighbouring property. The proposed excavation for the basement is 3.6 metres away, outside the TPZ, and will have no impact on the palm.

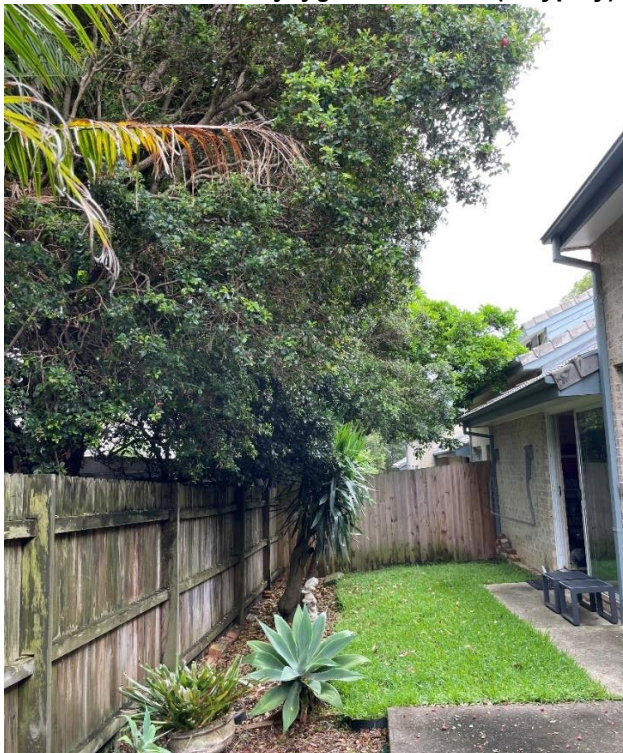
Figure 3: Trees 2 and 4 canopies overhang the site. The proposed excavation for the basement is 3.5 metres from Tree 2 which is a 5% impact in the TPZ, and 3 metres from Tree 4, which is outside the TPZ of 2.4 metres. This is theoretically a negligible impact from the proposed works on the root systems of these two trees.

The canopies may be required to be pruned to clear the building and scaffolding during construction. The species is well able to tolerate pruning and it is recommended that the pruning be not excessive, that is, to remove no more than 10% of the canopy of the trees. The existing building is 4 metres from the boundary and the proposed building is generally 3.5 metres from the boundary.

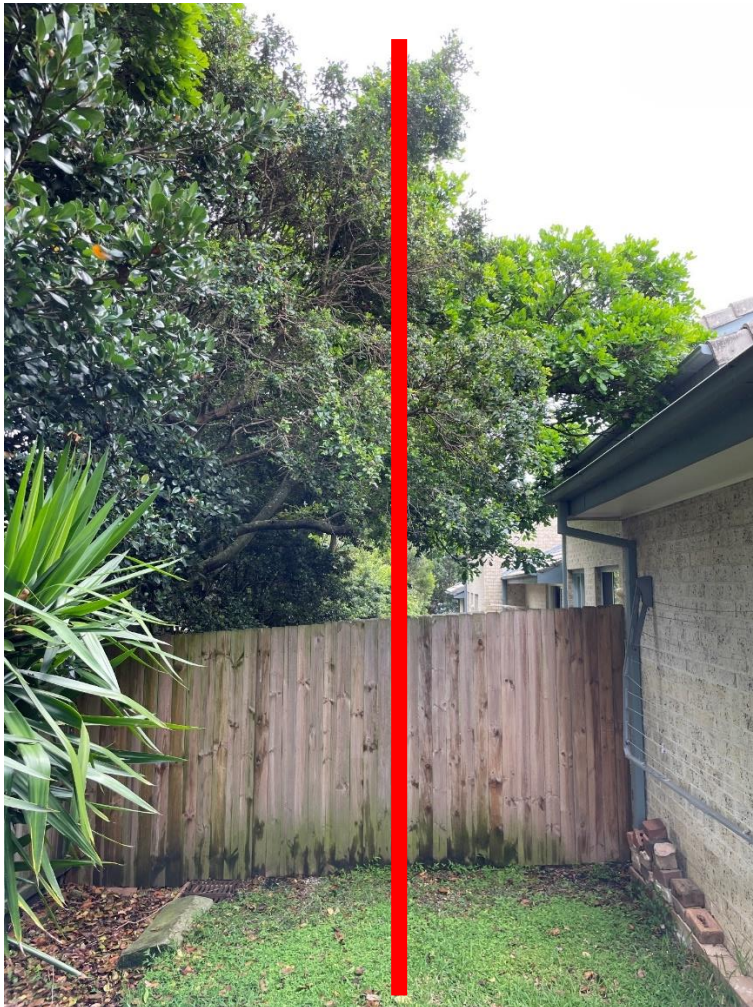
Figure 4: Trees 5, 6 and 7 canopies overhang the site. (Tree 3 is set well back from the boundary and will be not impacted at all). The proposed excavation for the basement is 3.5 metres from Trees 5 and 6 which is a 13% and 11% encroachment into the TPZs, which is a theoretical marginal impact on the root systems of these two trees. These trees should tolerate this impact. The excavation is 2.8 metres from Tree 7 which is outside the TPZ therefore of negligible impact.

The canopies of 5,6 and 7 will be required to be pruned to clear the building and scaffolding during construction. The species can tolerate pruning and it is recommended that the pruning be not excessive, to remove no more than 15% of the canopy of the trees. The existing building is 4 metres from the boundary and the proposed building is generally 3.5 metres from the boundary. The red line shows required pruning cut line at 2.5 metres from the boundary which would provide clearance for scaffolding.

Excavation works within the TPZ should be undertaken by tree-sensitive methods such as preliminary non-root-destructive hand excavation along the line of the proposed excavation and severing of roots by the project arborist. Tearing of roots will not be tolerated by the tree.

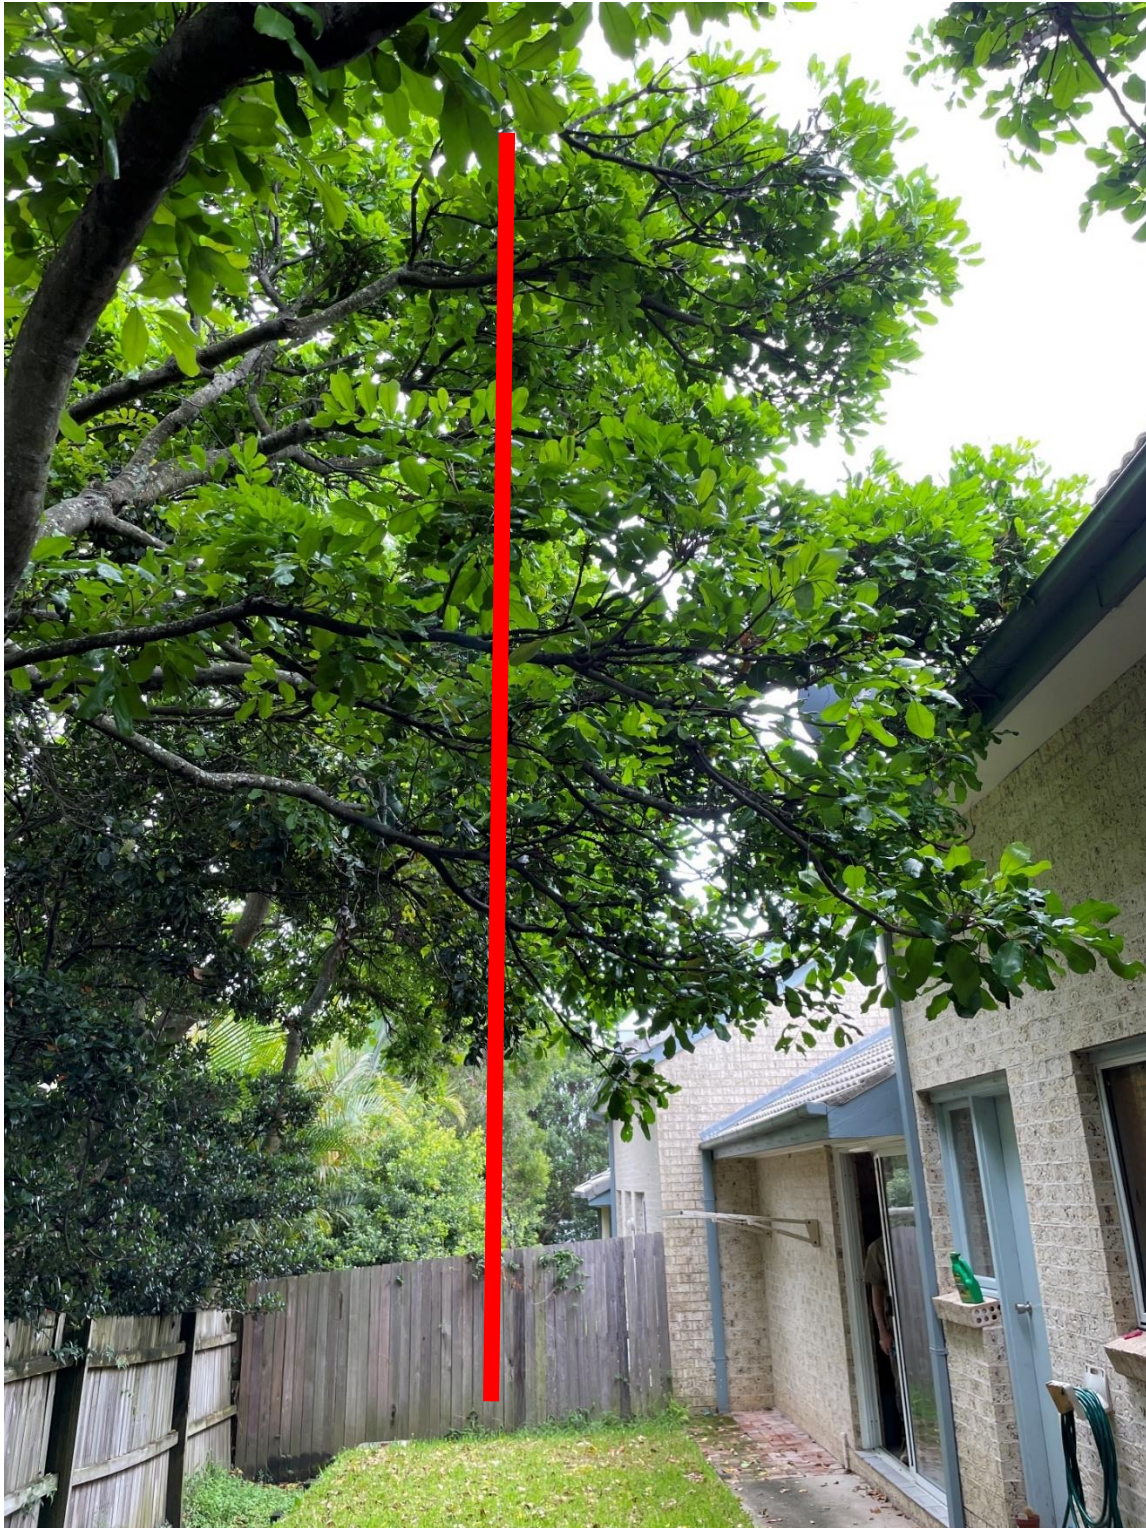
*Figure 5: close-up of proposed pruning cut line of Trees 5, 6 and 7 at approximately 2.5 metres from the boundary. All pruning shall be carried out as per Standards Australia 2007, Pruning of Amenity Trees, AS 4373-2007. Branches shall be cut back to the nearest branch collar.*

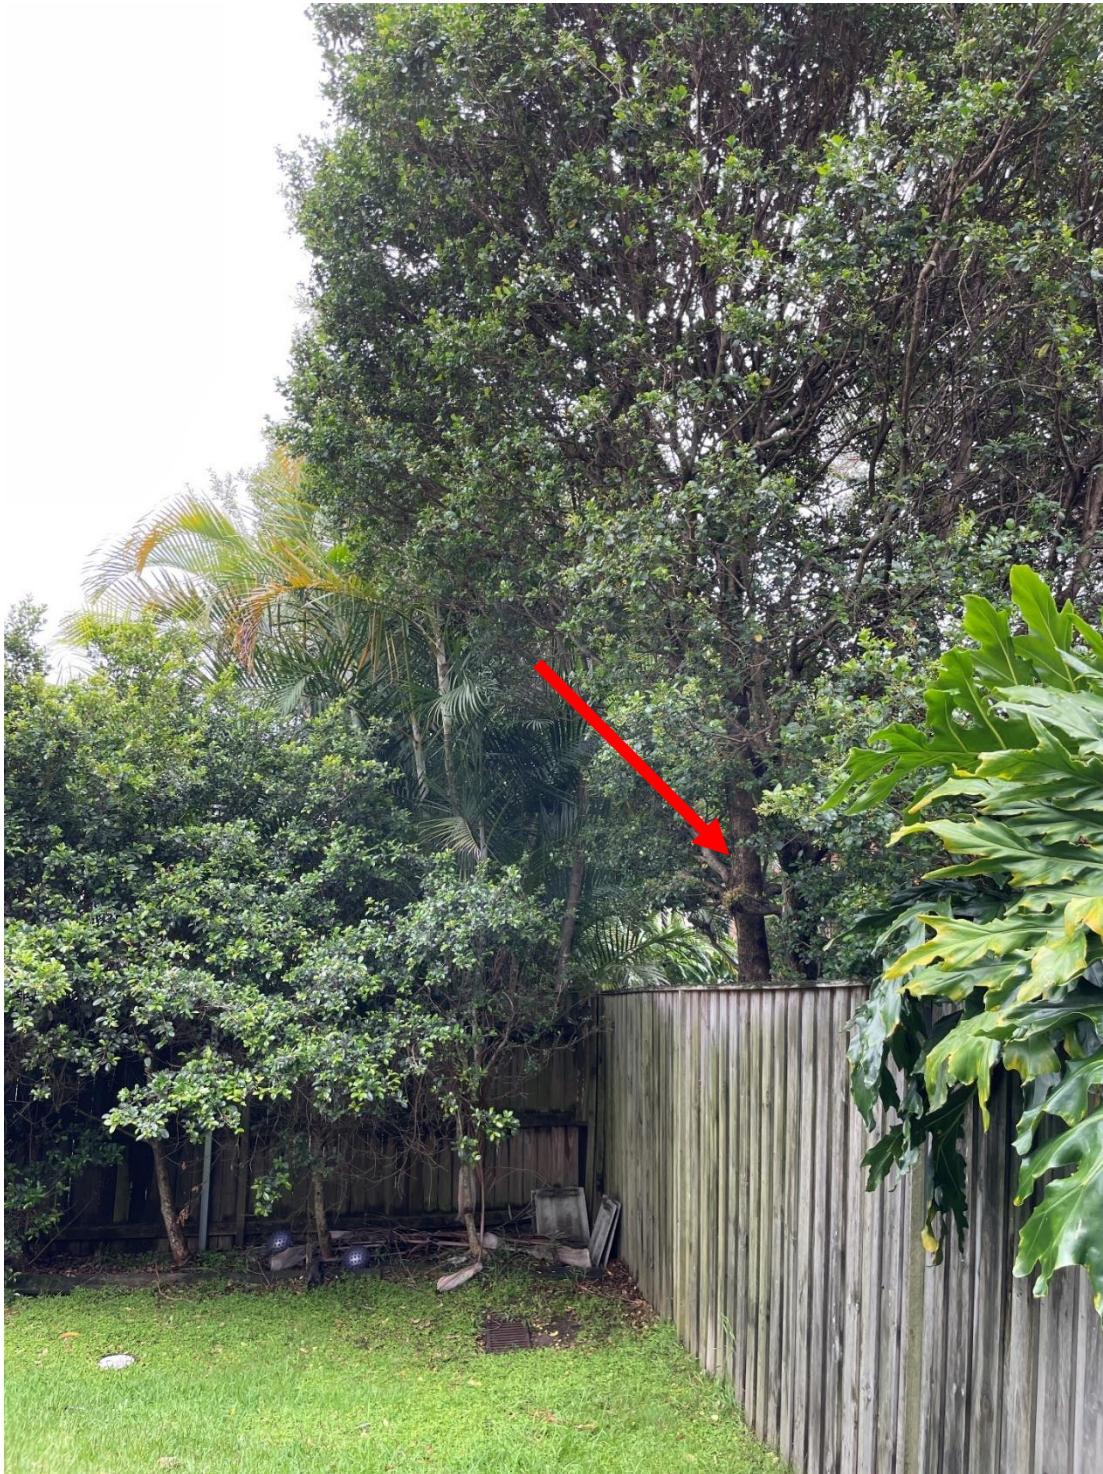
*Figure 6: Tree 9 at rear of neighbouring property to the north. The existing pit is to be replaced. New lines are to be installed outside the Tree Protection Zone, minimizing impact to the TPZ.*

*Excavation works within the TPZ should be undertaken by tree-sensitive methods such as preliminary non-root-destructive hand excavation along the line of any proposed excavation for new stormwater lines and pit, and severing of roots must be done cleanly and by the project arborist. Tearing of roots will not be tolerated by the tree.*

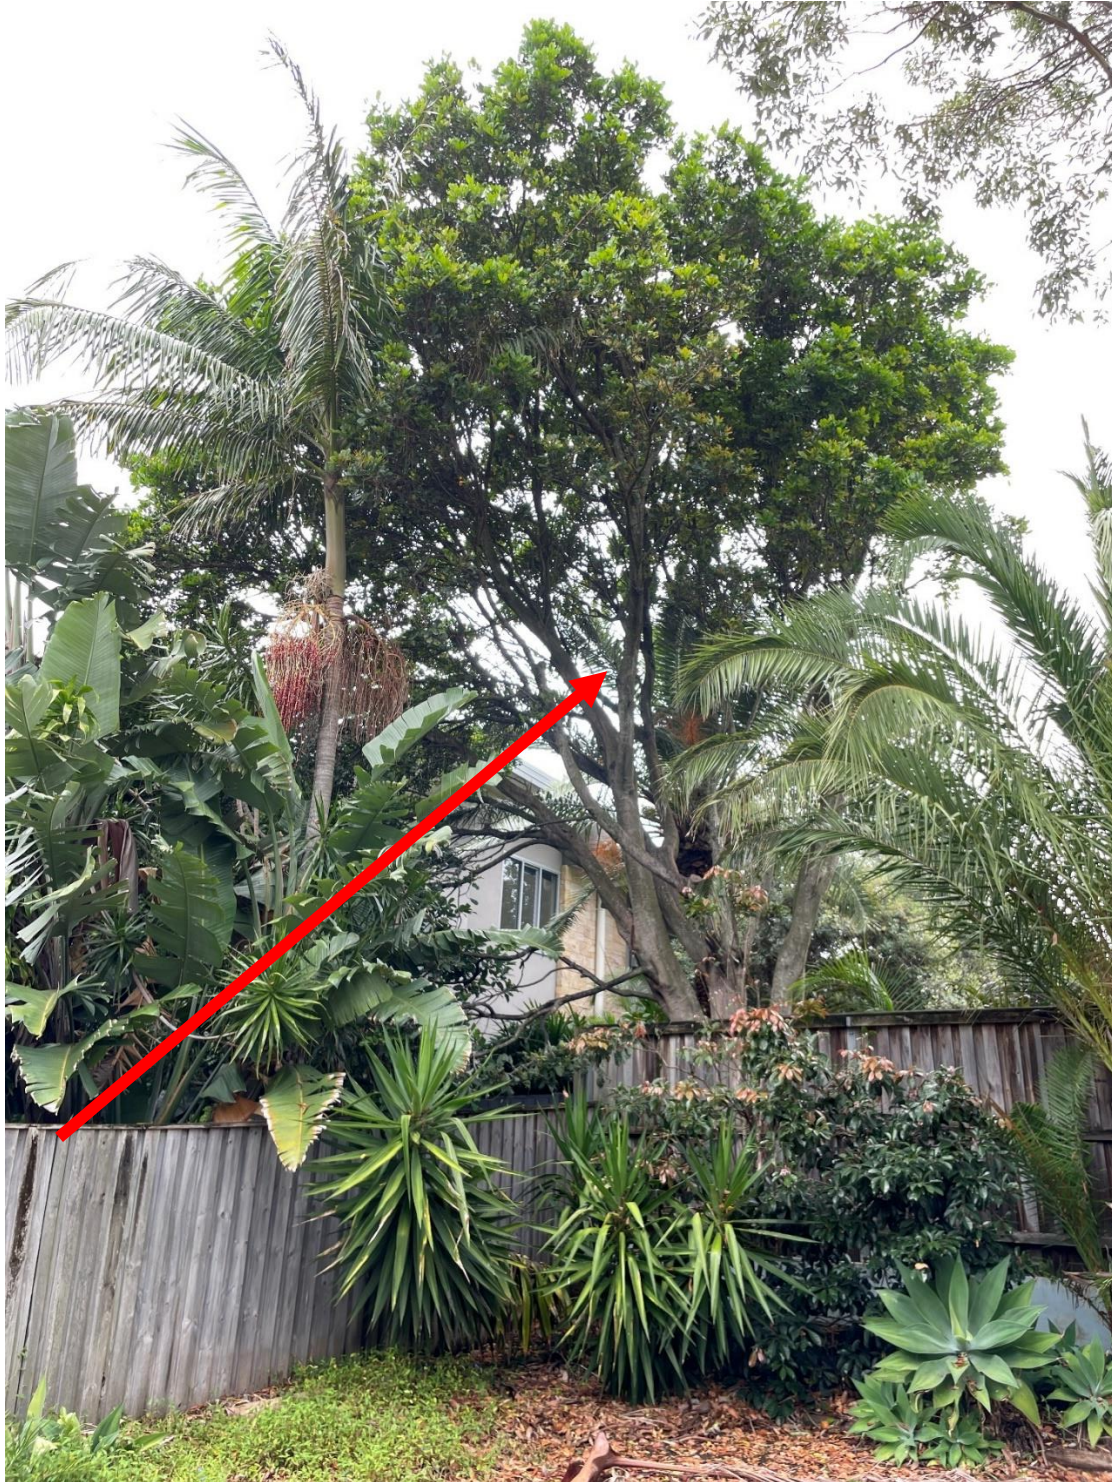
*Figure 7: Tree 10 at rear of neighbouring property to the east. The proposed excavation for the basement is 5.5 metres from the tree, a 2% encroachment into the TPZ, which is a negligible impact on the root system. The tree should tolerate this impact.*

*Note that Tree 11, a young Canary Island Date Palm, can be partially seen to the right of the photo. This palm is to be removed and is an exempt species.*

*The canopy will not be required to be pruned to clear the building.*

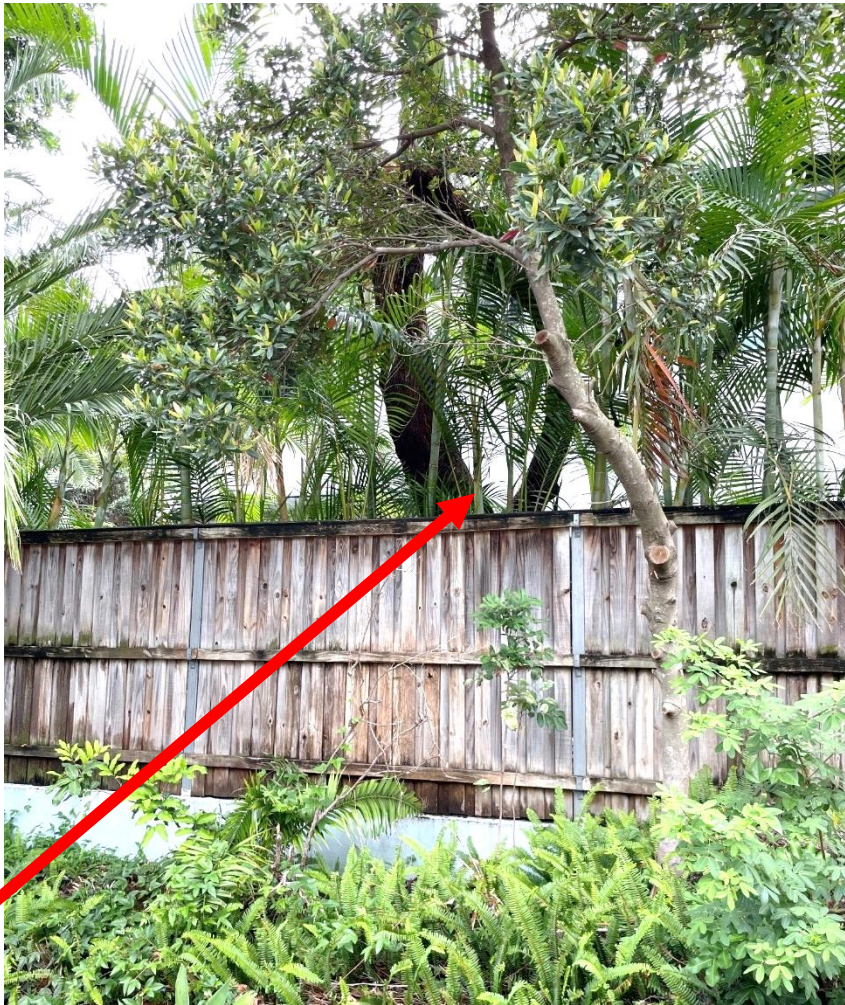
Figure 8: Tree 12 in neighbouring property to the east. The proposed excavation for the basement is 4.5 metres from the tree, and the ground floor is 4 metres away from the tree. This is an 8.8% encroachment into the TPZ, which is a theoretically minor impact on the root system. The tree should tolerate this impact. Excavation works within the TPZ should be undertaken by tree-sensitive methods such as preliminary non-root-destructive hand excavation along the line of the proposed excavation and severing of roots by the project arborist. Tearing of roots will not be tolerated by the tree.

The property to the east has constructed a retaining wall along the boundary (as can be seen in the photograph) and it is not known if roots were damaged when this wall was built. The tree appears to be in good vigour currently.

The canopy will be required to be pruned to clear the building at 4.0 metres away up to a height of approximately 9 metres. The canopy has been previously pruned on the eastern side to 2 metres from the stem. Numerous previous pruning cuts are noted, to uplift the crown.

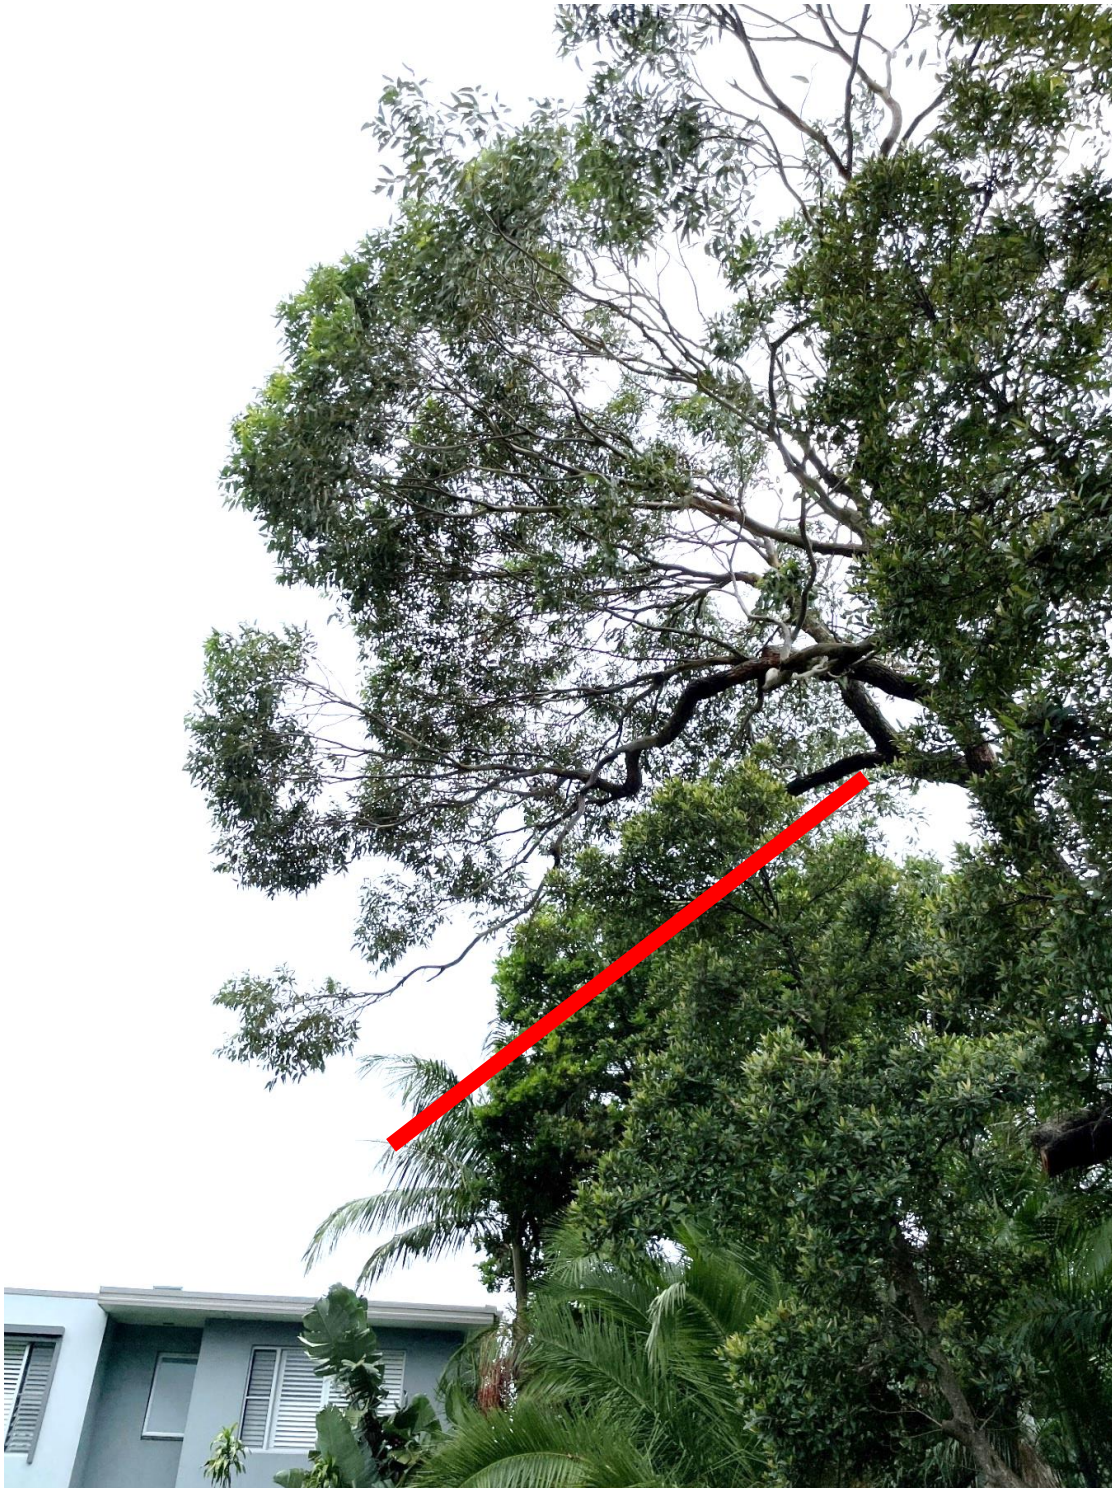
*Figure 9: Tree 12 branch heading west to be pruned back to clear the proposed building. All pruning shall be carried out as per Standards Australia 2007, Pruning of Amenity Trees, AS 4373-2007. Branches shall be cut back to the nearest branch collar.*

*Branches higher than the roof line of the building (approximately 9 metres) can in theory be retained unless the possible use of cranes requires that they be removed.*

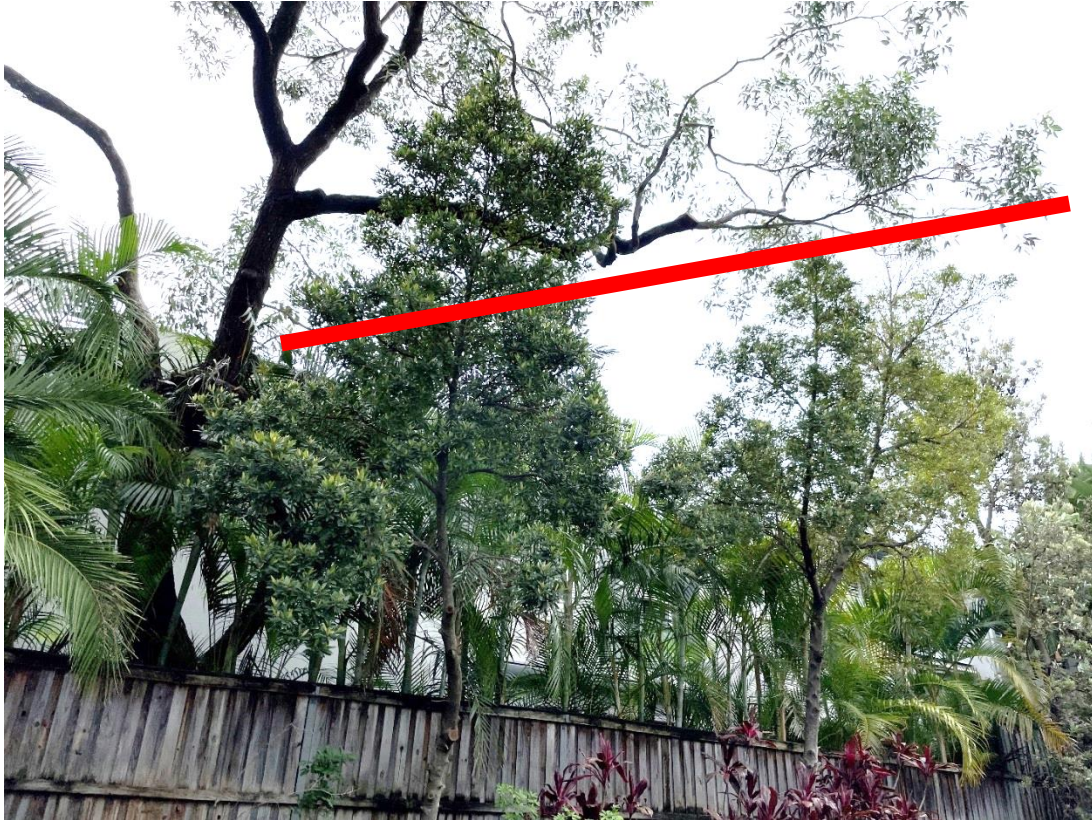
Figure 10: Tree 12 branch heading south to be pruned back to clear the proposed building. All pruning shall be carried out as per Standards Australia 2007, Pruning of Amenity Trees, AS 4373-2007. Branches shall be cut back to the nearest branch collar.

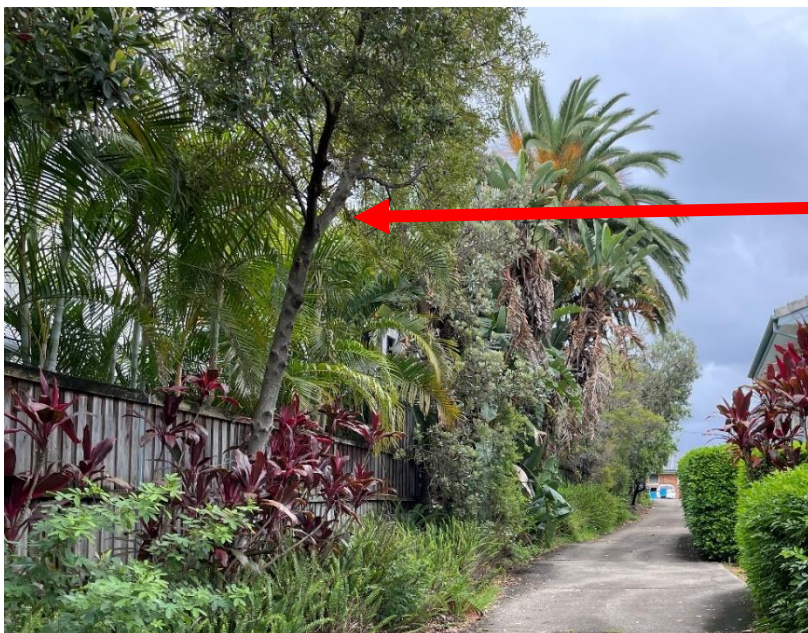
Figure 11: Trees 13 and 14 are young Blueberry Ash to be retained. The proposed excavation for the basement is 1.5 metres from the trees, a 15% encroachment into the TPZ, which is a marginal impact on the

root systems. The young trees should tolerate this impact and have a naturally upright, narrow form which is suitable for retention within the proposed 3.5 metre side setback.

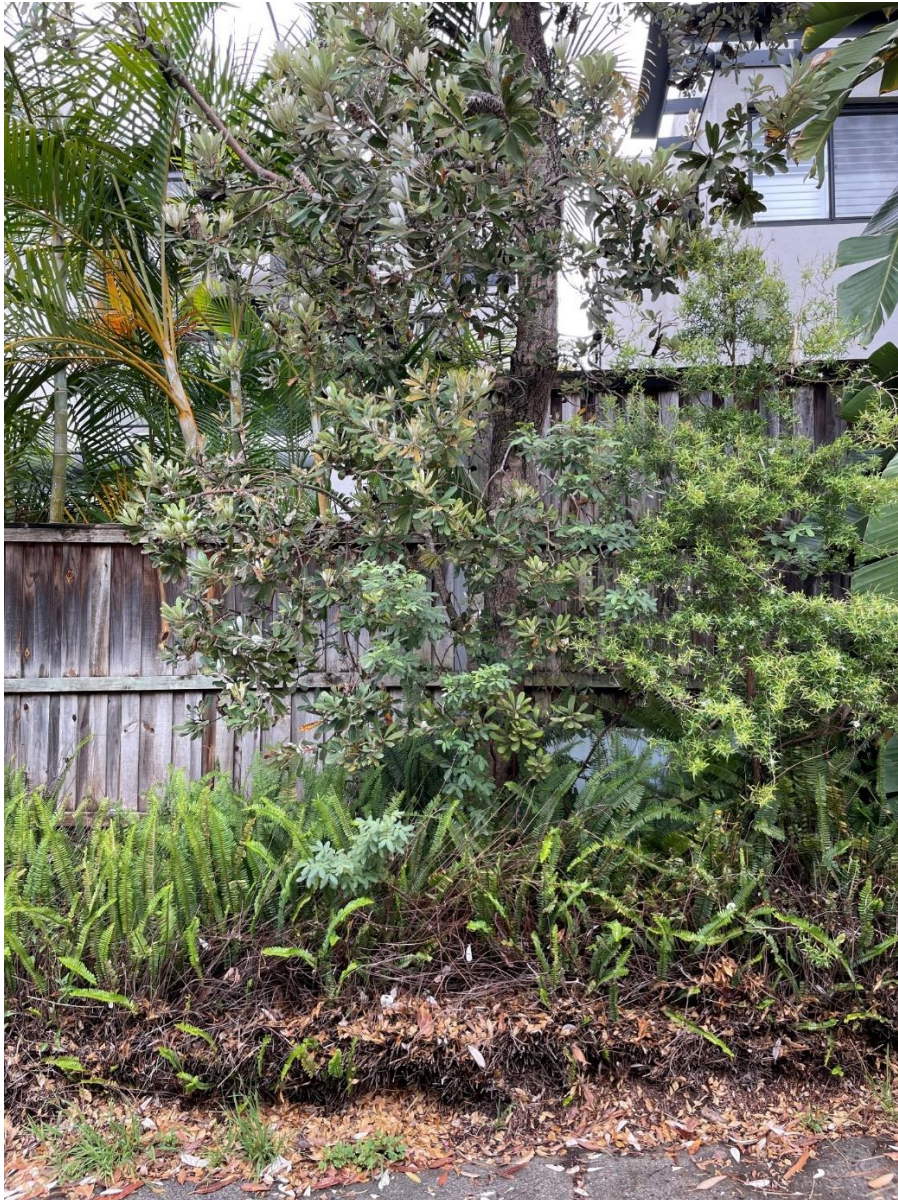
Figure 12: Tree 15 Coastal Banksia is to be retained. The proposed excavation for the basement is 1.7 metres from the tree, an 8% encroachment into the TPZ, and on the line of the SRZ. This is a marginal impact on the TPZ and is a one-sided impact in the theoretical SRZ. However, the tree is reasonably young and vigorous and should tolerate this impact.

Excavation works within the TPZ should be undertaken by tree-sensitive methods such as preliminary non-root-destructive hand excavation along the line of the proposed excavation and severing of roots by the project arborist. Tearing of roots will not be tolerated by the tree.

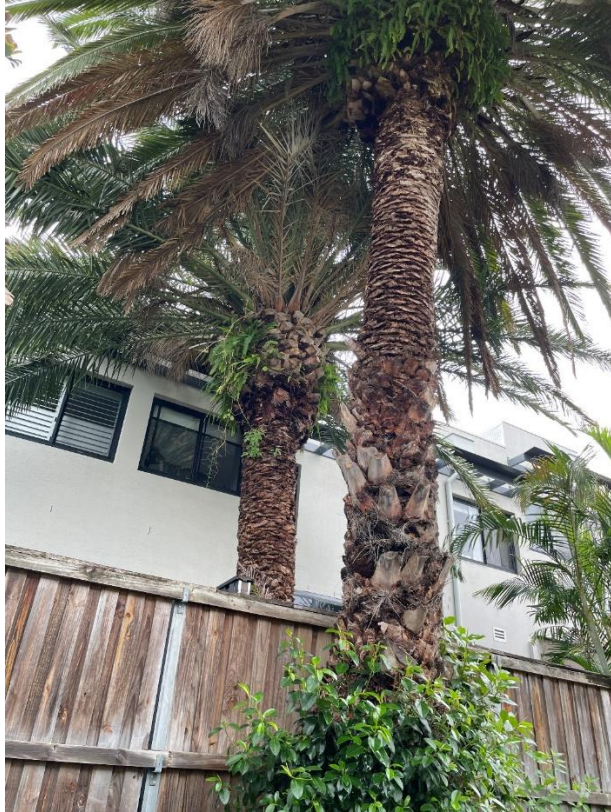
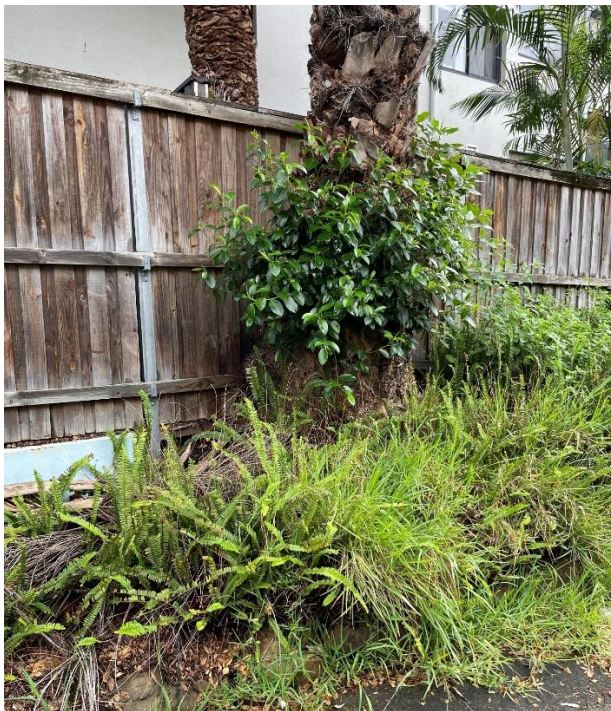
Figure 13: Trees 17 and 18 are two Canary Island Date Palms which appear to be arising from a shared root crown in the boundary fence line. Tree 17 is in a raised bed. The stems are clear to 8 metres therefore the canopies should be clear of the roof line and the proposed building without pruning.

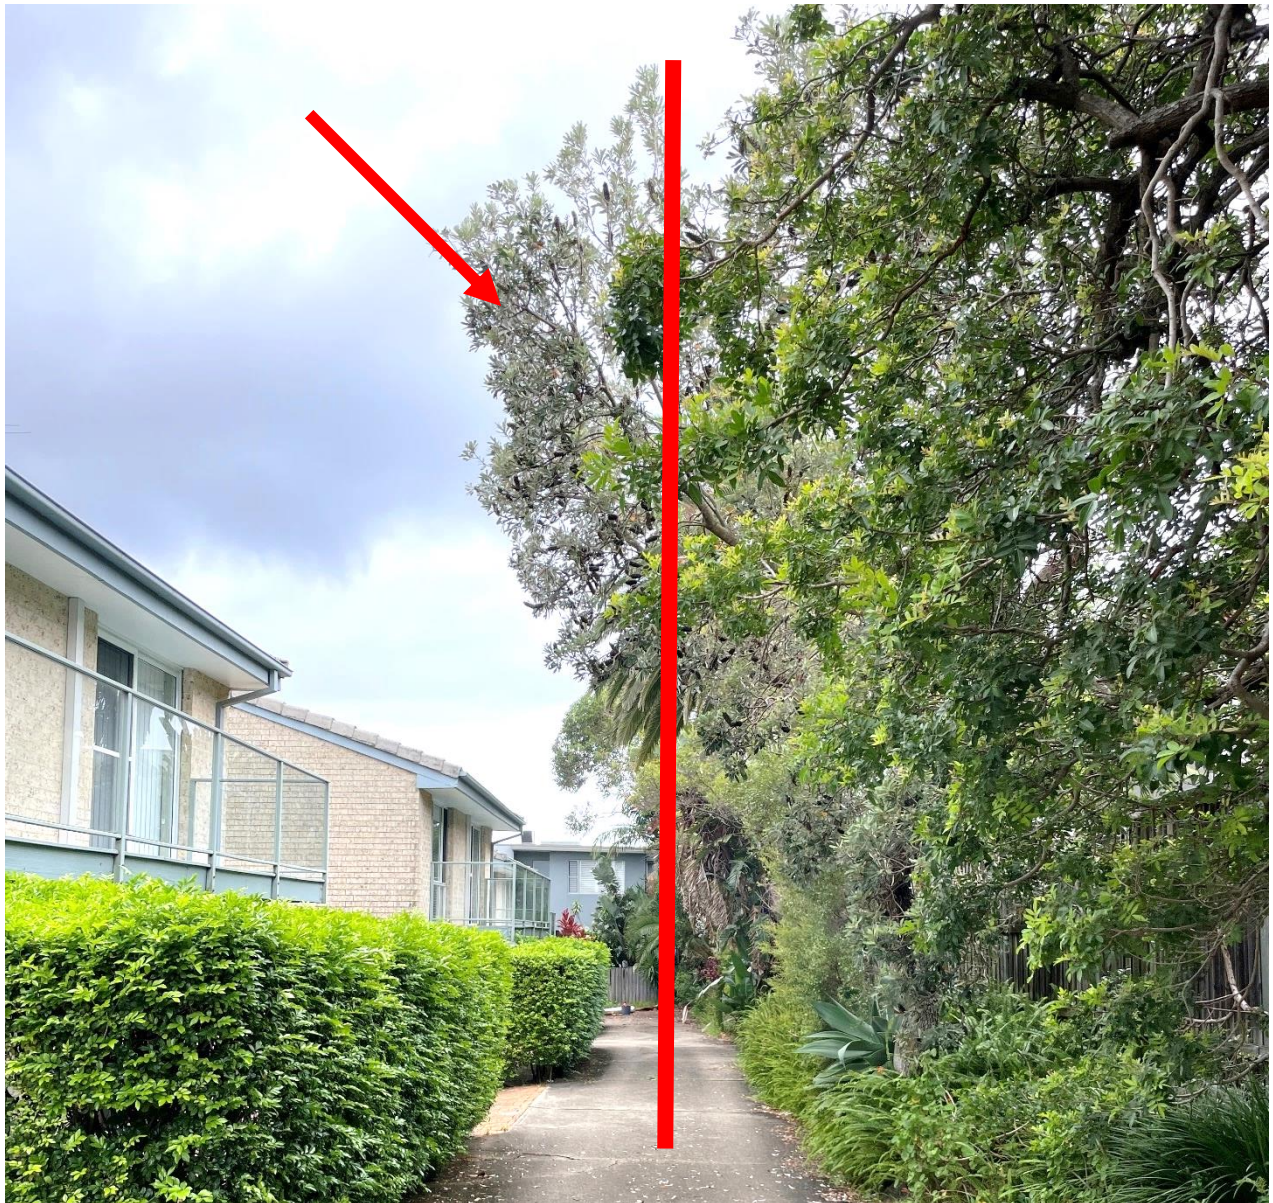
*Figure 14: Canopy of Tree 20 (arrowed) which is skewed to the west, would conflict with the building. The red line shows the line of the proposed building, which is 2 metres from the tree. The tree is to be removed in the proposal as it would not tolerate the excavation nor probably the extent of canopy pruning.*

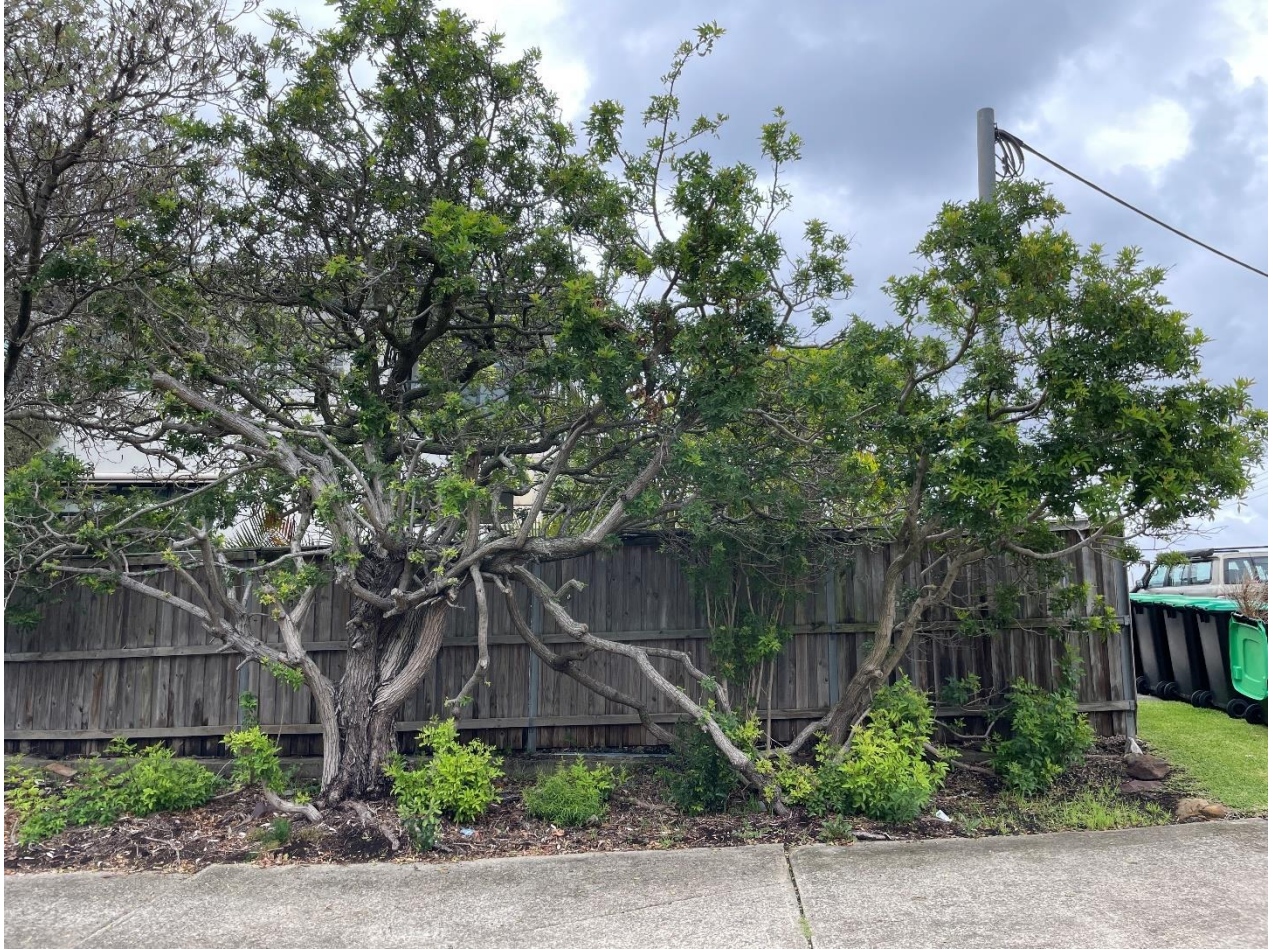
Figure 15: Trees 21 and 24, Brazilian Pepper Trees are undesirable, toxic, allergenic, environmental weed species and are to be removed. The two trees are suckering, heavily previously pruned specimens.

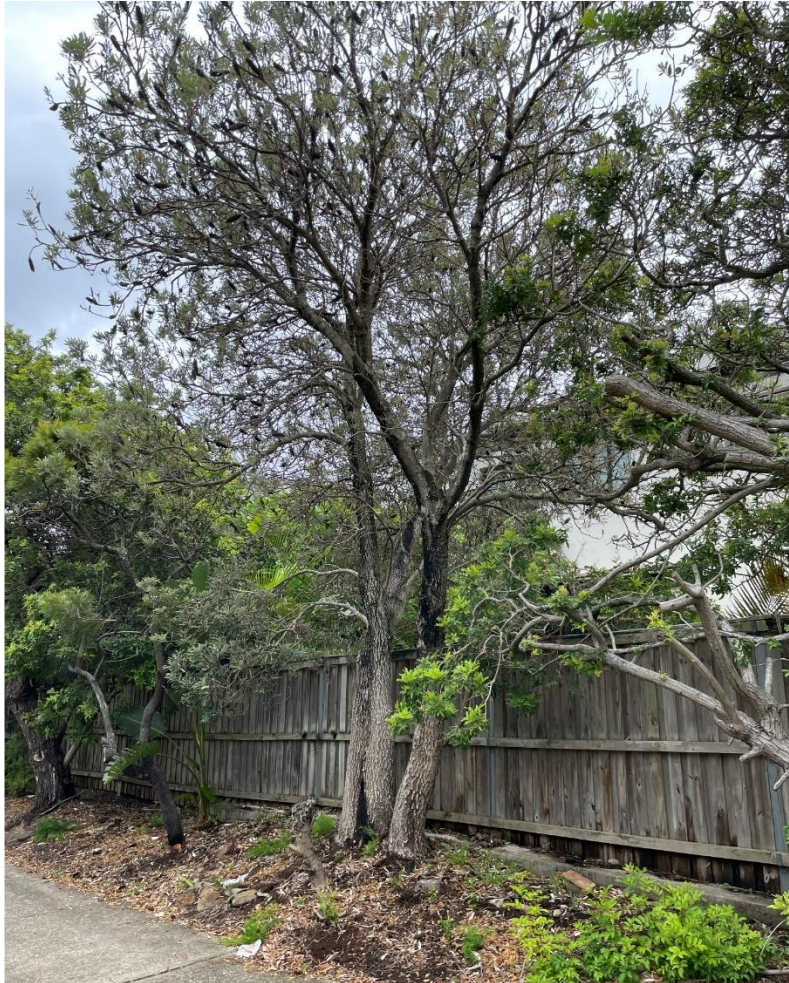
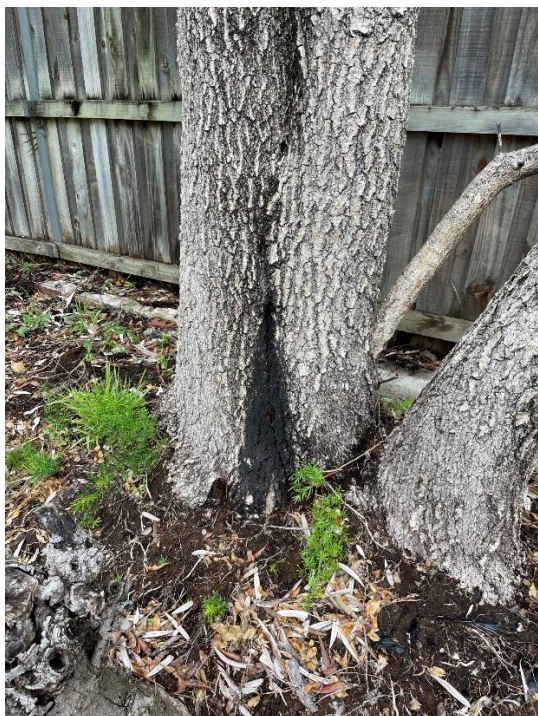
*Figure 16: Tree 23, Coastal Banksia is not likely to survive the proposed TPZ impacts of over 20% from excavation and built structures (bin area). The tree has a structural defect identified at the base, with very a vertical, co-dominant stem junction, which reduces its Useful Life Expectancy.*

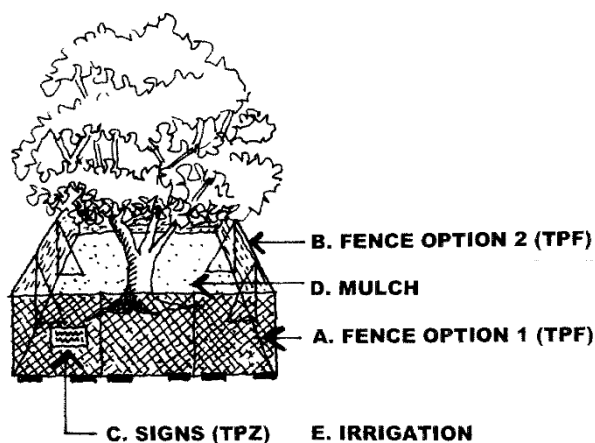
**Diagram 1 TREE PROTECTIVE FENCING (TPF)**

### **A. Fence Option 1 (TPF)**

1.8 metre high chain wire mesh panels with shade cloth attached if required, to be held in place with concrete blocks.

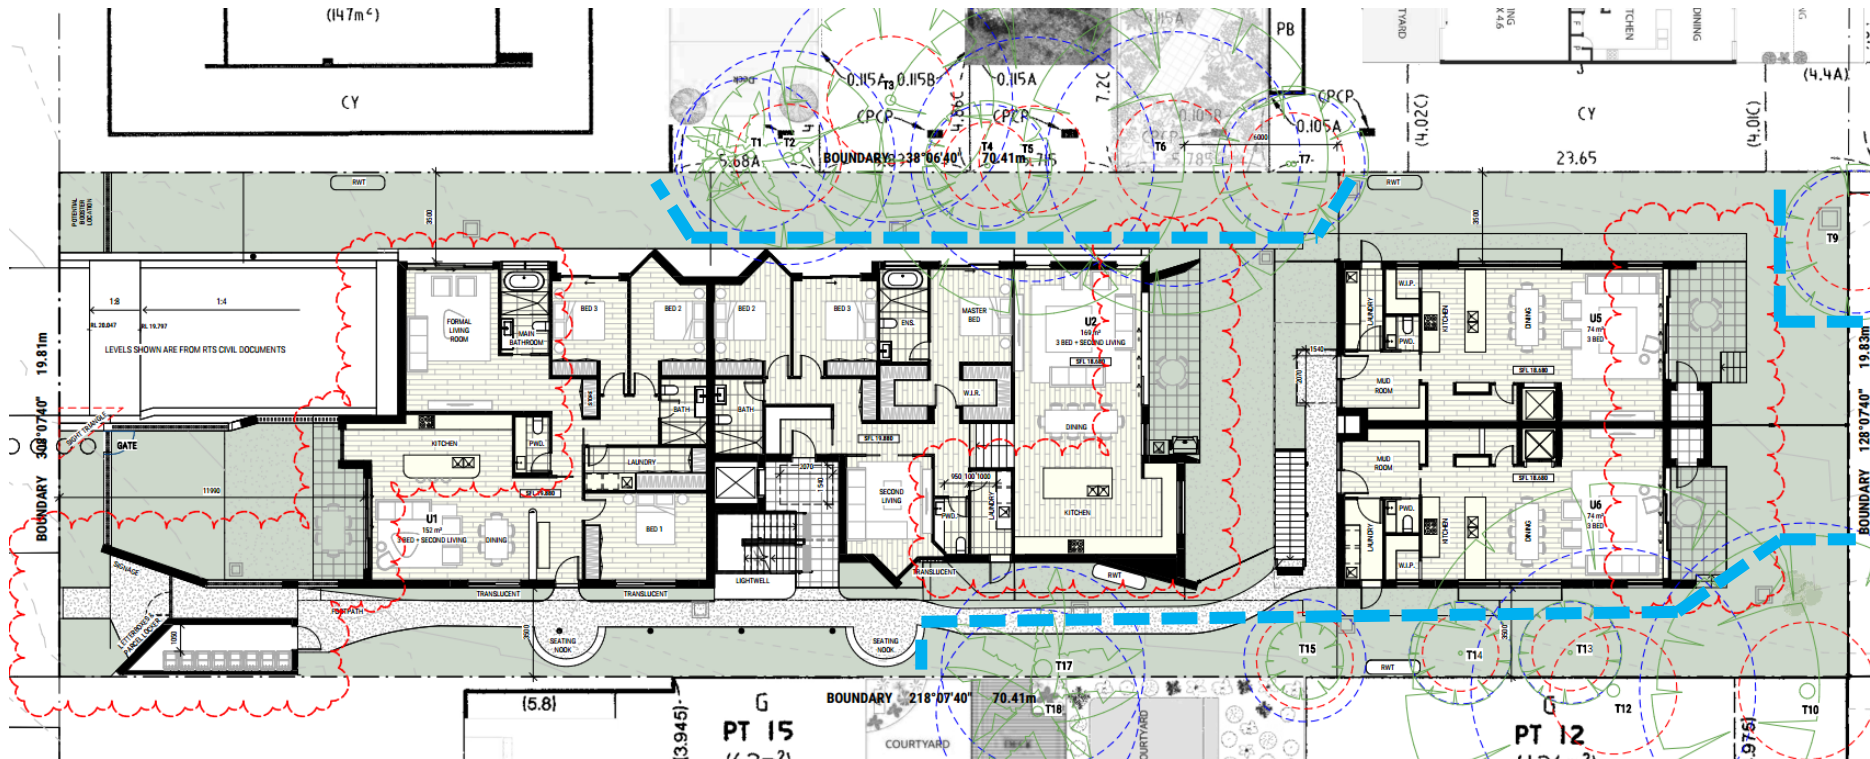
## APPENDIX E TREE PROTECTION PLAN -TPP02

Tree Protection Fencing (TPF) to be installed to protect TPZs of retained trees as per Diagram 1 in Tree Protection Specification.

TPF may be able to be moved under arborist supervision. If fencing cannot be installed to enclose the whole TPZ, then ground protection in the TPZs will be required as per Diagrams 2 and 3 in Tree Protection Specification.
