**Subject: Construction Certificate J100144  
Development Consent Permit 110/08  
25 Montpelier Place Manly**

Proposed Residential Development  
Lots 9-12  
Precinct 13, St Patrick's Estate, Manly

# Ecological assessment proposed residential development.

# **Construction Environmental Management Plan St. Patrick's Estate Manly**

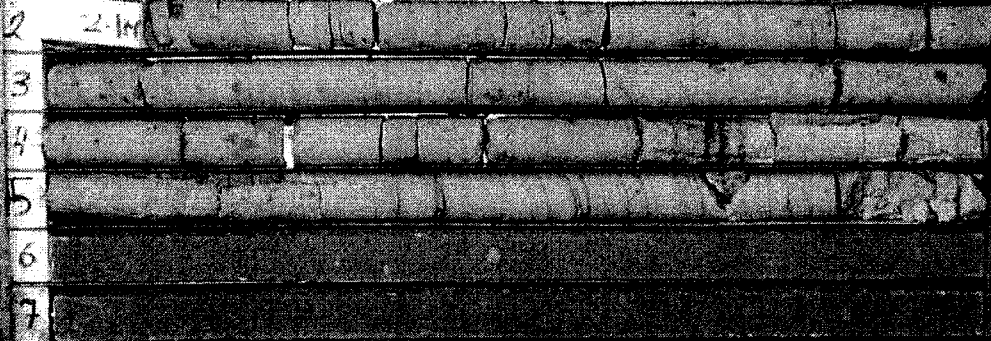
BORE 201 PROJECT 28058A SEPTEMBER 1999

Depth (m)	Description of Strata	Graphic Log	Soil										Rock Strength		Sampling & In Situ Testing			Test Results & Comments		
			Cohesive					Non-Cohesive							Sample Type	Core Rec. %	RQD %			
			Very Soft	Soft	Stiff	Very Stiff	Hard	Very Loose	Loose	Medium Dense	Dense	Very Dense	Ext. Low	Ext. High						
0	SAND - light brown sand																			
0.8	CLAYEY SAND - very stiff, brown grey clayey sand - 1.3m - light brown																	S		
2.1	SANDSTONE - low and extremely low strength; slightly weathered, fractured to slightly fractured, off white, coarse grained gravelly sandstone with extremely low and very low and medium strength bands  - 4.76m: J 80° - 85° smooth planar - 5.19m: J 80° - 85° smooth planar - 5.68m: J 40° - 45° rough planar																	C	100	88
6.0	TEST BORE DISCONTINUED AT 6.0 METRES																	C	100	74

**WATER OBSERVATIONS:** FREE GROUNDWATER OBSERVED AT 1.7m WHILST AUGERING

No free groundwater was observed while augering in Bores 206 to 210 for the attached housing and water was observed in Bore 201 only in the area of the apartment. Site observations, however, indicate that the near surface soils were saturated when the investigation was undertaken and this, combined with the shallow depth of bedrock, would tend to indicate a potential seepage problem during construction. Further comments on groundwater seepage and its effect on the building development in both Precincts are given below.

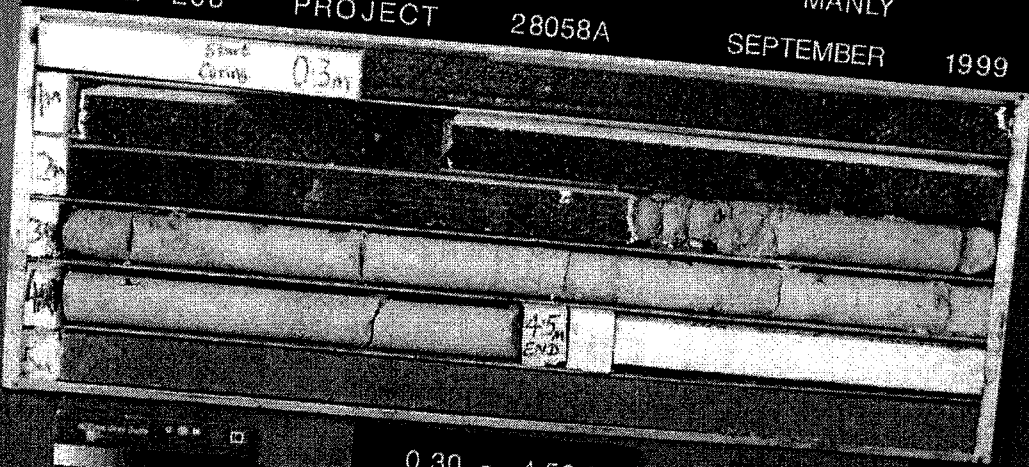
DOUGLAS PARTNERS PTY LTD  
ST. PATRICK'S ESTATE PRECINCT 2 - MANLY  
BORE 208 PROJECT 28058A SEPTEMBER 1999

**WATER OBSERVATIONS:** NO FREE GROUNDWATER OBSERVED WHILST AUGERING
