GEOTECHNICAL RISK MANAGEMENT POLICY FOR PITTWATER
FORM NO. 1 – To be submitted with Development Application

Geotechnical Investigation
7 Bower Street, Manly NSW 2095

Report Number: WittC-CplusC-R-C

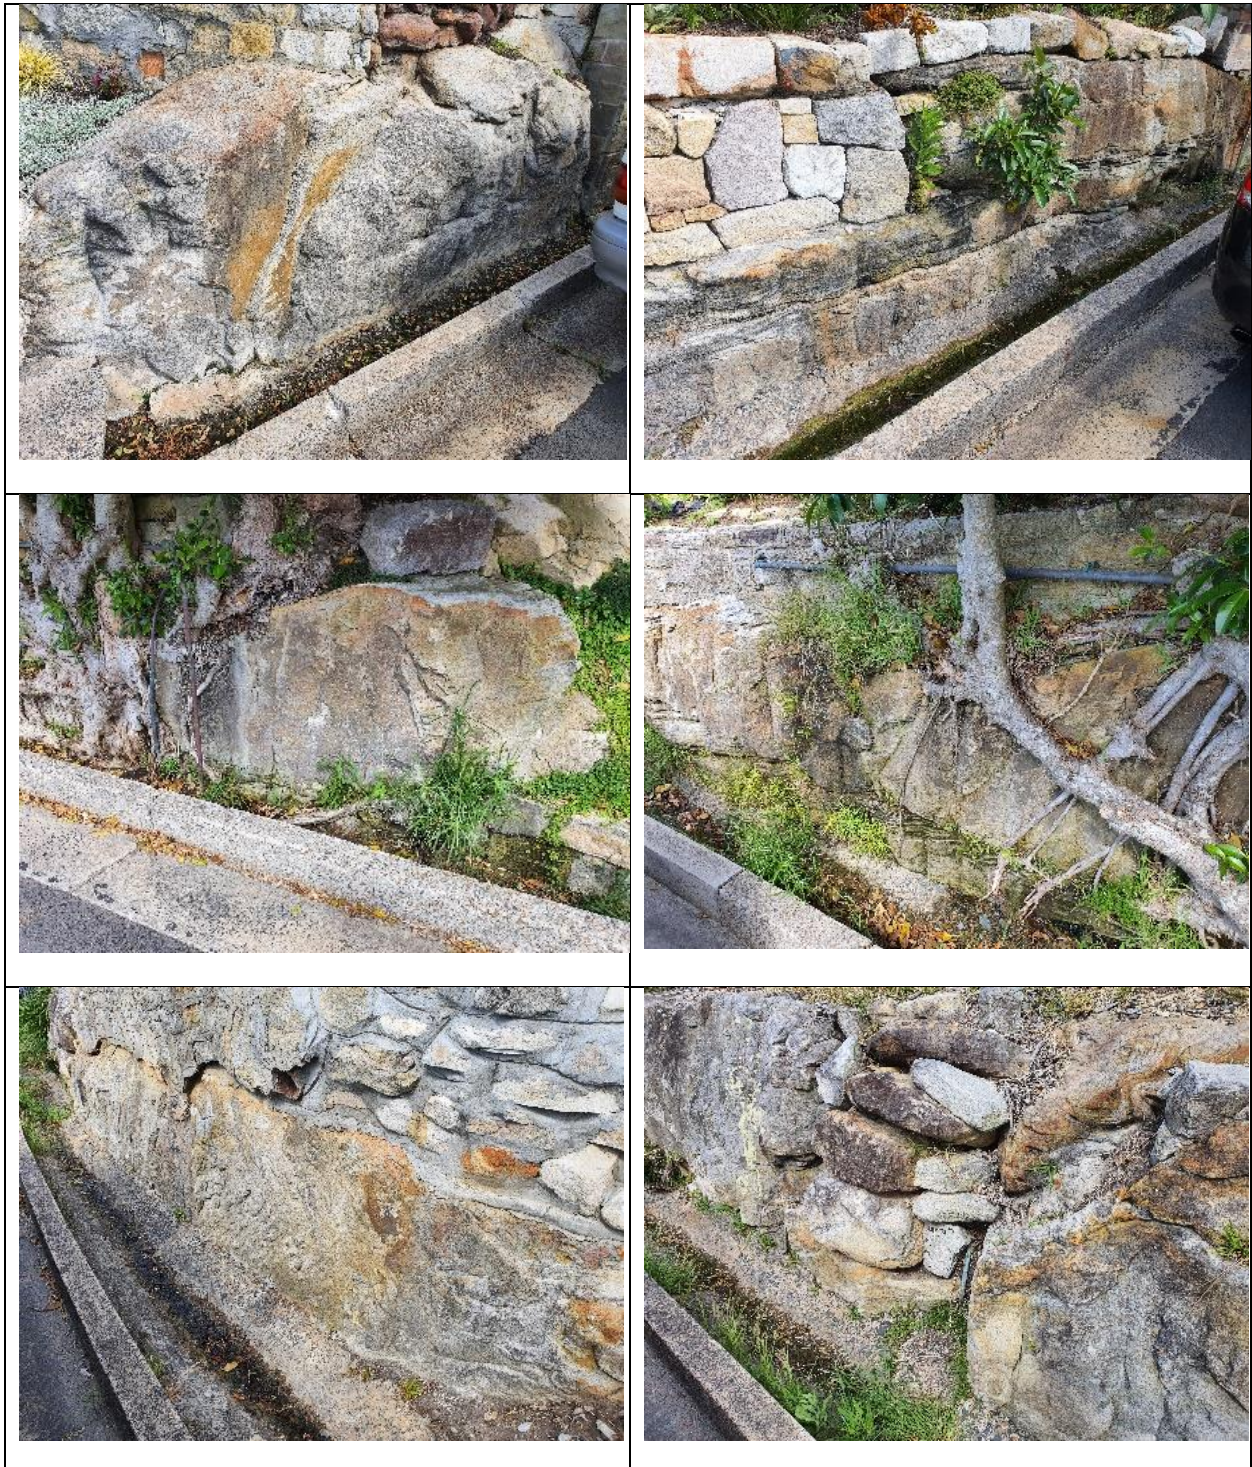
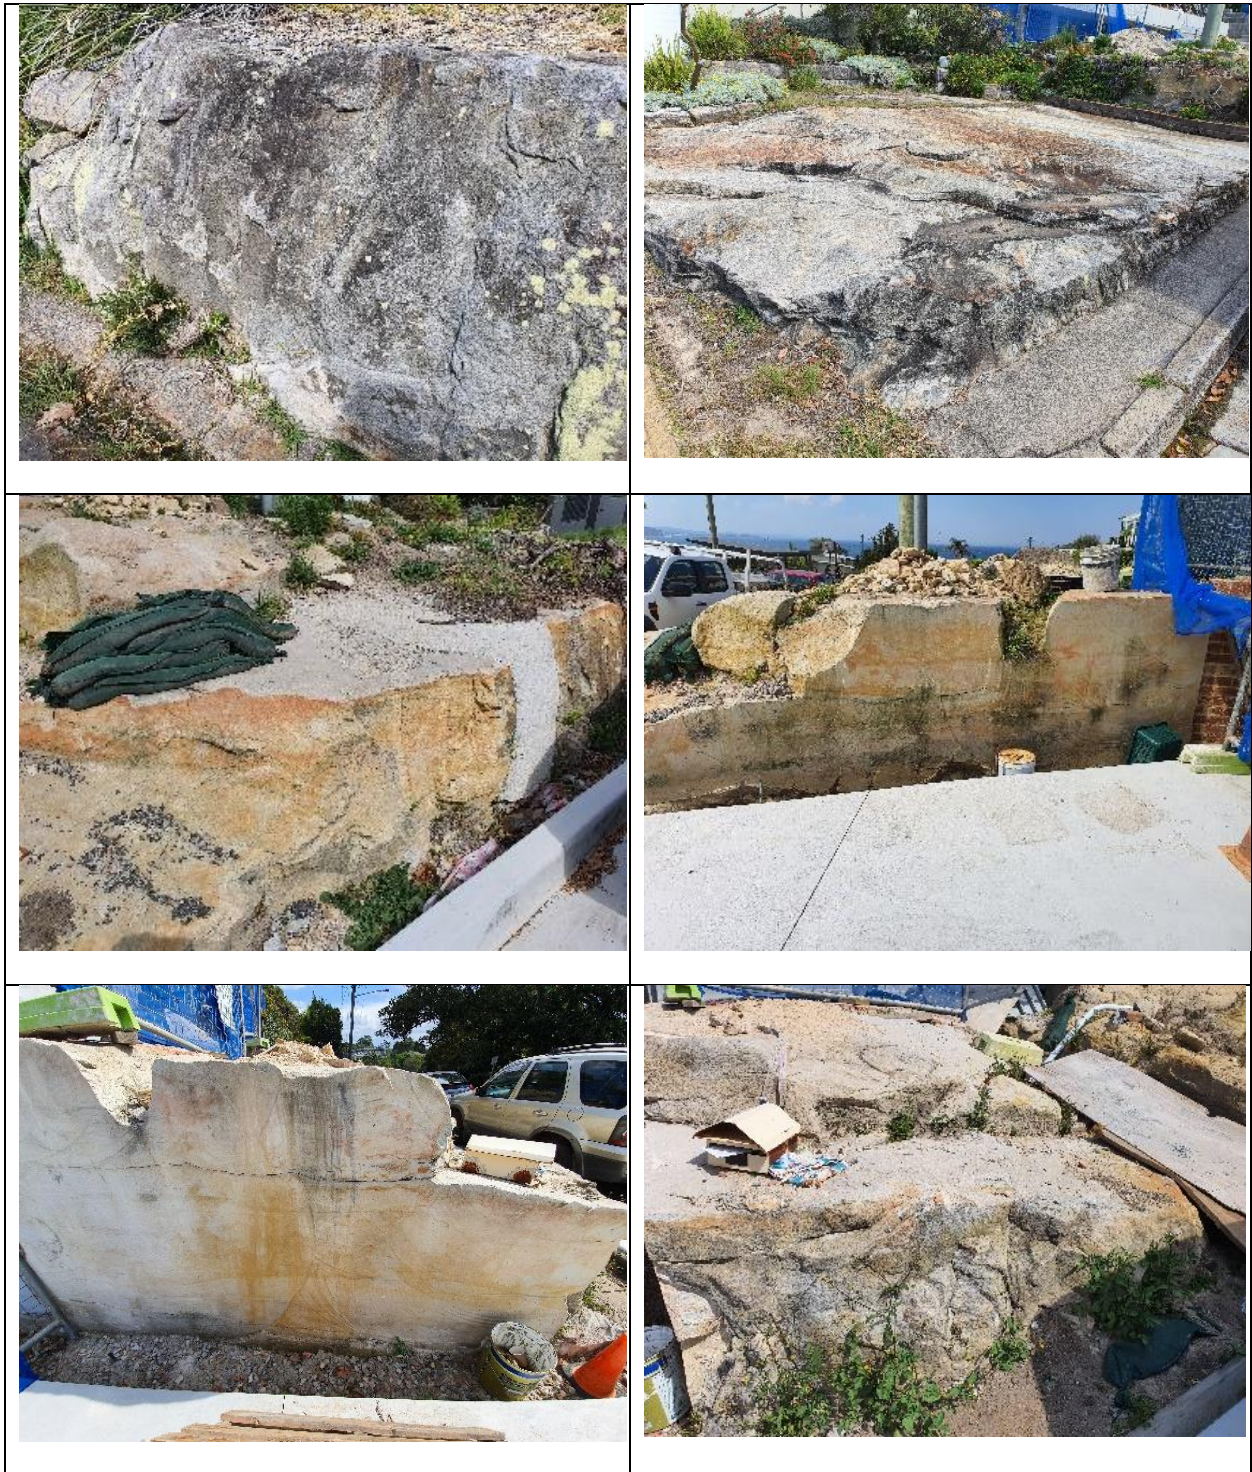
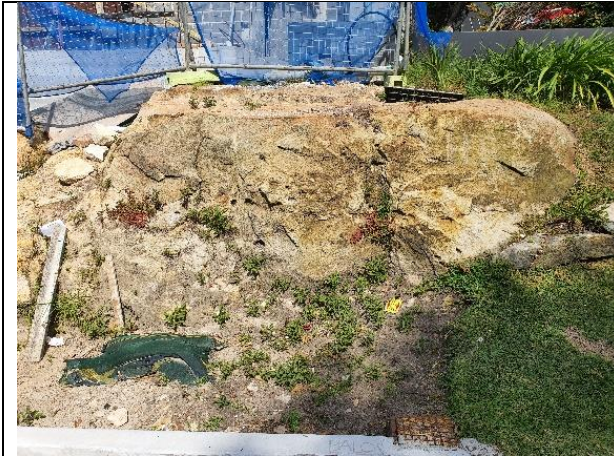
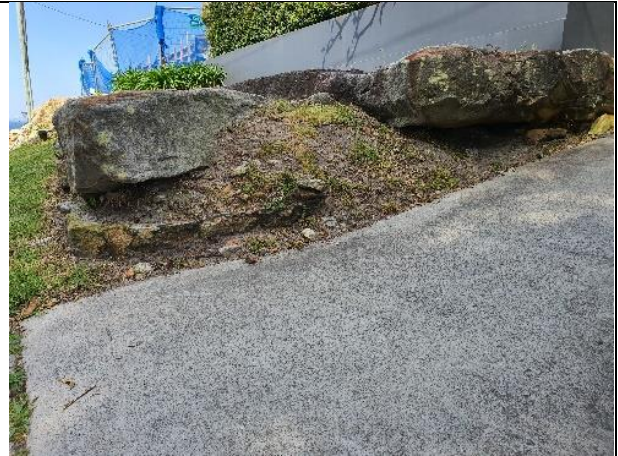
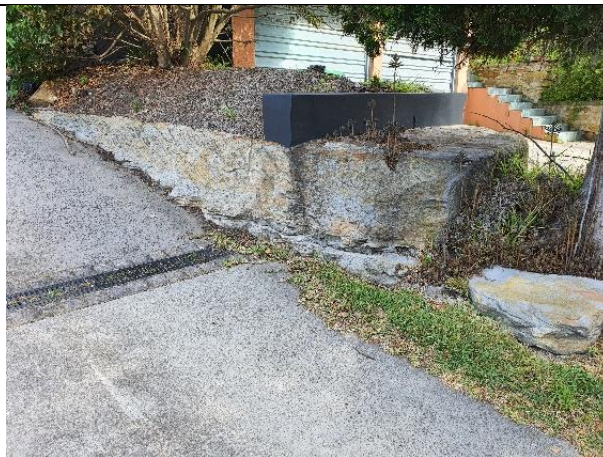
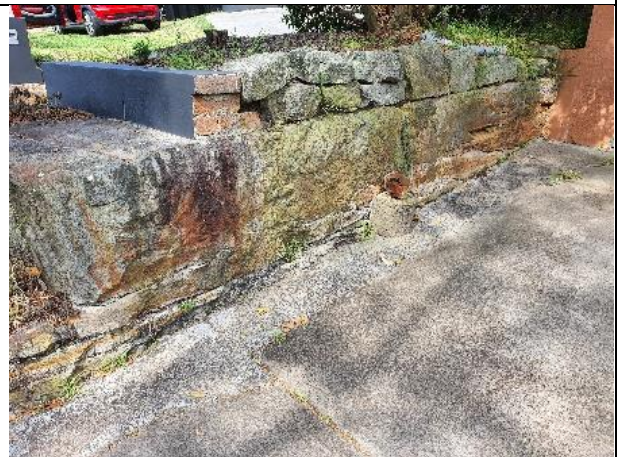
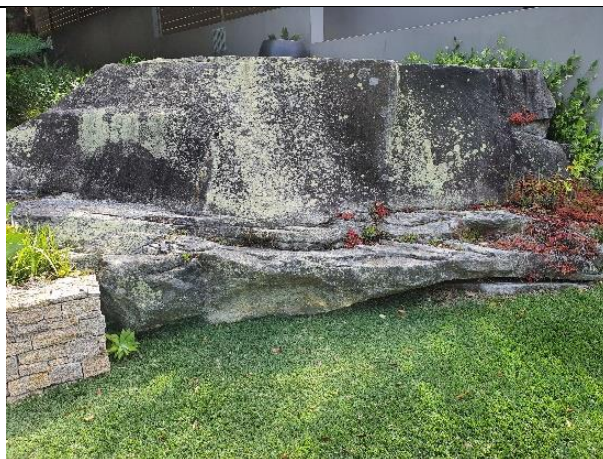
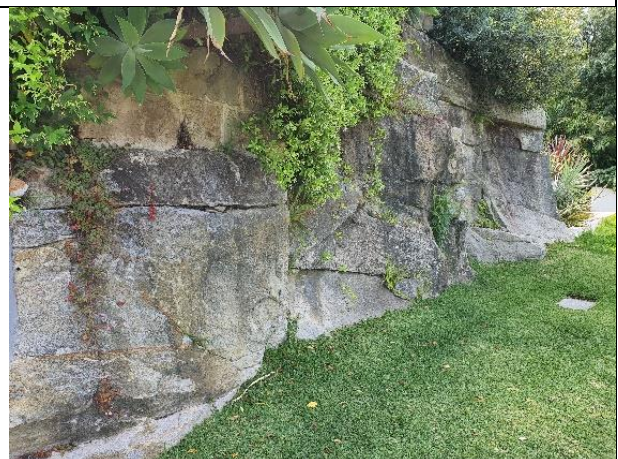
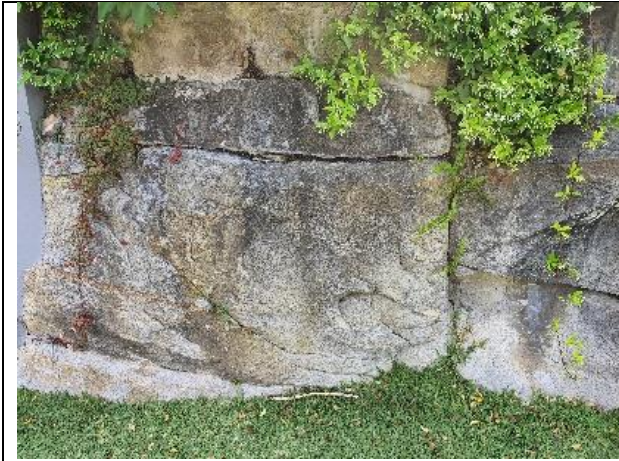
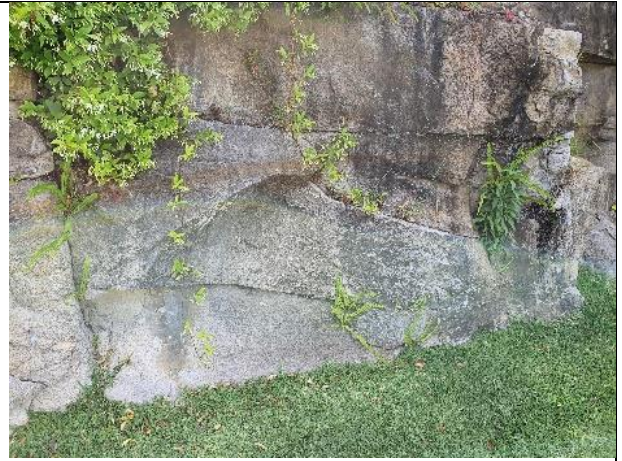
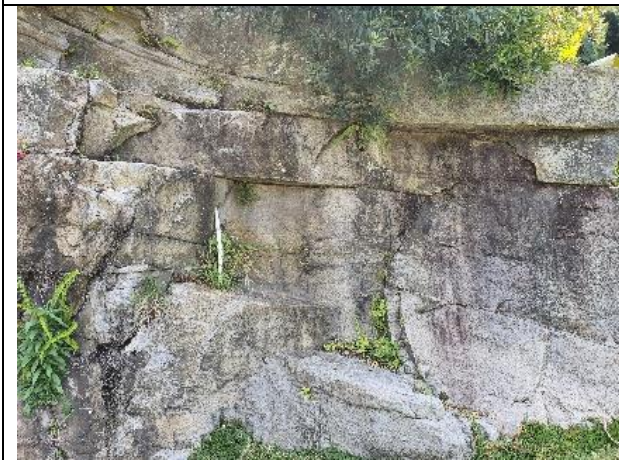
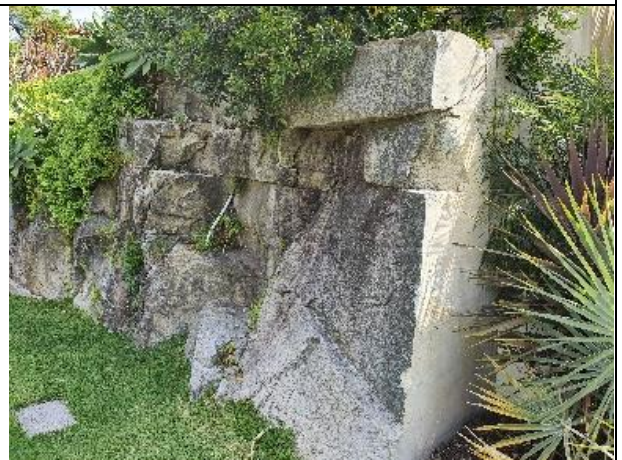
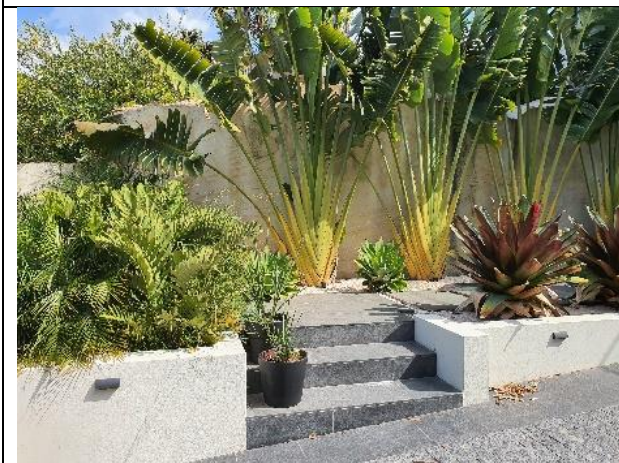
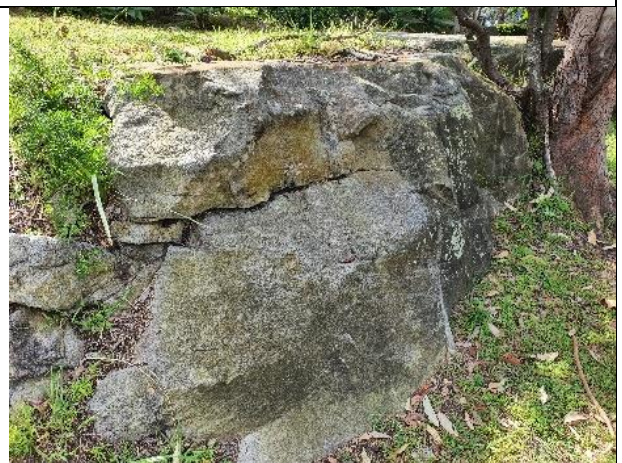
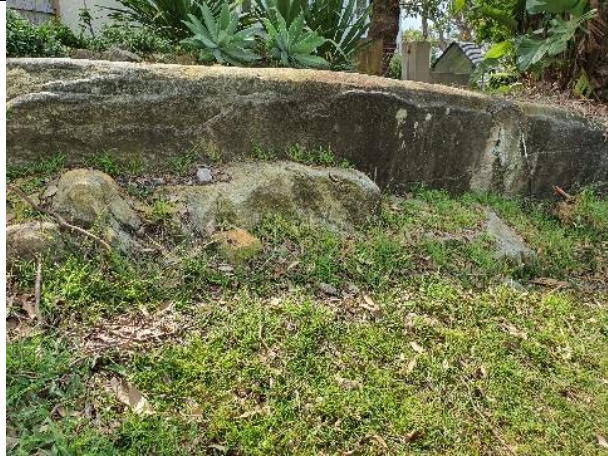
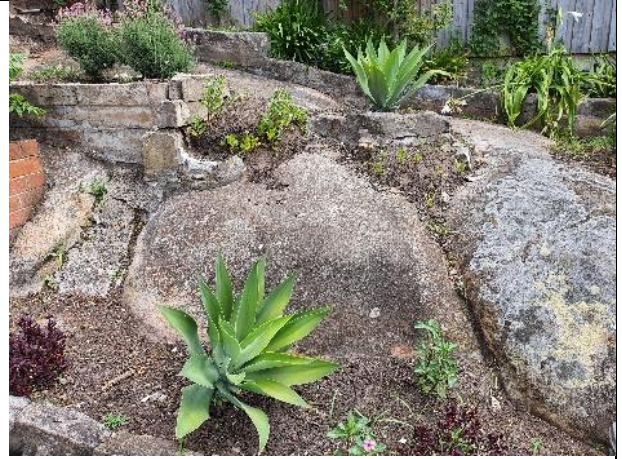
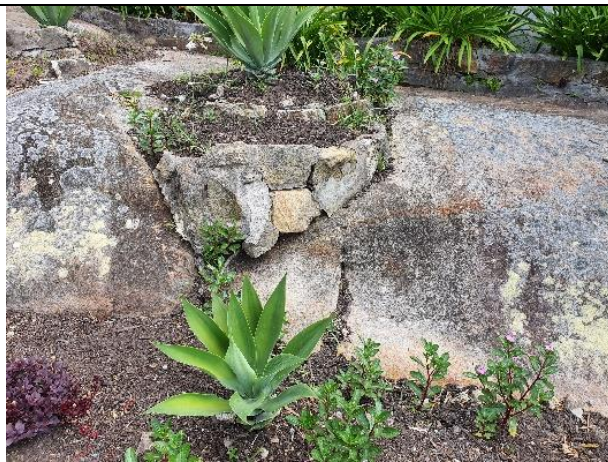
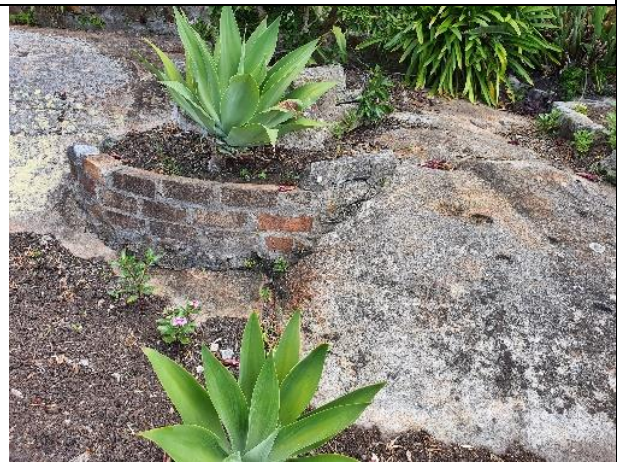
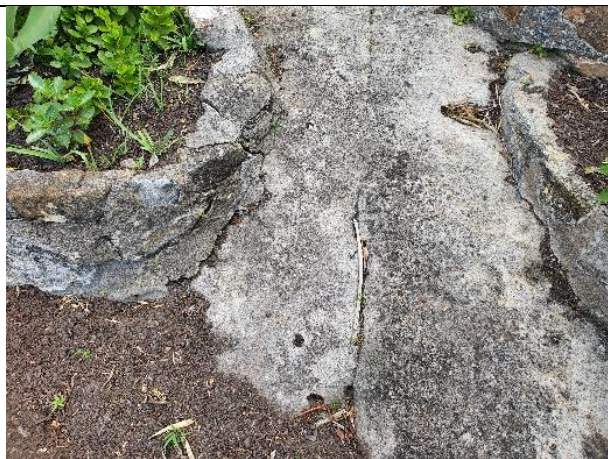
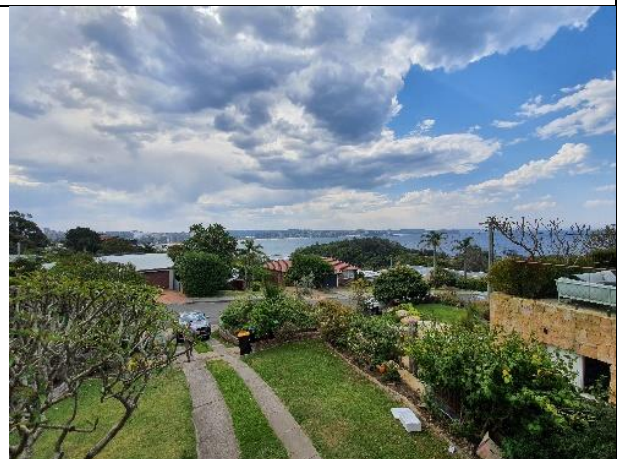
Appendix C. Bower Street Site Inspection Photos

A large sandstone outcrop was observed along the coastline of Shelley Beach approximately 200 m from the site. Similarly, sandstone was also observed on both sides of the road spanning from 3 to 39 Bower Street as presented in **Appendix C**.

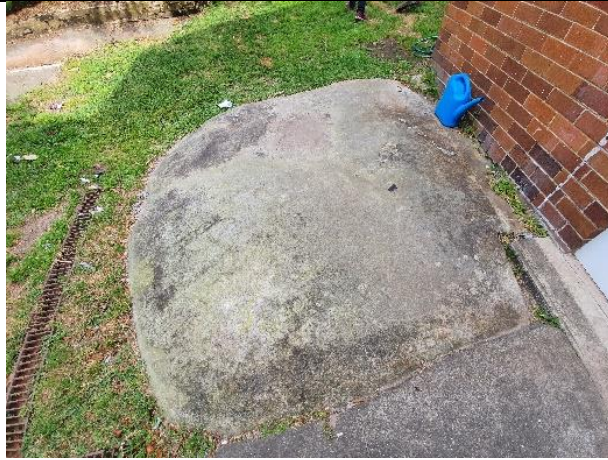
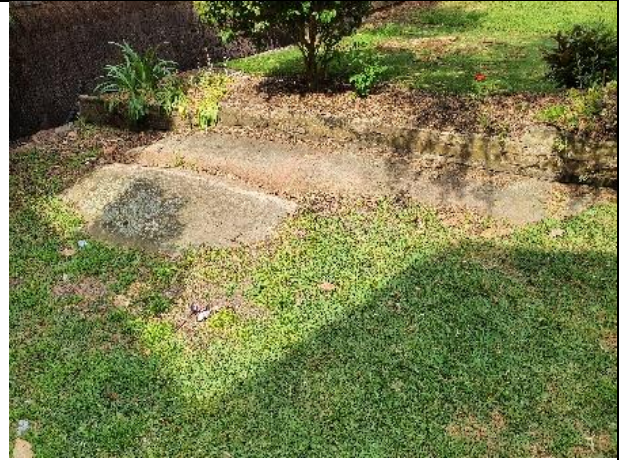
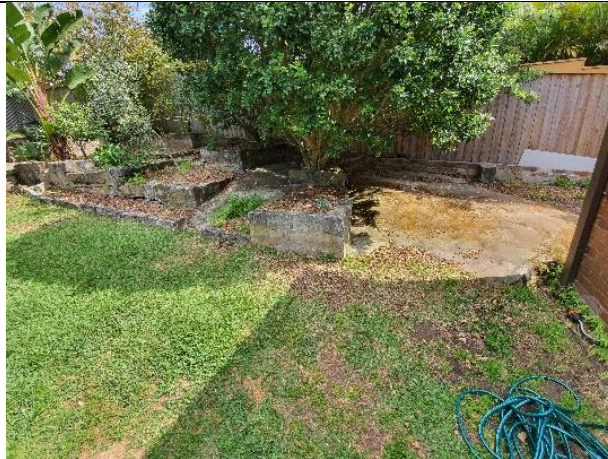
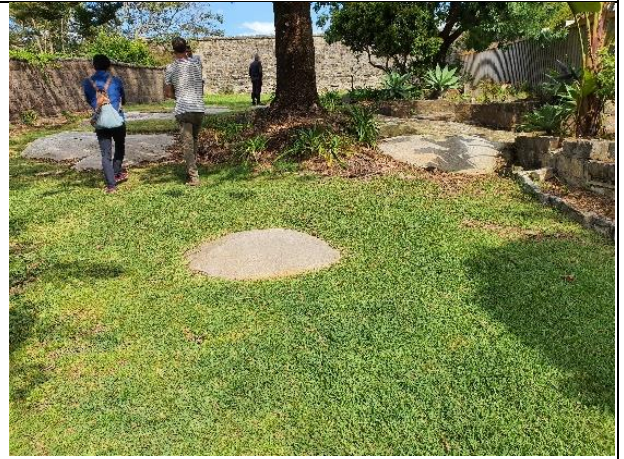
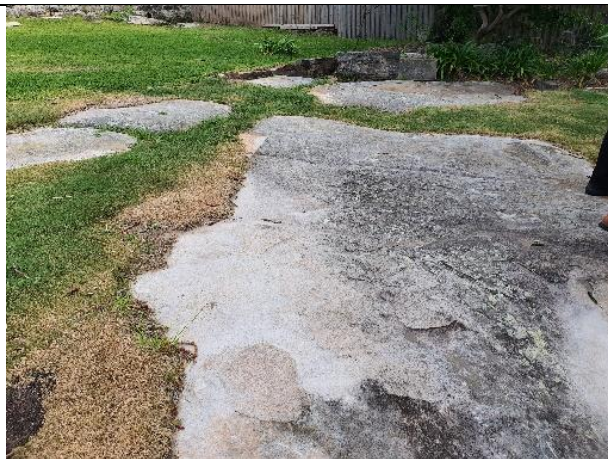
Appendix D. 7 Bower Street Backyard Site Inspection Photos

The ground surface at the site is predominantly covered by topsoil and organic material. Sandstone was observed to outcrop throughout the backyard as can be seen in **Appendix D**.
