Proposed Tennis Court and Gazebo 3 Riverview Road, Avalon NSW

Geotechnical Assessment

Our ref: 5803-2-G1 23 September 2021

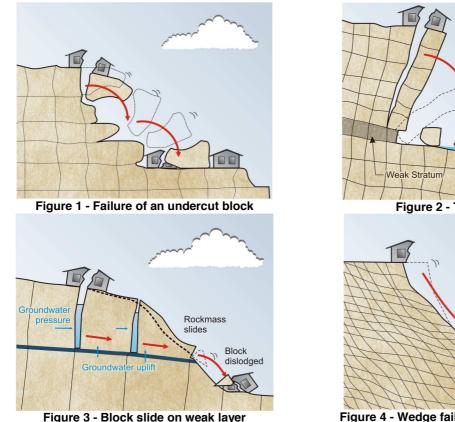
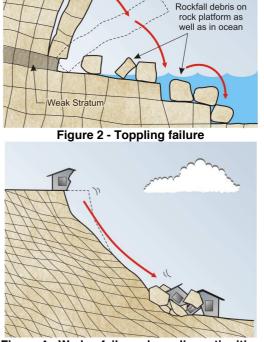
Figure 4 - Wedge failure along discontinuities

Weathering can lead to landslides (GeoGuide LR2) on rock slopes. The type of landslide depends on the nature of rock, the way it has weathered and the presence or absence of discontinuities. It is hard to generalise, though normally a specific combination of discontinuities and material types will be the determining factor and these are often underground and out of sight. Typical examples are provided in the figures 1 to 4. A geotechnical practitioner can assess the landslide risk and propose appropriate maintenance measures. This often entails making geological observations over an area significantly larger than the site and a review of available background information, including records of known landslides and aerial photographs. Depending on the amount of information available, geotechnical investigation may or may not be needed. Every site is different and every site has to be assessed individually.

It is impossible to predict exactly when a landslide will occur on a rock slope, but failure is normally sudden and the consequences can be catastrophic.

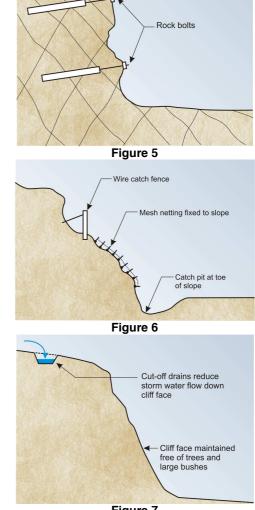
Figure 7

Cut-off drains (Figure 7) - can be used to intercept surface water run-off and reduce flows down the cliff face. Suitable drains are often excavated into the rock, or constructed from mounds of concrete, or stabilised soil, depending on conditions. Drains must be laid to a fall of at least 1% so they drain adequately. Frequent inspection is needed to ensure they are not blocked and continue to function as intended.

Clear trees and large bushes (Figure 7) - from slopes since roots can prize boulders from the face increasing the landslide hazard.

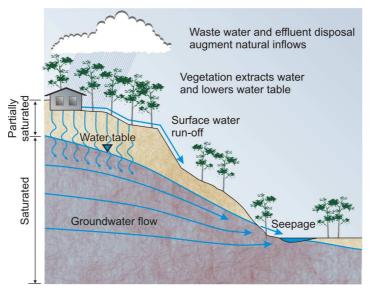
Figure 1 - Groundwater flow

The ground is permeable and water flows through it as illustrated in Figure 1. When rain falls on the ground, some of it runs along the surface ("surface water run-off") and some soaks in, becoming groundwater. Groundwater seeps downwards along any path it can find until it meets the water table: the local level below which the ground is saturated. If it reaches the water table, groundwater either comes to a halt in what is effectively underground storage, or it continues to flow downwards, often towards a spring where it can seep out and become surface water again. Above the water table the ground is said to be "partially saturated", because it contains both water and air. Suctions can develop in the partially saturated zone which have the effect of holding the ground together and reducing the risk of a landslide. Vegetation and trees in particular draw large quantities of water out of the ground on a daily basis from the partially saturated zone. This lowers the water table and increases suctions, both of which reduce the likelihood of a landslide occurring.

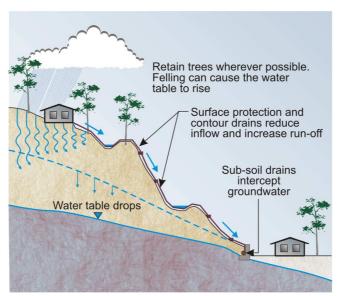
Figure 2 - Techniques used to control groundwater flow

The following techniques may be considered to limit the destabilising effects of rising groundwater due to development and are illustrated in Figure 2.

Surface water drains (dish drains, or table drains) - are often used to prevent scour and limit inflow to a slope. Other than in rock, they are relatively ineffective unless they have an impermeable lining. You should clear them regularly, and as required, and not less than once a year. If you live in an area with seasonal rainfall, it is best to do this near the end of the dry season. If you notice that soil or rock debris is falling from the slope above, determine the source and take appropriate action. This may mean you have to seek advice from a geotechnical practitioner.

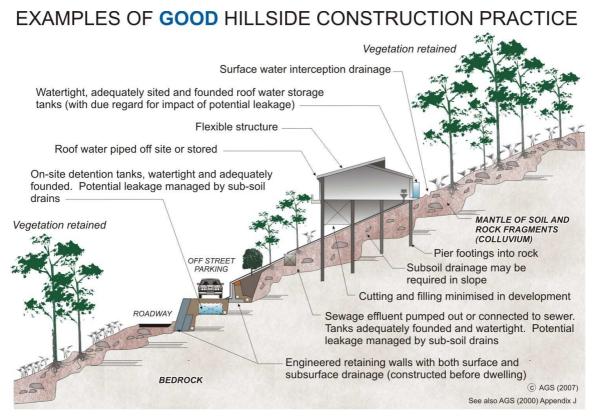
Sensible development practices are required when building on hillsides, particularly if the hillside has more than a low risk of instability (GeoGuide LR7). Only building techniques intended to maintain, or reduce, the overall level of landslide risk should be considered. Examples of good hillside construction practice are illustrated below.

Roadways and parking areas - are paved and incorporate kerbs which prevent water discharging straight into the hillside (GeoGuide LR5).

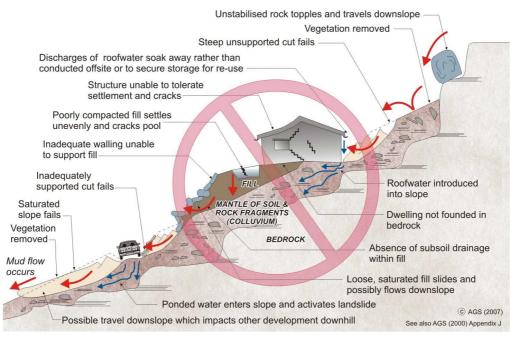
EXAMPLES OF **POOR** HILLSIDE CONSTRUCTION PRACTICE

Roadways and parking areas - are unsurfaced and lack proper table drains (gutters) causing surface water to pond and soak into the ground.

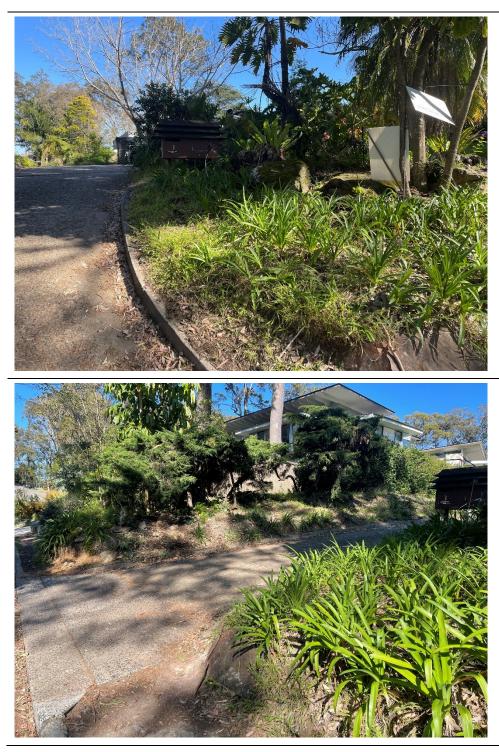
Photo 1

View of entrance to the Site. Note sandstone boulders to the right of the driveway.

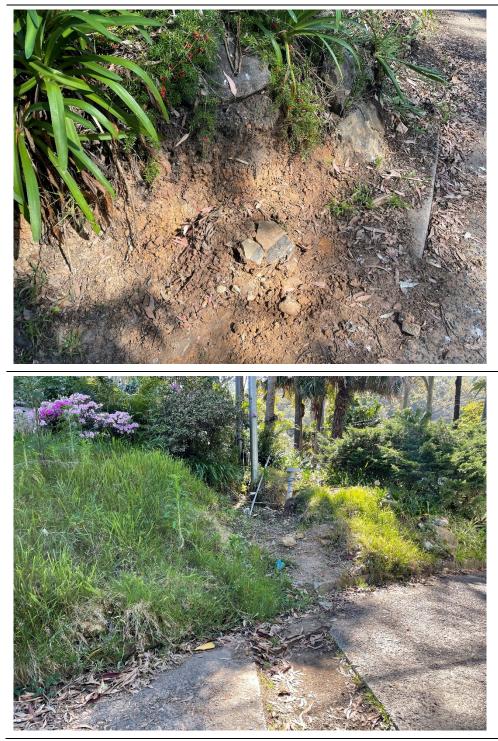
Photo 3 Shallow soil cutting

on left-hand side of driveway.

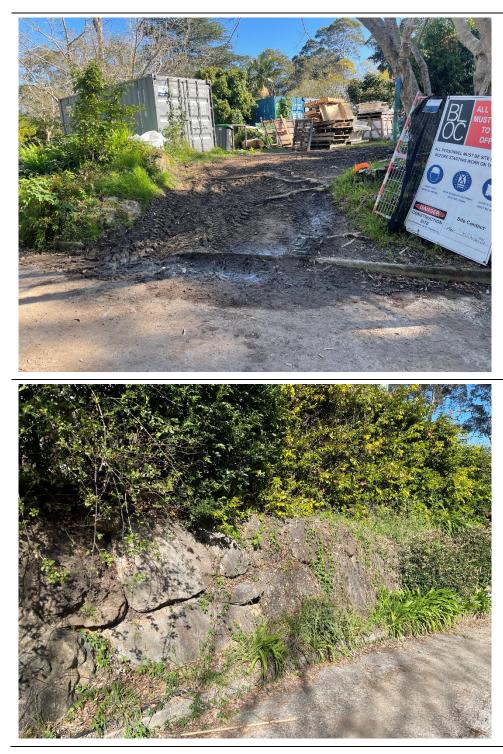
Photo 5

View of storage compound for materials for construction of the dwelling and associated works downslope. Note surface water seepage from recent watering of potted trees within the storage area.

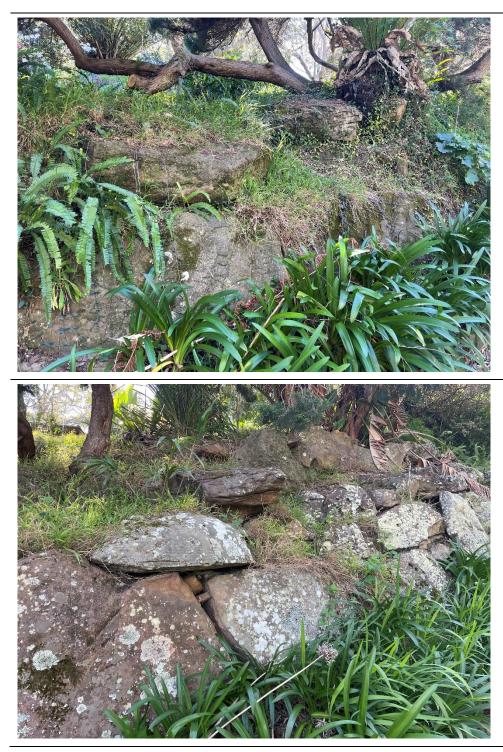
Photo 7

View of Sandstone outcrop and overlying sandstone boulders adjacent to concrete driveway.
