Geotechnical Report
1102 Barrenjoey Road, Palm Beach NSW 2108

Report Number: WittC-TMattox-R-A

November 2019

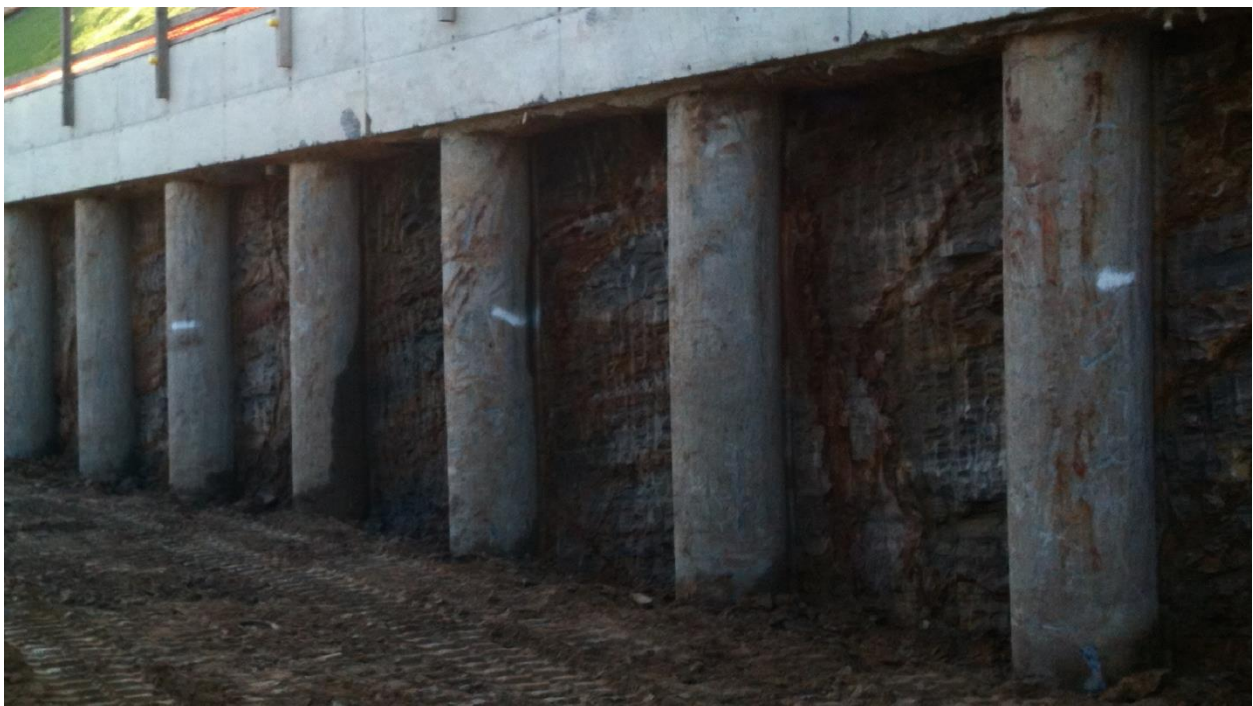
Figure 3, geological conditions behind soldier pile retaining wall on eastern boundary prior to placement of shotcrete infill.

The geotechnical model along the eastern boundary of the site consisted of interbedded siltstone and sandstone from the surface. The geotechnical conditions behind the face of the soldier pile wall can be seen in Figure 3 below. Figure 3 is a photo supplied by the owner taken during the construction of the soldier pile wall.

We understand that the existing soldier pile retaining wall was designed to work as a cantilevered retaining wall when the ground level on the western side was excavated to the current ground level at approximately RL 2.9 m. We understand that the soldier pile retaining wall was also designed to have the structural capacity to work as an anchored retaining wall should additional excavation works be undertaken on the western side of the wall.

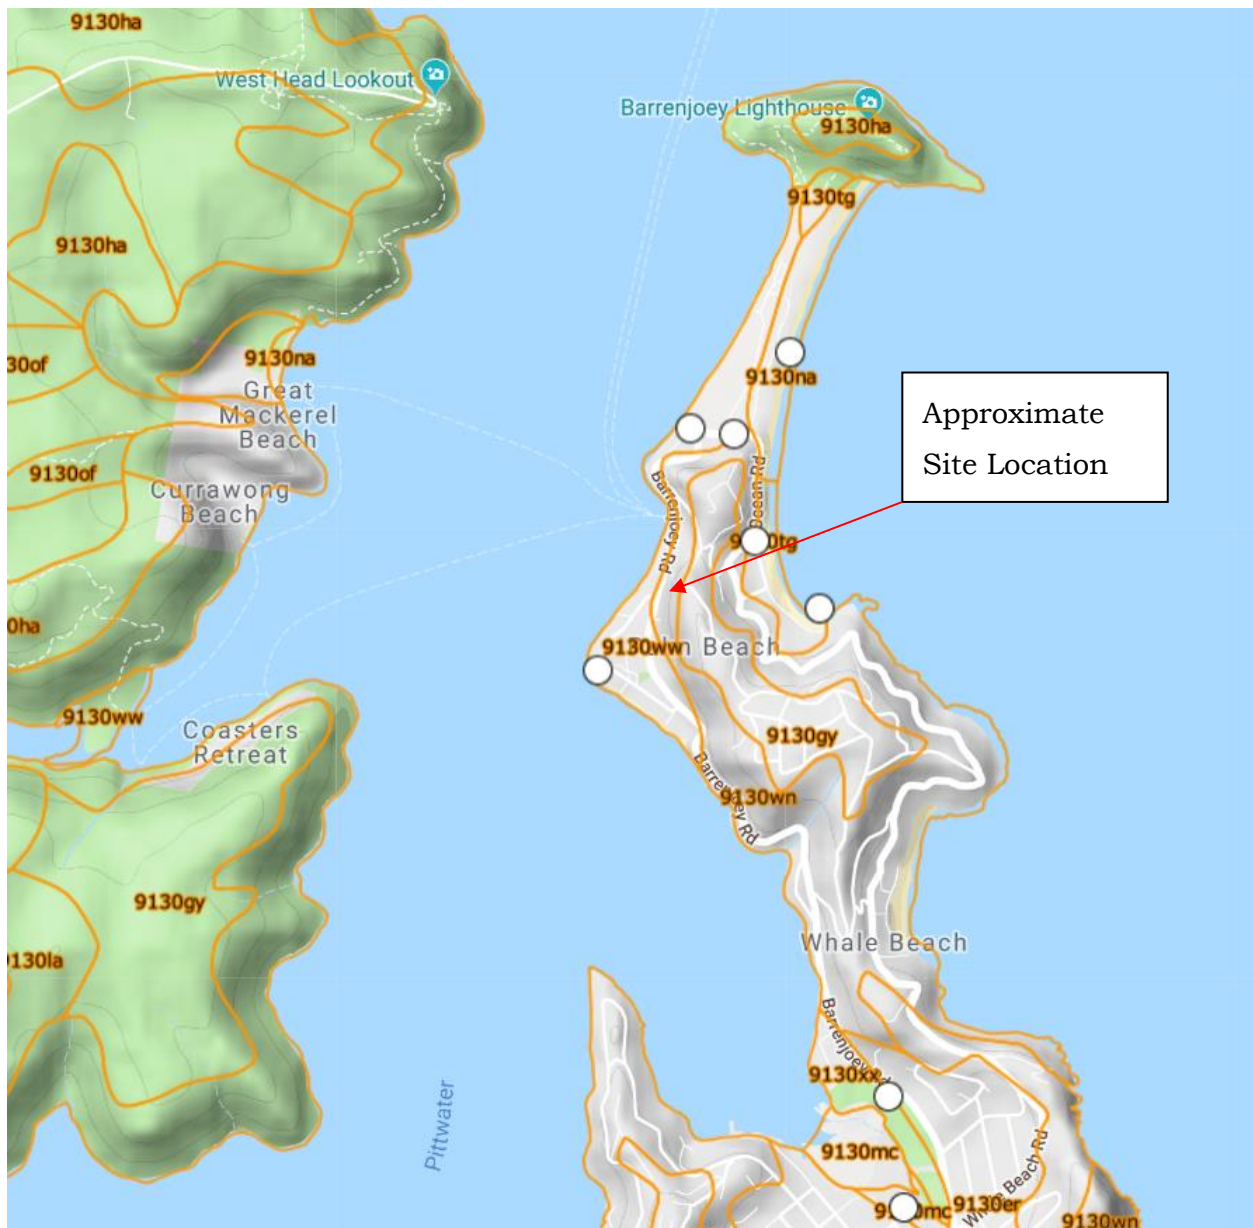
Excerpt of eSPADE web application showing approximate site location

The NSW Environment & Heritage eSPADE web application identifies the soil landscape at the site as Woy Woy (9130ww). The Woy Woy soil landscape is characterised by;

An excerpt of the eSPADE web application showing the location of the site with the associated soil landscapes is presented in **Appendix C**.

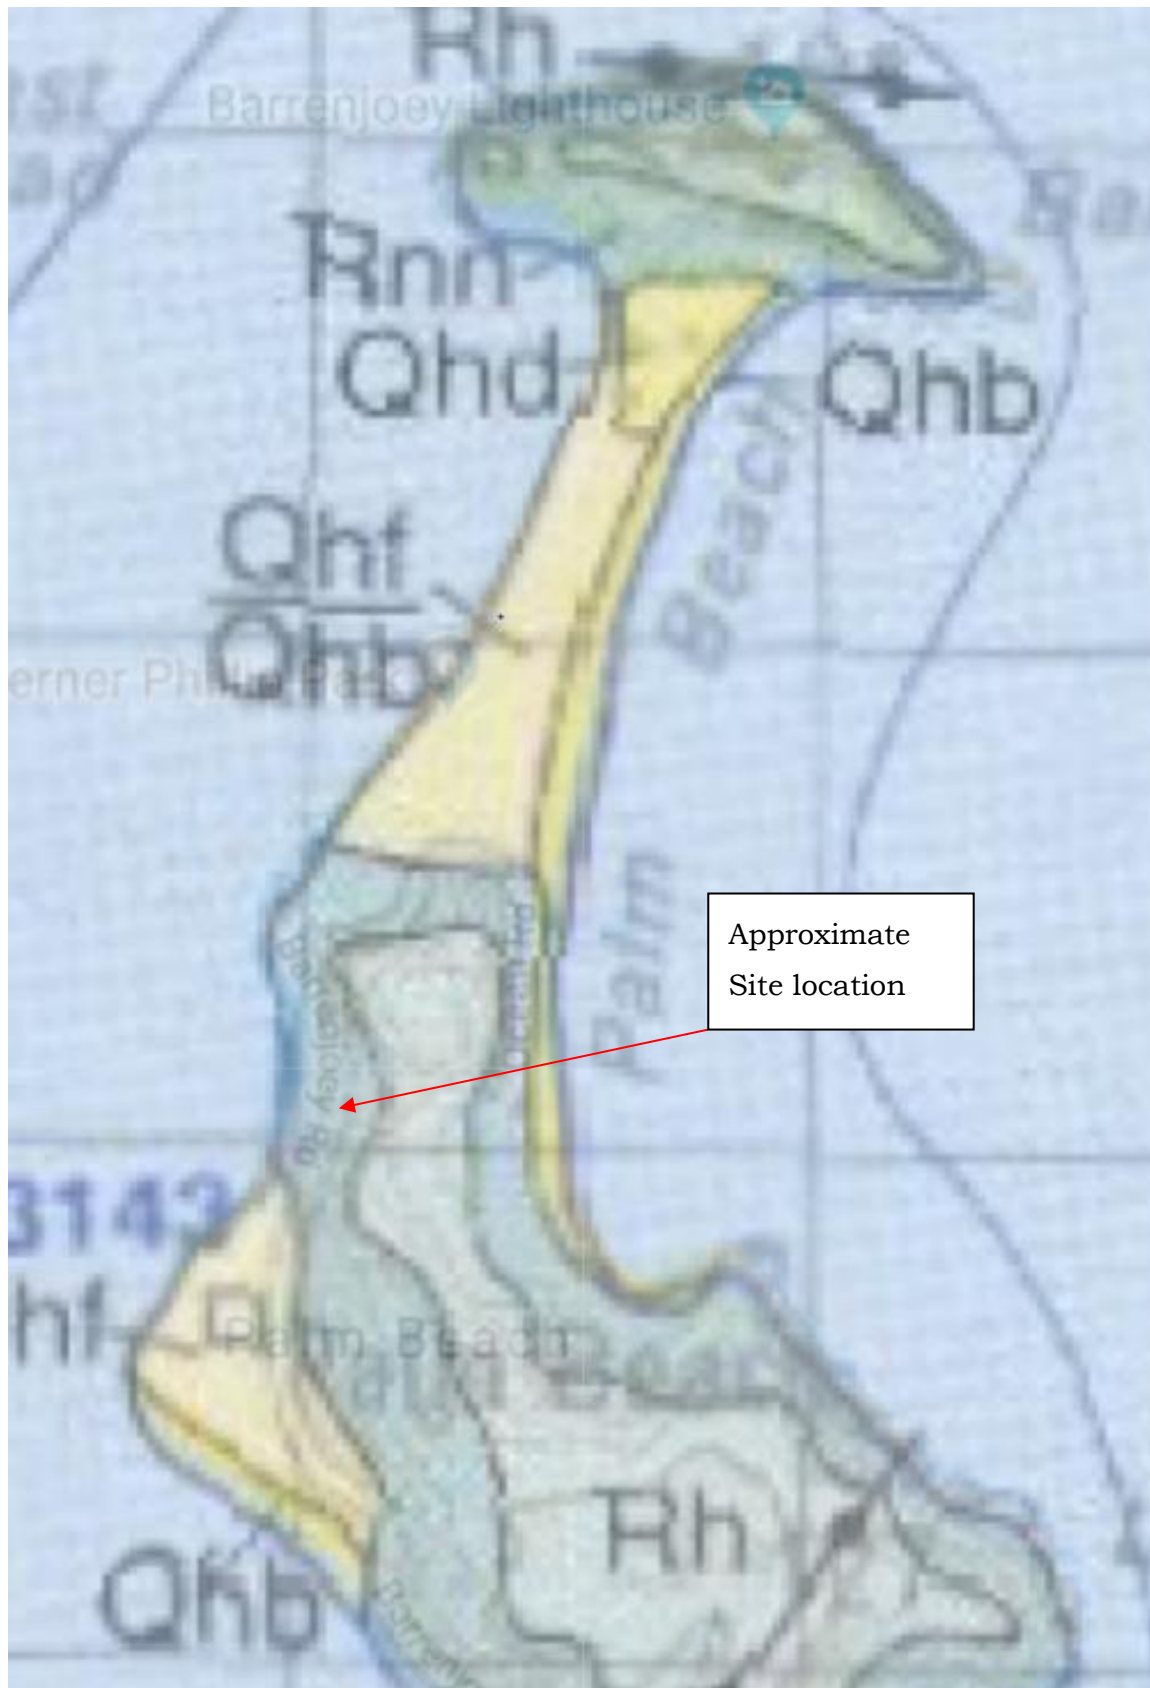
Excerpt from Sydney 1:100,000 Geological Series Sheet

The Sydney 1:100,000 Geological Series Sheet 9130 indicates that the site is underlain by Newport Formation and Garie Formation (Rnn) of the Narrabeen group.

An excerpt of the 1:100,000 Geological Series Sheet 9130 showing the location of the site is presented in **Appendix D**. The geology within the general vicinity of the site is easily observed at MacKay Reserve approximately 200 m south of the site. The typical stratigraphy in the areas is shown in Figure 1 below.
