## **GEOTECHNICAL INVESTIGATION REPORT**

### **PROPOSED NEW DWELLING**

**16 REDDALL STREET, MANLY, NSW**

**Project No.: 2024-166**

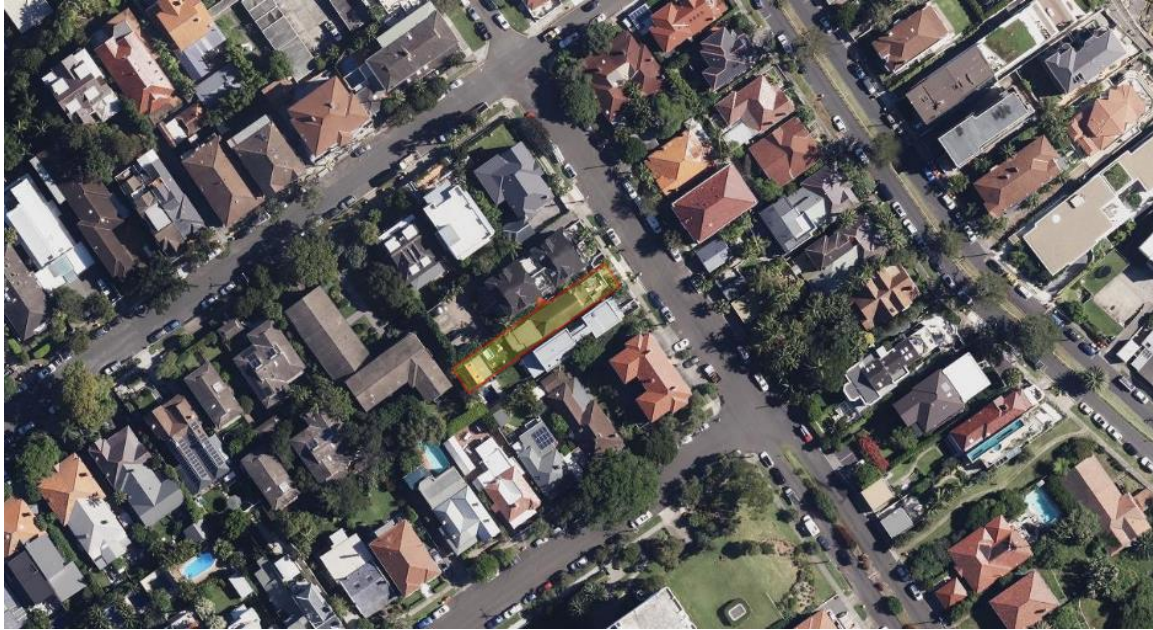
From the provided survey plan, the site has front eastern boundary and rear western boundary of approximately 7.695m respectively, whilst the side northern and southern boundaries are approximately 48.785m and 48.055m respectively, covering a total site area of 375.7m<sup>2</sup>. An aerial photograph of the site and its surrounds with boundary designations is shown below in Photograph 1, as sourced from NSW Government Six Map Spatial Data.

*Photograph 1: Aerial site view and surrounds (NSW Government Six Map Spatial Data)*

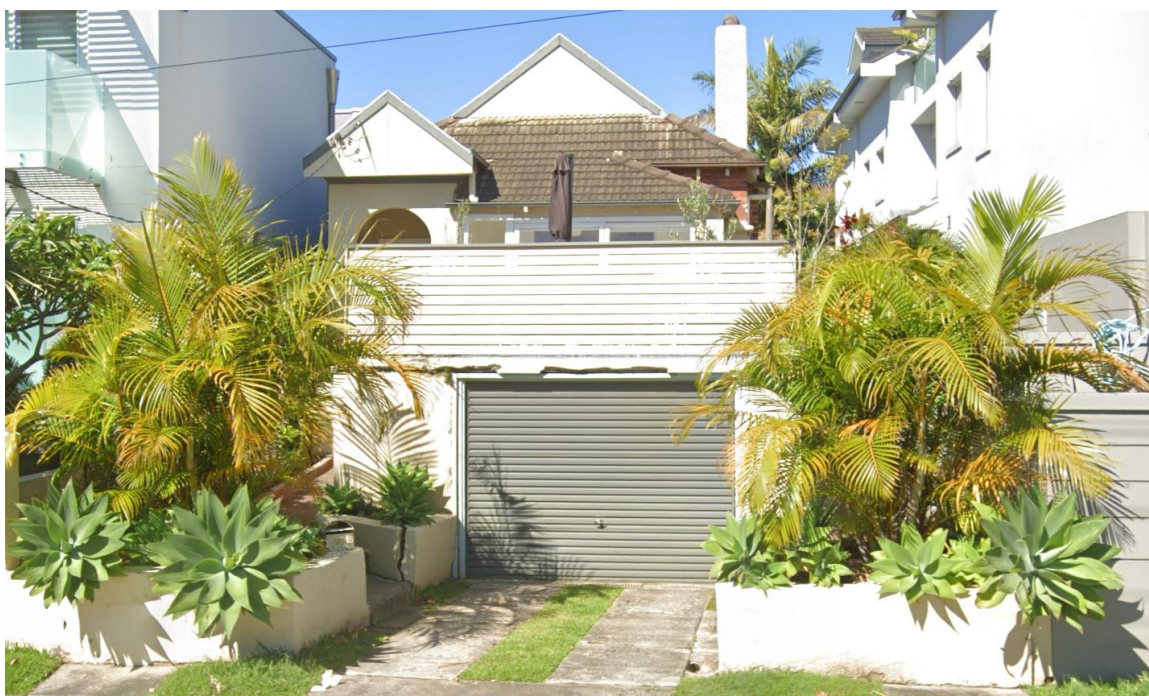
*Photograph 2: View of the front of the site, facing broadly west from Reddall Street (Retrieved from Google Street View)*

The site is situated on the south-western side of Reddall Street within gentle north-east dipping topography at mid slope level. Reddall Street is formed with a bituminous sealed pavement that is gently south dipping and is separated from the site by a concrete kerb, pedestrian pathway and a nature strip comprising grass lawns. There were no signs of excessive settlement or cracking within the roadway to indicate any large-scale slope stability concern. Photograph 2 below provides a view of the site from Reddall Street.

The site contains a single storey masonry house formed atop a sandstone block base of anticipated construction age >80 years situated broadly towards the middle of the site. A rendered garage situated at roadway level is attached to the front of the house accessed via a concrete strip driveway between supported garden beds. A concrete pathway provides access to the house along the southern side of the garage and a concrete and bitumen pathway provides access to the site rear along the northern side of the garage/house. The remainder of the front contains retained garden beds of  $\leq 0.50\text{m}$  height supporting vegetation.

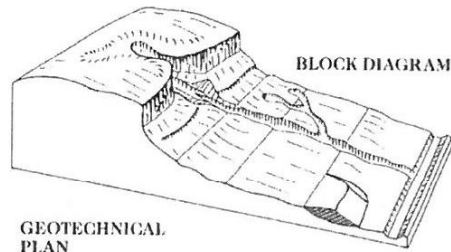
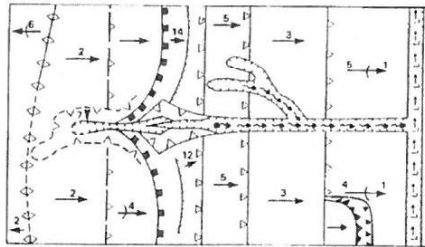
GEOTECHNICAL  
PLAN

SYMBOL	GROUND PROFILE	
		Convex
		Concave
		Convex
		Concave
	Breaks of slope	} Convex and concave too close together to allow the use of separate symbols
	Changes of slope	
	Sharp	} Ridge crest
	Rounded	
	Cliff or escarpment or sharp break 40° or more (estimated height in metres)	
	Uniform slope	} Slope direction and angle (Degrees)
	Concave slope	
	Convex slope	
	Top	} Cut or fill slope, arrows pointing down slope
	Bottom	
	Hummocky or irregular ground	
	Open drain, unfilled	
	Open drain, lined	
	Fence line	
	Property boundary	
	Dry stone wall	
	Major joint in rock face (opening in millimetres)	
	Tension crack (opening in millimetres)

### Example of Mapping Symbols
