GEOTECHNICAL SITE ASSESSMENT REPORT

PROJECT: 16 Roscommon Crescent, Killarney Heights
CLIENT: Green Design Sydney
DATE: 19/05/21
REPORT No.: NE929

1. INTRODUCTION

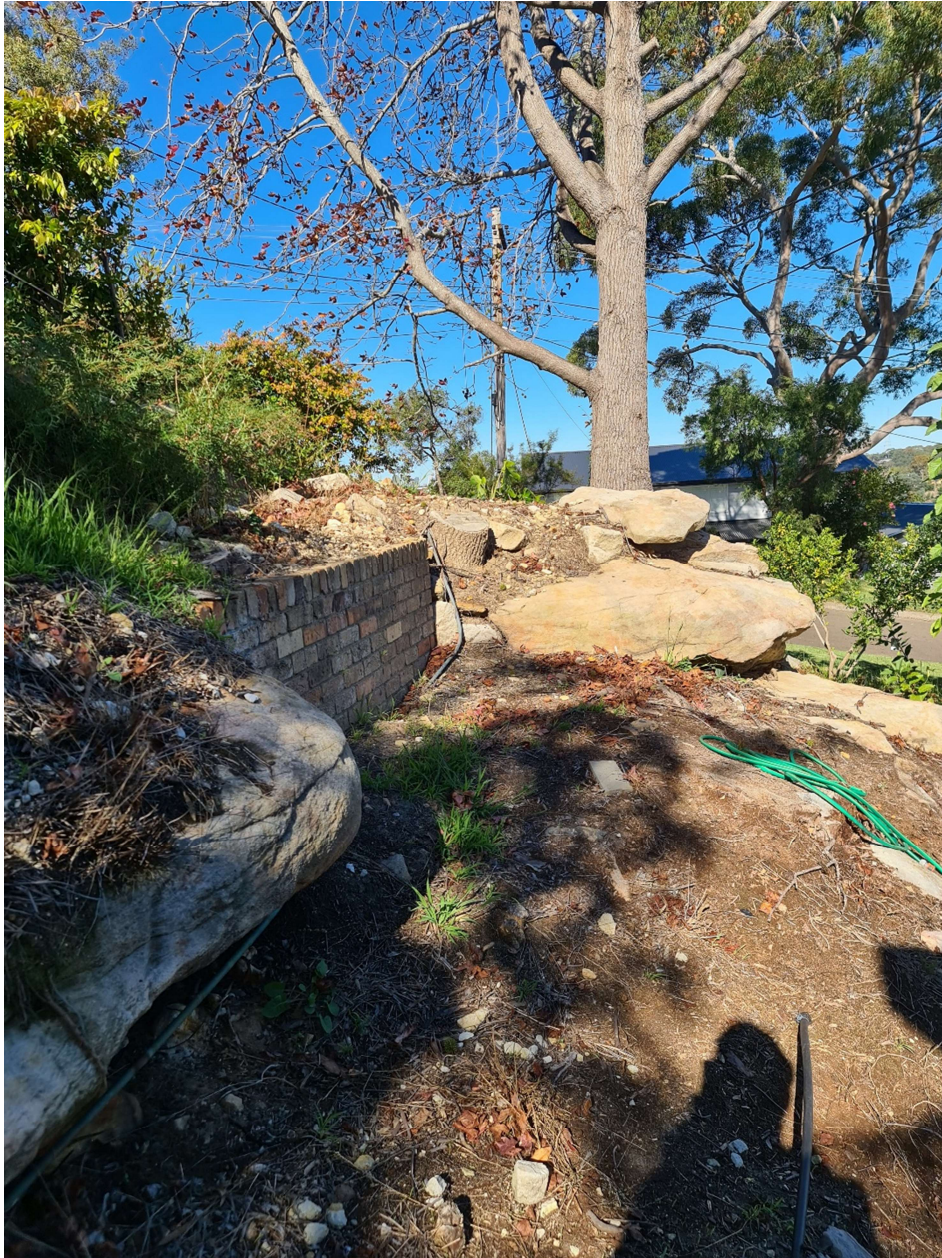
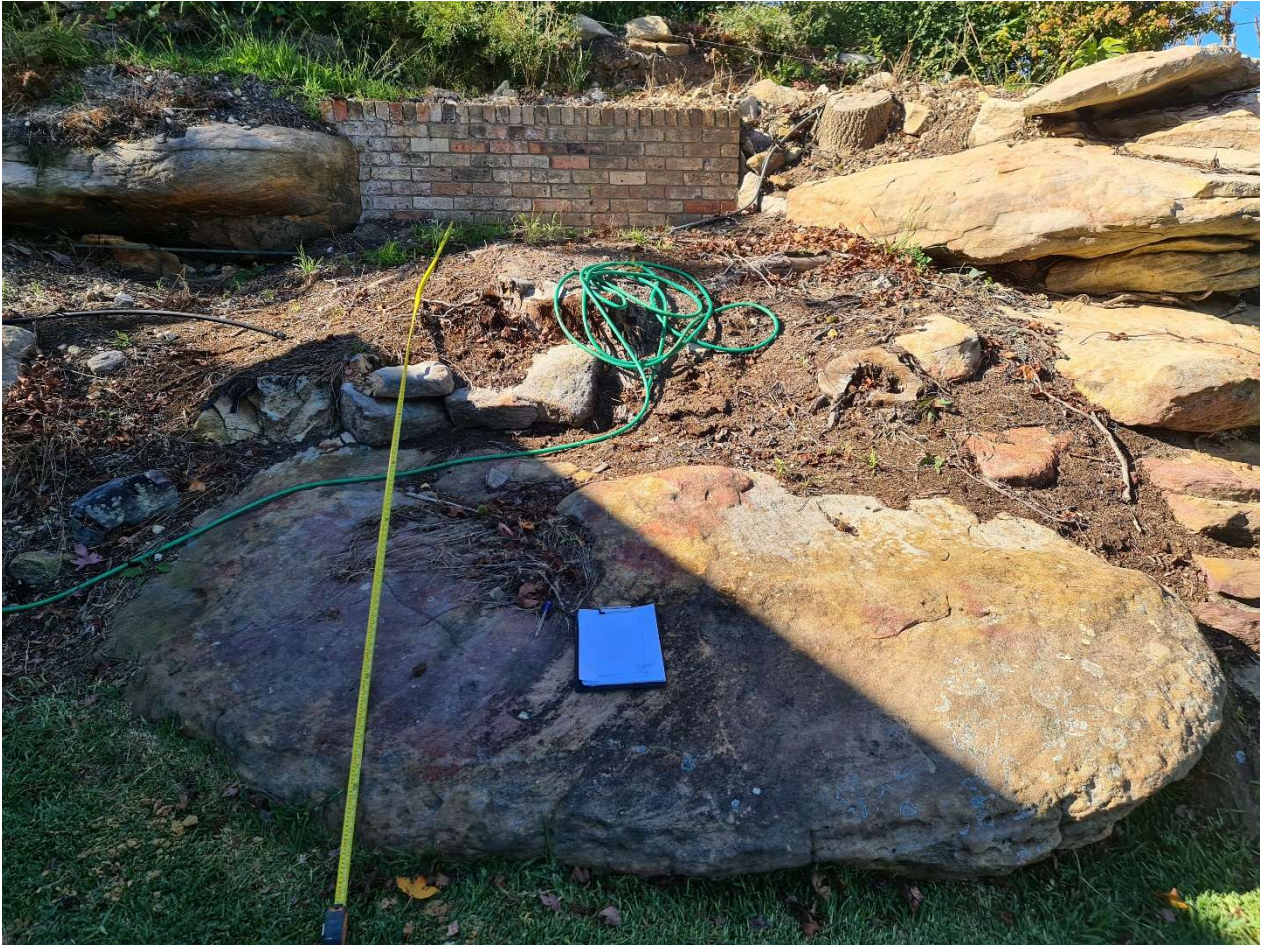
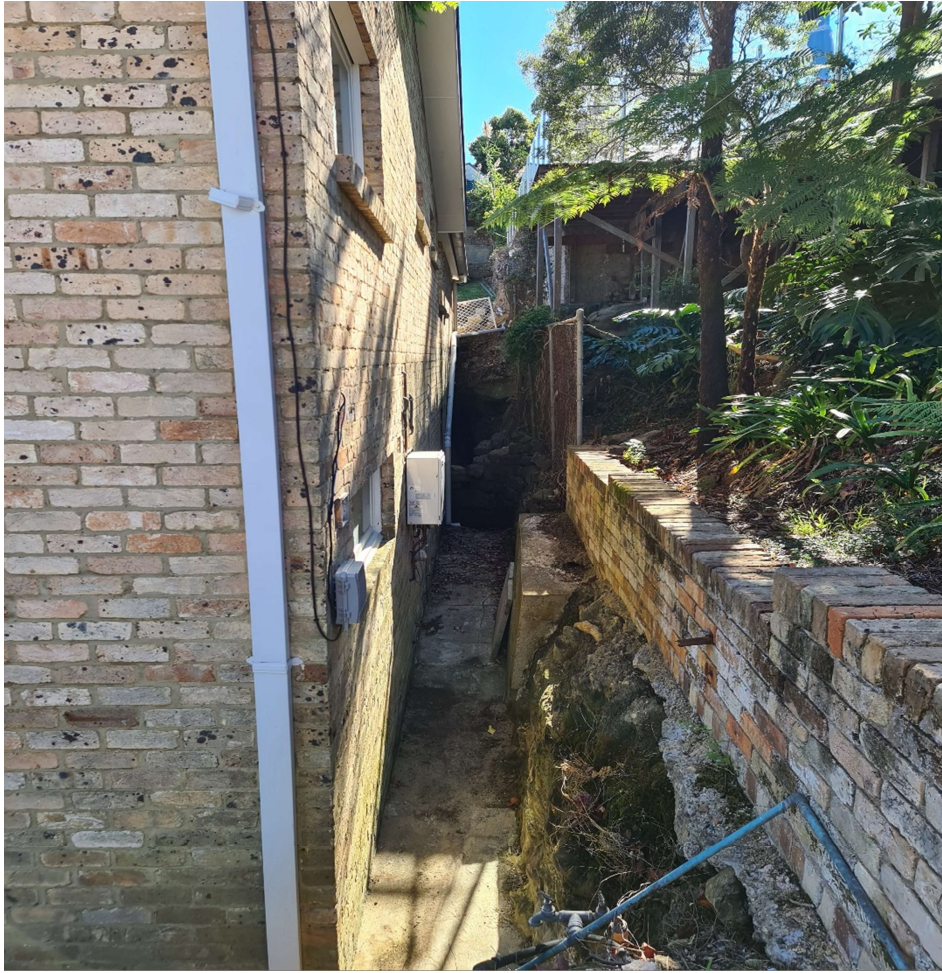
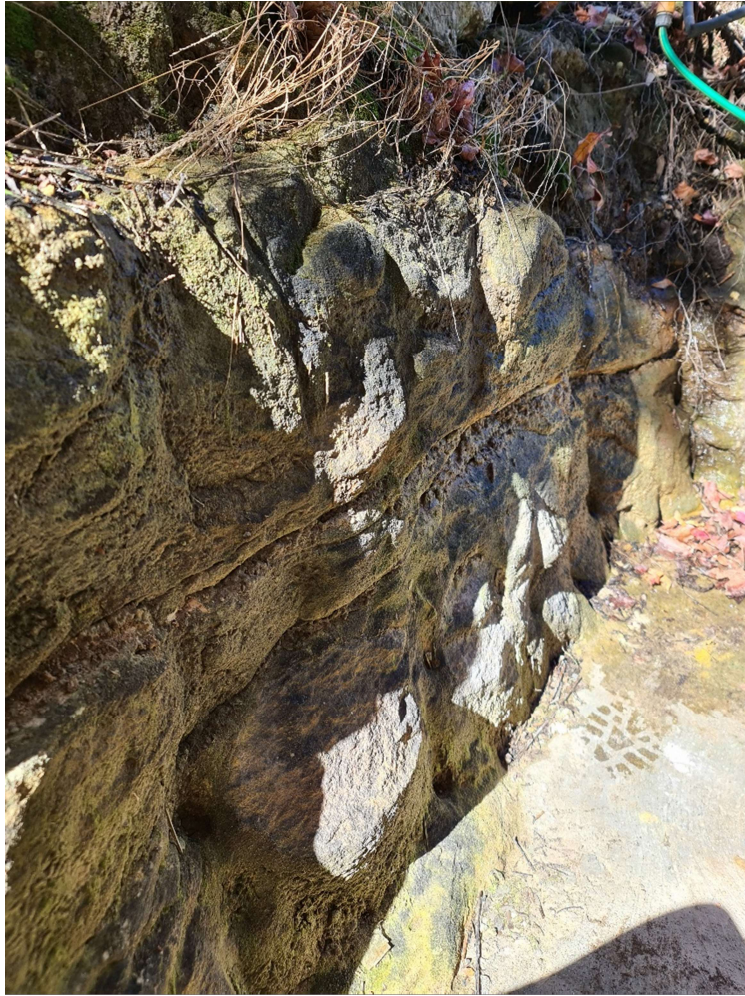
Site Photos

The site is situated at 16 Roscommon Crescent, Killarney Heights NSW 2087, on the northern side of Roscommon Crescent. At the time of investigation, the site was occupied by a double storey residential house. The site is situated at the same level with Roscommon Crescent and was sloping at an angle of approximately 5 degrees towards western direction. A small brick retaining wall of about 0.75m in height and 0.23 m in width was present at the right-hand side boundary of the property (eastern side) over sandstone outcrop at about 1.3 from the face of building wall. The site features with the borehole location is shown in Figure 1. Some detached sandstone blocks were seen on the front yard of the house which does not falls in the zone of construction of retaining wall. It should be noted that, the depth of building foundation level is about 2.0 m from base of retaining wall and founded on sandstone. A concrete block of about 2.3m in length and 0.3m in width and 2 m depth was observed below the brick retaining wall. Some Fill was found behind the brick retaining wall, with few trees. One detached sandstone was observed near the backside of the building. Sandstone outcrops were observed in the backyard. No excavation or site filling will occur in in the vicinity of the sandstone outcrops in the backyard. There is a swimming pool in the eastern property toward the end of the lot.
