RE: FINAL: 7 Crown Road Queenscliff, Aboriginal Heritage Due Diligence Assessment

Dorn Design has requested Artefact Heritage prepare an Aboriginal Heritage Due Diligence assessment in relation to the proposed development of Lot 2 DP 514296, 7 Crown Road, Queenscliff (the study area). The study area falls within the boundaries of the Northern Beaches Council Local Government Area (LGA). The Northern Beaches LGA recognises that the area is rich in Aboriginal heritage and that a precautionary approach should be taken during any proposed development.

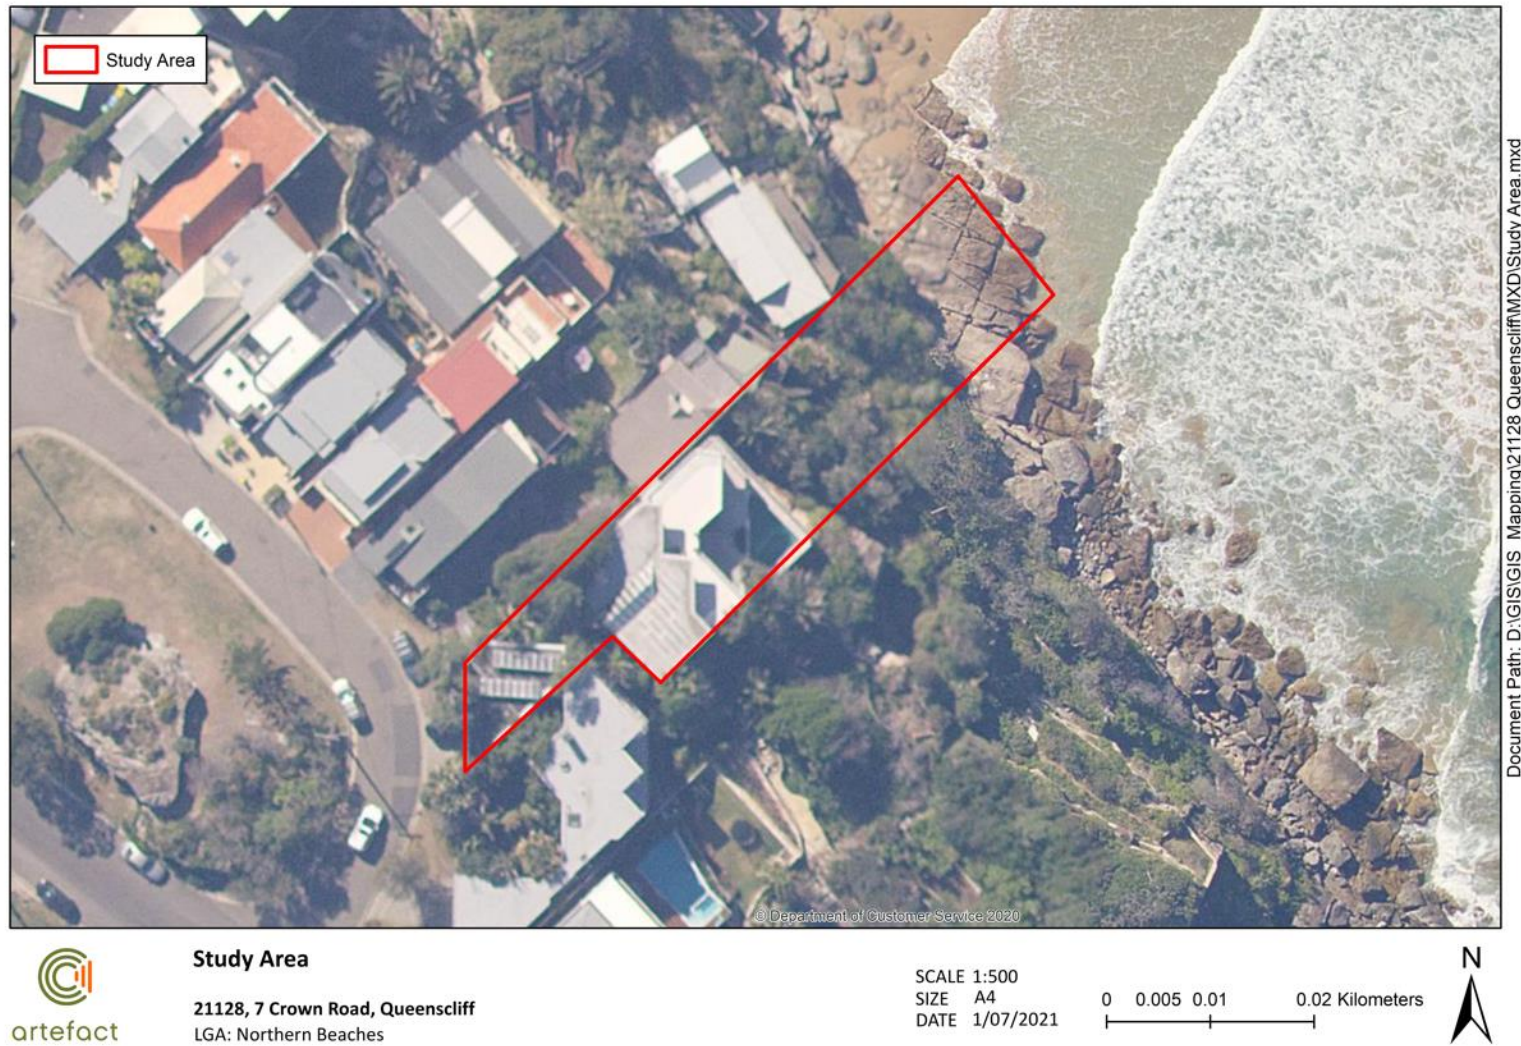
Figure 1. Study area

The study area is approximately 970 square metres and located within Lot 2 DP514296 within the Northern Beaches LGA, Parish of Manly Cove, County of Cumberland. The study area is located within the Sydney Metropolitan Local Aboriginal Land Council boundary and the Gumeraygal people are its custodians. The study area is bounded on the west and east by residential premises, by Crown Road on the south side and by Freshwater Beach to the north (Figure 1).

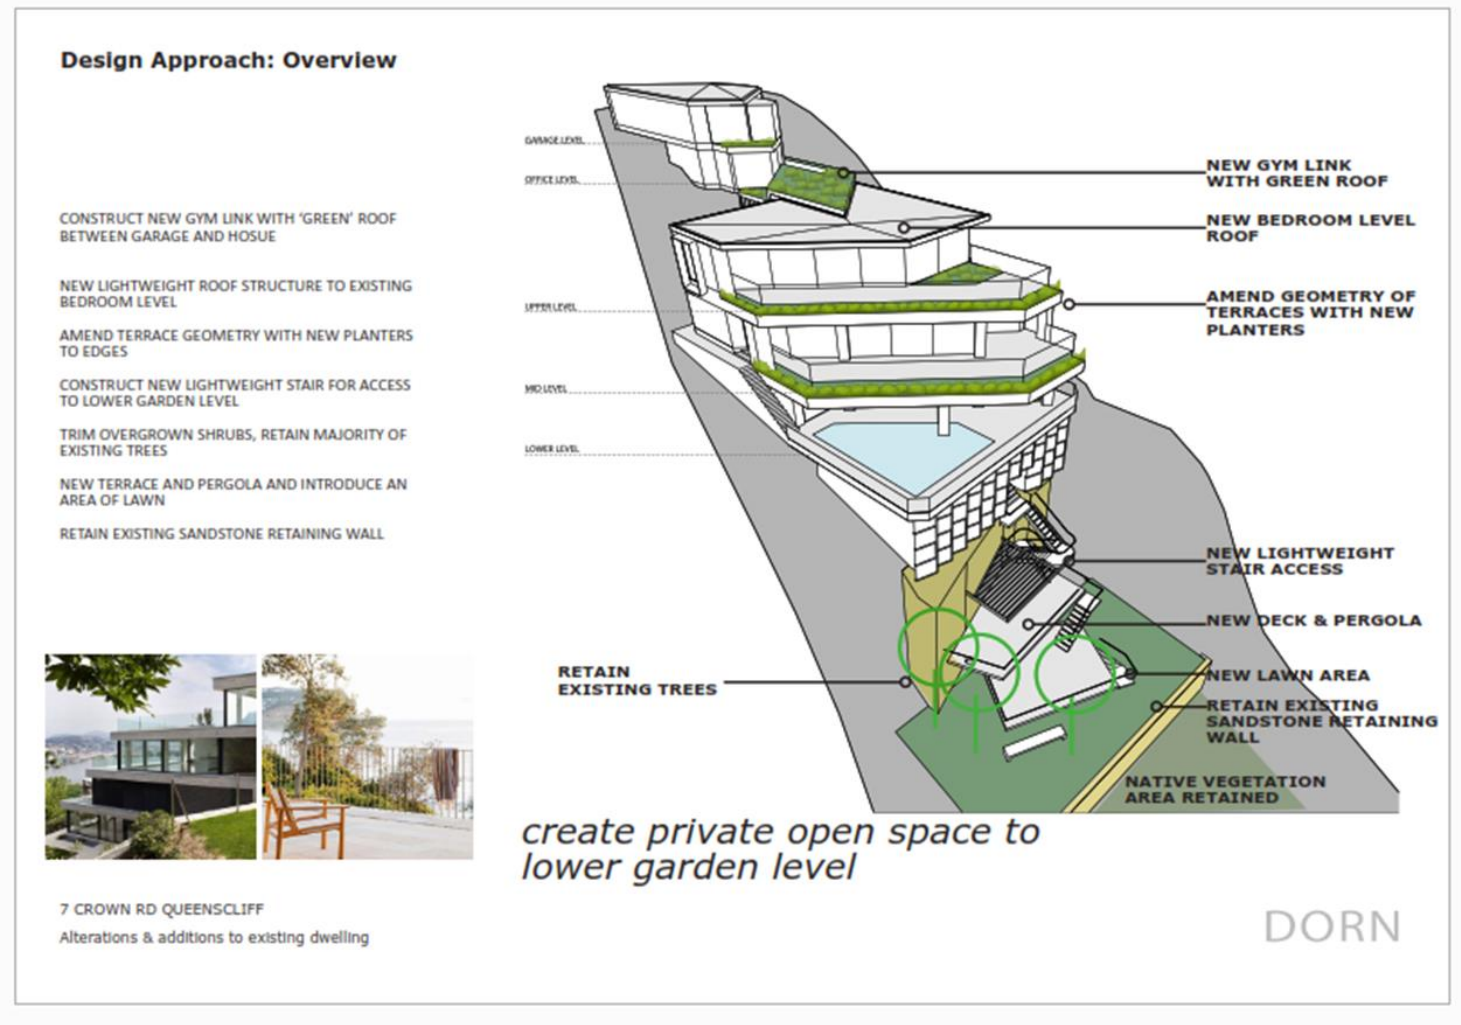
Figure 2: Proposed Developments to Premises

The proposed works are shown schematically in Figure 2, and include the following alterations to the premises:

1. New planters to the existing garage roof
2. Extension northwards of existing garage towards existing residence
3. Lifting of existing bedroom and gym ceilings by 300mm
4. New stone steps from garage to residence
5. New stone steps along eastern and western boundaries.
6. Extension of bedroom and bedroom terrace northwards
7. Extension of residence terrace northwards
8. Fitting of new windows and louvres
9. New lightweight stairs to lower garden level
10. Formation of a new pergola at the lower deck.
11. Selective removal of vegetation below the pergola level to form an open lawn.

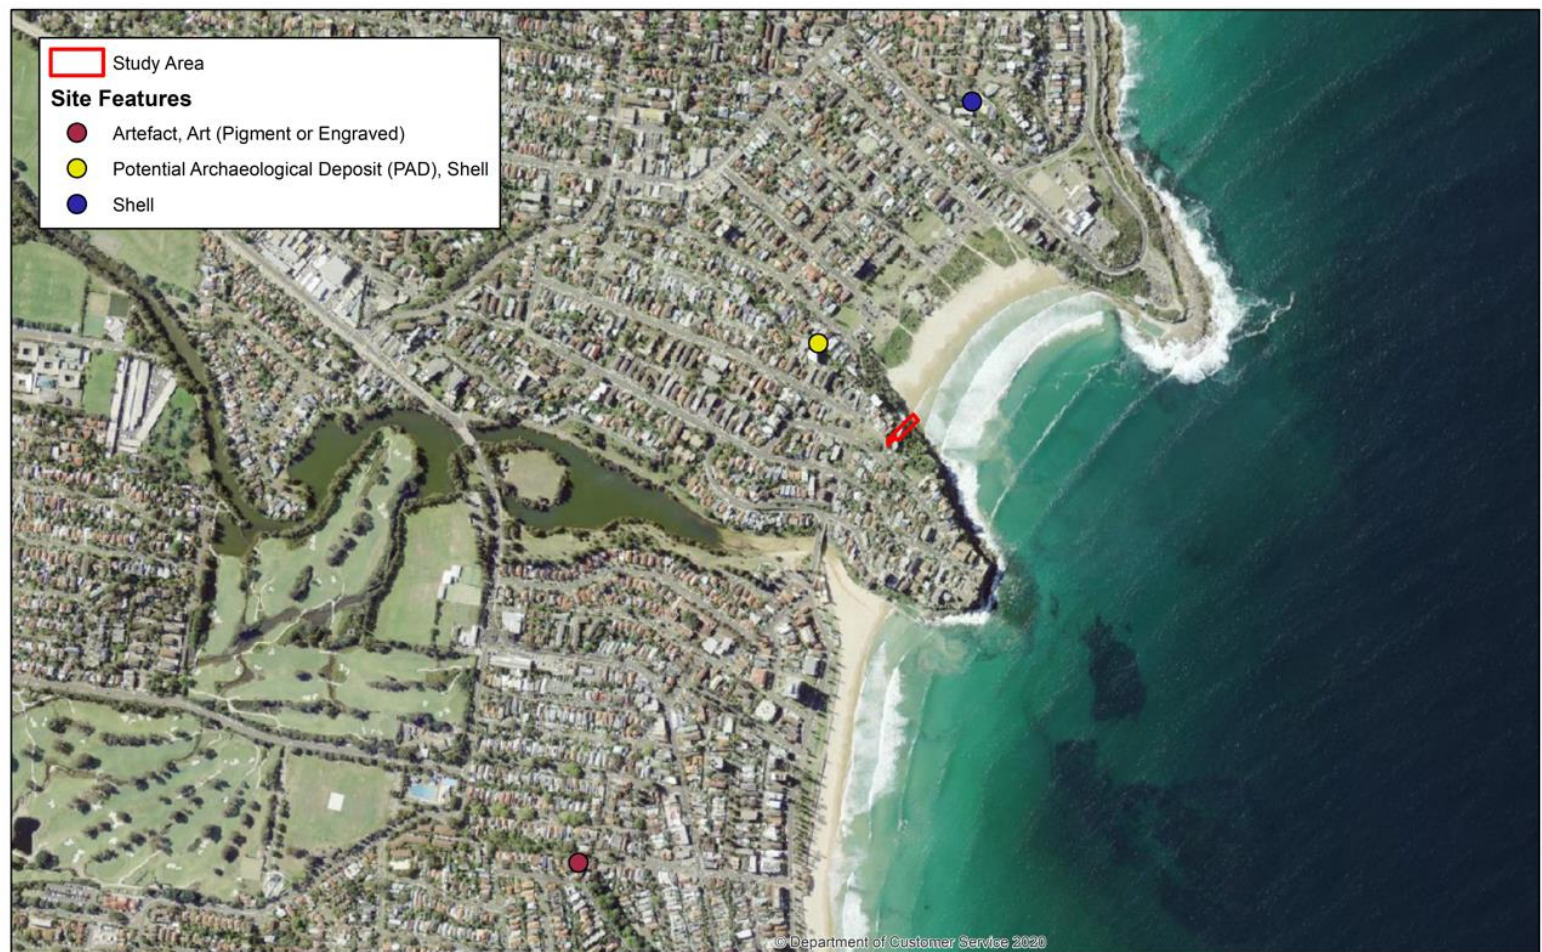
Figure 3: Extensive AHIMS search results

Of the three sites identified in the search, one was an isolated Rock Shelter with Art, one a Shelter (with associated art and archaeological deposit) and the last was a Rock Shelter - PAD. The results of the search are summarised in Table 1 and a copy of the extensive search is provided in Appendix A. The distribution of recorded sites within the AHIMS extensive search area is shown in Figure 3.

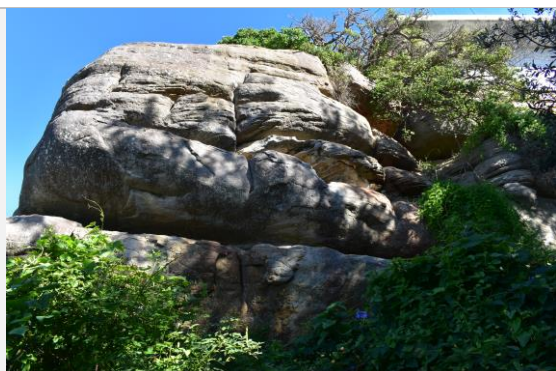
The study area measures approximately 970 metres². It is bounded by Crown Street to the south and Freshwater Bay to the north. The study area's highest point is the terraced section where the residence is located on the south. The residence is partially built over a sheer sandstone cliff face, that drops away considerably as towards Freshwater Bay in the north (Figure 4). This northern section of the study area was inspected for potential archaeological sensitivity.

Figure 4: Premises sitting on top of sandstone outcrop – top right corner (view from the south).

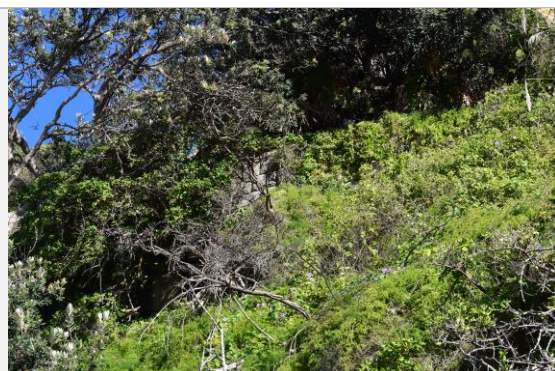
Ground surface visibility was poor due to thick vegetation growth (Figure 5). Shrubs, vines, weeds as well as leaf litter limited ground surface visibility and access to some sections of the sandstone outcrops. The house is constructed directly upon the sandstone and over time vegetation has grown unchecked around it. The northern section of the study area (abutting the sandstone) has a manufactured retaining wall, built-up to provide access to Freshwater Bay and some form of landscaping. This section appeared to contain introduced fill.

Figure 5: Vegetation growth across northern section of study area (view from the south).

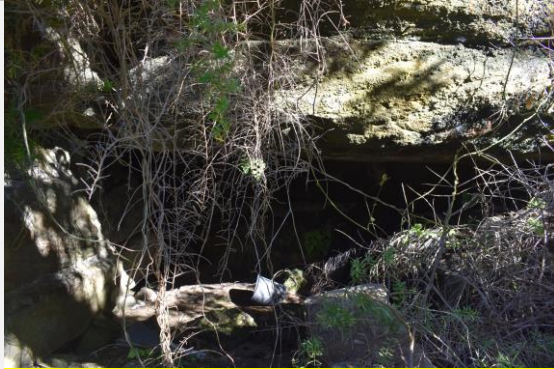
Various varieties of vegetation have been able to successfully grow within cracks/fissures of the sandstone (Figure 6). This has resulted in sections of the sandstone outcrop being obscured. Only one small section of sandstone (approximately 6m long) was clear and could be inspected (Figure 7).

Figure 6: Vegetation growth against Sandstone wall (view west).

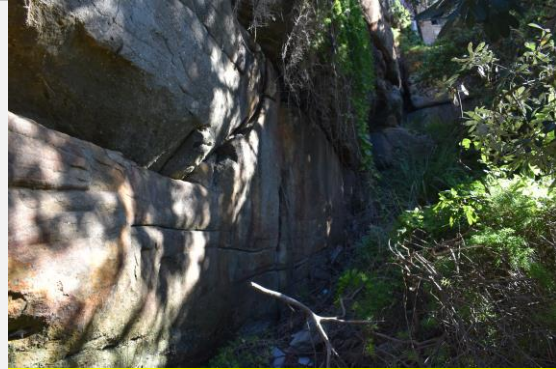
Figure 7: Inspection of sandstone wall (view west).

Inspection of the sandstone outcrops in the study area was undertaken where physically possible. The majority of the sandstone outcrops could not be inspected because the surrounding vegetation impaired visibility, or the outcrops were physically inaccessible or even too dangerous to reach. Therefore a small section of the rock face (approximately 6m) was inspected. The surfaces that could be inspected were found to be coarse and heavily encrusted with salt. This is consistent with the northerly exposure of the sandstone outcrops to the wind and water erosion.

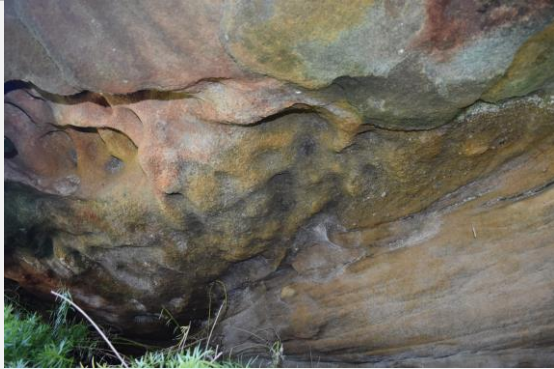
Figure 8: Inspection of sandstone wall (view south).

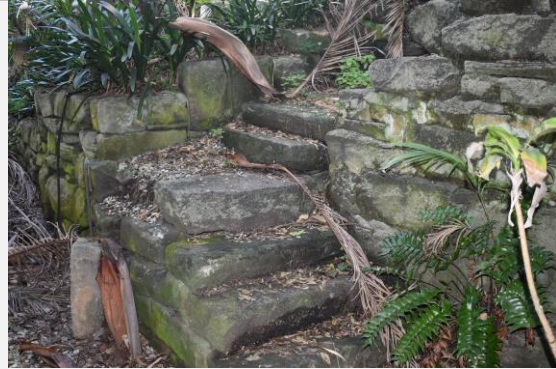
The original vegetation of the study area has been subject to disturbance through extensive clearance to accommodate the construction of the premises. Areas where sandstone had been cleared of vegetation or soil was inspected (Figure 8) within the study area (Figure 9, Figure 10). A grotto feature has been partially filled and used a landscape feature (Figure 11) further illustrating modification of the ground surface.

Figure 9: Modified sandstone steps (view west).

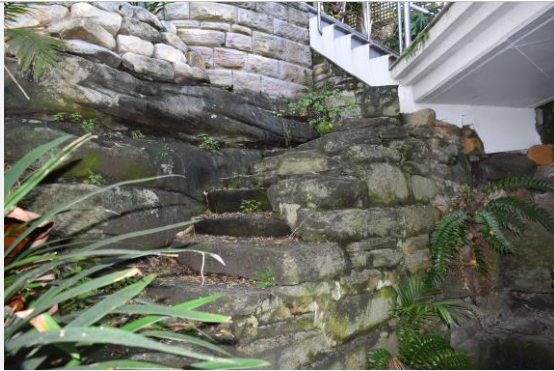
Figure 10: Sandstone steps (view south).

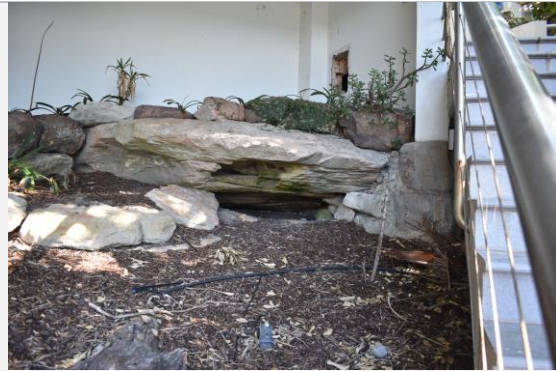
Figure 11: Modified sandstone blocks for internal garden (view south).
