**GEOTECHNICAL RISK MANAGEMENT POLICY FOR PITTWATER
FORM NO. 1 – To be submitted with Development Application**

Report Title: Geotechnical Report 117 Rickard Road, North Narrabeen

GEOTECHNICAL INVESTIGATION:

Alterations and Additions at **117 Rickard Road, North Narrabeen**

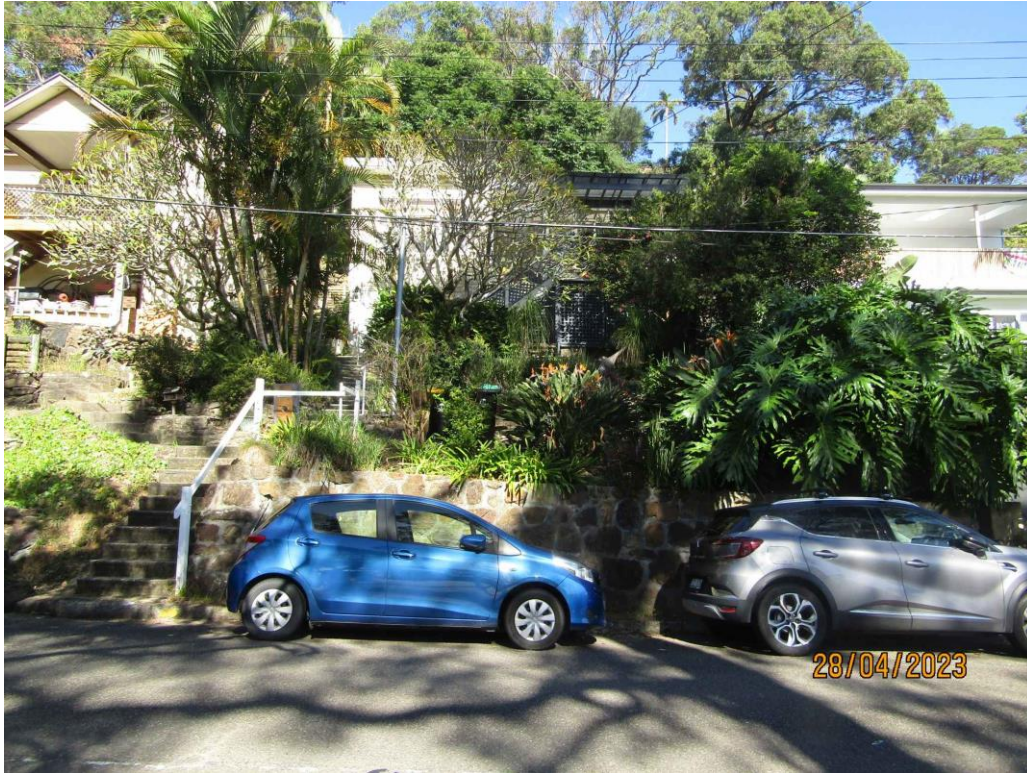
Photo 1

- 2.3** Stable sandstone flagging ~1.7m high lines a cut for the road and fill for a garden area above (Photo 1). Other low fill batters for garden areas and gravel pathways are located on the downhill side of the house. The single storey brick and timber clad house is supported on brick walls and piers (Photos 2 & 3). The supporting walls and piers stand vertical and show no significant signs of movement (Photo 4). A cut ~2.5m high provides a level platform for a paved area on the uphill side of the house. The cut is lined with sandstone flagging (Photos 5 & 6). The flagging displays minor cracking. See '**Section 16** Ongoing Maintenance'. A steeply graded garden and

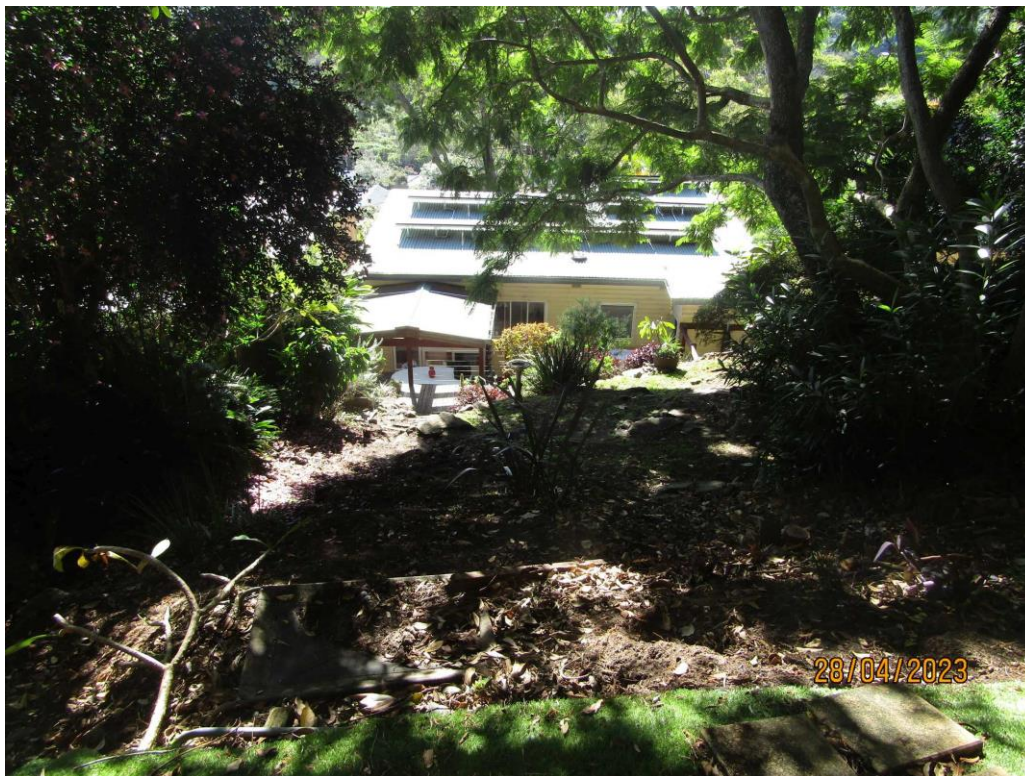
Photo 7

lawn area extends from the uphill side of the cut to the uphill property boundary (Photo 7). Detached sandstone joint blocks are scattered across the slope.

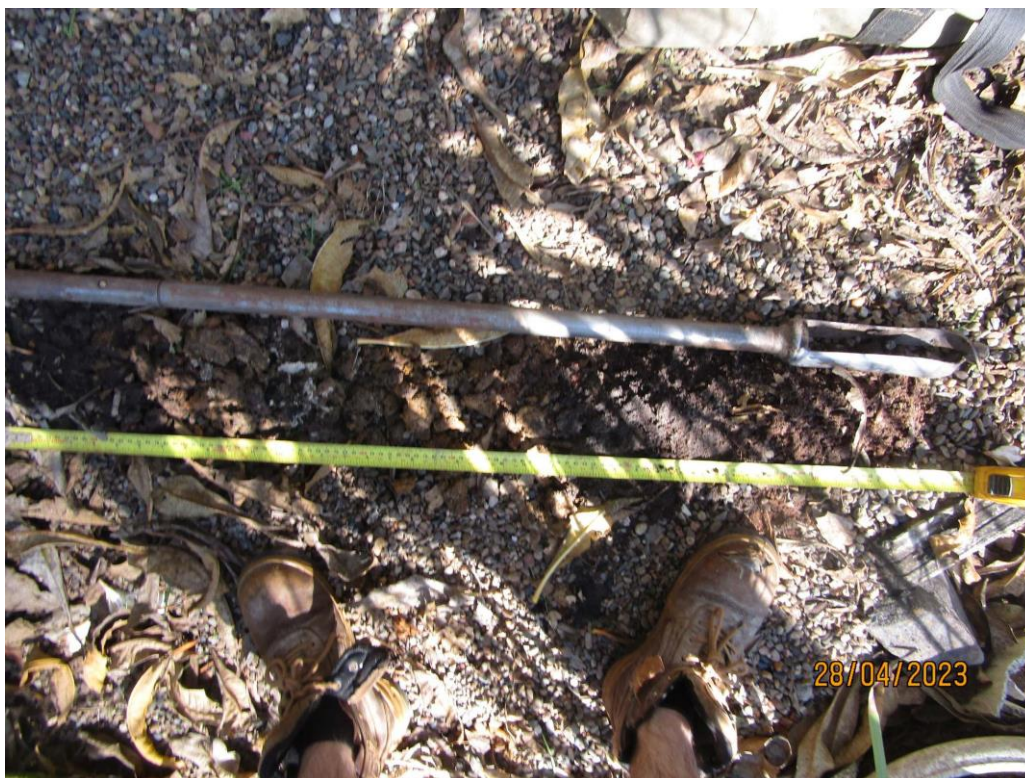
AUGER HOLE 1 (~RL25.2) – AH1 (Photo 8)

Depth (m)	Material Encountered
0.0 to 1.0	FILL , sandy soil and clay, with some rock fragments, dark brown, brown orange, moist, fine to course grained.

Refusal @ 1.0m, auger grinding on rock. No water table encountered.

Photo 8: AH1 – Downhole is from left to right.
