## **REPORT ON PRELIMINARY GEOTECHNICAL SITE INVESTIGATION**

### **PROPOSED NEW DEVELOPMENT**

**21 WHISTLER STREET, MANLY**

**Project No.: 2018-141**

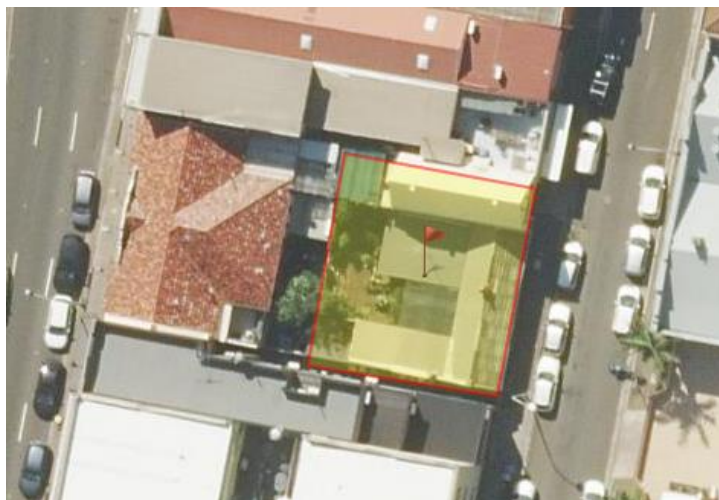
*Photograph 1: Aerial photo of site and surrounds*

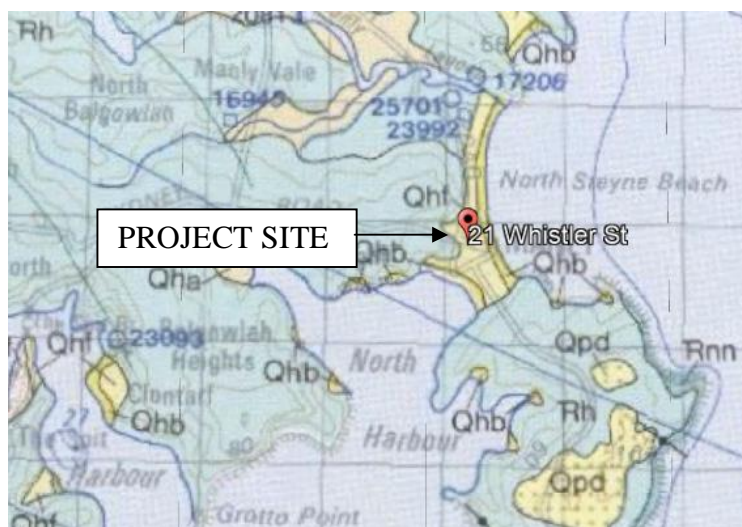
Reference to the Sydney 1: 100,000 Geological Series sheet (9130) indicates that the site is underlain by Quaternary sands (Qhf). This foredune soil is described as medium to fine grained marine sand (Qhf) and quartz sand consisting of minor shell content, interdune silt and fine sand (Qhbr). Previous experience in the local area indicates the depth to bedrock below the sands can vary significantly however it is generally >30m.

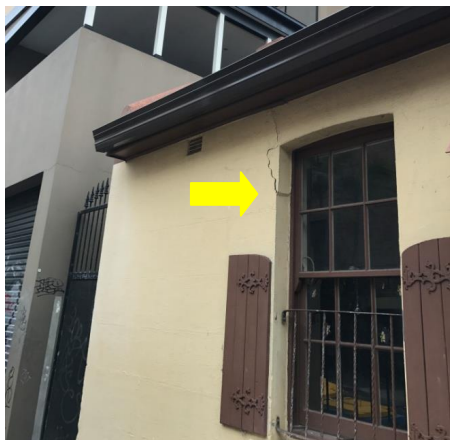
The front of the existing dwelling is positioned directly adjacent to the Whistler Street footpath. Some cracking/distress was observed in the front wall of the dwelling, as seen in Photograph 3 below.

*Photograph 3: Observed cracking within the front wall of the dwelling, looking west.*

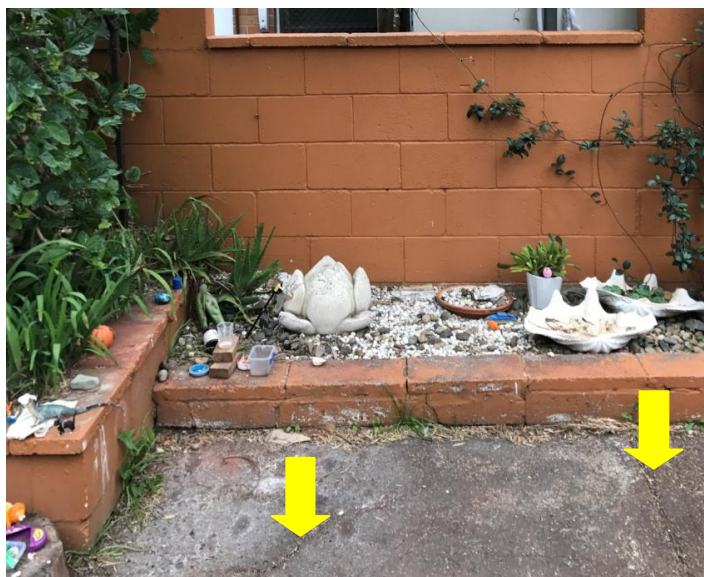
The courtyard area is separated into two sections by a small garden, with the section adjacent to the rear of the property raised approximately 0.40m above the section adjacent to the dwelling. The raised courtyard comprises a concrete/pebble surface whilst the lower courtyard is tiled. The raised concrete/pebble surface courtyard displayed some cracking and possible settling, whilst the lower tiled section did not. Photograph 4 displays some cracking present in the raised courtyard section.

*Photograph 4: Cracking in raised courtyard, looking west.*

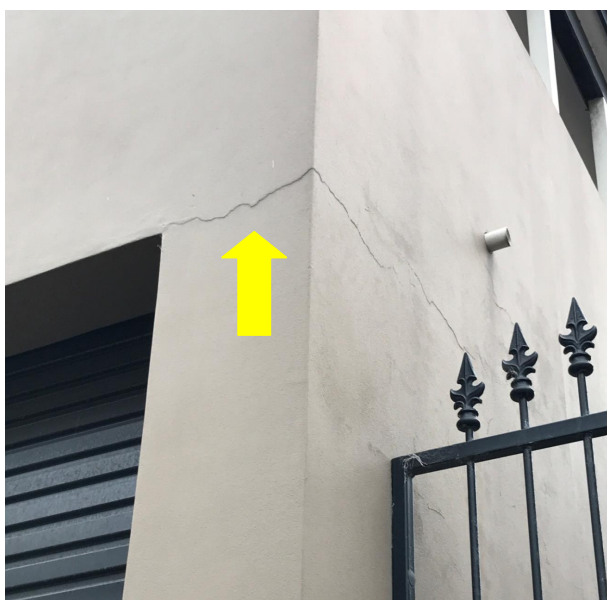
The neighbouring property to the south of the site, No. 33 Belgrave Street, comprises a three storey rendered commercial and unit building approximately 1.0m from the common boundary. The north-east corner of the building displayed some signs of cracking, as seen in Photograph 5 below. The ground surface level within this property appears similar to the site at the boundary with the remainder of the block having a similar topography to the site.

Photograph 5: *Cracking observed in adjacent property (No. 33 Belgrave Street), looking west.*
