**GEOTECHNICAL INVESTIGATION &
ACID SULFATE SOILS ASSESSMENT**

**FOR
DELVE DESIGN
9 ALLINGTON CRESCENT, ELANORA
HEIGHTS**

**REPORT GG10613A.001
27 OCTOBER 2022**

Geotechnical Investigation for proposed alterations and additions to an existing residential dwelling at 9 Allington Crescent, Elanora Heights.

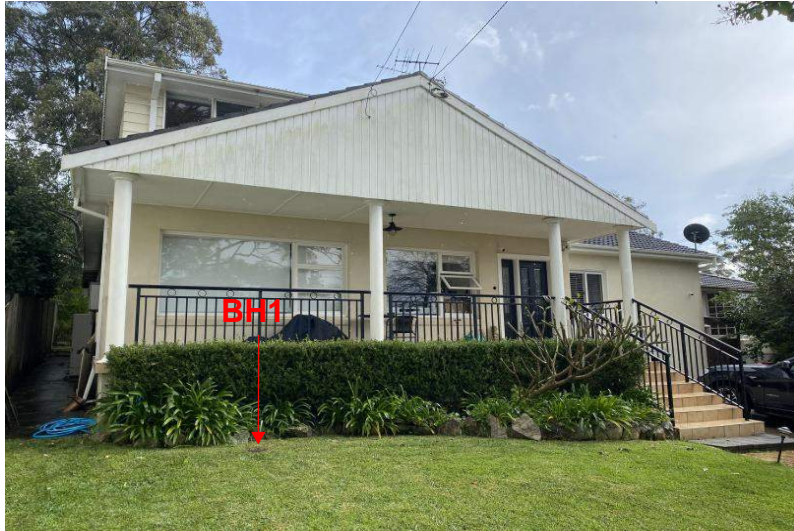
Position of BH1 in front garden area

BH1: BH1 encountered an upper layer of topsoil/fill to a depth of 0.25 metres overlying natural silty sands and clayey sands which extend to a depth of 0.9 metres. The natural sandy soils were assessed to be residual in nature and loose becoming medium dense with depth. Hand auger refusal occurred in BH1 on sandstone bedrock at a depth of 0.9 metres. The soils below a depth of 0.25 metres were assessed to be moist to wet, and water accumulated in the borehole at a depth of 0.25 metres shortly after drilling.

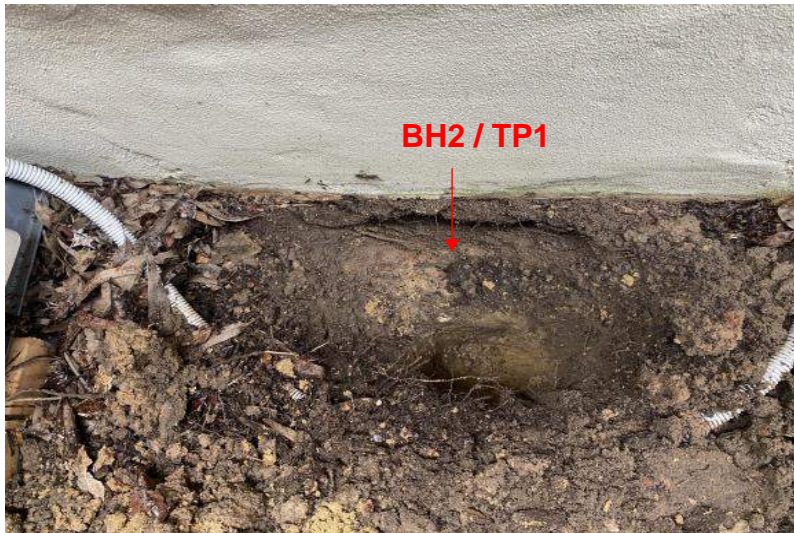
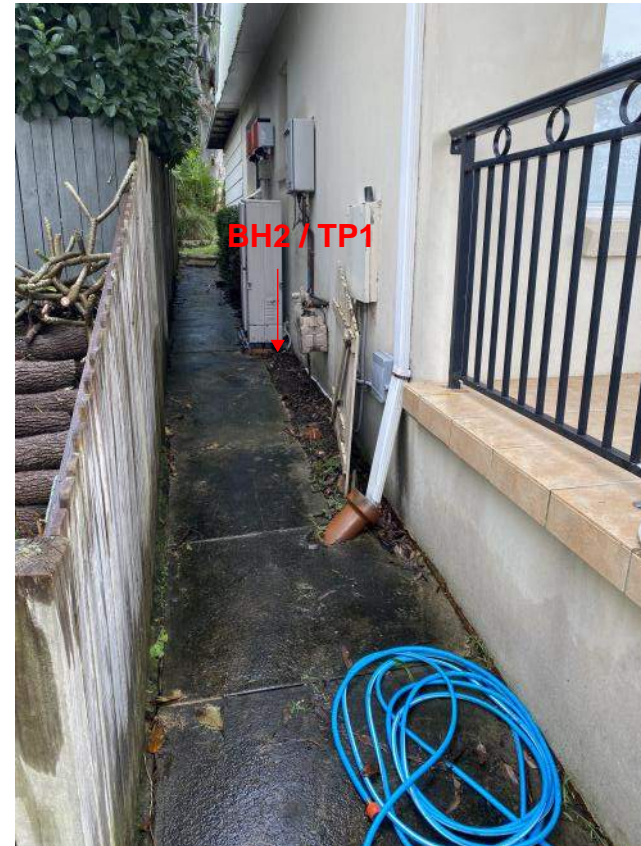
Position of BH2 / TP1

BH2/TP1: BH2 encountered an upper layer of fill to a depth of 0.25 metres overlying natural clayey silty sands which extend to a depth of 0.67 metres. The natural sandy soils were assessed to be residual in nature and loose becoming medium dense with depth. Hand auger refusal occurred in BH2/TP1 on sandstone bedrock at a depth of 0.67 metres. Some seepage was observed at the fill/natural interface during excavation.

The existing building foundations are constructed of concrete and are founded at a depth of approximately 0.53 metres on a medium dense residual clayey silty sand.

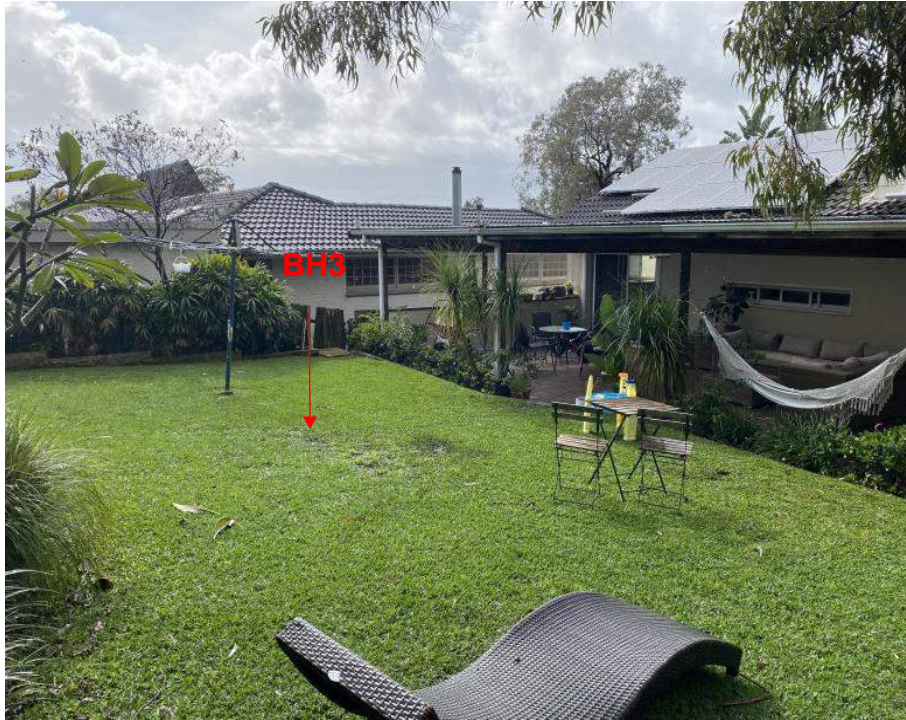
Position of BH3 in rear garden area

BH3: BH3 encountered an upper layer of topsoil/fill to a depth of 0.45 metres overlying natural silty sands which extend to a depth of 0.64 metres. The natural sandy soils were assessed to be colluvial in nature and loose to medium dense. Hand auger refusal occurred in BH3 on sandstone bedrock at a depth of 0.64 metres. The upper topsoil/fill materials were assessed to be moist to wet and water accumulated in the borehole at a depth of 0.2 metres shortly after drilling.

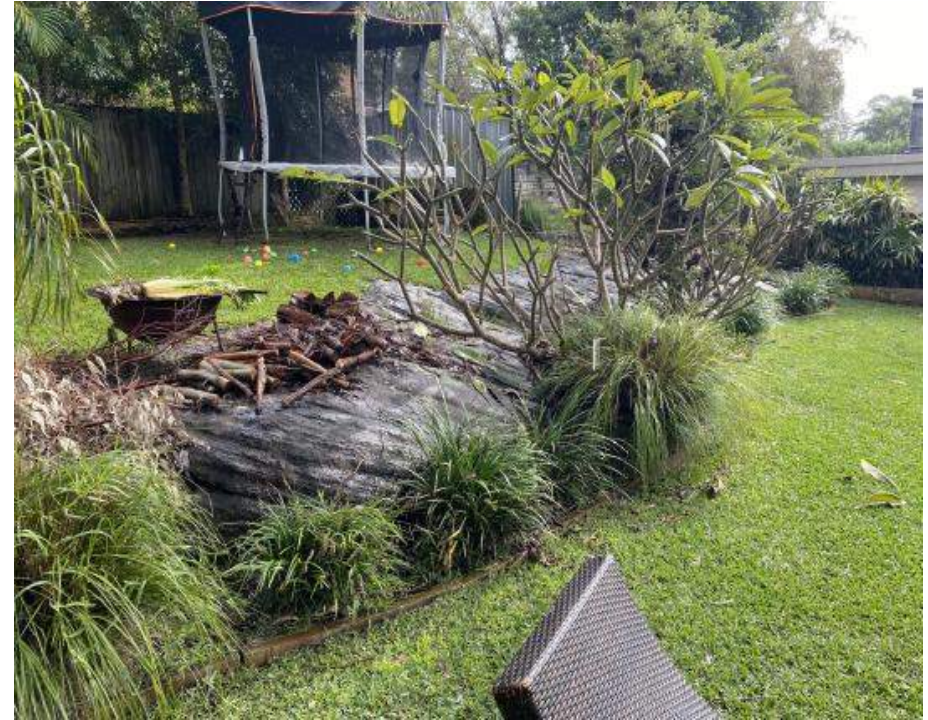
Outcropping bedrock in rear garden area

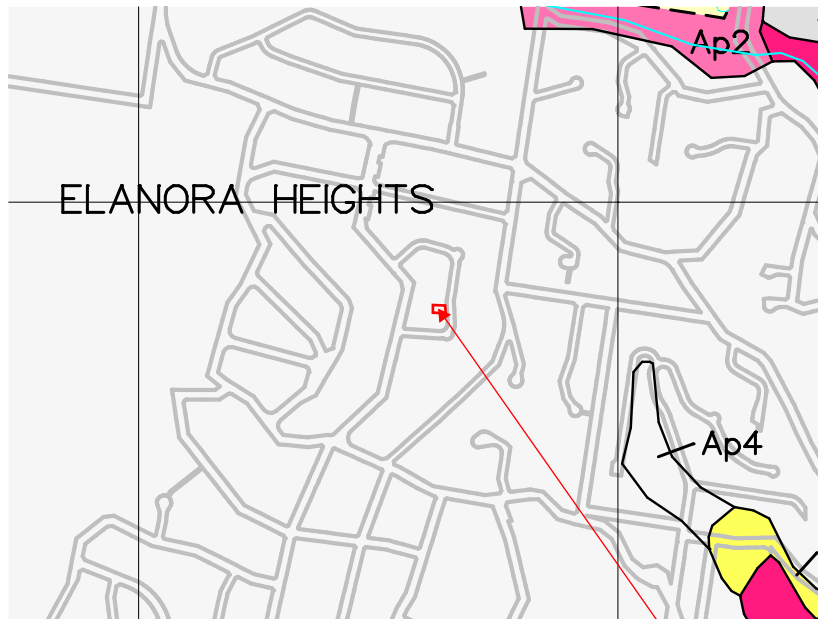
Hornsby - Mona Vale Acid Sulfate Soils Risk Map

Reference to the Hornsby – Mona Vale ASS Risk Map indicates the property is within an area where there are no known occurrences of ASS. It should however be noted that maps are a guide only.

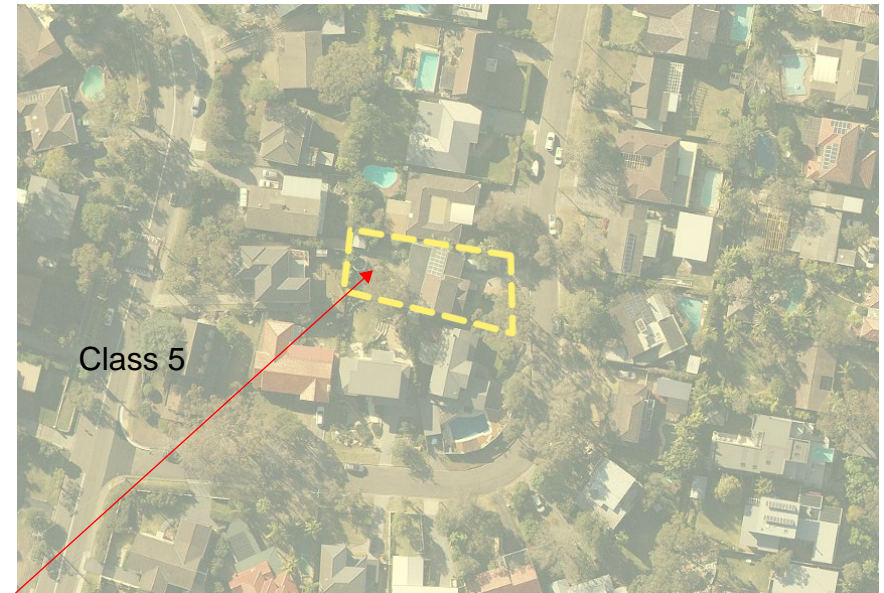
Acid Sulfate Soils Classification Mapping (Source ePlanning Spatial Viewer)

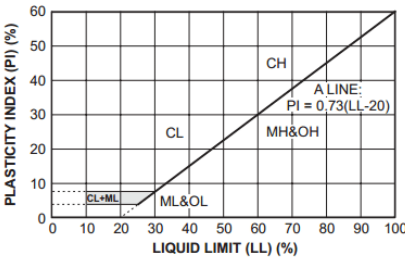
</div> <div>Plasticity Chart For laboratory classification of fine-grained soils</div>
