Proposed Parking Facility 1165 Barrenjoey Road, Palm Beach

Stage 3 Design Road Safety Audit Report

Report No: PT19058r01_V1

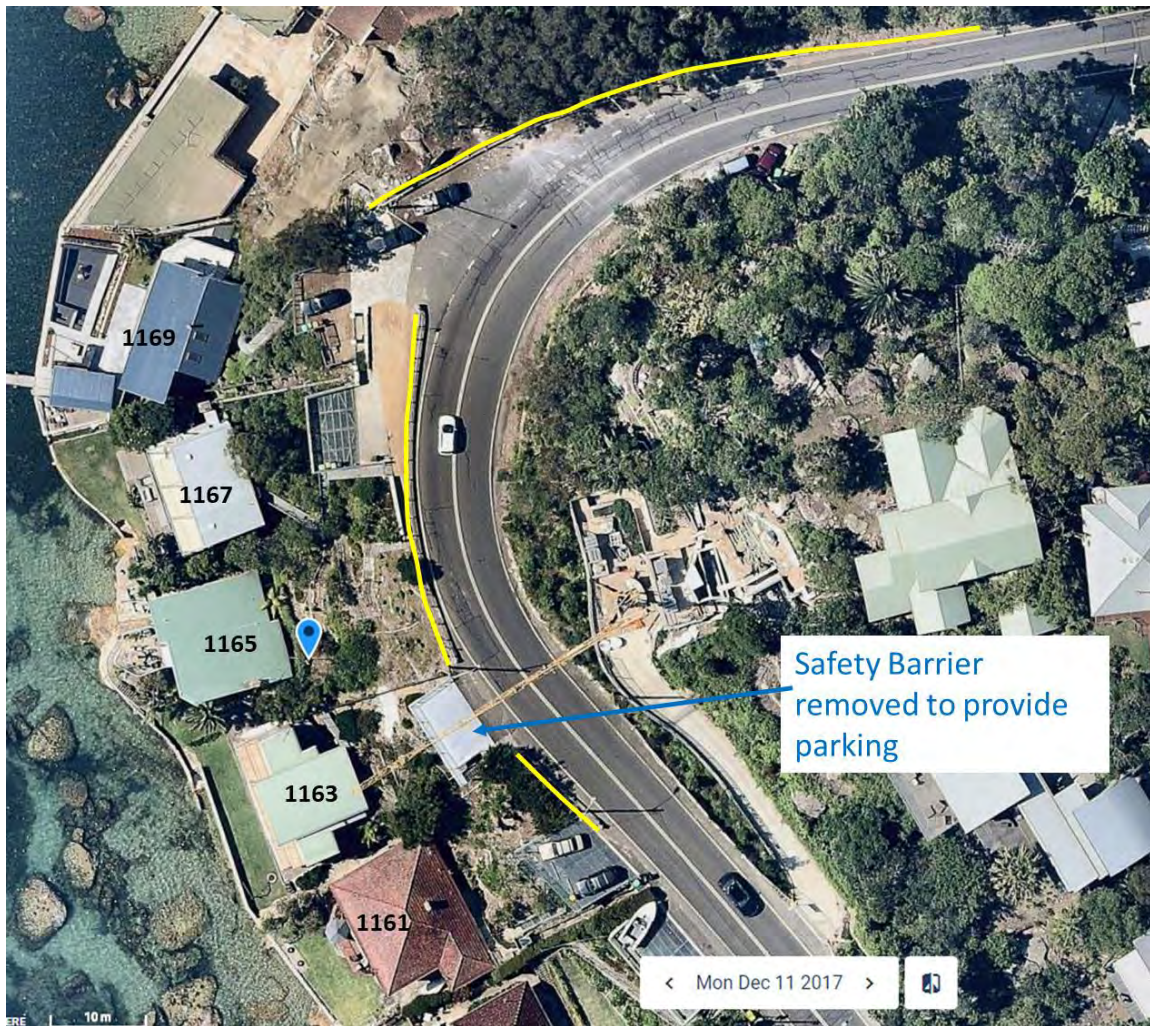
Figure 2 - Safety Barrier / Wall Locations Prior to Palm Beach Walkway Works

Of note from Figure 2 a section of barrier adjacent to No.1163 Barrenjoey Road (dwelling immediate south of the subject site) had been removed to provide an off street parking deck.

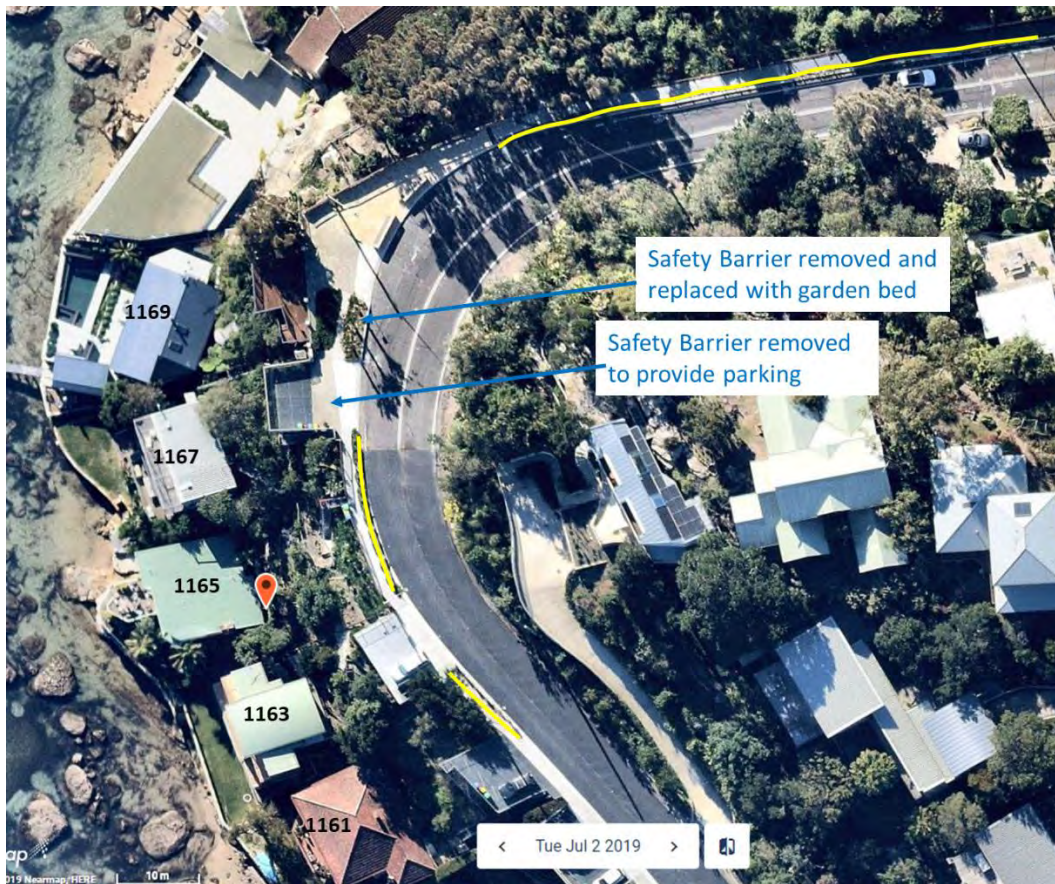
Figure 4 - Safety Barrier Locations Post to Palm Beach Walkway Works

It is noted that the Palm Beach Walkway works have resulted in the shortening of the existing barrier outside No.1167 and No.1169 to provide direct vehicular access to the respective deck parking structures. A low garden bed has been placed along the kerbline between No.1167 and No.1169 Barrenjoey Road.

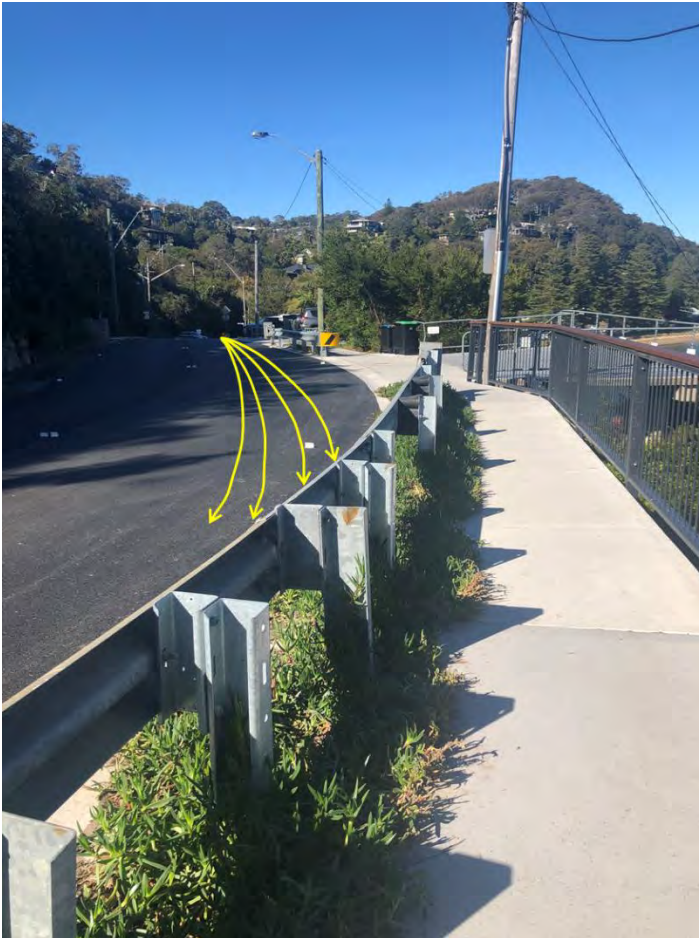
Figure 5 - Potential Path of Travel for Northbound Errand Vehicle

If note, the commencement of the existing barrier near the common boundary of No.1163 / 1165 Barrenjoey Road is somewhat out of the potential paths of vehicles on the basis that the errand vehicle is endeavouring to turn out of the impact.

It is also noted that currently in locations where no barrier is present, say the location of existing parking decks on the bend or where the barrier has been removed, there is no protection from an errand vehicle impacting on houses below.

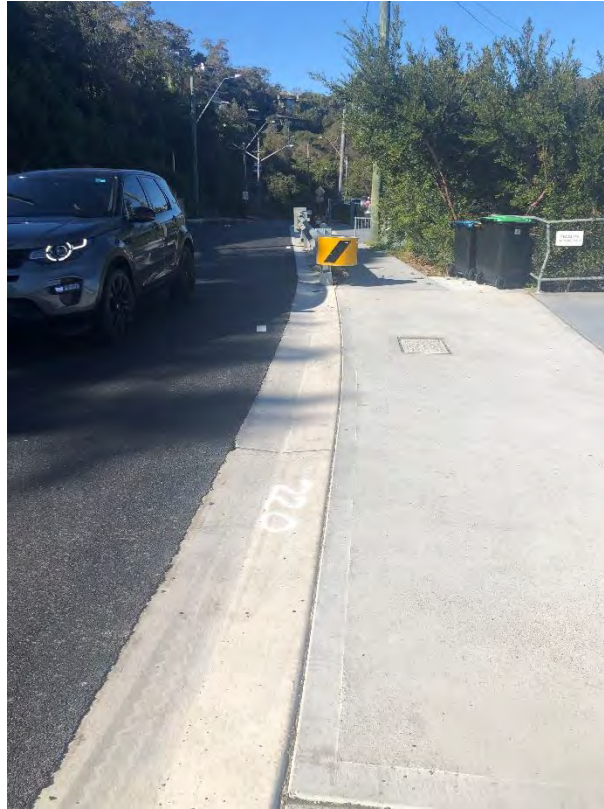
Parking Deck of No.1163 Barrenjoey Rd

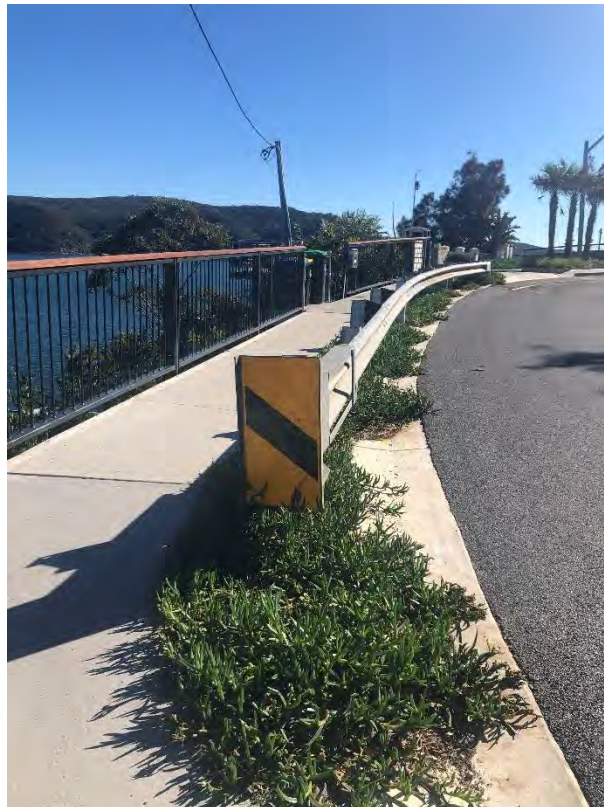
Existing Barrier Across No.1165 Barrenjoey Rd

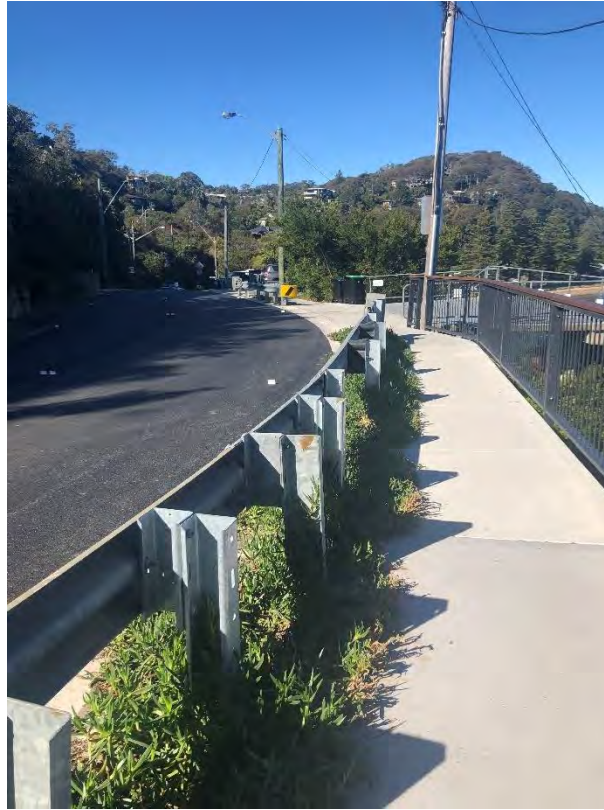
Existing Barrier Across No.1165 Barrenjoey Rd

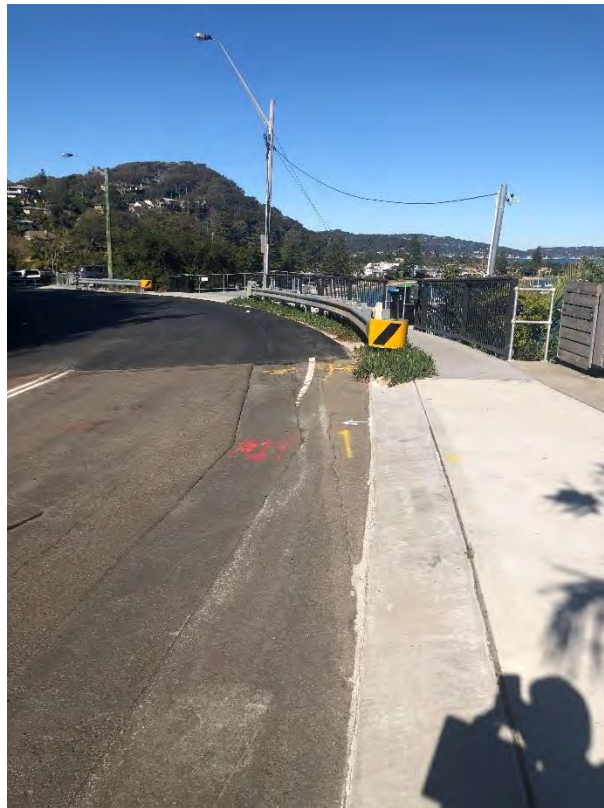
Shortened Barrier to Provide Parking Access to No.1167 Barrenjoey Road

Any reduction in length of the existing barrier adjacent to No.1165 and No.1167 should include as a condition of consent appropriate end of barrier arrangements in accordance with RMS standards.

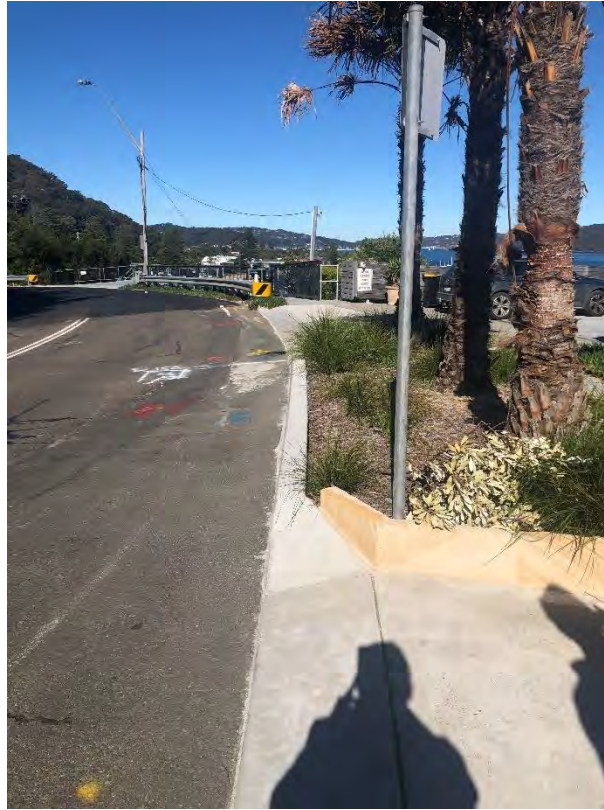
Location of new garden as replacement of previous safety barrier for reconstructed bus bay

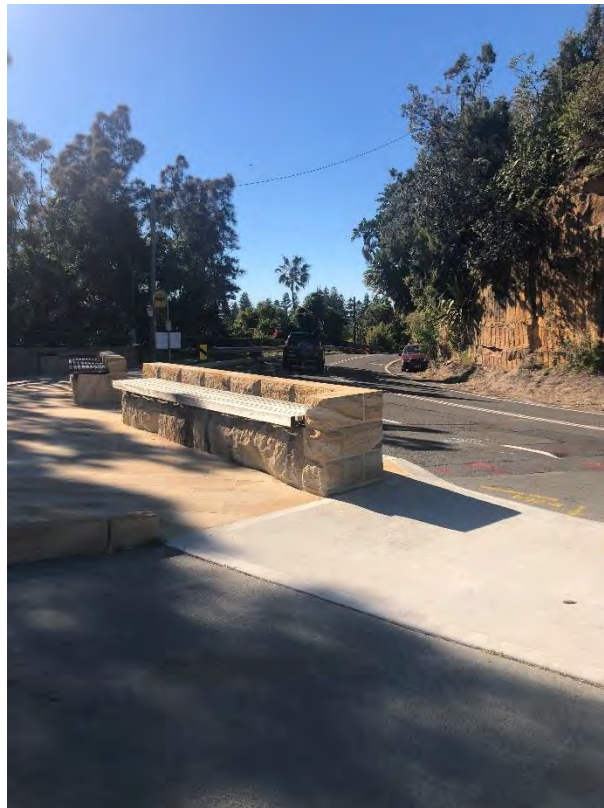
Sandstone seating of reconstructed bus bay

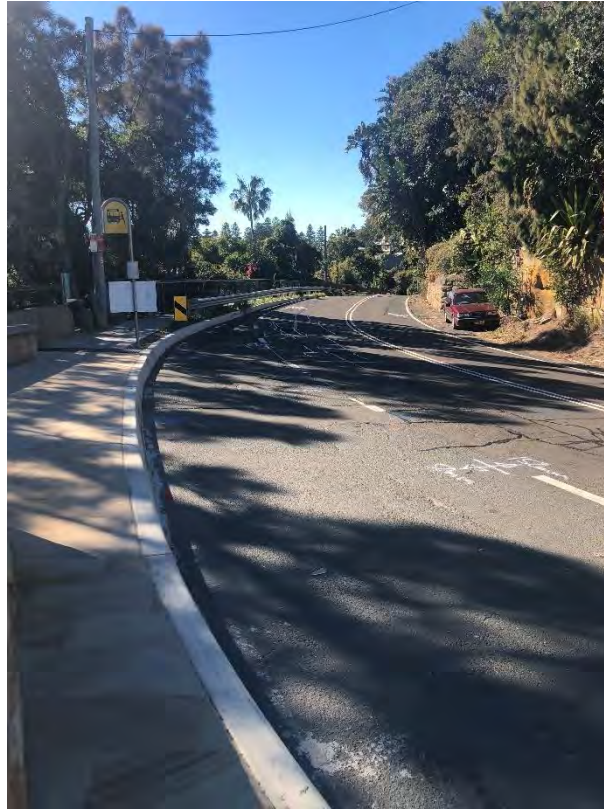
New indented bus bay

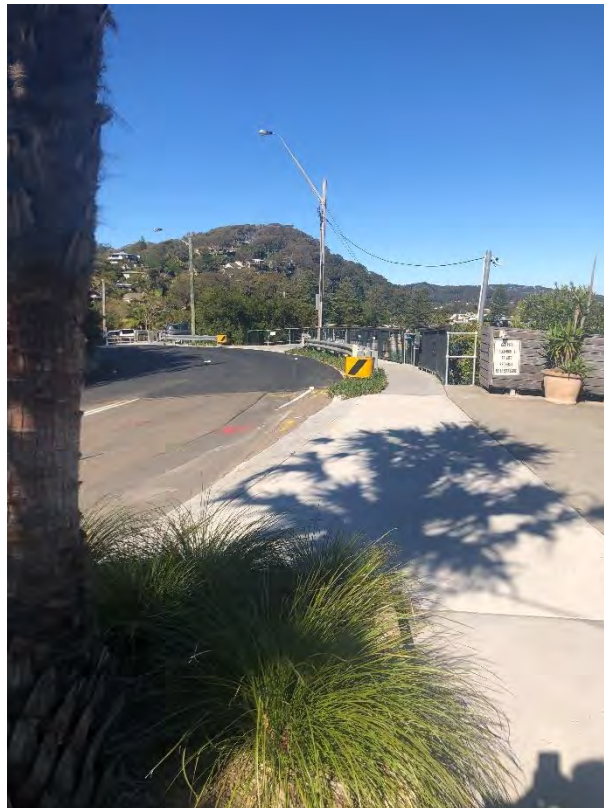
Modified barrier to provide access to No.1169 Barrenjoey Road

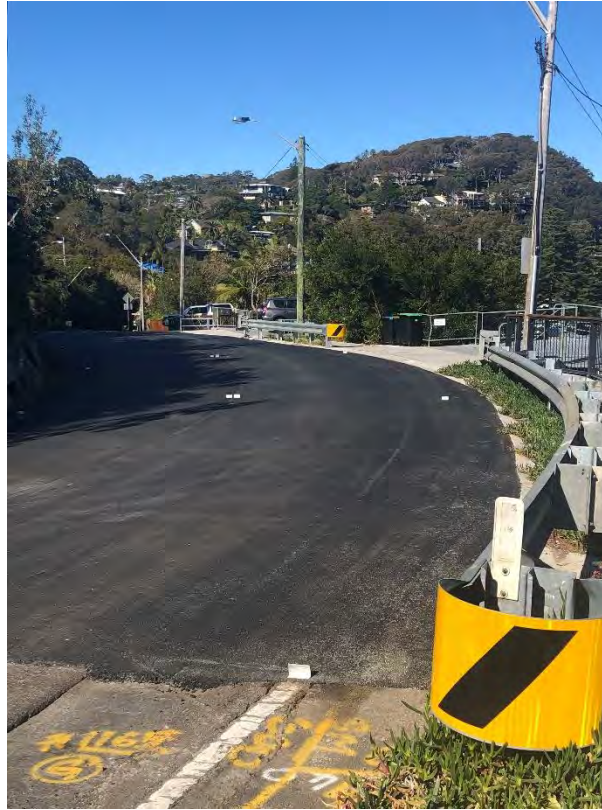
Modified barrier for driveway works to No.1163 Barrenjoey Road

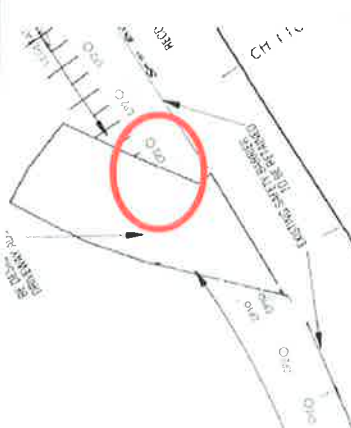
Item No.	Drawing No.	Location/Chainage	Descriptions of Findings	Drawing	Likelihood	Severity	Risk Rating	Designer Response
2	Sd1708-008: 3/11	100m	The residential driveway of 1153 Barrenjoey Road slopes steeply down from the proposed walkway. The proposed walkway will be flat across the residential driveway. Consequently, there will be a 'step' between the walkway and the driveway. The step between the driveway and the proposed walkway might be addressed by increasing the gradient of the driveway which may be hazardous for pedestrians/motorists in this section of the proposed walkway.

Improbable	Moderate	Low	<i>Driveway to be reconstructed to plan DP-05 Driveway profile low level shown</i>
3	Sd1708-008: 3/11	135m	A new kerb ramp is proposed at chainage 135m. A kerb ramp is not proposed on the opposite side of Barrenjoey Road and therefore pedestrians will not be able to cross the road safely, particularly pedestrians in wheelchairs, parents with prams and elderly pedestrians.

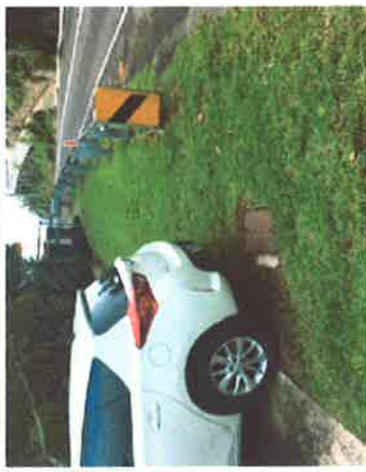
Improbable	Moderate	Low	NIL
5	Sd1708-008: 8/11	155m	The proposed driveway will reduce the length of an existing residential carport. Consequently, vehicles parked in the carport will extend across the proposed walkway which will restrict visibility along the walkway and the effective width of the walkway.

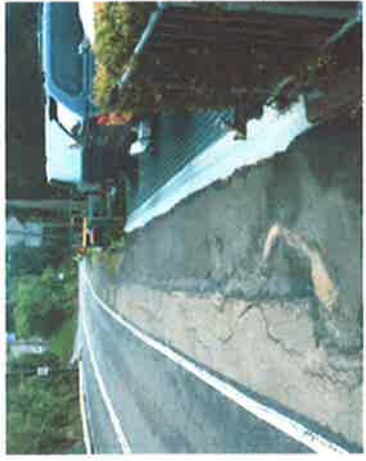
Improbable	Moderate	Low	? small car ok. parallel only.
6	Sd1708-008: 8/11	200m	Residents currently park 'front to kerb' in carports along Barrenjoey Road. Residents will have poor visibility when reversing from the carport across the walkway which may lead to pedestrian/vehicle conflict. Consideration shall be given to residents parking 'rear to kerb' to ensure motorists have adequate visibility of pedestrians on the walkway when exiting the carport.

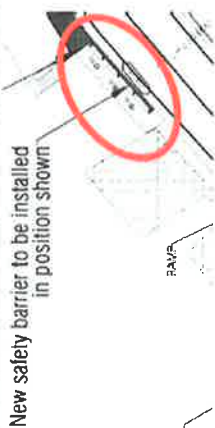
Item No.	Drawing No.	Location/Chainage	Descriptions of Findings	Drawing	Likelihood	Severity	Risk Rating	Designer Response
7	Sd1708-008: 8/11	235m	<p>The end section of this safety barrier does not flare away from the road. The end section of the safety barrier is parallel with the road and therefore will not deflect errant motorists back towards the road if they lose control of their motor vehicle.</p>

<p>New safety barrier to be installed in position shown</p>	Improbable	Moderate	Low	Barrier to be flared
8	Sd1708-008: 8/11	290m	<p>The proposed bus stand area does not appear to have been designed in accordance with the STA bus design guidelines. A bus stopped within the Bus Stand area will prohibit access to a residential property.</p> <p>As a minimum, a swept path of a standard bus entering and exiting the proposed Bus Stand should be undertaken to ensure a bus does not encroach into the northbound travel lane.</p> <p>On a side note, the continuity line marking should extend across the full length of the bus bay.</p>

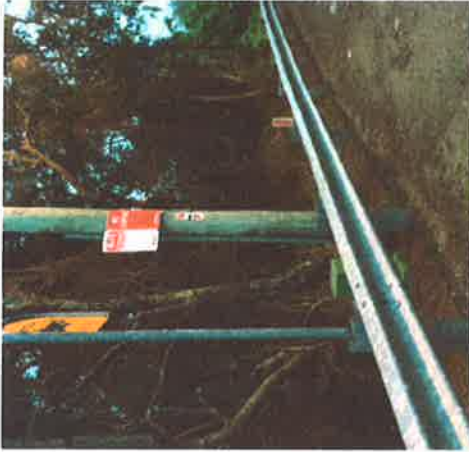
Item No.	Drawing No.	Location/Challange	Descriptions of Findings	Drawing	Ukellhood	Severity	Risk Rating	Designer Response
9	Sd1708-008: 8/11	295m	The location of an existing power pole is not shown on the plans. The power should be shown to ensure it is not an obstruction to pedestrians.

Improbable	Minor	Low	<i>Pole added to Plans</i>
10	Sd1708-008: 10/11	495m	Inadequate sight visibility is provided from this residential driveway towards the proposed walkway. Overgrown vegetation restricts visibility which may lead to conflict between vehicles and pedestrians. Consideration should be given to providing adequate pedestrian sight visibility from this driveway, and all other driveways in Barrenjoey Road, in accordance with the Australian Standards.

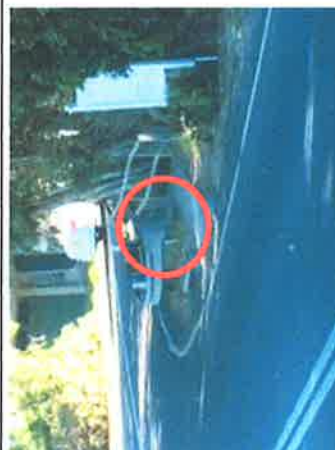
Improbable	Moderate	Low	VDM
12		Various locations	The end terminals on a number of guard rails in Barrenjoey Road do not have any delineation. A lack of delineation on the guard rail end terminal reduces the effectiveness of the guard rail which may increase the severity of an incident.

Improbable	Moderate	Low	End terminals to all have delineation

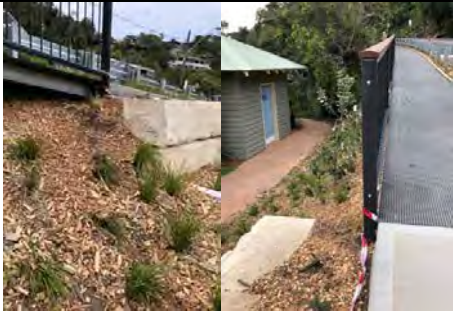
Item No.	Descriptions of Findings	Drawing	Likelihood	Severity	Risk Rating	Designer Response
3	<p>There is a pedestrian desire line from the start of the walkway which leads down to the toilets. The alternative route (i.e. through the car park) involved a diversion through the car park. The desire line is clearly used down a relatively steep embankment and if pedestrians use this shorter route, they could slip and fall.</p>

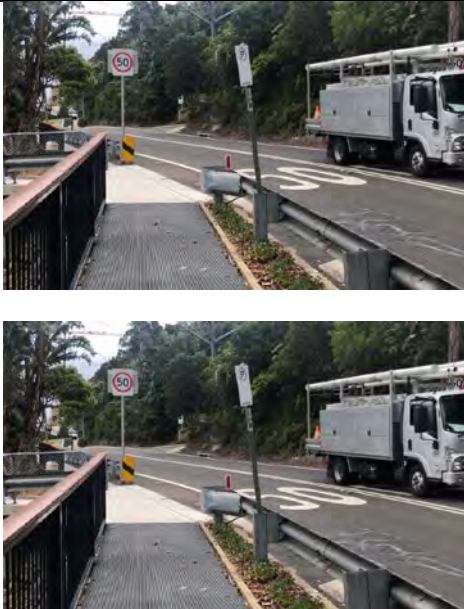
Improbable	Moderate	Low	
4	<p>No Parking signage is installed along Barrenjoey Road between the Palm Beach Water Taxi access road and Palm Beach Road. No Parking signage permits motorists to park for up to two minutes which would not be safe in this location as there is insufficient road shoulder width.</p> <p>If motorists parked within the No Parking area, following motorists would have to cross double barrier lines to overtake the parked vehicle which is illegal.</p>

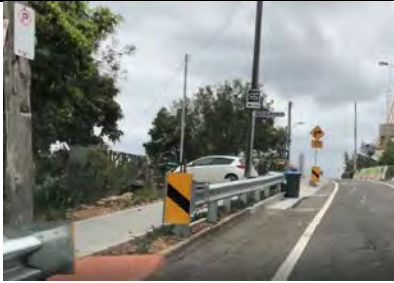
Item No.	Descriptions of Findings	Drawing	Likelihood	Severity	Risk Rating	Designer Response
	<p>Furthermore, there are no parking restrictions in some locations which may result in motorists parking within the narrow road shoulder.</p>

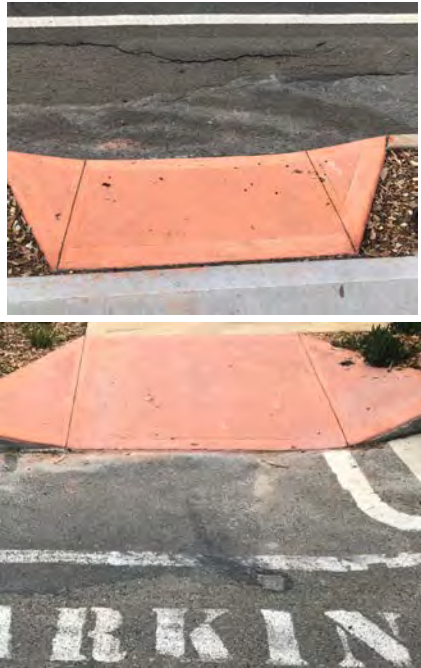
4	<p>The pedestrian access ramps do not include any pavement decals.</p> <p>Given a high proportion of path users will be tourists, consideration should be given to providing additional delineation. i.e. "Look Left".</p>

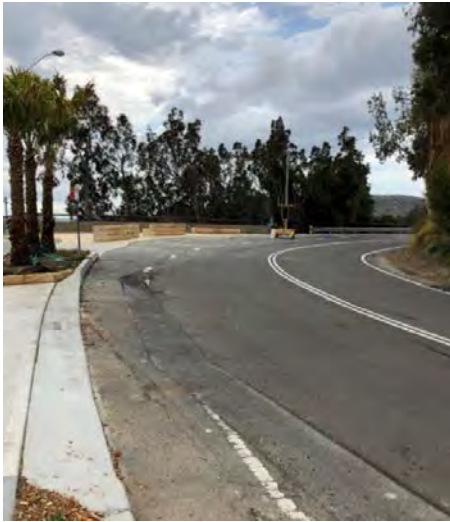
5	The lane markings and extent of the bus zone are not easily identifiable. This could result in cars entering the bus zone with potential late lane changes when they find it is a bus zone. This could result in side swipe type crashes.

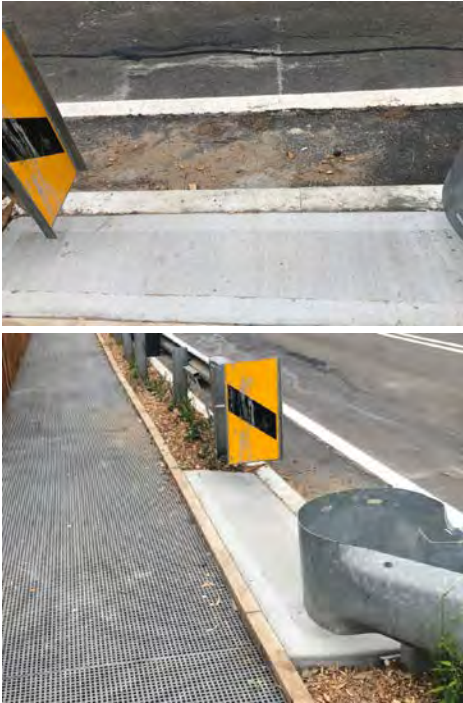
Item No.	Descriptions of Findings	Drawing	Likelihood	Severity	Risk Rating	Designer Response
6	<p>Gaps are provided between safety barriers along Barrenjoey Road to permit pedestrian access.</p> <p>However, the pedestrian footpath facilities do not provide any pedestrian access facilities for disabled persons or parents with prams.</p>

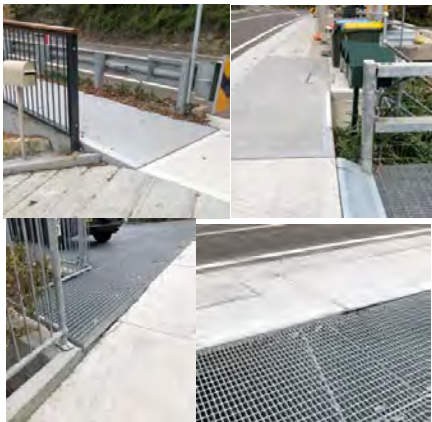
Item No.	Descriptions of Findings	Drawing	Likelihood	Severity	Risk Rating	Designer Response
9	There were a large number of trip hazards adjacent to the footpath

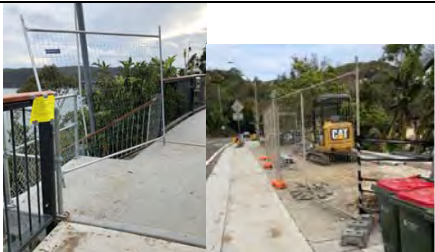
Improbable	Moderate	Low	
10	Some of the property accesses were not complete at the time of the audit.

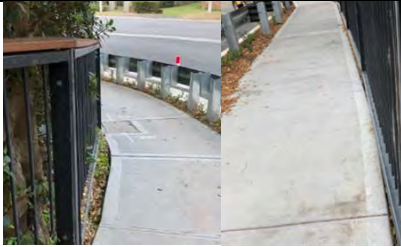
12	There were some steep falls located a short distance away from the footpath. This could result in pedestrians falling down the bank as there is no fence to prevent this from happening.

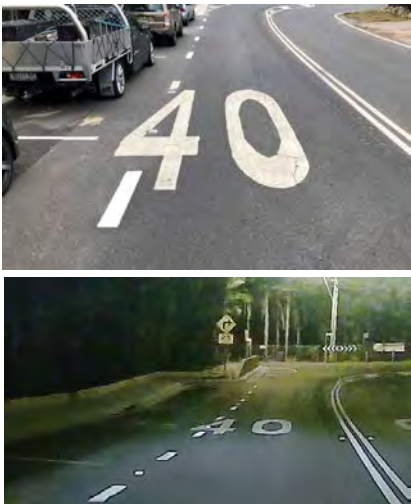
Item No.	Descriptions of Findings	Drawing	Likelihood	Severity	Risk Rating	Designer Response
13	The 40m /h road marking may be covered when a large vehicle parks within the parking space.

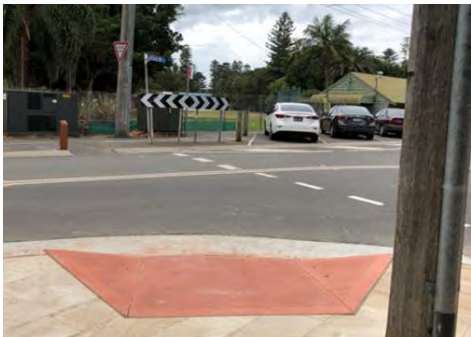
Improbable	Moderate	Low	
14	The alignment of the drop kerb crossing was such that it does not match up with the break in the kerb on the other side.

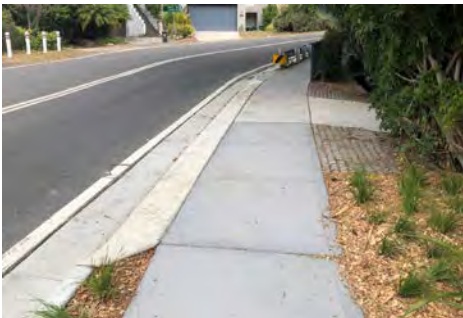
Item No.	Descriptions of Findings	Drawing	Likelihood	Severity	Risk Rating	Designer Response
15	It is unclear why the driveway to 1180 Barrenjoey Road is 6-8m wide. A wide driveway may encourage motorists to undertake turning manoeuvres into/ from the property at speed across the walkway.

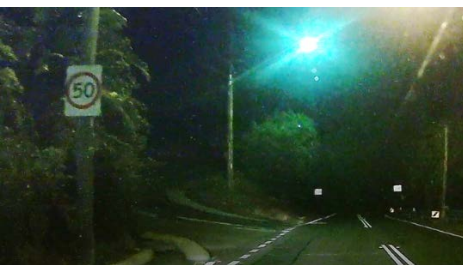
Improbable	Moderate	Low	
16	The 50 km/h repeater sign is unnecessarily close to the 40 km/h sign.

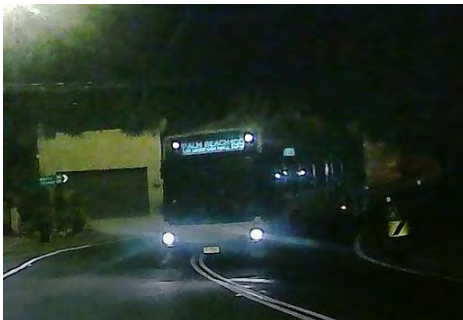
Improbable	Moderate	Low	
17	A northbound bus was observed crossing the centre double barrier line on the corner adjacent 1180 Barrenjoey Road. The bus could collide with a vehicle travelling in the opposing direction when a northbound bus (or large truck) crosses the centre line.

Occasional	Moderate	Medium
