# Additional Geotechnical Investigation

10-28 Lawrence Street, Freshwater NSW

**Report No:** E25874.G04\_Rev1

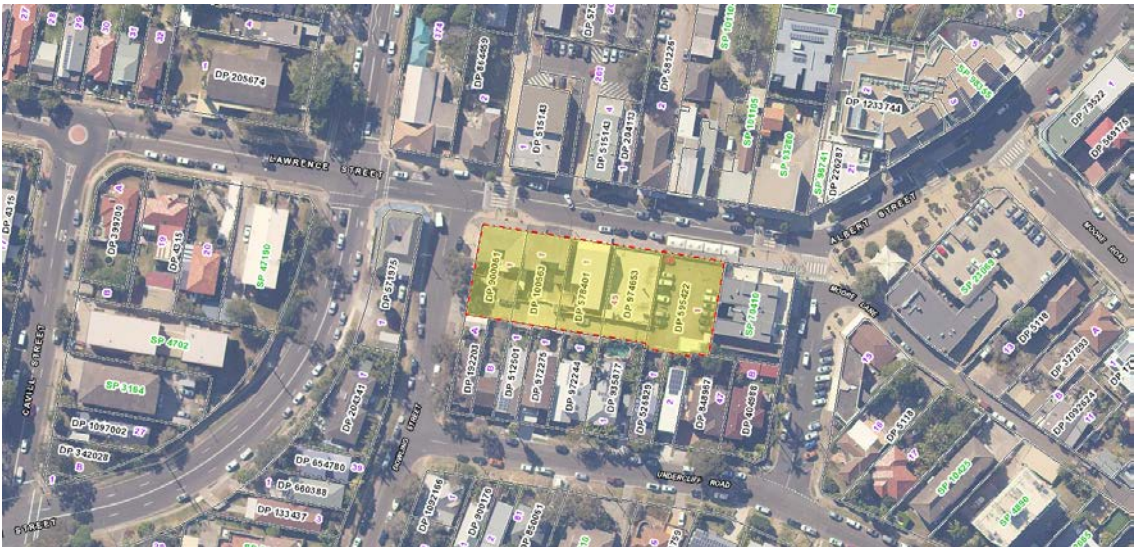
Plate 1: Aerial photograph of the site (source: SixMap, accessed 20/02/2023)

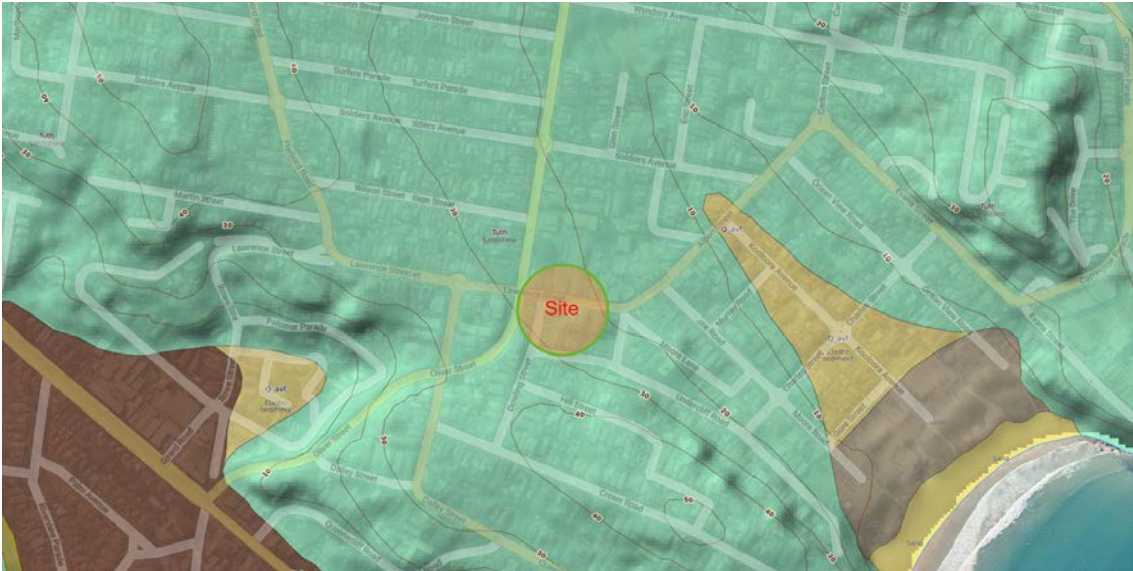
Plate 2: Excerpt of geological map showing location of site.

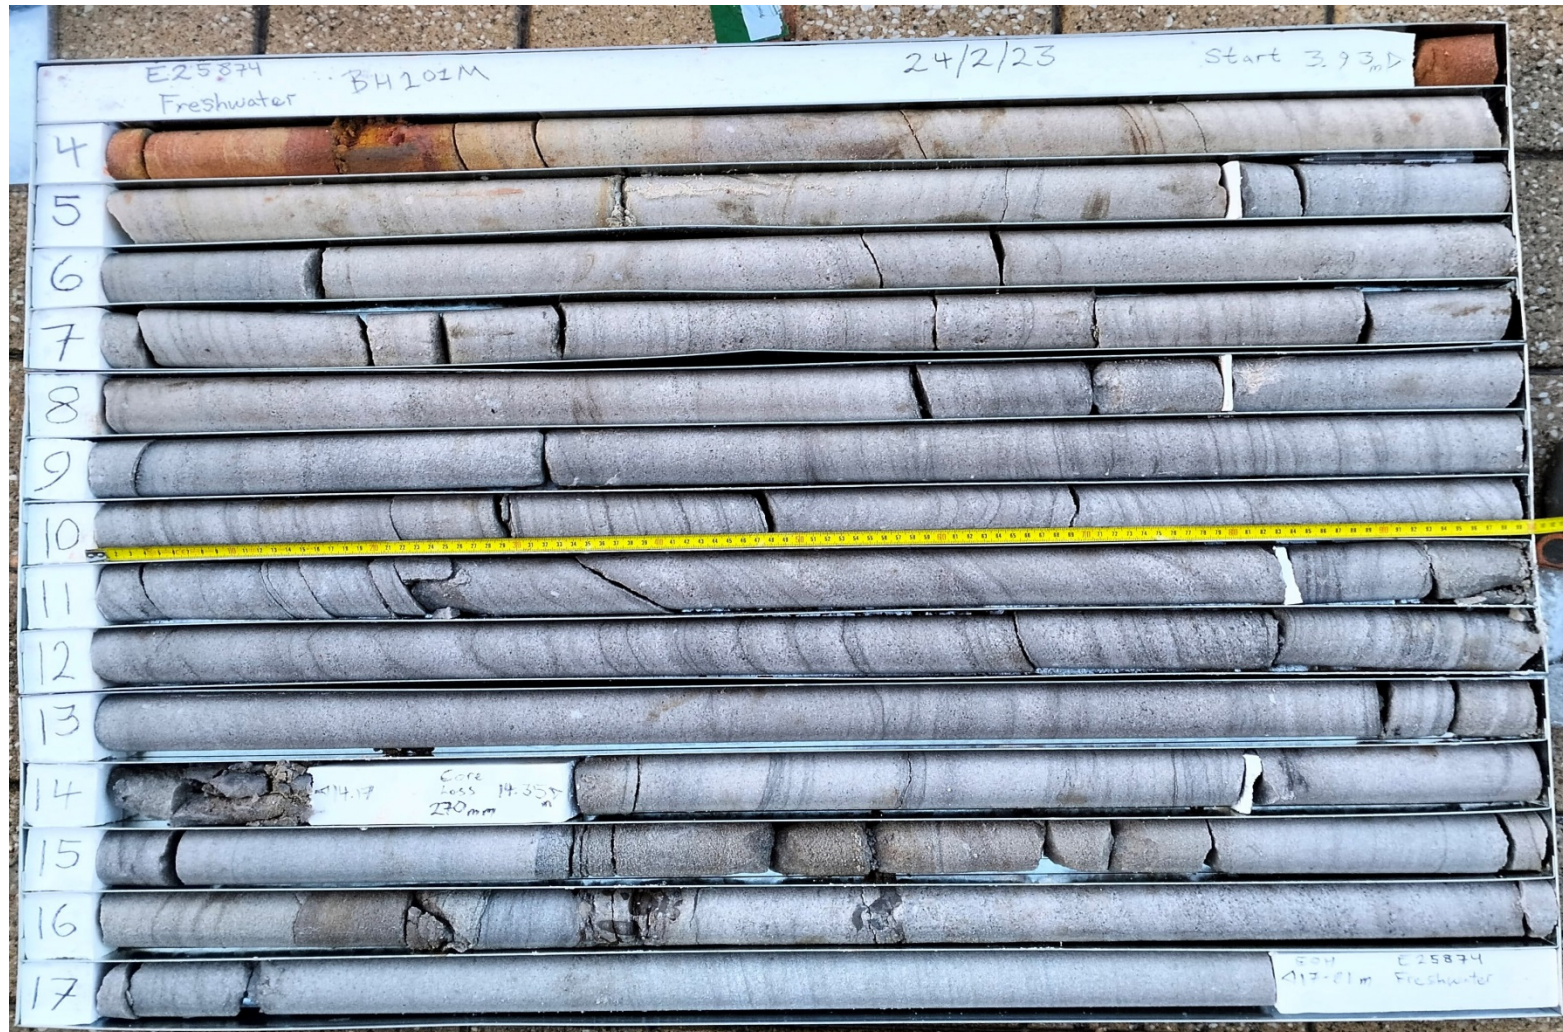
# CORE PHOTOGRAPH OF BOREHOLE: BH101M

<b>Project</b>	Proposed Development	<b>Depth Range</b>	3.93m to 17.83m BEGL	
<b>Location</b>	Lawrence Street, Freshwater NSW	<b>Contractor</b>	Geosense Drilling Services	
<b>Position</b>	See Figure 2	<b>Drill Rig</b>	Comacchio Geo205	
<b>Job No.</b>	E25874.G03.02	<b>Logged</b>	DD	<b>Date</b> 24 / 02 / 2023
<b>Client</b>	MD Living Pty Ltd	<b>Box</b>	4 of 4	<b>Date</b> 0 / 8 / 202

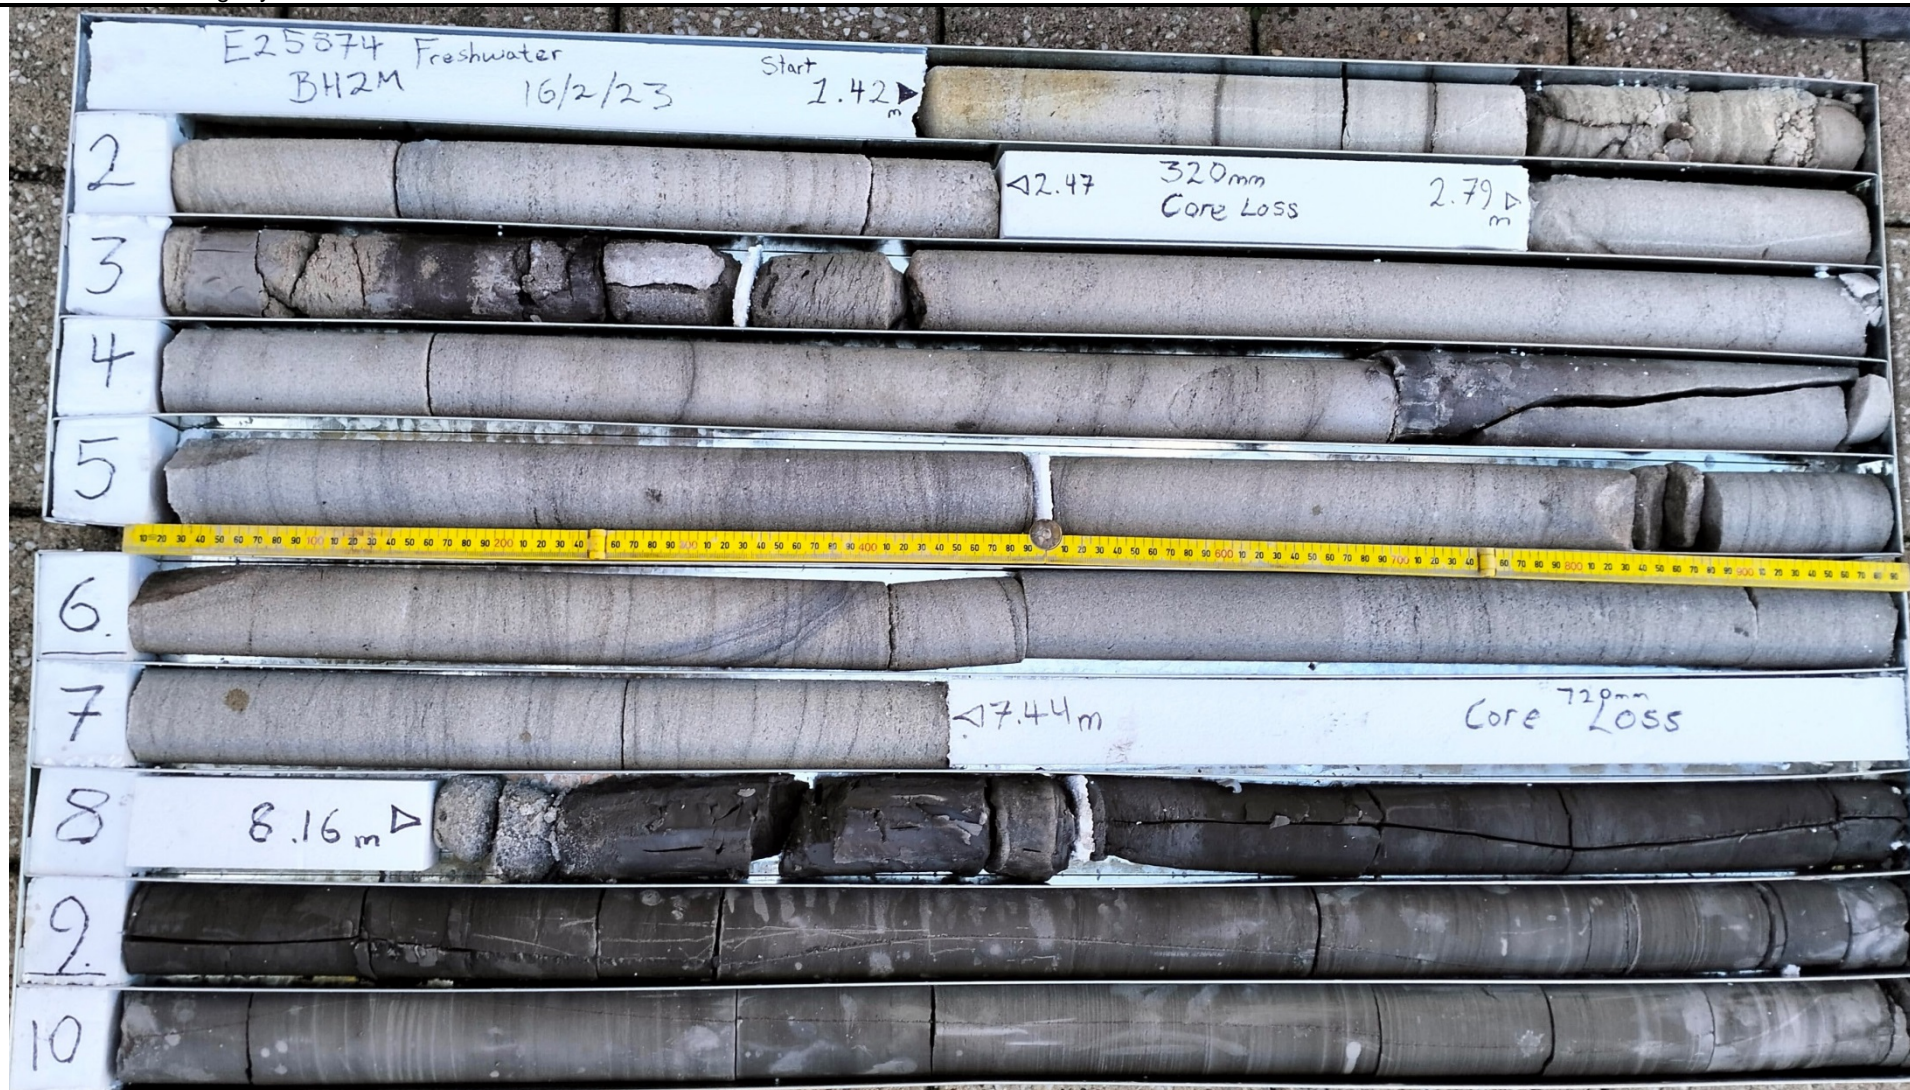
# CORE PHOTOGRAPH OF BOREHOLE: BH102M

<b>Project</b>	Proposed Development	<b>Depth Range</b>	1.42m to 11.0m BEGL	
<b>Location</b>	Lawrence Street, Freshwater NSW	<b>Contractor</b>	Geosense Drilling Services	
<b>Position</b>	See Figure 2	<b>Drill Rig</b>	Comacchio Geo205	
<b>Job No.</b>	E25874.G03.02	<b>Logged</b>	DD	<b>Date</b> 16 / 02 / 2023
<b>Client</b>	MD Living Pty Ltd	<b>Box</b>	1 of 2	<b>Checked</b> SK <b>Date</b> 27 / 02 / 2023

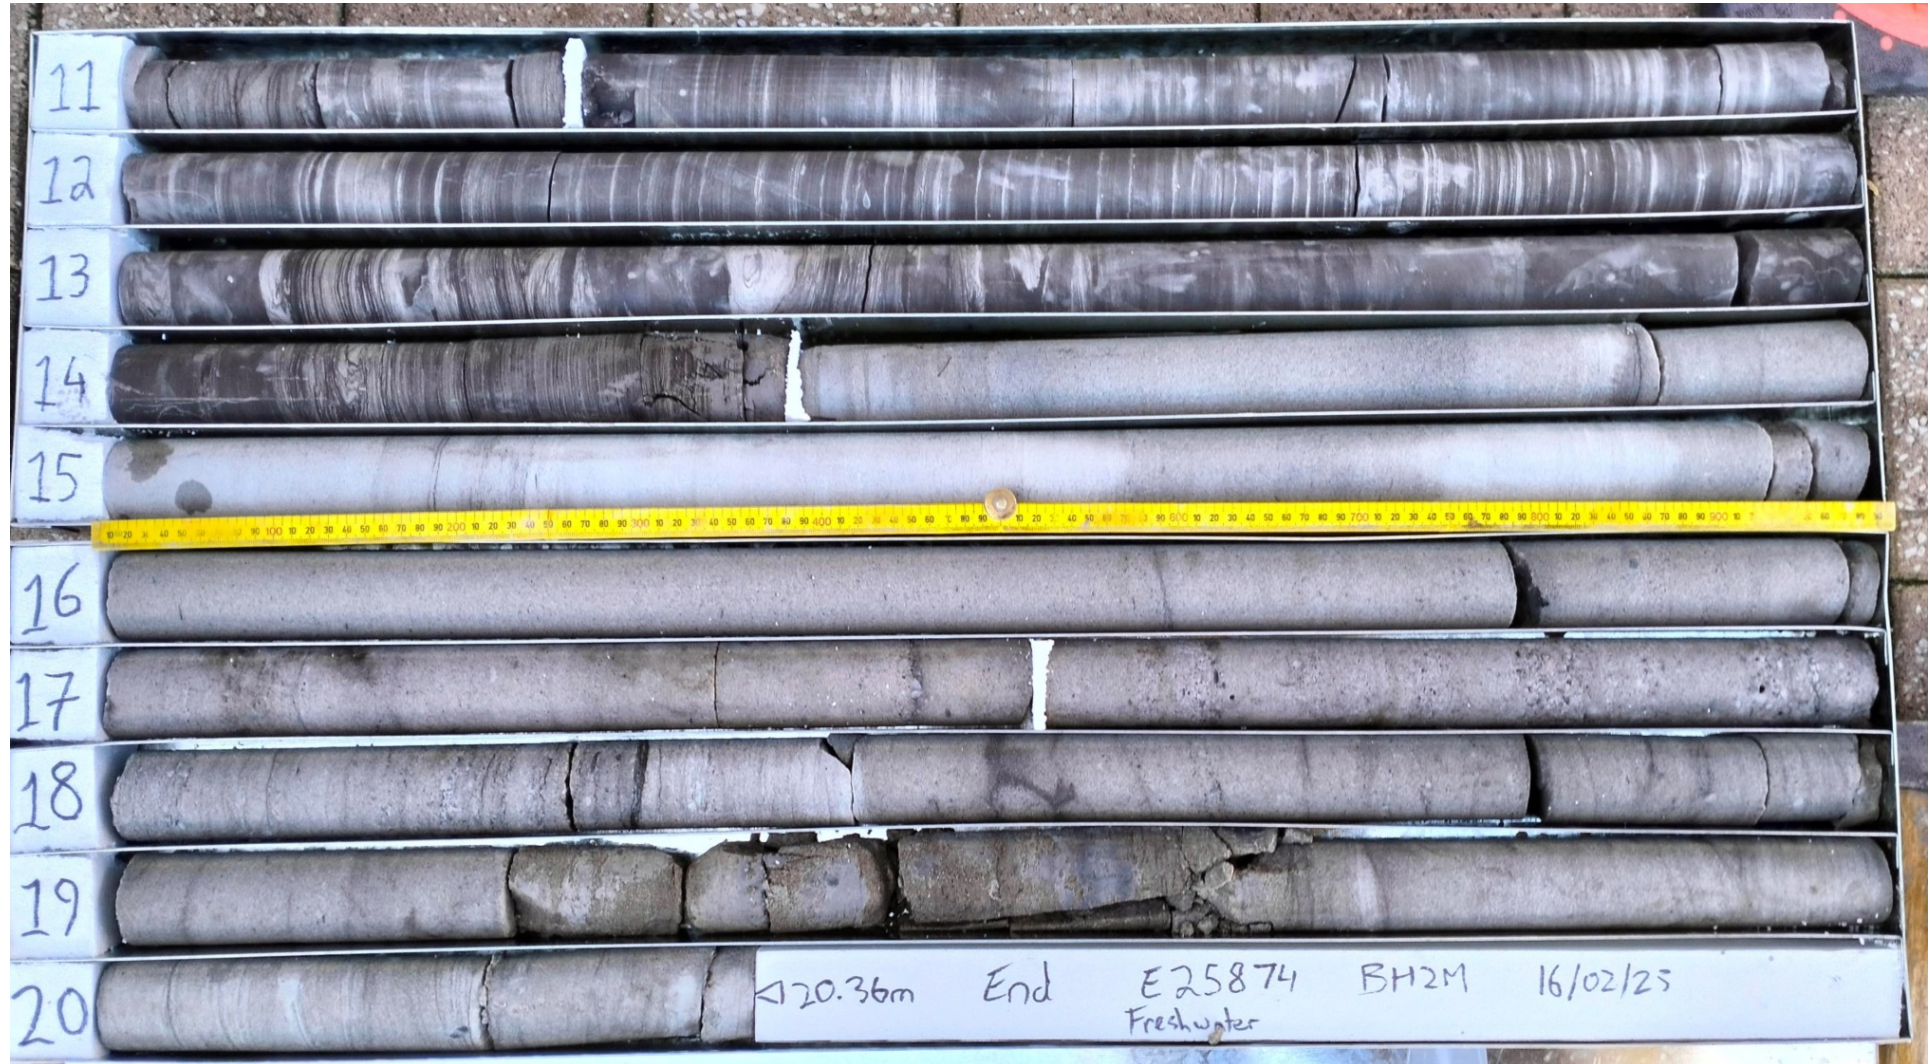
# CORE PHOTOGRAPH OF BOREHOLE: BH102M

<b>Project</b>	Proposed Development	<b>Depth Range</b>	11.00m to 20.36m BEGL	
<b>Location</b>	Lawrence Street, Freshwater NSW	<b>Contractor</b>	Geosense Drilling Services	
<b>Position</b>	See Figure 2	<b>Drill Rig</b>	Comacchio Geo205	
<b>Job No.</b>	E25874.G03.02	<b>Logged</b>	DD	<b>Date</b> 16 / 02 / 2023
<b>Client</b>	MD Living Pty Ltd	<b>Box</b>	2 of 2	<b>Checked</b> Date 28 / 08/ 2023

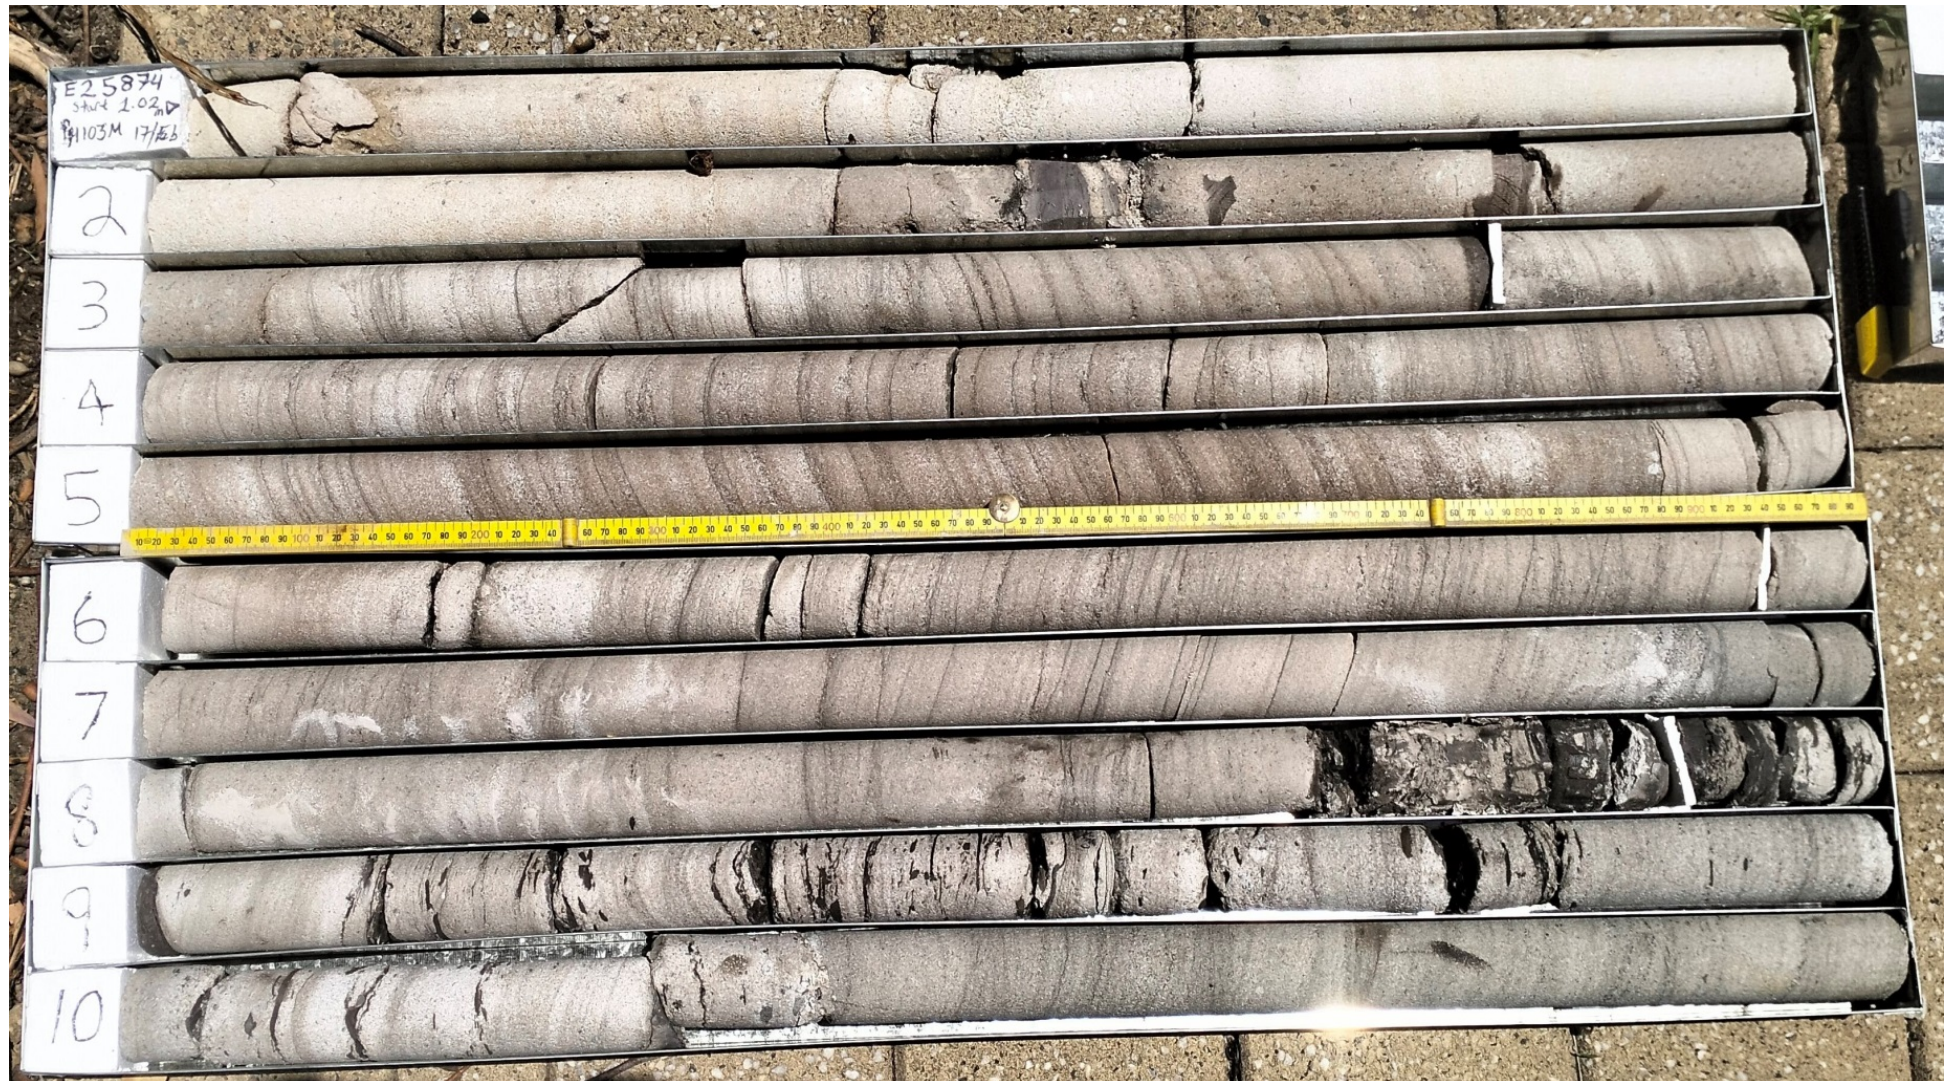
# CORE PHOTOGRAPH OF BOREHOLE: BH103M

<b>Project</b>	Proposed Development	<b>Depth Range</b>	1.02m to 11.0 BEGL	
<b>Location</b>	Lawrence Street, Freshwater NSW	<b>Contractor</b>	Geosense Drilling Services	
<b>Position</b>	See Figure 2	<b>Drill Rig</b>	Comacchio Geo205	
<b>Job No.</b>	E25874.G03.02	<b>Logged</b>	DD	<b>Date</b> 17 / 02 / 2023
<b>Client</b>	MD Living Pty Ltd	<b>Box</b>	1 of 1	<b>Checked</b> Date

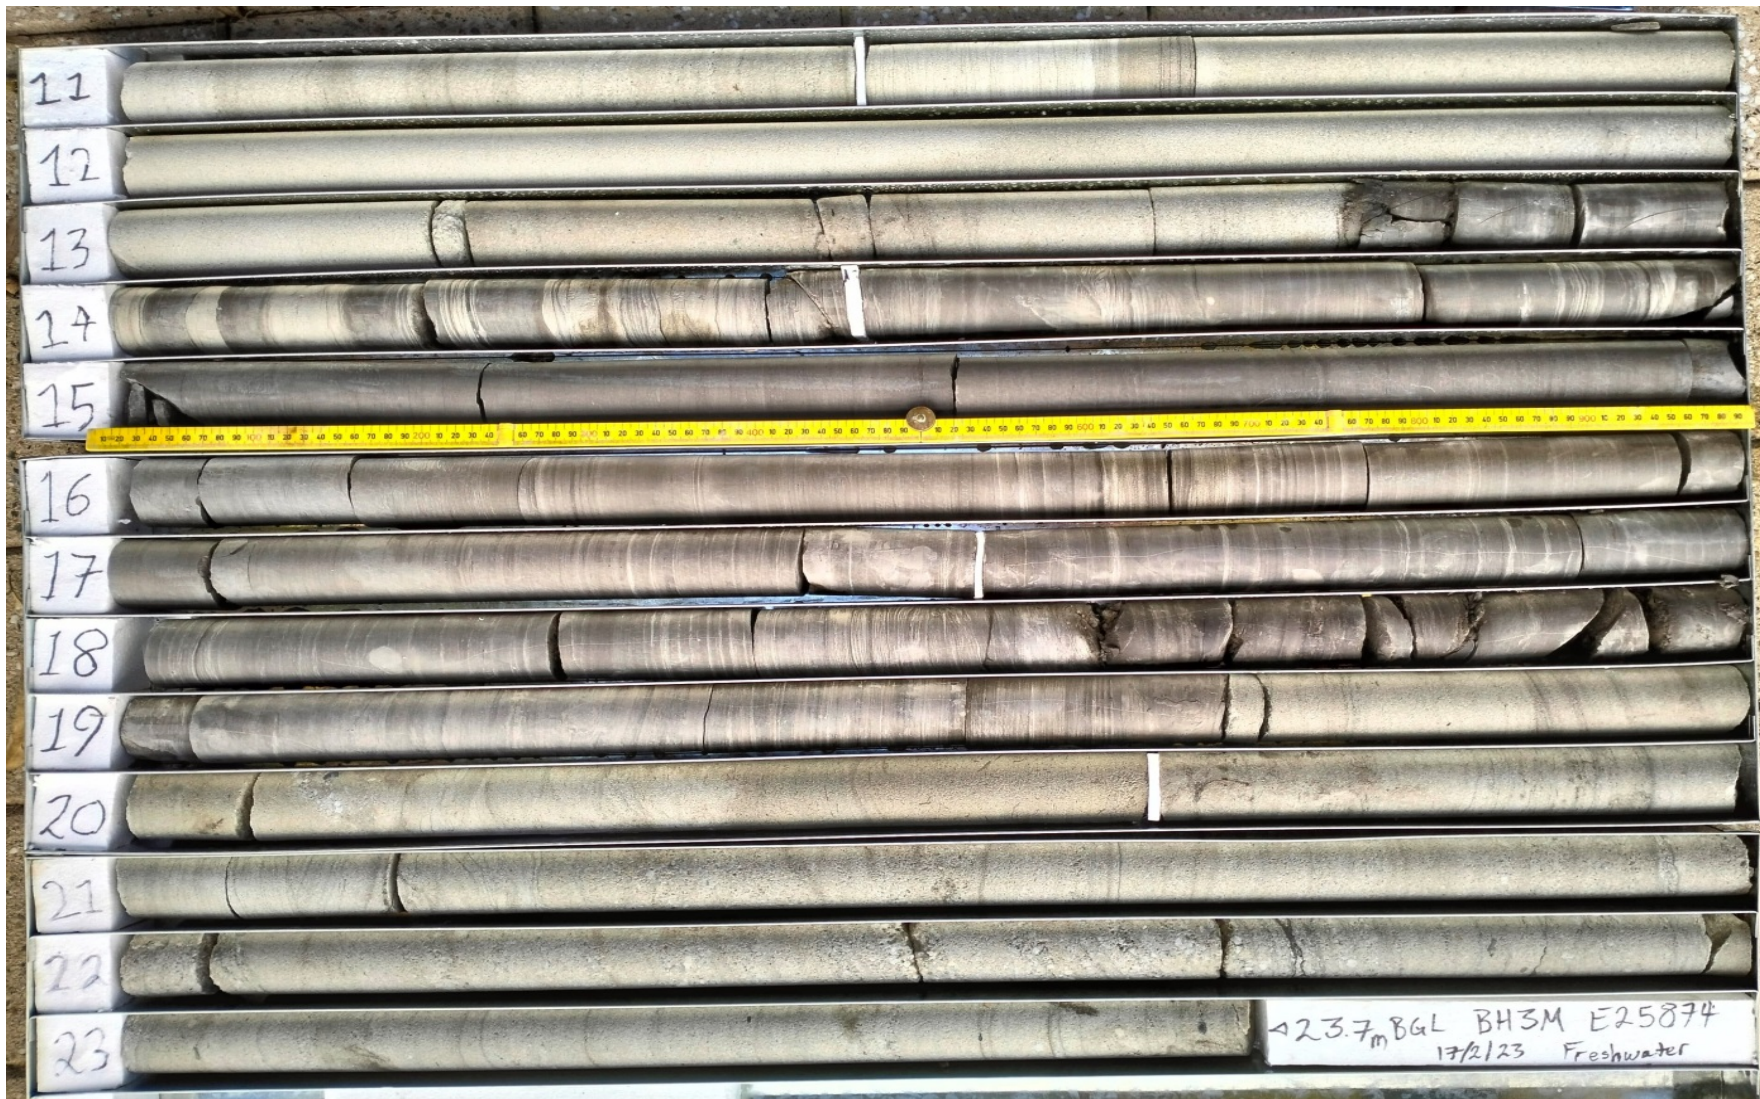
# CORE PHOTOGRAPH OF BOREHOLE: BH103M

<b>Project</b>	Proposed Development			<b>Depth Range</b>	11.0m to 18.00m BEGL		
<b>Location</b>	Lawrence Street, Freshwater NSW			<b>Contractor</b>	Geosense Drilling Services		
<b>Position</b>	See Figure 2	<b>Surface RL</b>	29.8mAHD	<b>Drill Rig</b>	Comacchio Geo205		
<b>Job No.</b>	E25874.G03.02	<b>Inclination</b>	-90°	<b>Logged</b>	DD	<b>Date</b>	07 / 07 / 2021
<b>Client</b>	MD Living Pty Ltd	<b>Box</b>	2 of 2	<b>Checked</b>		<b>Date</b>	00 / 00 / 2000
