Date: 23 July 2021 **No. Pages:** 3 **Project No.:** 2021-161

Preliminary Landslip Risk Assessment for 105 Arthur Street, Forestville.

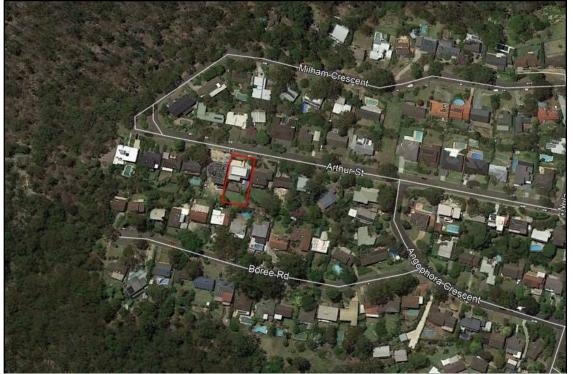
Photograph 1: Aerial photo of site (outlined red) and surrounds

The site contains a three-storey rendered residence located within the front half of the site and an in-ground pool adjacent to the east boundary. A timber deck is located to the south of the site residence constructed adjacent to a broadly approximately east west trending cliff line which varies between approximately 1.5m-2.0m in height. The residence appeared in good condition with no signs of cracking visible in the external walls.
