## **ARBORICULTURAL IMPACT ASSESSMENT**

**22 Bilberry Avenue, Bilgola Plateau**

| <b>Report type:</b> | Arboricultural Impact Assessment (AIA) |

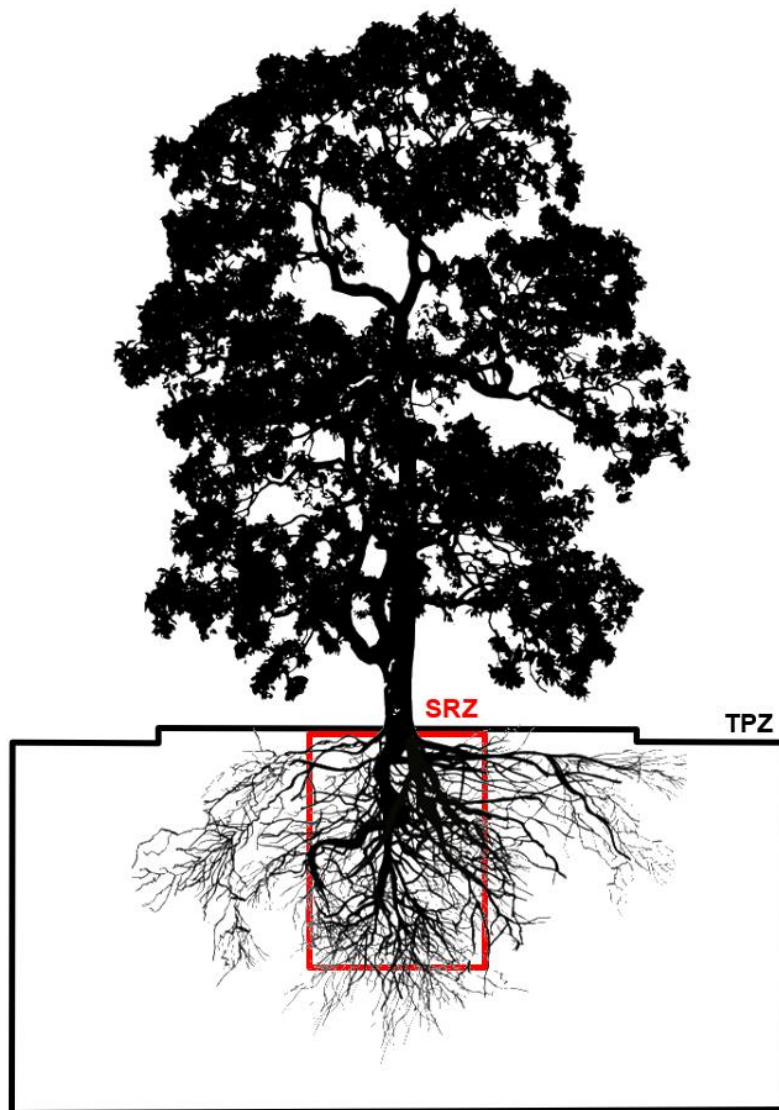
- **Tree protection zone (TPZ):** The TPZ is the optimal combination of crown and root area (as defined by AS 4970-2009) that requires protection during the construction process so that the tree can remain viable. The TPZ is an area that is isolated from the work zone to ensure no disturbance or encroachment occurs into this zone. Tree sensitive construction measures must be implemented if work is to proceed within the TPZ.
- **Structural root zone (SRZ):** The SRZ is the area of the root system (as defined by AS 4970-2009) used for stability, mechanical support and anchorage of the tree. Severance of structural roots (>50 mm in diameter) within the SRZ is not recommended as it may lead to the destabilisation and/or decline of the tree.

Figure 1: Indicative TPZ and SRZ

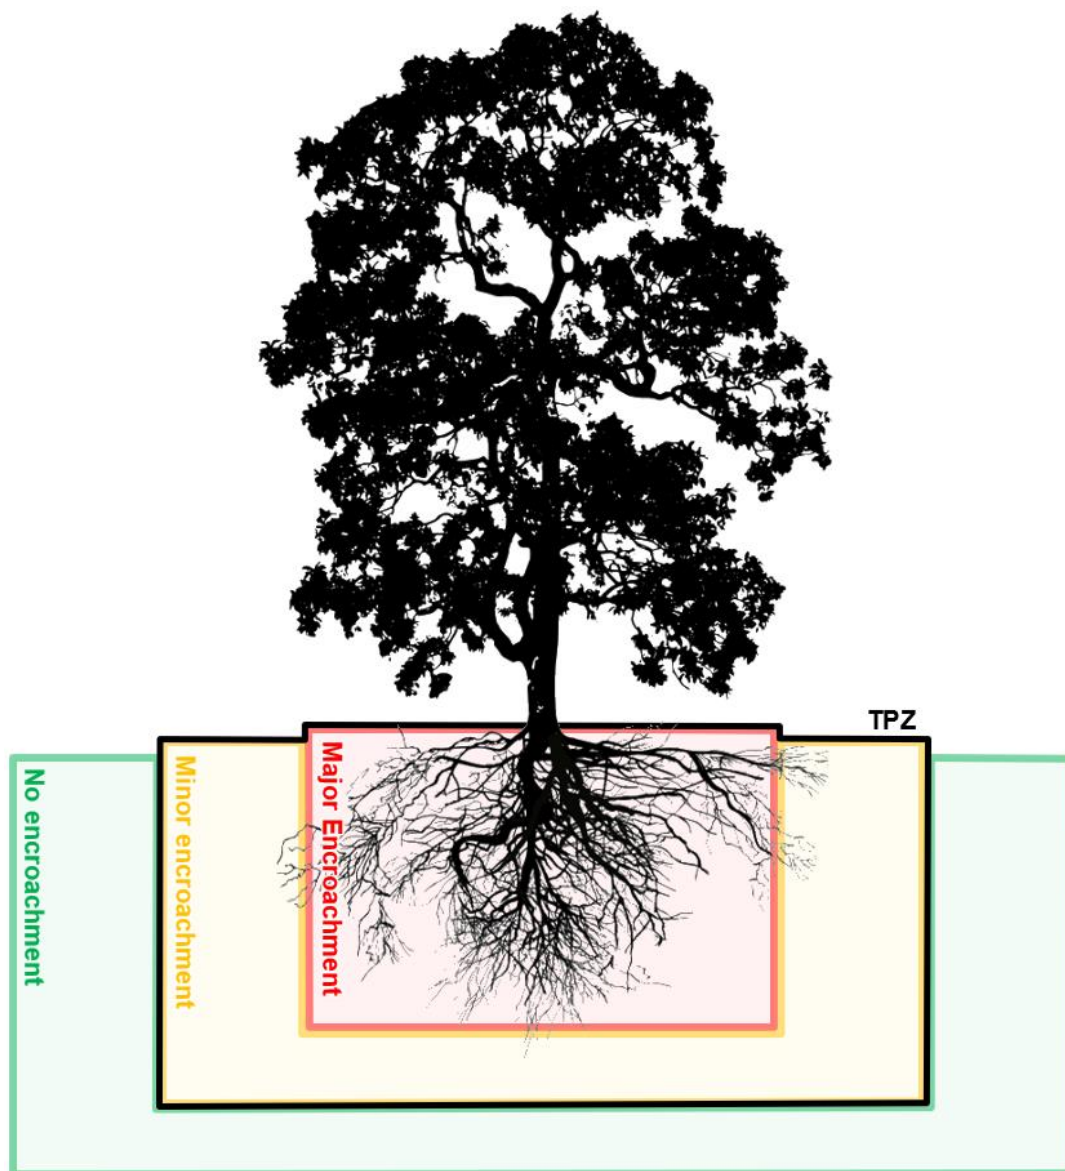
- **No encroachment (0%):** No likely or foreseeable encroachment within the TPZ.
- **Minor encroachment (<10%):** If the proposed encroachment is less than 10% (total area) of the TPZ, and outside of the SRZ, detailed root investigations should not be required. The area lost to this encroachment should be compensated for elsewhere and be contiguous with the TPZ.
- **Major encroachment (>10%):** If the proposed encroachment is greater than 10% of the TPZ, the project arborist must demonstrate that the tree(s) remain viable. The area lost to this encroachment should be compensated for elsewhere and be contiguous with the TPZ. Root investigation by non-destructive methods may be required for any proposed works within this area.

Figure 2: Indicative zones of encroachment within the TPZ

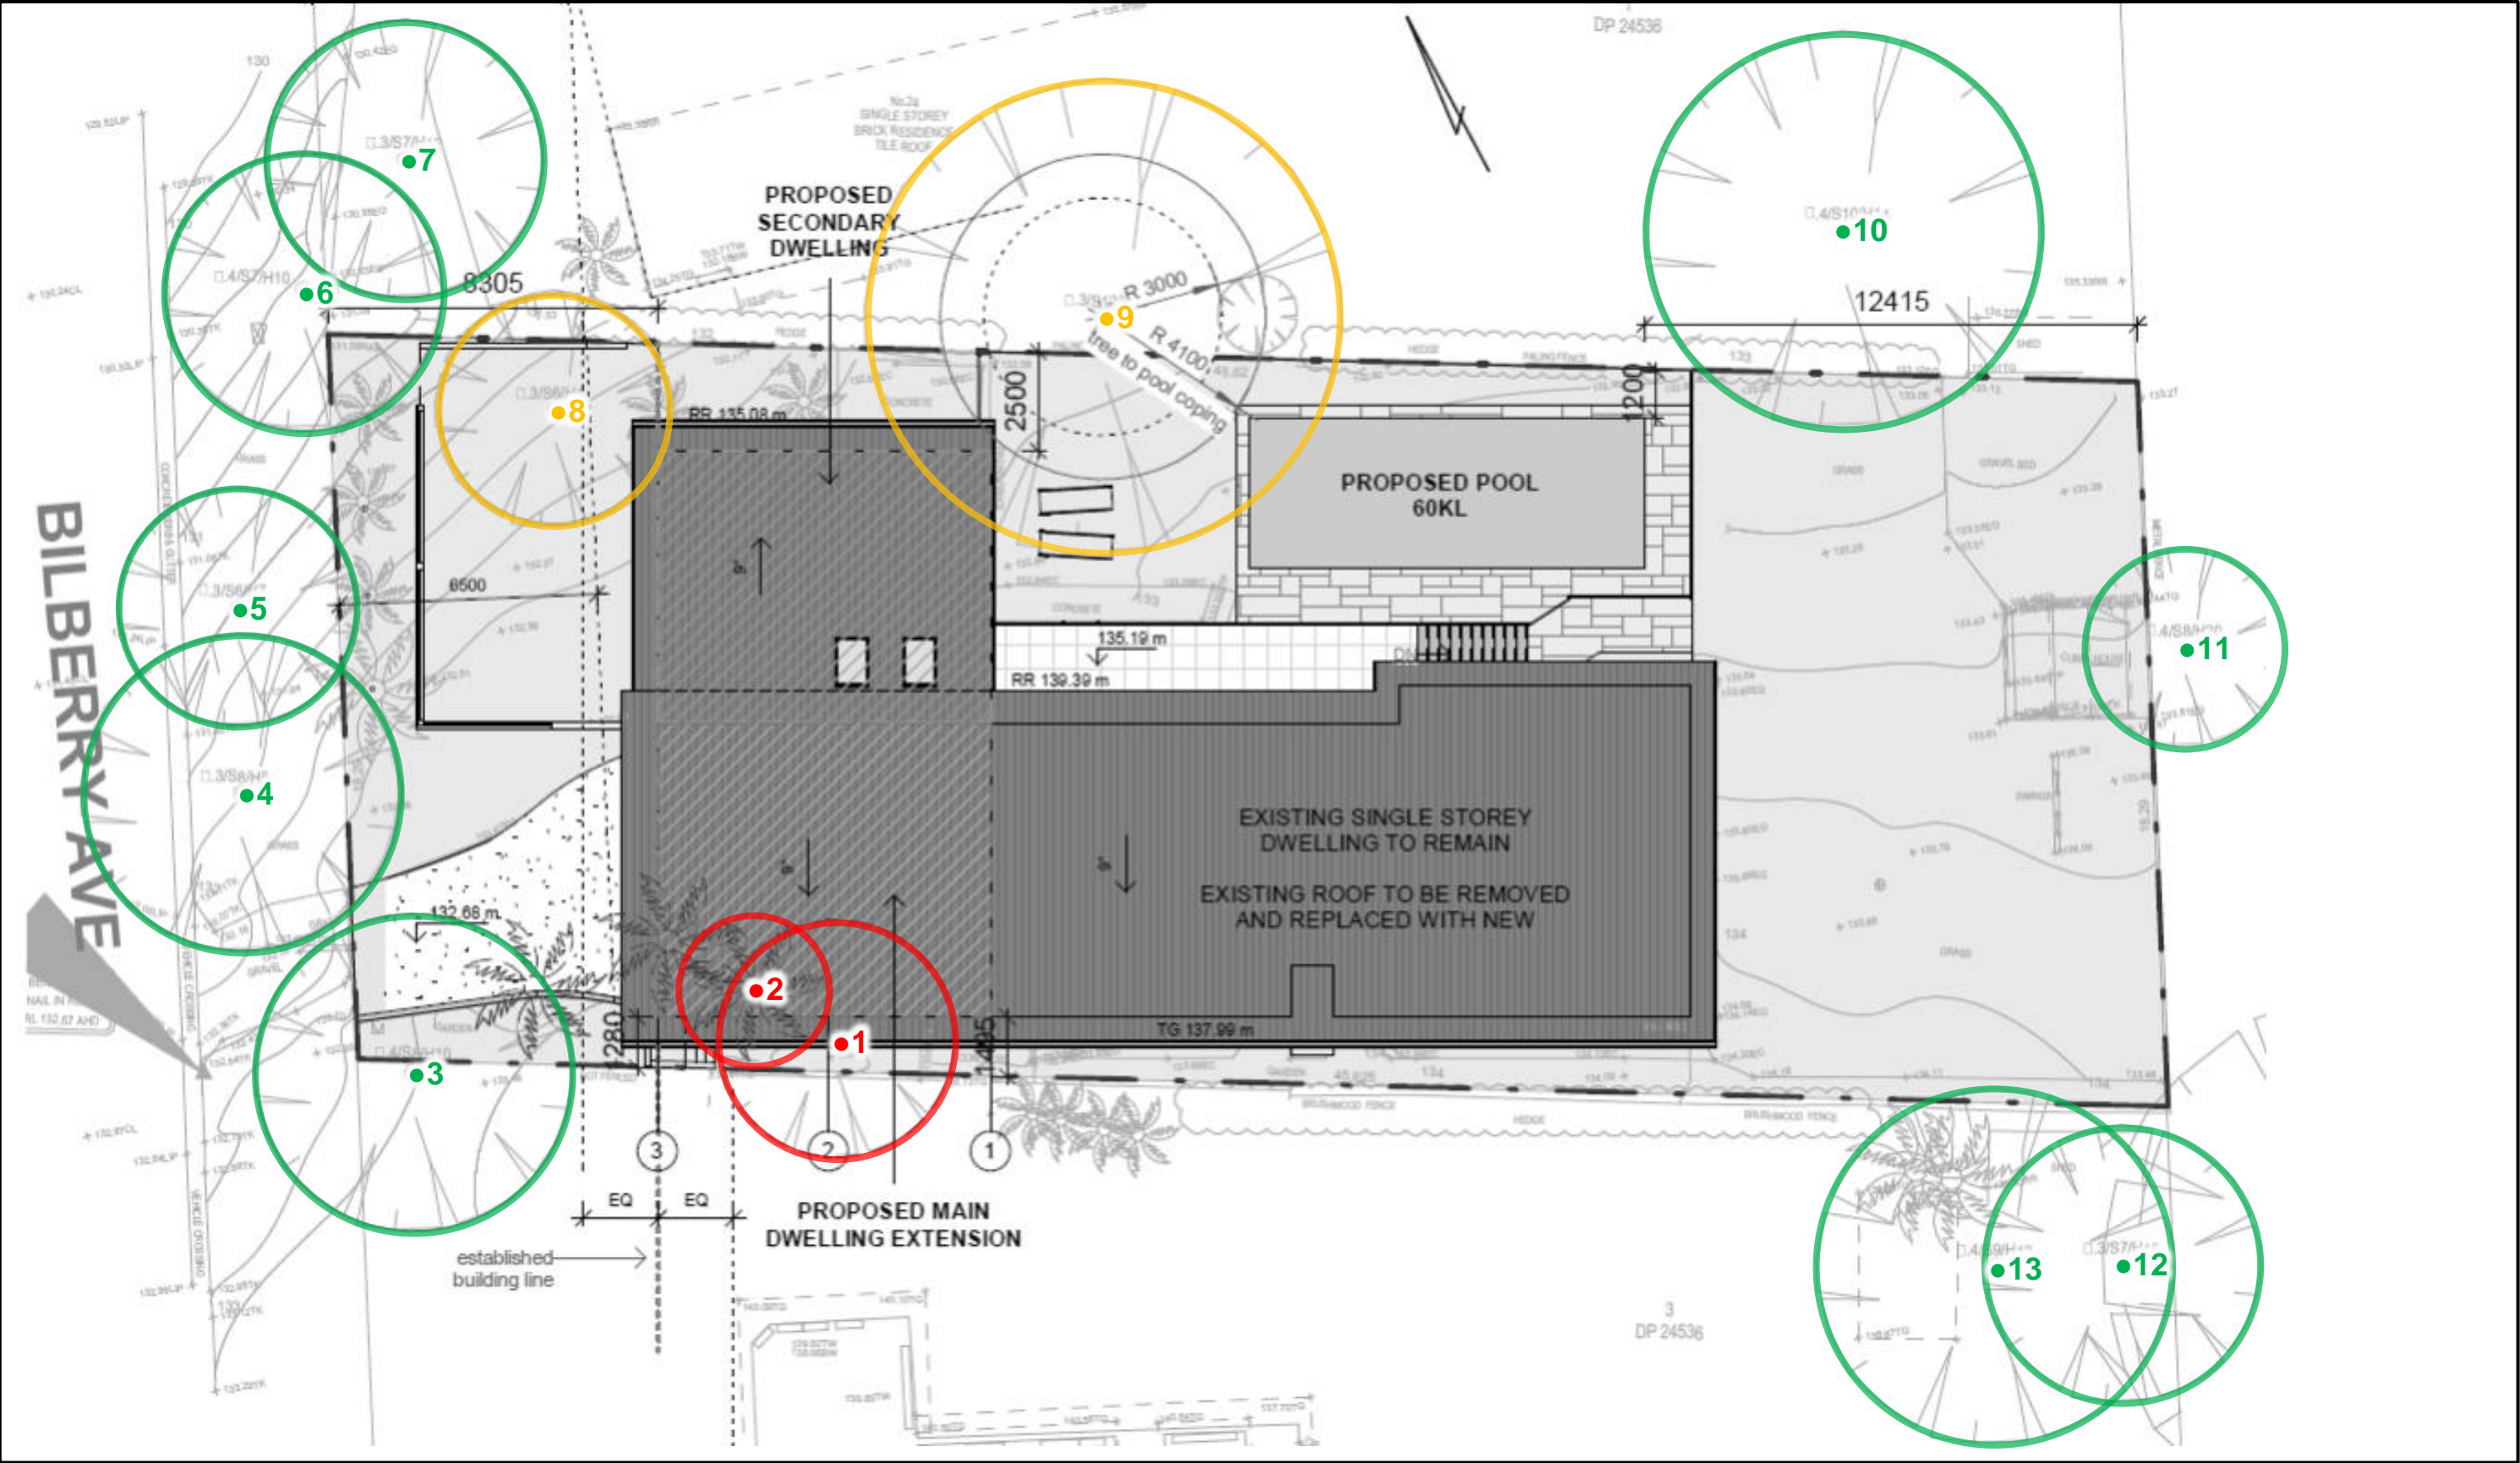
Appendix I - Impact assessment

Appendix I: No encroachment, minor encroachment, major encroachment

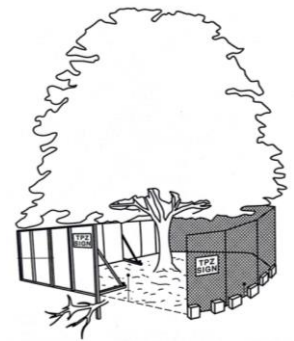
- Enclosed to the full extent of the TPZ (or as specified in the Recommendations and Tree Protection Plan).
- Temporary mesh panel fencing (minimum height 1.8m).
- Certified and inspected by the project arborist.
- Installed prior to the commencement of works.
- Prominently signposted with 300mm x 450mm boards stating, "NO ACCESS - TREE PROTECTION ZONE".

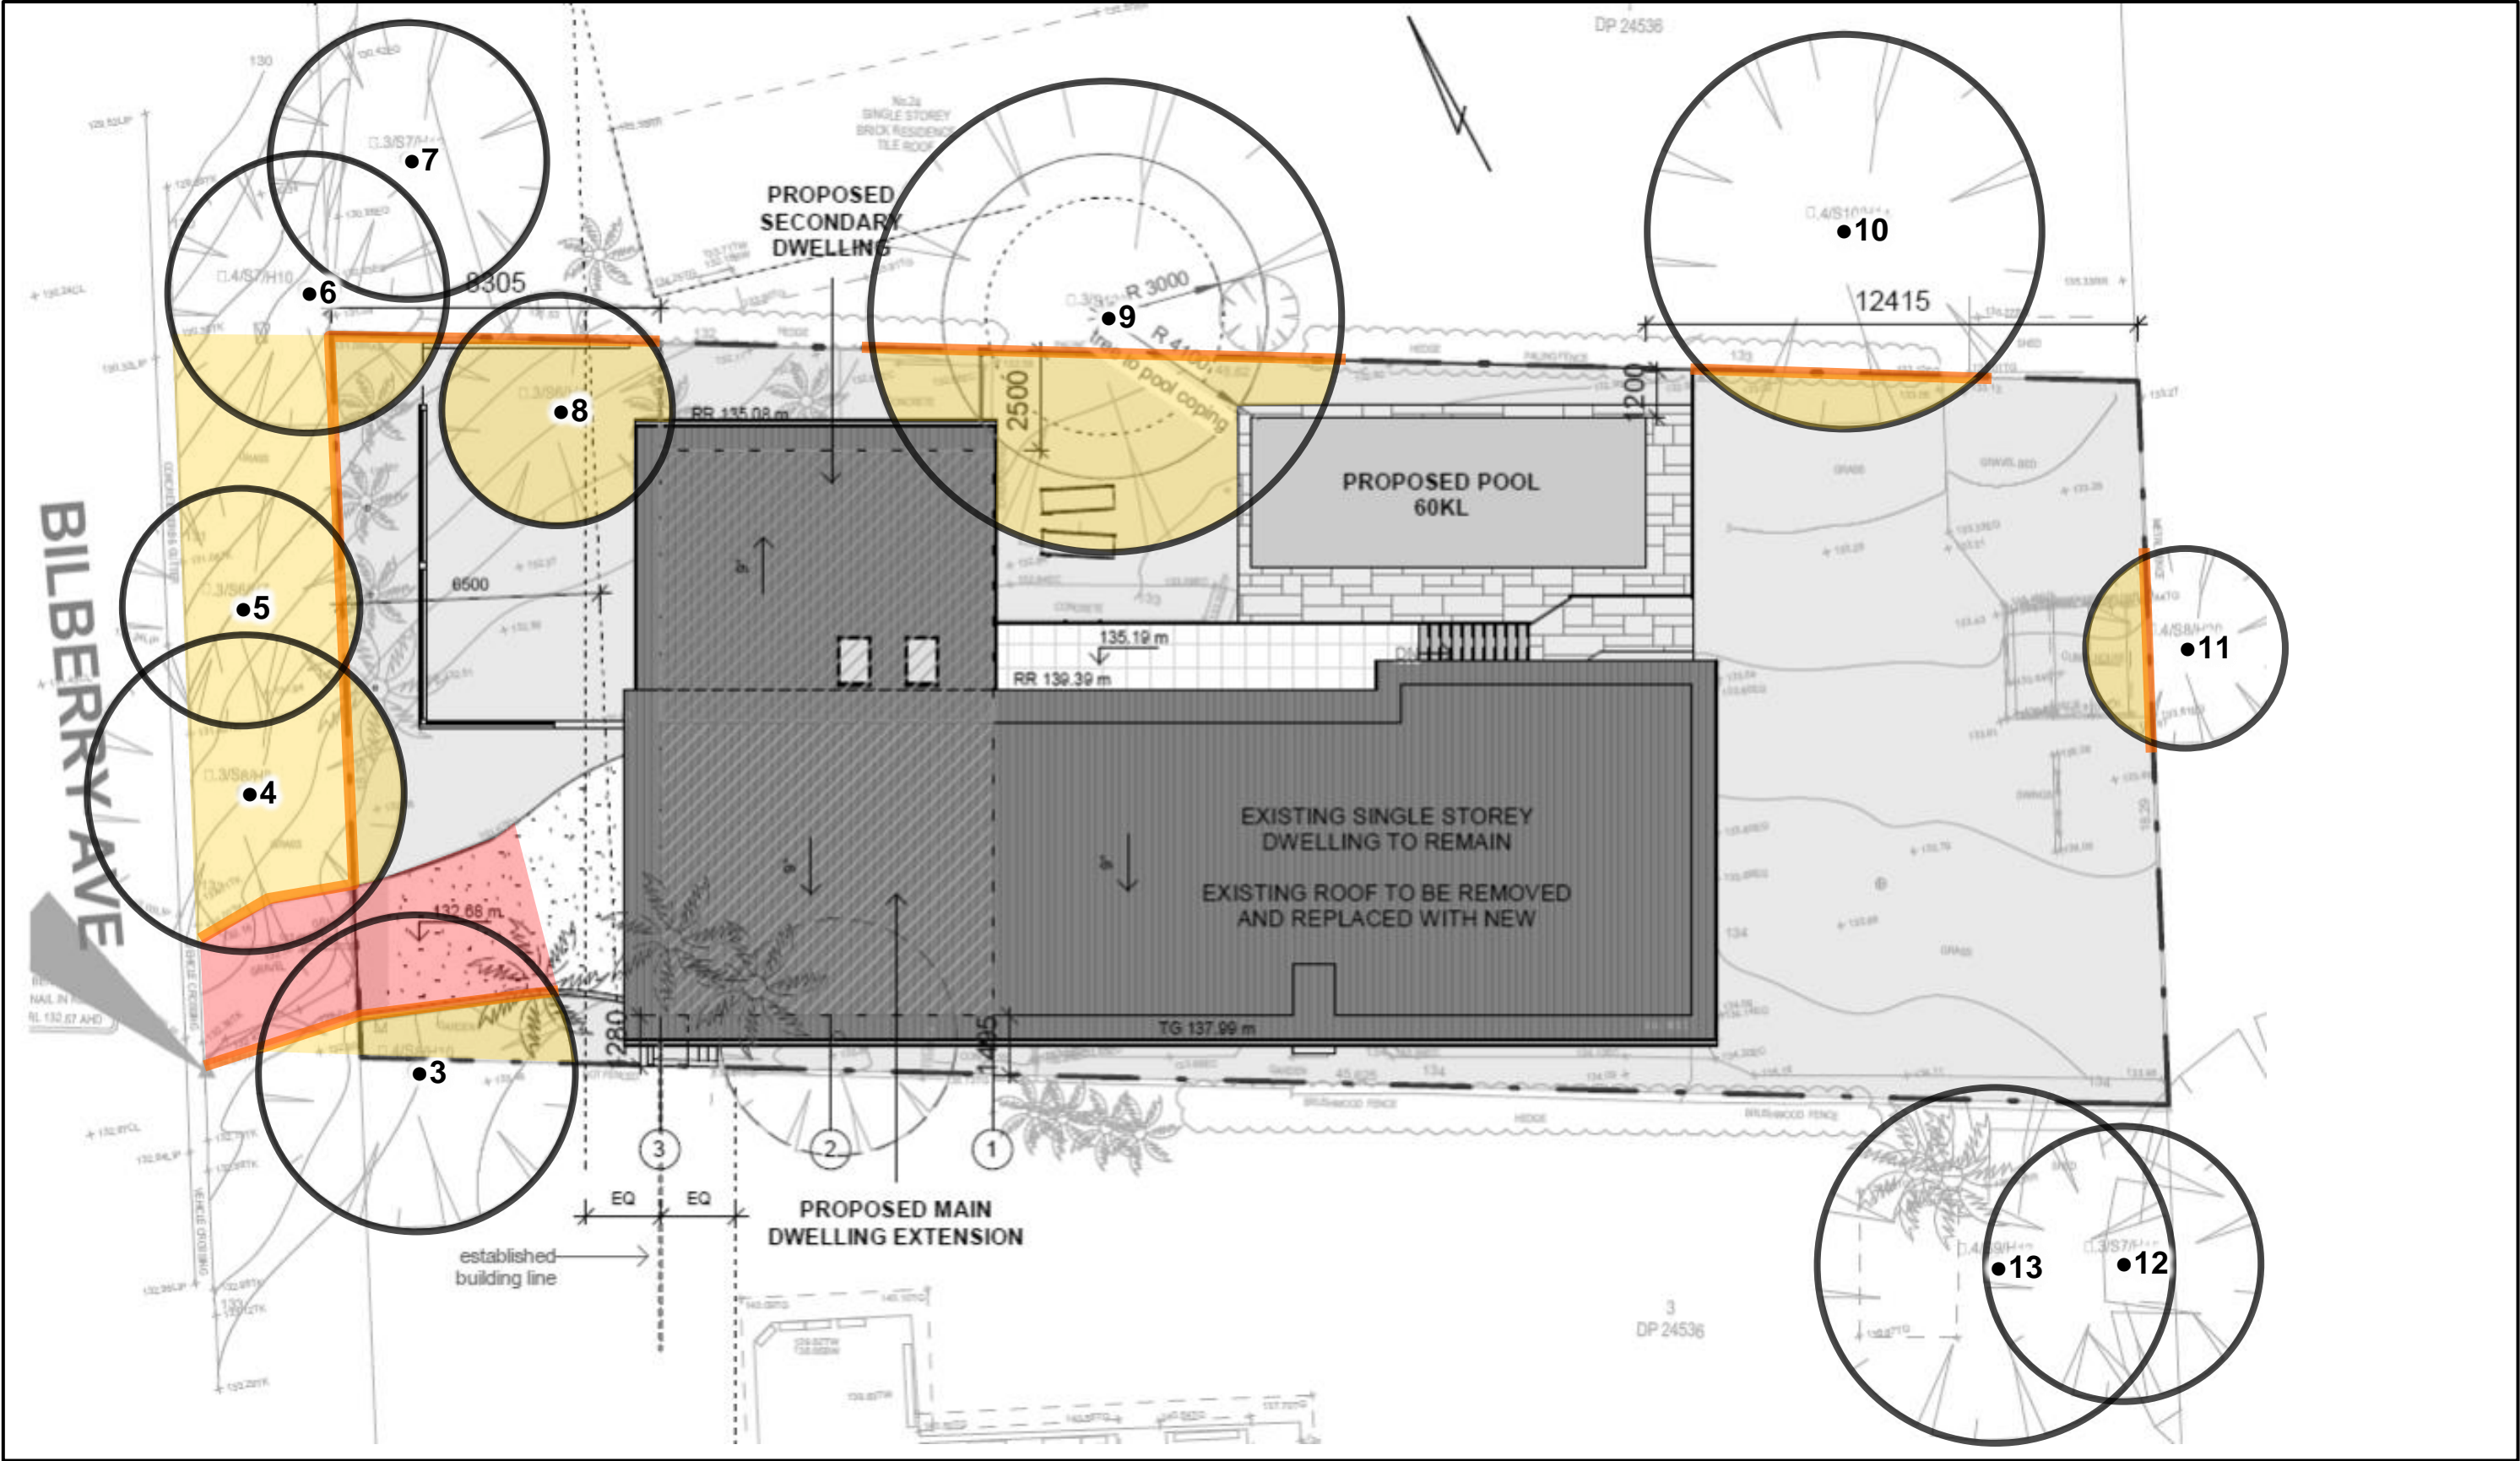
Appendix III - Tree protection map

Appendix III: Tree protection zone, tree protection fencing (existing boundary fence can be used), ground protection (existing driveway to be used)

Tree protection fencing must be established in the locations shown in **Appendix III**. Existing fencing, site hoarding or structures (such as a wall or building) may be used as tree protection fencing, providing the TPZ remains isolated from construction footprint.

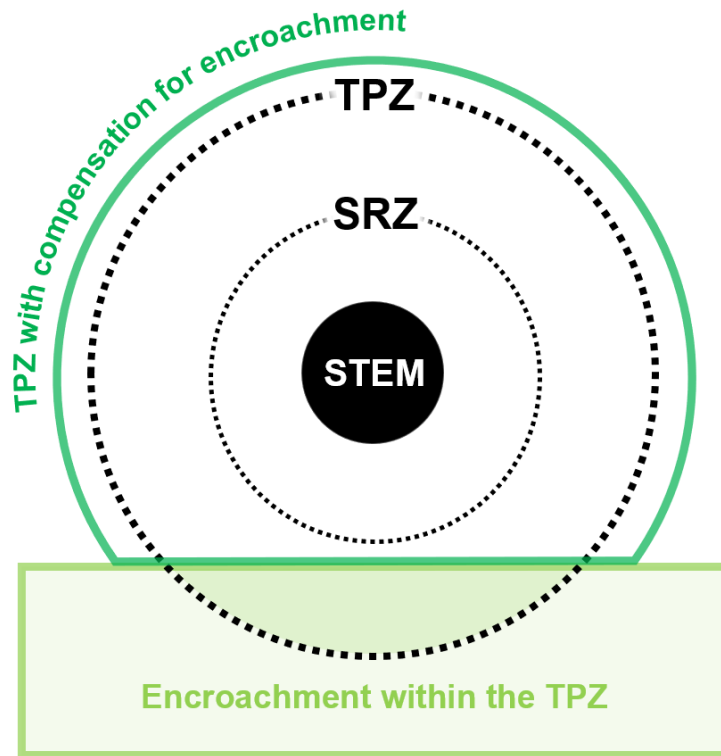
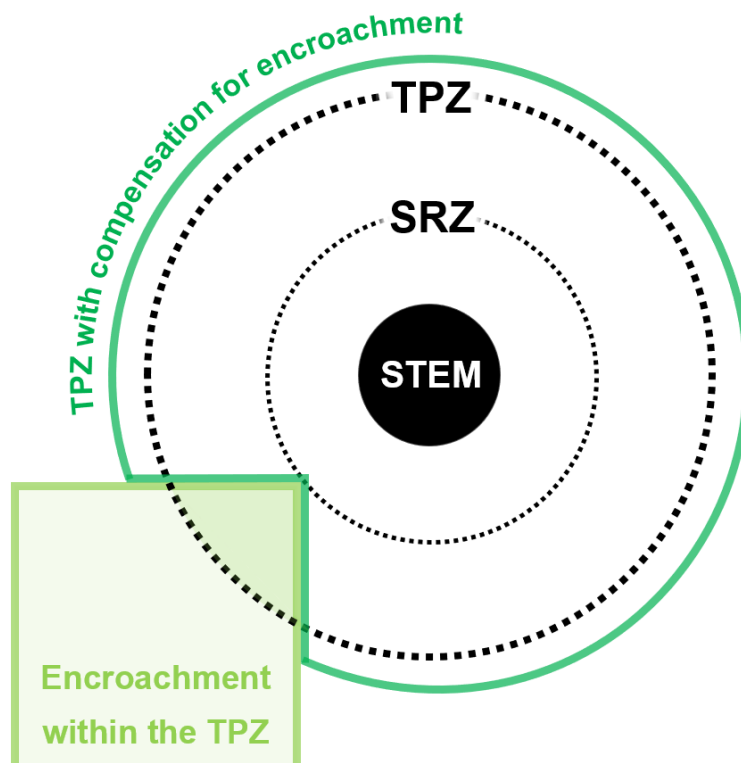
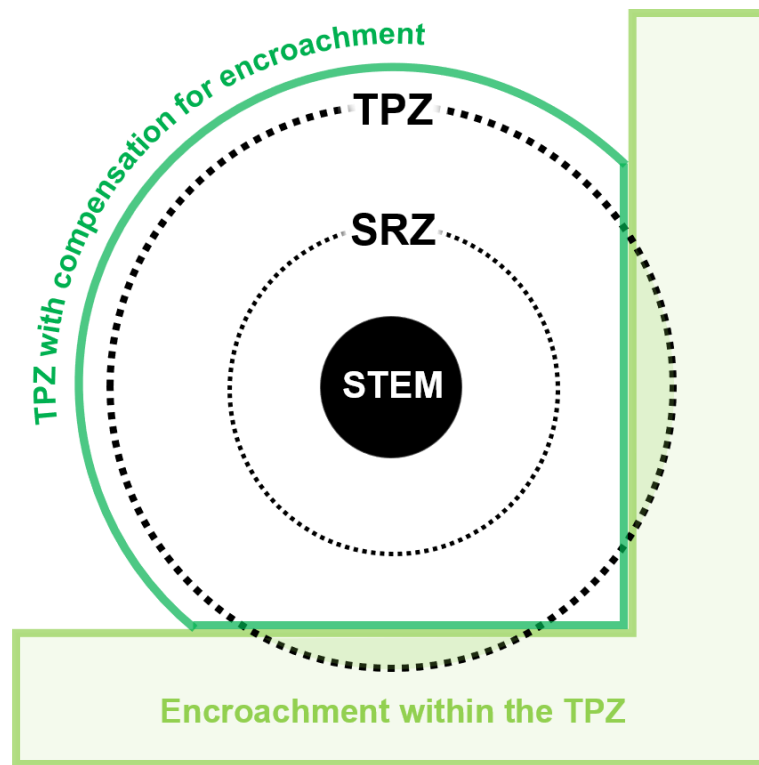
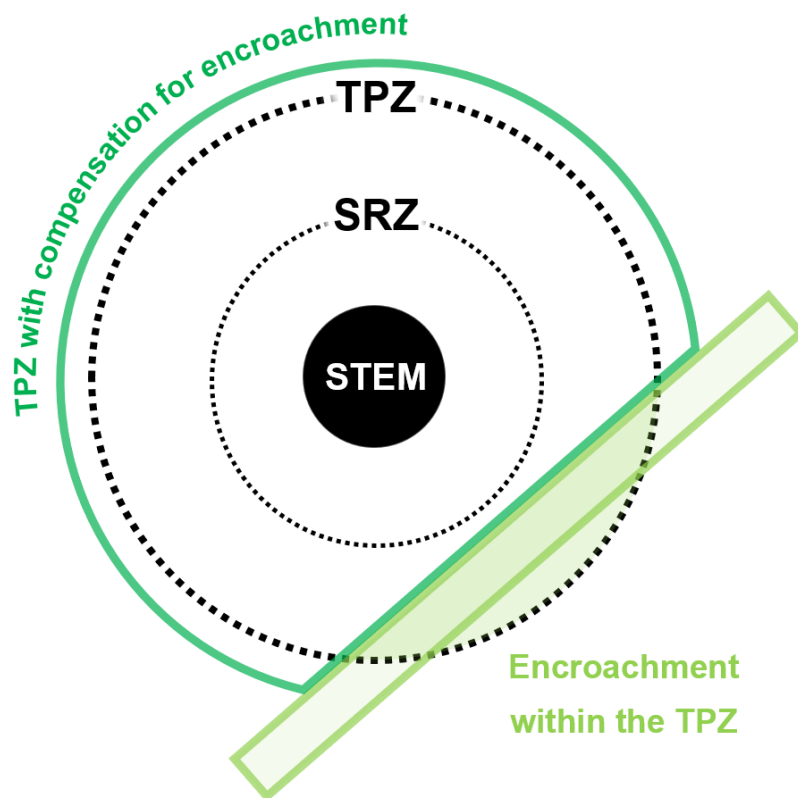
## Appendix IV - Encroachment within the TPZ

The images below show how encroachment within the tree protection zone can be compensated for elsewhere.

- The tree protection plan (**Appendix II**) must be implemented.
- The area lost to this encroachment should be compensated for elsewhere, contiguous with the TPZ (see **Appendix IV**).
