REPORT TO  
**ALLEN GROUP DEVELOPMENTS PTY LTD**

ON  
**GEOTECHNICAL INVESTIGATION**

FOR  
**PROPOSED RESIDENTIAL DEVELOPMENT**

AT  
**33-35 FAIRLIGHT STREET, FAIRLIGHT, NSW**

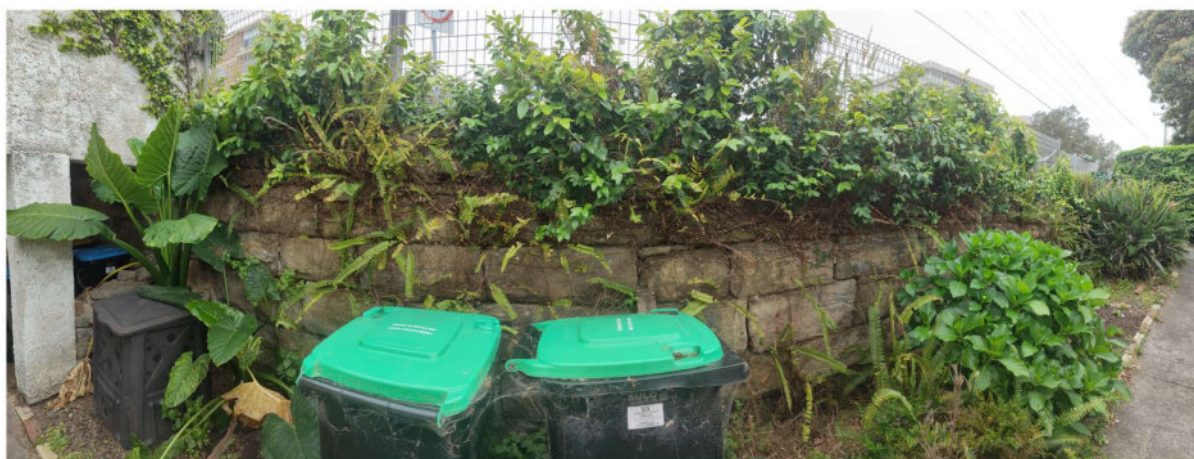
**Plate 1a: Northern Boundary Partially Mortared Sandstone Block Retaining Wall**

- In the north-western corner at the street level a single storey rendered garage which appeared to be in fair condition.
- Along the northern boundary, a partially mortared sandstone block retaining wall, maximum 1.9m high, supports the footpath along Fairlight Street. The retaining wall appeared to be in poor condition based on the wall leaning towards the south at approximately 8° to 10°. The concrete footpath above appeared to be in good condition. Plate 1a is a photograph of this wall.

As previously discussed, we recommend the northern boundary wall at No. 33 (Ref: Plate 1a), which is leaning towards the site, be temporary propped/anchored or replaced prior to excavations. There is also an irregular sandstone block wall and loose blocks of rock at the north-western portion of the site (Ref: Plate 2) which should be supported or removed prior to excavation. The likely support is to include shotcrete, mesh and dowels/bolts.

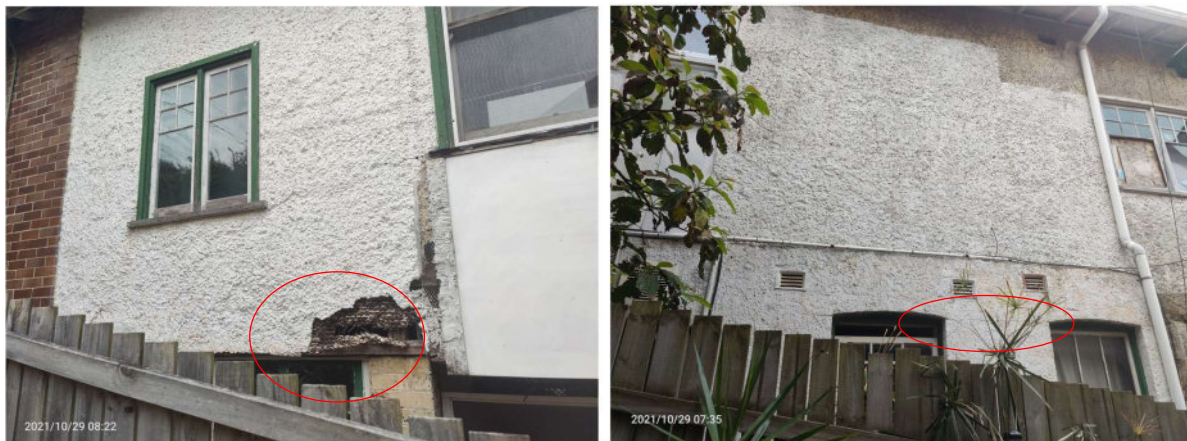
**Plate 1b: Northern Side of House, No. 33 (2 Photographs)**

- Over the central portion, a one, two and three storey rendered clad, brick and stone house which appeared to be in fair to poor external condition. This was based on horizontal cracks up to approximately 2mm to 3mm wide and a detached portion of rendering (over an area of about 0.5m x 0.3m), which were both observed on the northern side of the house. Plate 1b includes two photographs of the northern side of the house.
