J5926. 28th February, 2025. Page 1.

GEOTECHNICAL INVESTIGATION:

Alterations and Additions at **11 Cook Terrace, Mona Vale**

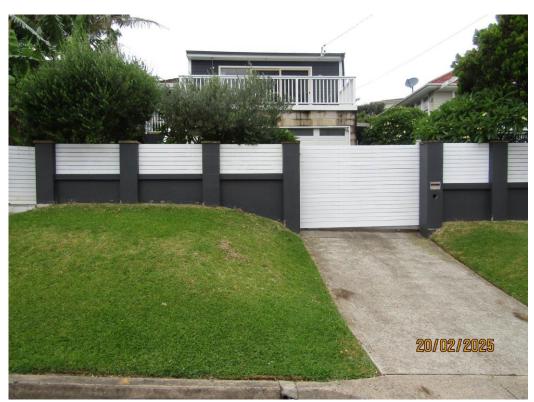
Photo 1

2.3 At the road frontage, a concrete driveway runs up the slope to a garage on the lower ground floor of the house (Photo 1). The part two storey house with garage (Photos 1 to 3) is supported on brick walls, concrete block walls, brick piers and a concrete slab. The exterior of the house shows no significant signs of movement. A stable and recently constructed pool is located at the uphill side of the house

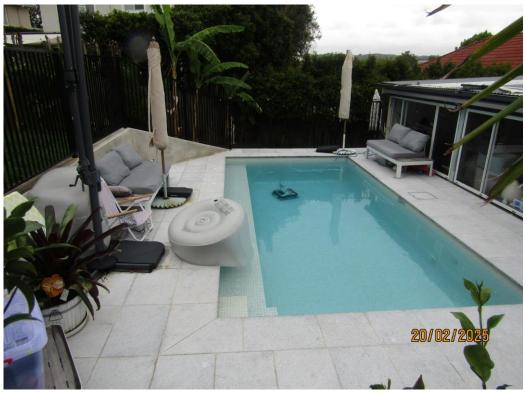
Photo 4

(Photo 4). A stable low rendered masonry retaining wall supports a cut for the pool paving. A gently sloping lawn and timber shed are located between the pool and the uphill property boundary. No signs of slope instability were observed on the property. The adjoining neighbouring properties were observed to be in good order as seen from the street and subject property.

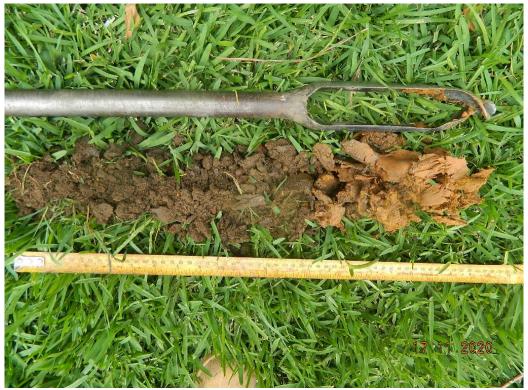
AUGER HOLE 1 (~RL35.3) – AH1 (Photo 6)

Depth (m)	Material Encountered
0.0 to 0.3	TOPSOIL , brown, moist, fine to medium grained with fine trace organic matter.
0.3 to 0.5	CLAY , light brown/orange, firm to stiff, moist.

End of Hole @ 0.5m in firm to stiff clay. No watertable encountered.

Photo 5: AH1 – Downhole is from left to right.

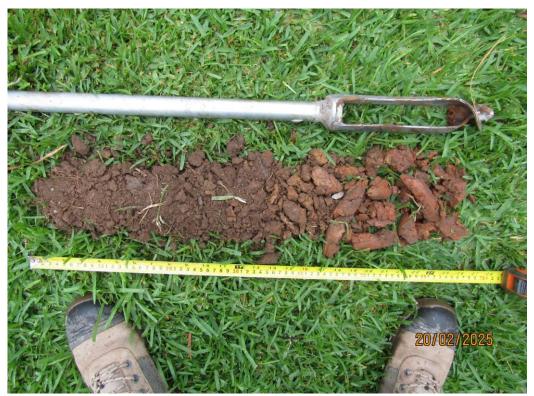
AUGER HOLE 2 (~RL31.7) – AH2 (Photo 7)

Depth (m)	Material Encountered
0.0 to 0.4	TOPSOIL , clayey soil, dark brown, dry, fine to medium grained.
0.4 to 0.7	CLAY , orange, orange brown, firm to stiff, dry.

End of Hole @ 0.7m in firm to stiff clay. No watertable encountered.

Photo 6: AH2 – Downhole is from left to right.
