Report Title: Geotechnical Report 34-36 Bardo Road, Newport

GEOTECHNICAL INVESTIGATION:

New Seniors Housing Complex at 34-36 Bardo Road, Newport

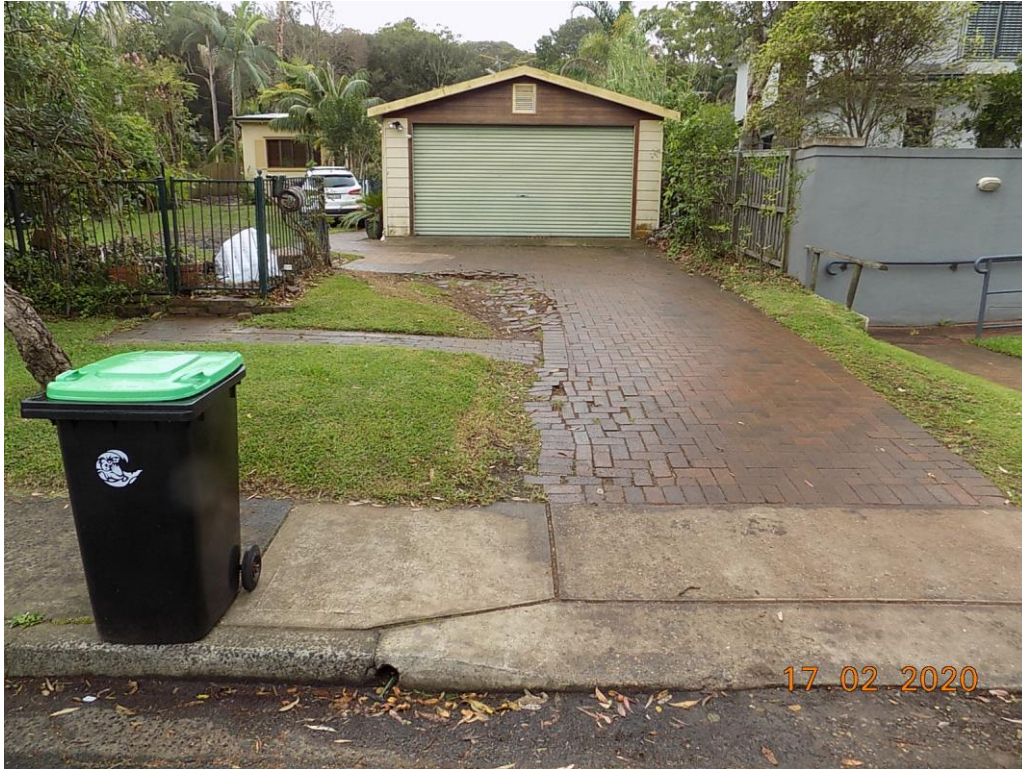
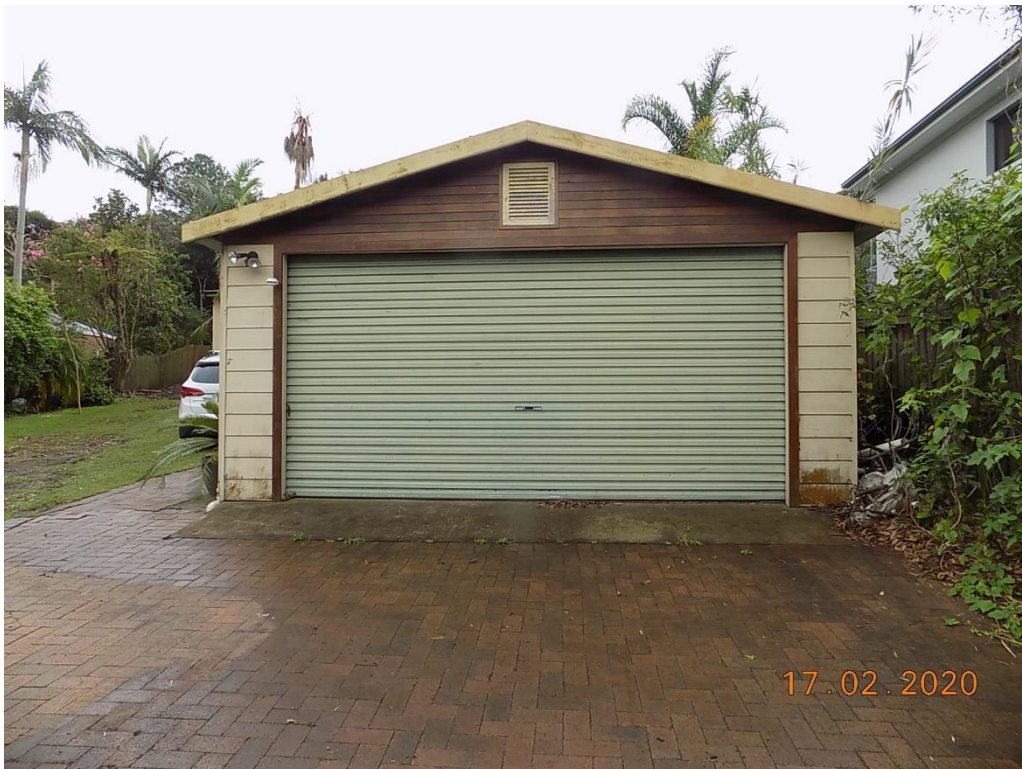
Photo 1

- 2.3 34 Bardo Road** – At the road frontage, a brick-paved driveway runs to a timber framed garage on the downhill side of the property (Photos 1 & 2). Between the garage and the house is a pool that has been cut into the slope (Photo 3). A gently sloping lawn extends off the uphill side of the house to the upper common boundary (Photo 4). The house, garage, and pool will be demolished and the site will be cleared as part of the proposed works.

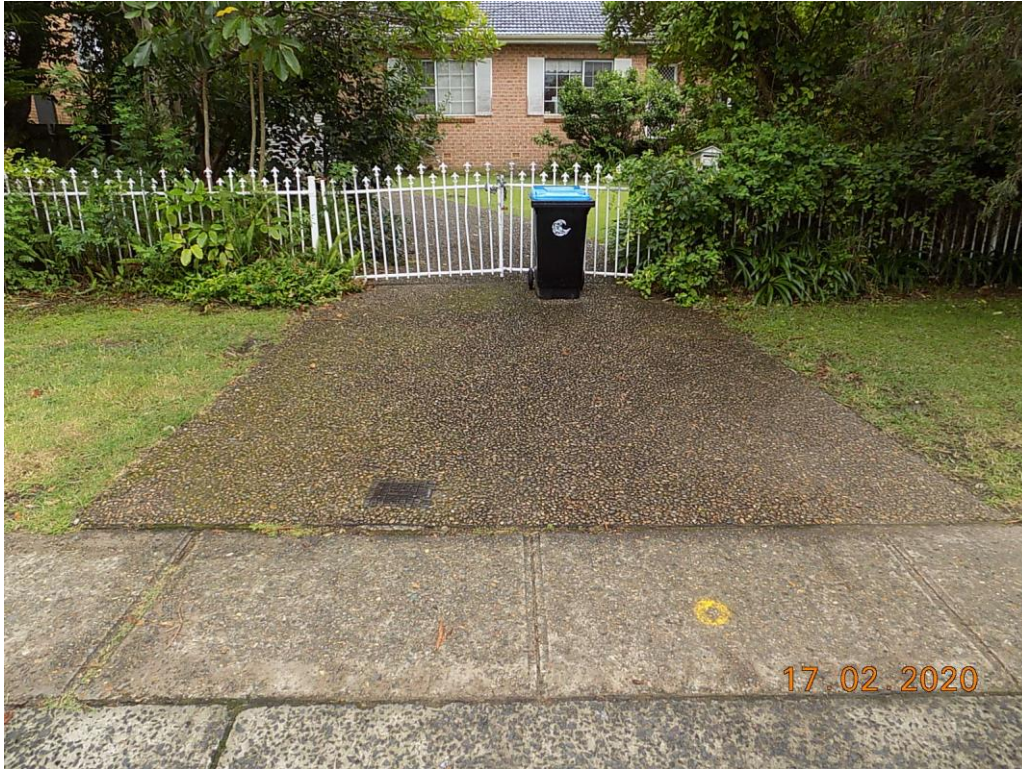
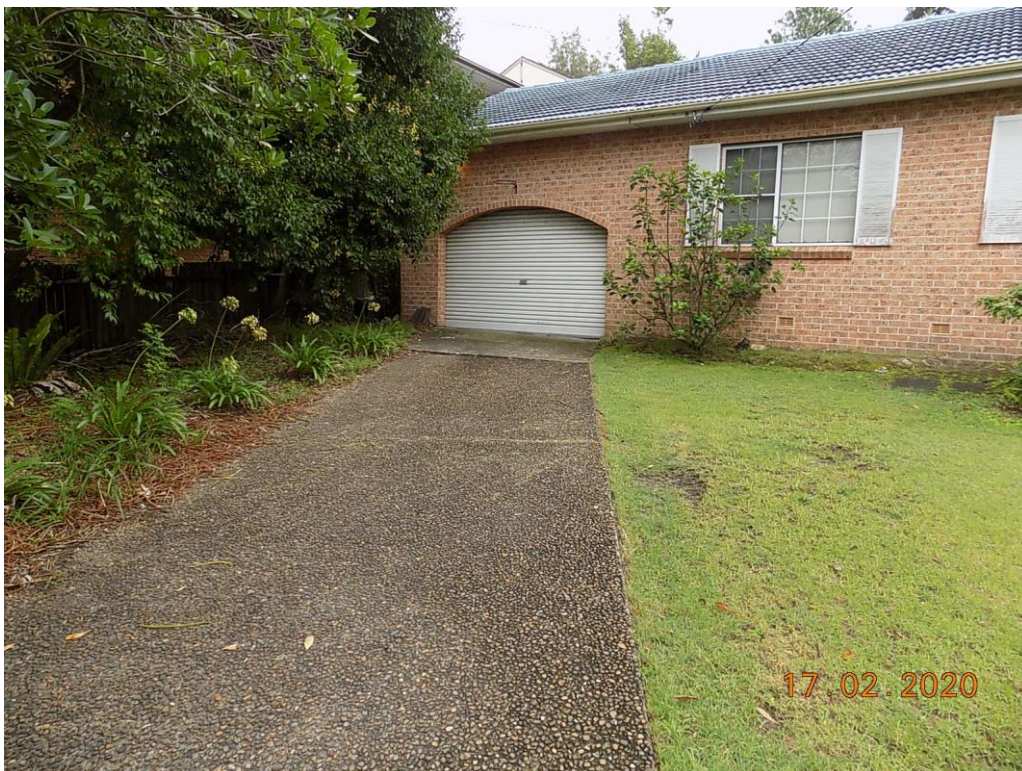
Photo 5

- 2.4 36 Bardo Road** – At the road frontage, a concrete driveway runs to a garage attached to the W side of the house (Photos 5 & 6). Between the road frontage and

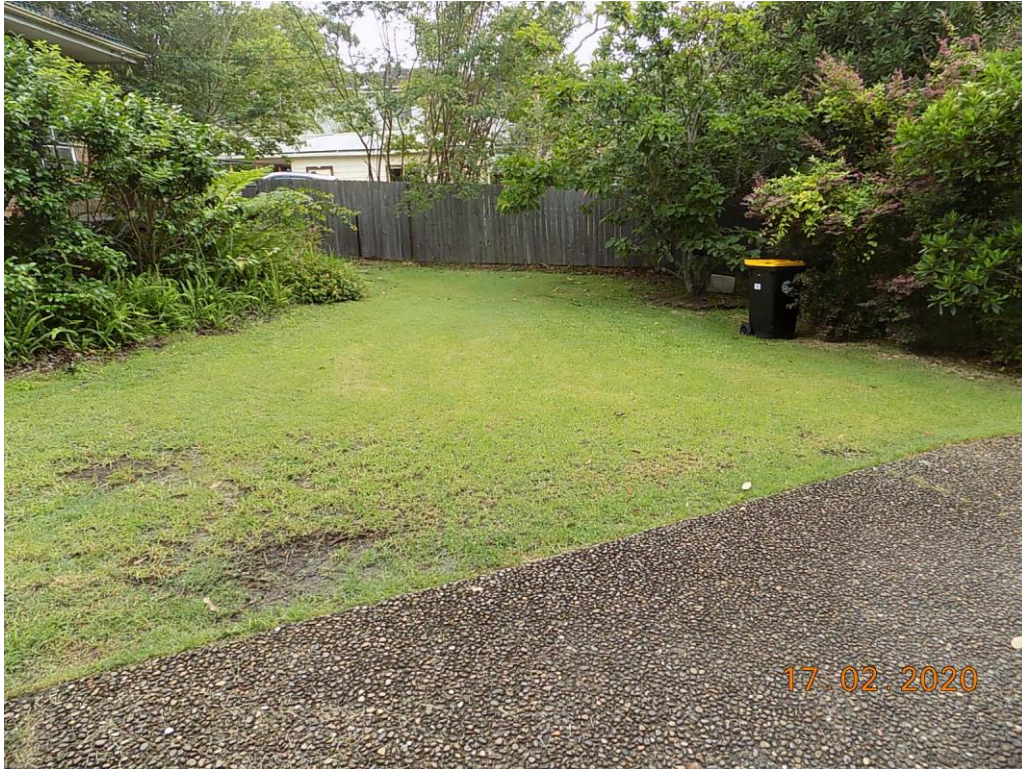
Photo 7

the house is a gently sloping lawn (Photo 7). The cut for the house is supported by a concrete block retaining wall ~1.0m high (Photo 8). Another gently sloping lawn extends off the uphill side of the house to the upper common boundary (Photo 9). The house and retaining wall will be demolished and the site will be cleared as part of the proposed works.

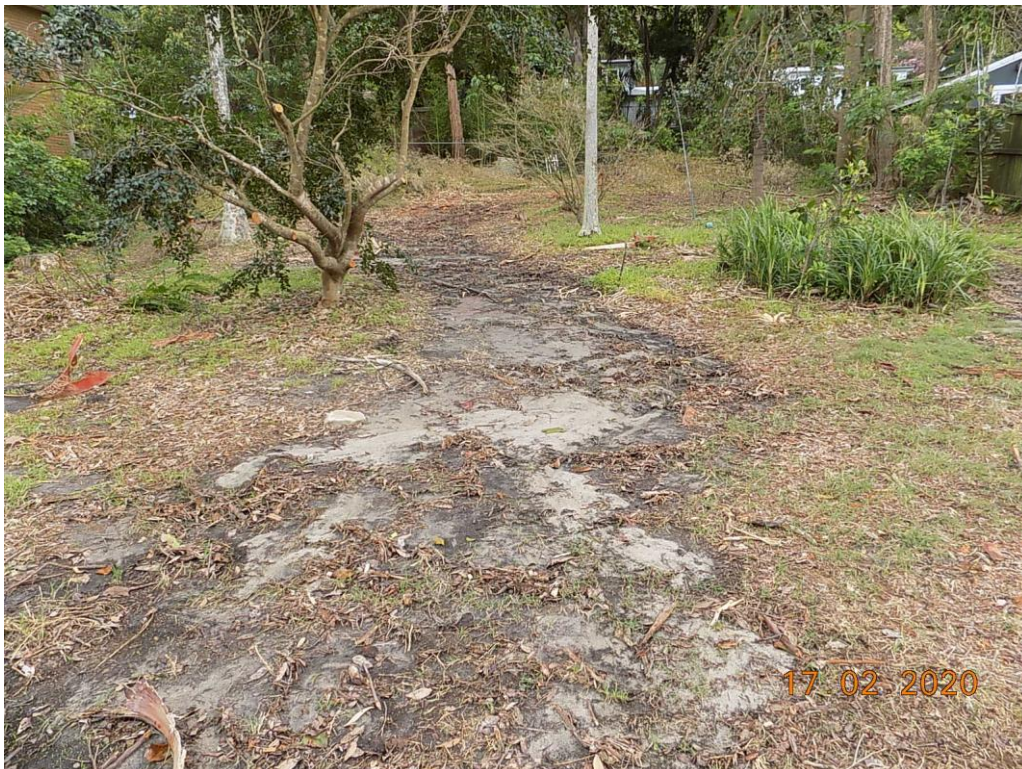
Photo 10

Evidence of surface flows were observed on the uphill side of 36 Bardo Road in the form of cleared ground cover and minor erosion of the topsoil (Photo 10). As stated above the inspection followed an extreme rainfall event. The evidence observed is likely the result of these rain events. Adequate surface drainage is to be installed as part of the proposed works.

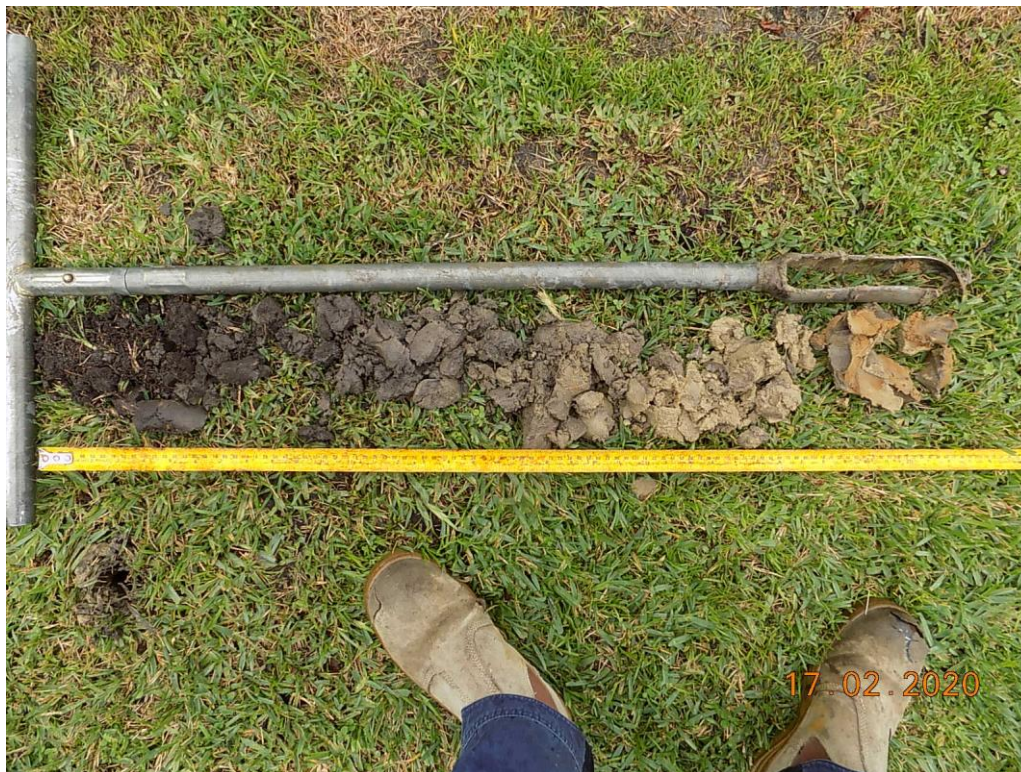
AUGER HOLE 1 (~RL18.0) – AH1 (Photo 11)

Depth (m)	Material Encountered
0.0 to 0.2	TOPSOIL , sandy soil, dark brown, very loose, dry, fine to medium grained with fine trace organic matter.
0.2 to 0.8	SAND , grey, very loose to loose, damp, coarse grained.
0.8 to 1.0	SANDY CLAY , grey and brown, soft to hard, damp, fine to coarse grained.

End of hole @ 1.0m in hard sandy clay. No watertable encountered.

Photo 11: AH1 – Downhole is from left to right.

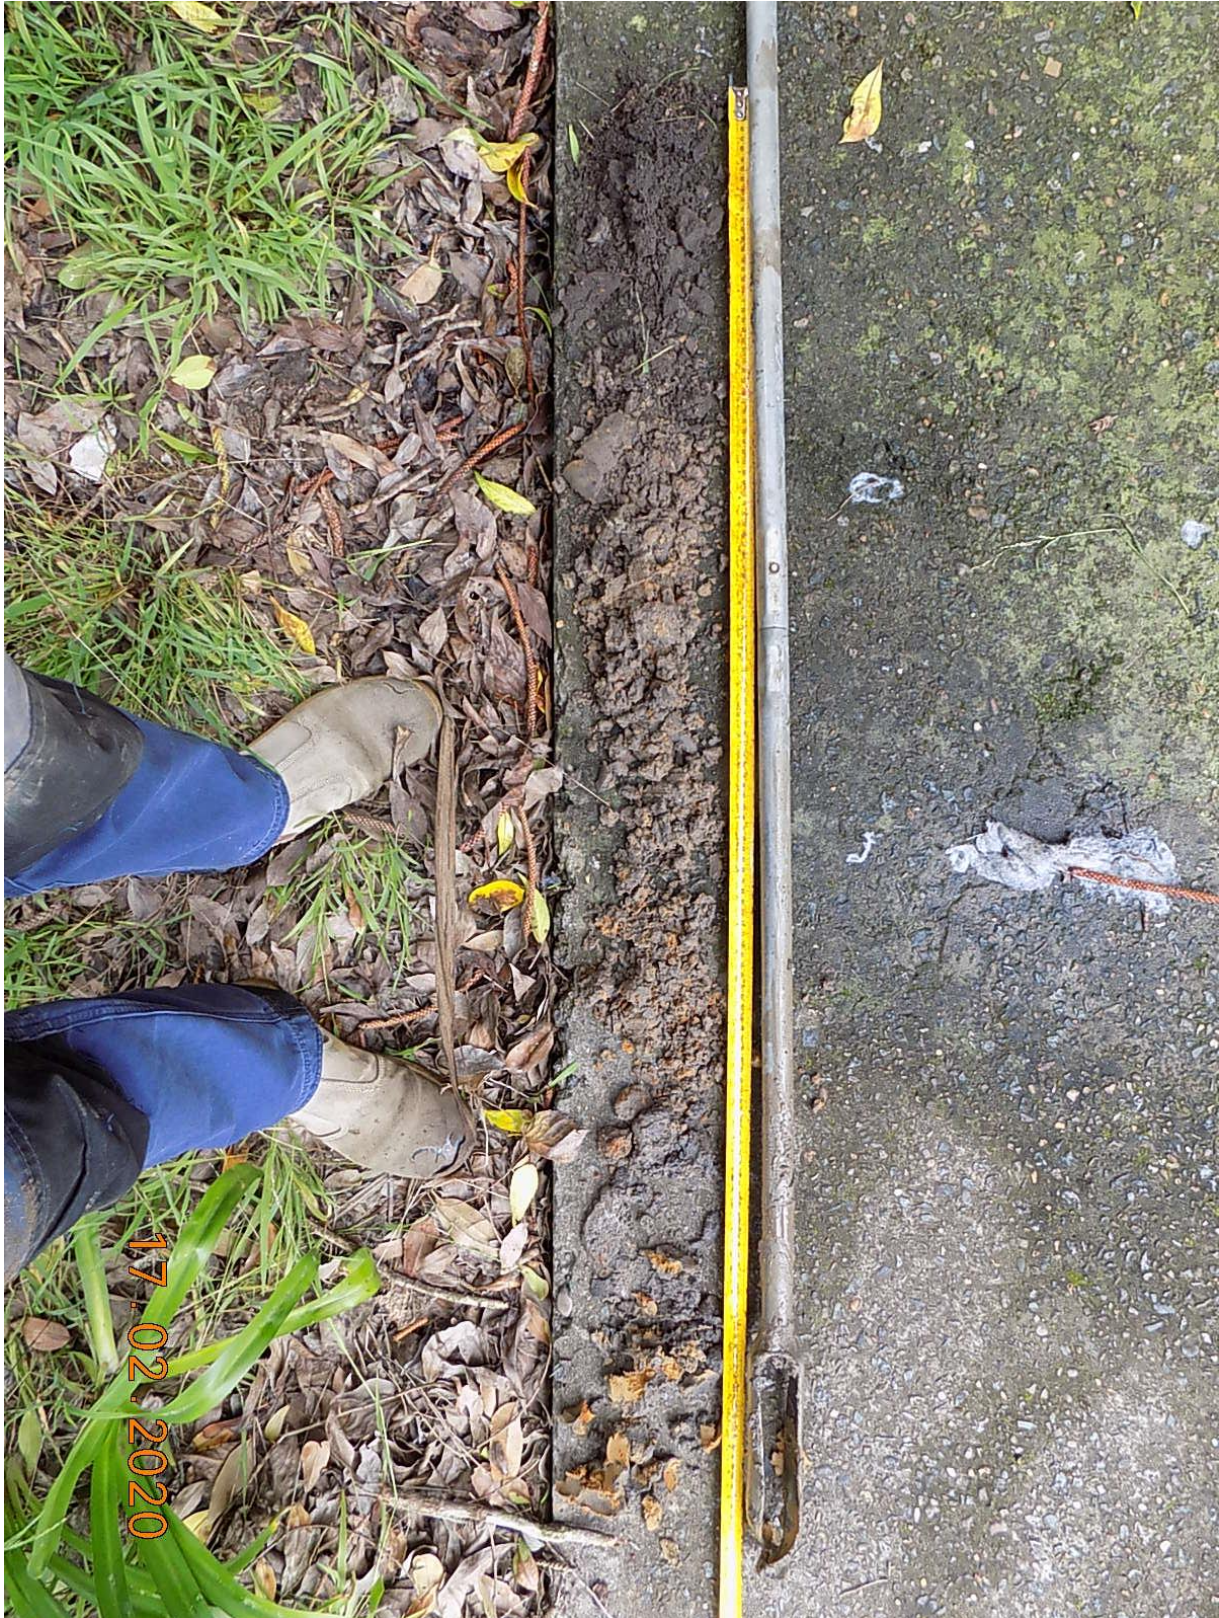
AUGER HOLE 3 (~RL15.1) – AH3 (Photo 13)

Depth (m)	Material Encountered
0.0 to 0.3	TOPSOIL , sandy soil, dark brown, very loose, dry, fine to medium grained with fine trace organic matter.
0.3 to 1.2	SAND , grey and orange, very loose to loose, wet, coarse grained.
1.2 to 1.4	SANDY CLAY , brown and orange, soft, wet, fine to coarse grained.

End of hole @ 1.4m in soft sandy clay. No watertable encountered.

Photo 13: AH3 – Downhole is from top to bottom.
