## **Marine Habitat Survey**

**Address | 24 Cabarita Road, Avalon Beach**

**Job Number 22-049-08**

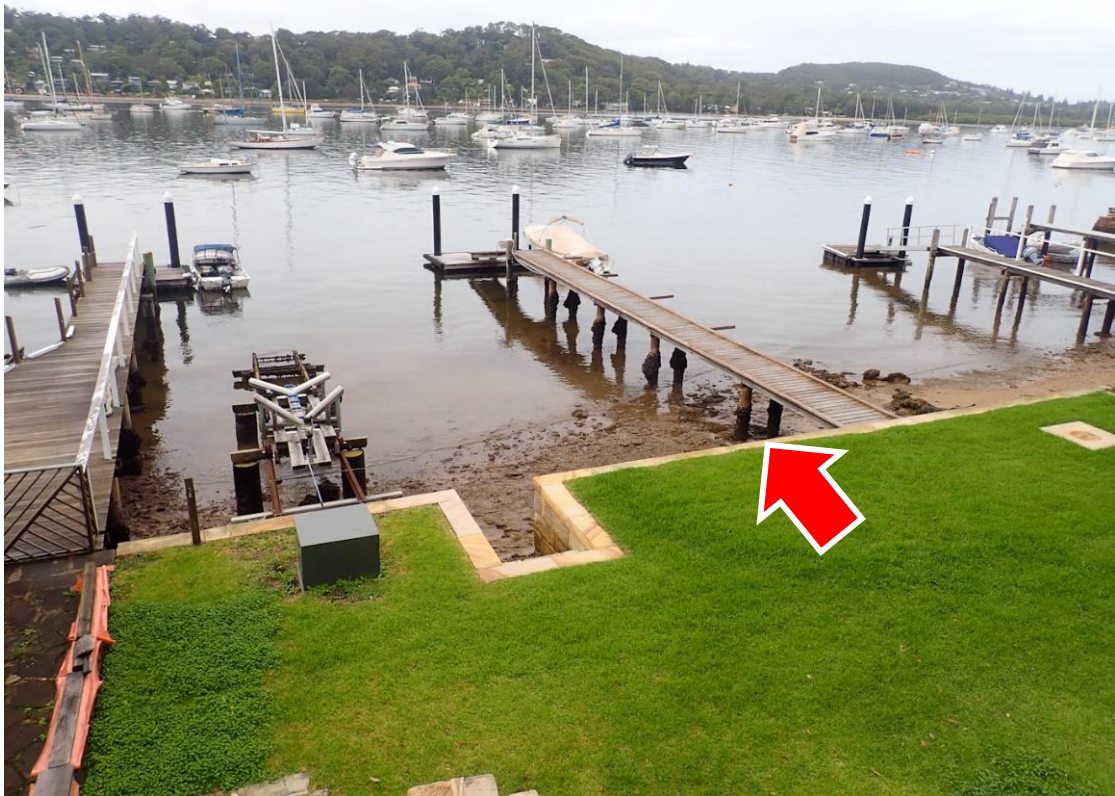
The existing structures (Photos 1 - 3) present at The Property at the time of the on-site survey included:

- a timber jetty (20.5 x 1.5 m) on the southern half of The Property, supported on 10 concrete piers and two outermost timber piles;
- a timber ramp (6 x 1.5 m);
- a pontoon (3 x 5 m) with two sleeved steel stabilising piles inset on the outer corners; and
- a set of sliprails (15 m in length) on the northern boundary of The Property, supported on sleeved concrete piers.

**Photo 1.** The existing structures at The Property (slip rails, jetty, ramp and pontoon). The red arrow indicates the location of the proposed new mesh skid ramp on the northern side of the jetty.

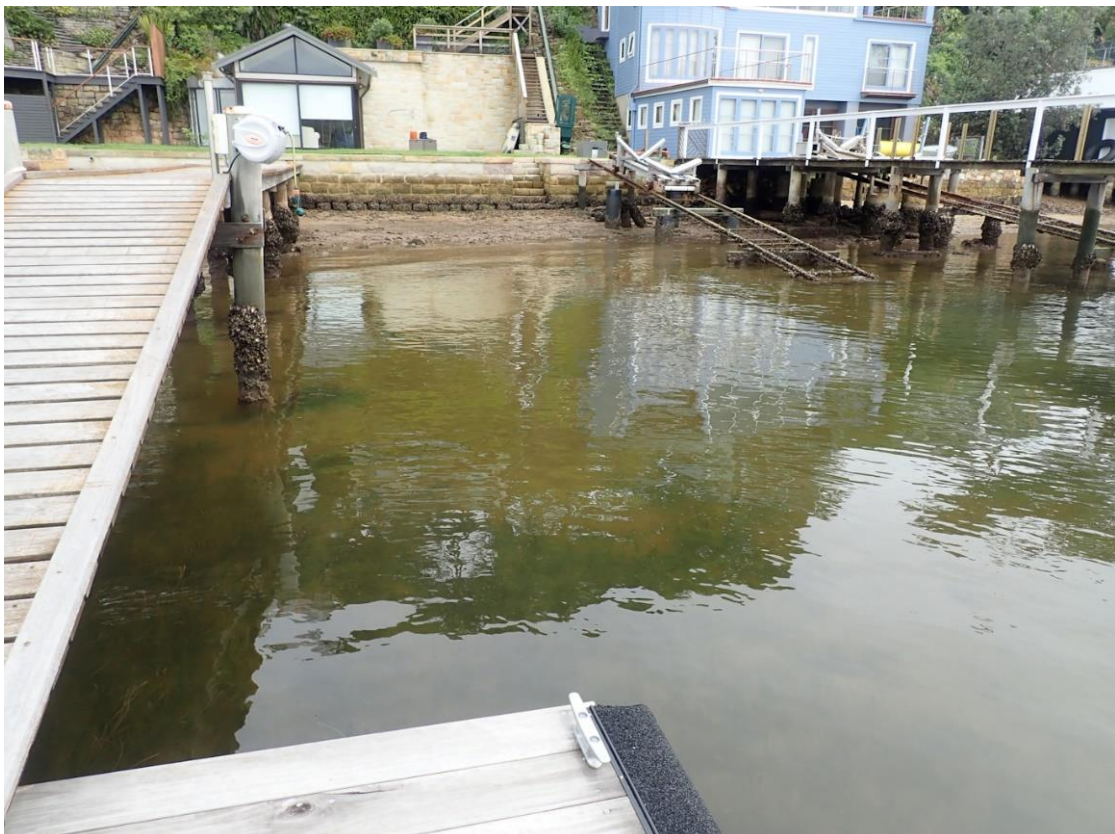
The intertidal zone at The Property consisted of artificial and natural habitats. A sandstone block seawall stretched across the width of The Property (Photos 1 - 2). The seawall was fronted by intertidal sand (Photos 2 - 3), extending out 4.5 m on the northern side of the jetty (in the location of the proposed new skid) and 6.3 m on the southern side of the jetty. The sand transitioned to an area of intertidal rocky rubble (Photo 3) that extended out to the end of the intertidal zone 9.5 m off the seawall.

**Photo 2.** The intertidal habitats of seawall fronted by sand in the location of the proposed new mesh skid ramp. The slip rails (at right) are proposed to be removed.

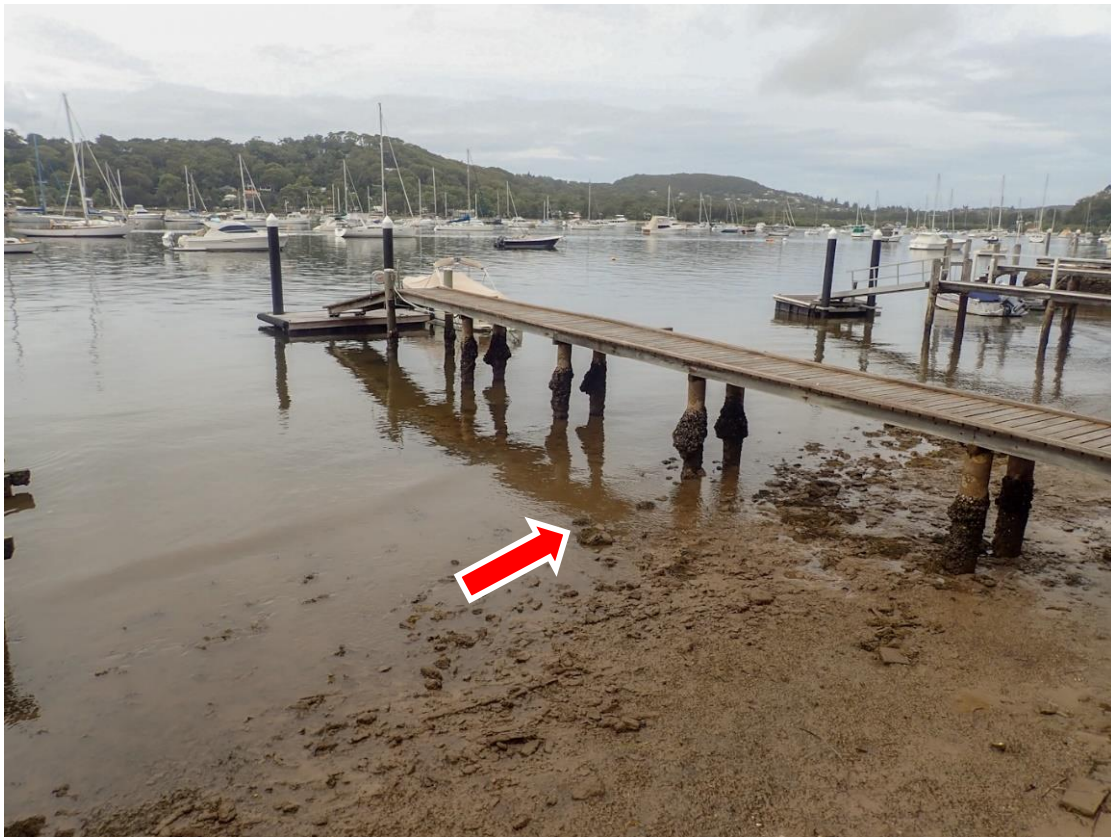
**Photo 3.** The sandy and then rocky intertidal habitat on the northern side of the existing jetty. The red arrow indicates the location of the proposed new skid piers in the rocky habitat.

The proposed new 8 m long mesh skid ramp would be located over a 3.2 m wide patch of medium density, very short-leaved *Zostera* that was growing on the intertidal sand off the front of the seawall (Photo 4). To mitigate the potential indirect shading impact from the skid ramp on the underlying seagrass, the decking would be constructed of mesh to allow adequate levels of sunlight to pass through to the underlying seagrass. In addition, the skid ramp has been designed to only have piers at its outer edge, which would be located 3 m offshore of the seagrass patch (Photo 3).

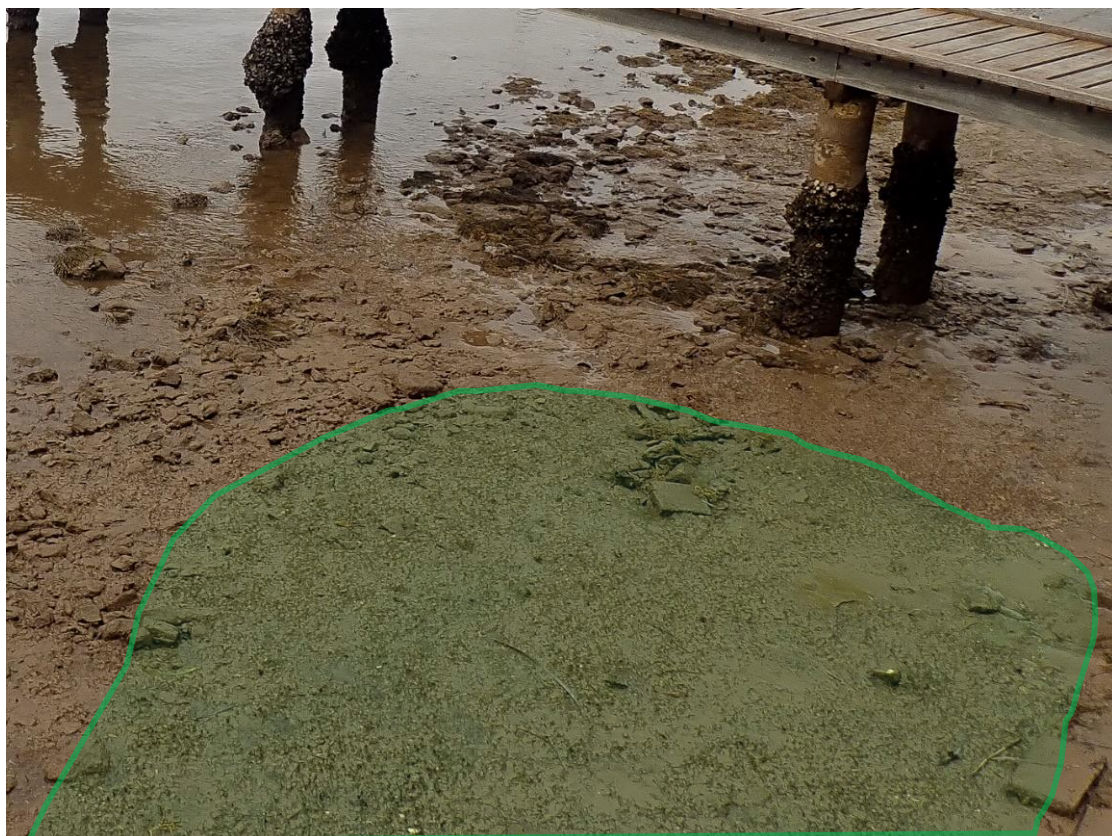
There was a patch of medium density, short-leaved *Zostera* seagrass (ZosB2S) colonising the intertidal sand area near the seawall on both sides of the existing jetty. Due to their location in the intertidal zone, the leaf length in both of these patches was very short. On the northern side of the jetty the *Zostera* patch started 1.3 m off the seawall and finished 4.5 m off the seawall (Photo 4). The proposed new mesh skid ramp would be located over this patch of *Zostera* (see seagrass map in Appendix B). The *Zostera* patch on the southern side of the jetty (and not impacted by the proposed mesh skid) was located slightly further offshore, from 4.5 - 6.8 m off the seawall.

**Photo 4.** The very short-leaved patch of *Zostera* (ZosB2S; indicated by shading) located in the intertidal sand under the proposed new mesh skid ramp.

mesh skid ramp	seagrass from shading	minimal harm to the intertidal <i>Zostera</i> seagrass patch that is located under the proposed new mesh skid ramp. To mitigate the potential indirect shading impact from the skid ramp on the underlying seagrass, the decking would be constructed of mesh to allow adequate levels of sunlight to pass through to the underlying seagrass.
----------------	-----------------------	--

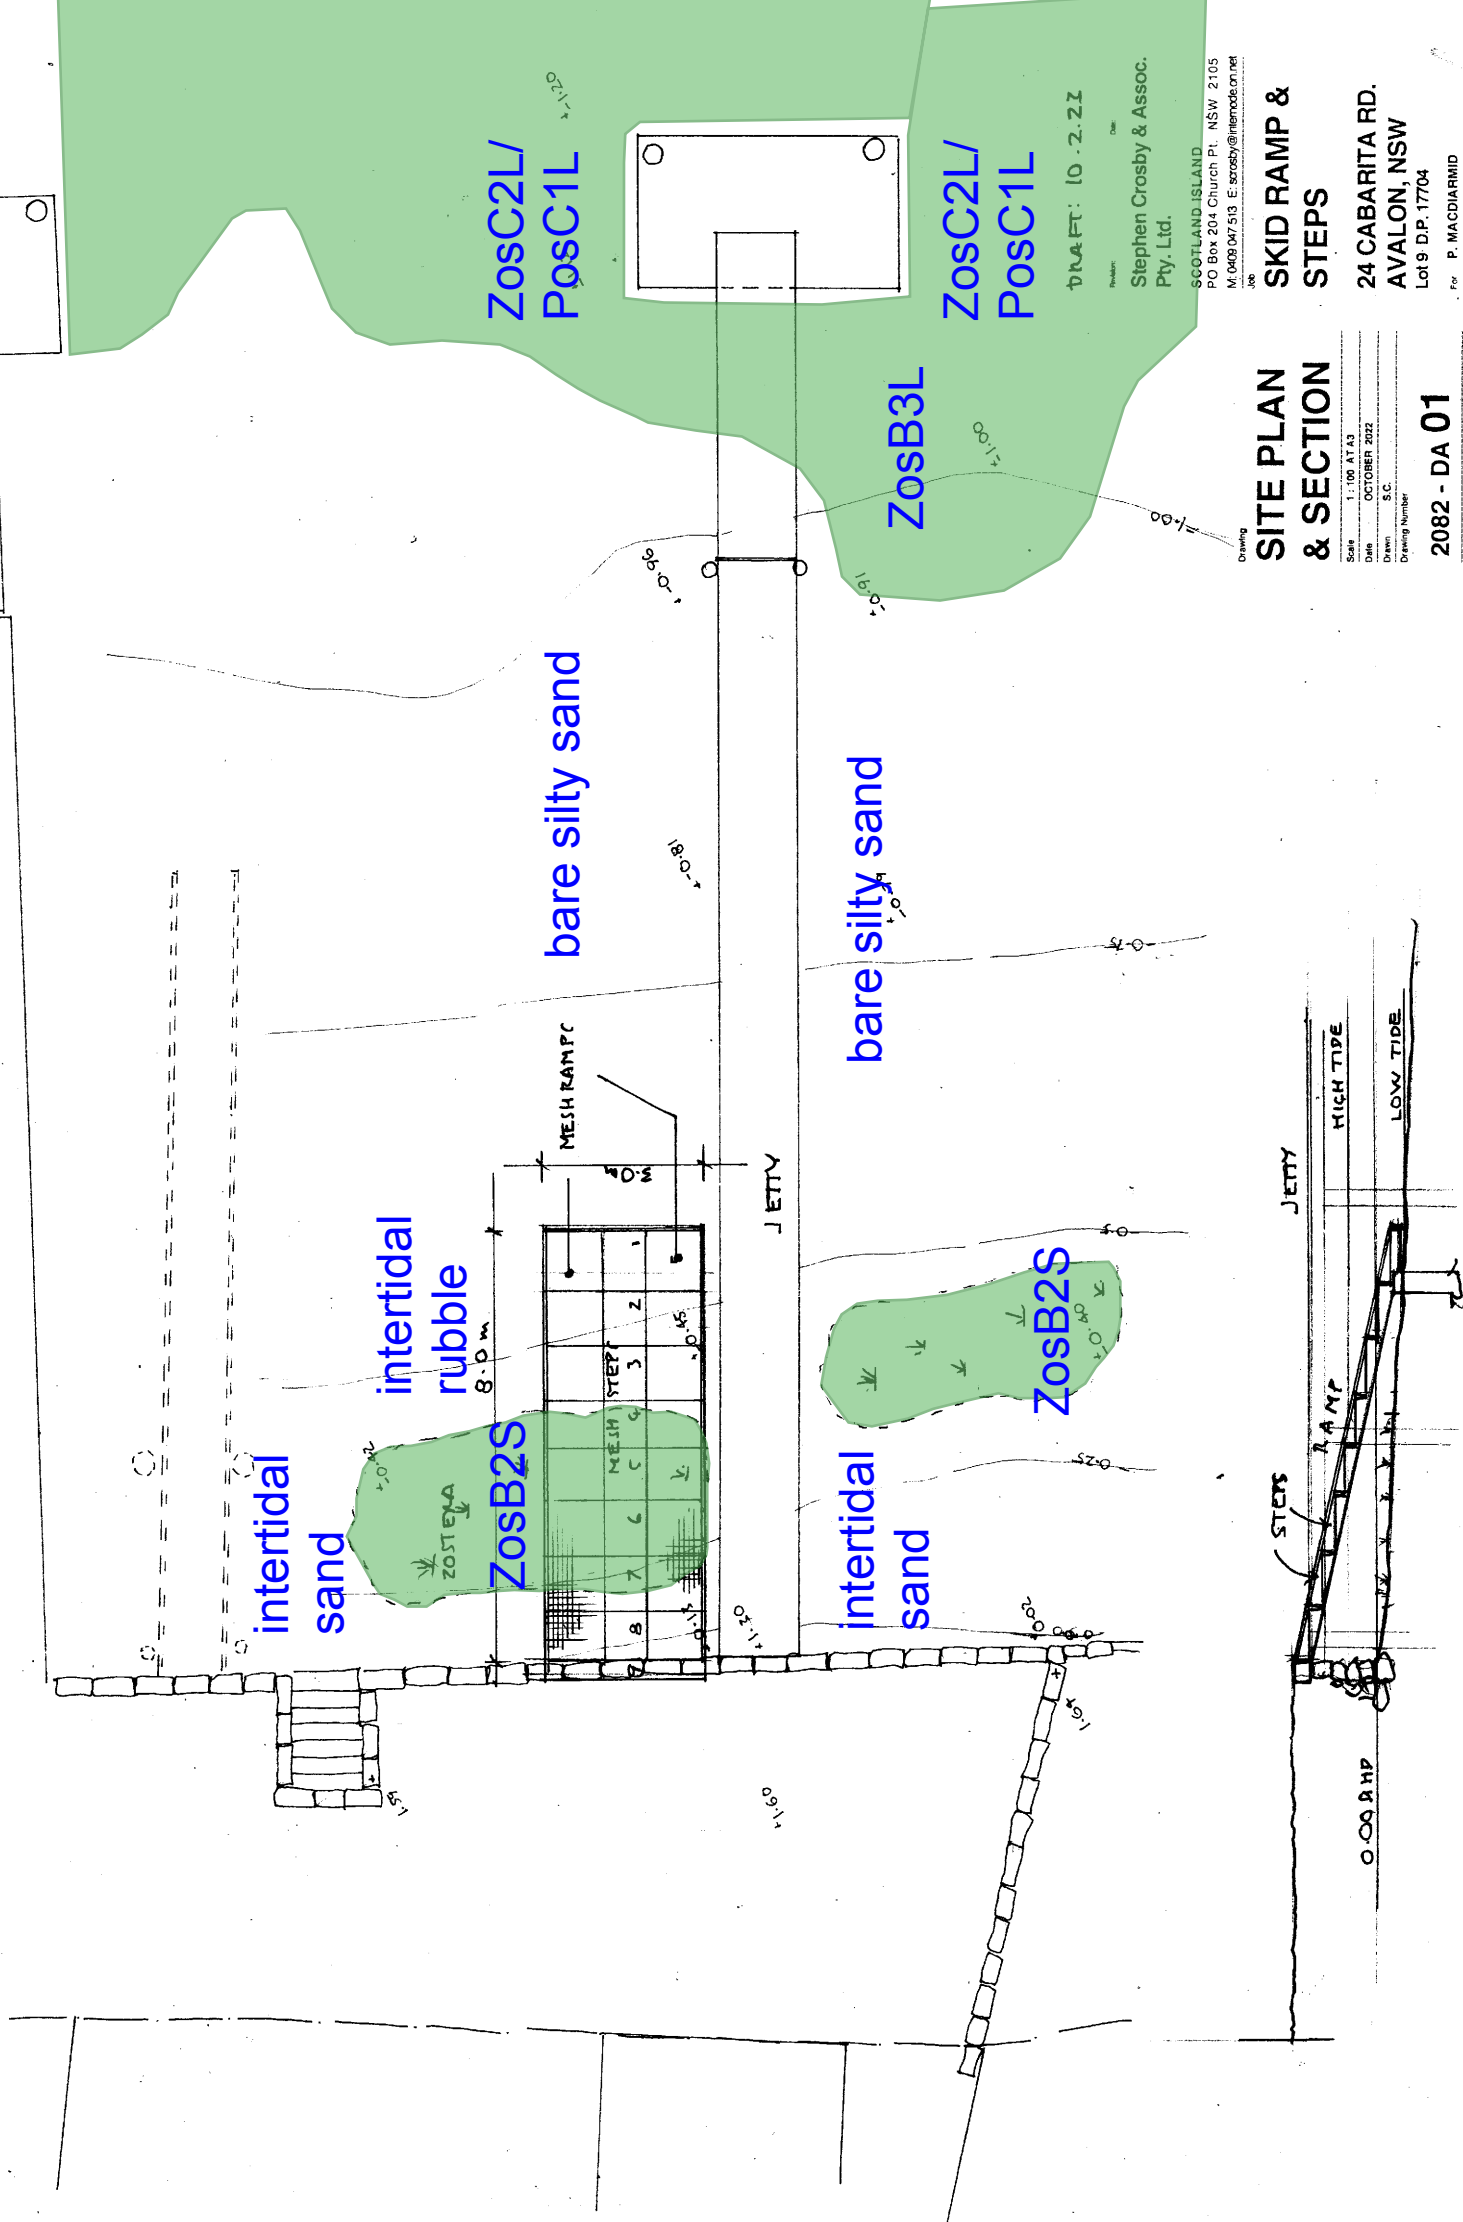
Scale 1:100 AT A3  
Date OCTOBER 2022  
Drawn S.C.  
Drawing Number  
2082 - DA 01

The subtidal seabed was unvegetated out to the end of the jetty. The seabed under and around the ramp was colonised by a large patch of high density, long-leaved *Zostera* (ZosB3L) followed by a bed of mixed *Zostera* and *Posidonia* around the existing pontoon and continuing further offshore (ZosC2L/PosC1L). The proposed new skid ramp would be located 14.5 m inshore of the *Zostera* patch (See seagrass map in Appendix B).

**SITE PLAN  
& SECTION**

**SKID RAMP &  
STEPS**
