GEOTECHNICAL INVESTIGATION

VCROSS DEE WHY PTY LIMITED

12 THE STRAND, DEE WHY

REPORT GG11775.001A 30 APRIL 2025

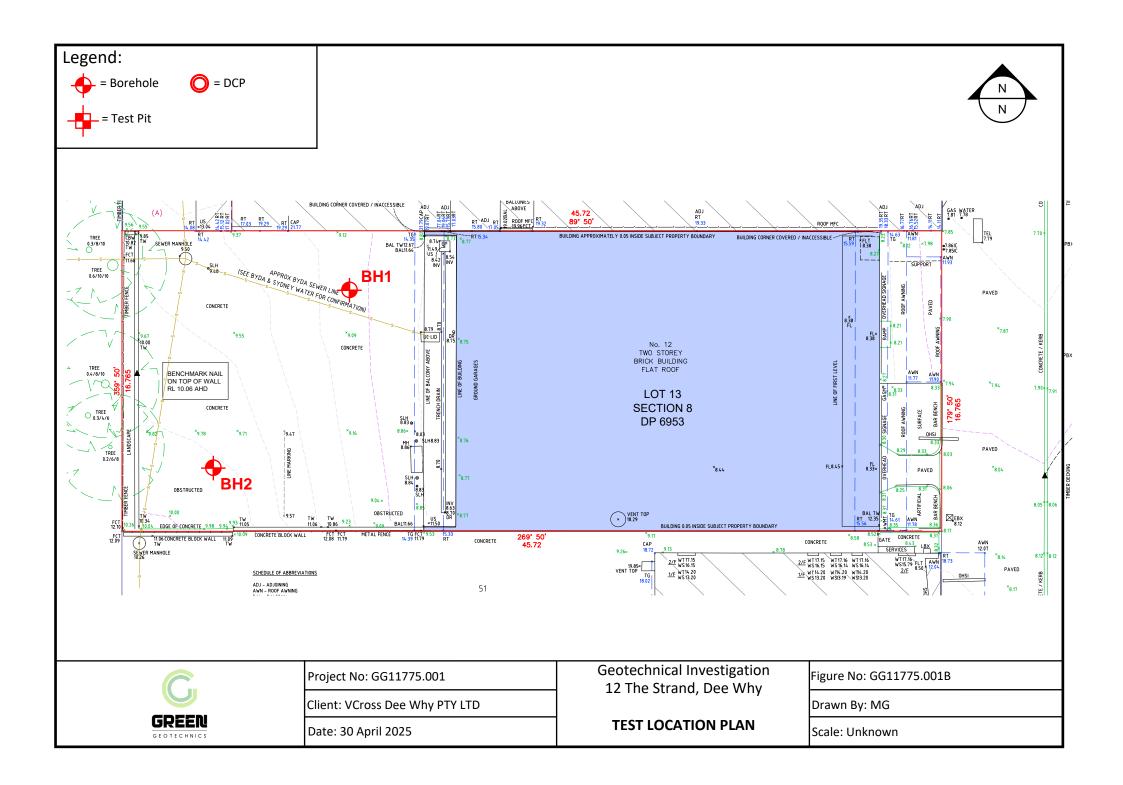
FIGURE 11775.001B – Site Plan and Borehole Locations

The site location is shown in the attached Figure A. The borehole locations, as shown on Figure B, were determined by taped measurements from existing surface features overlain on available survey drawings of the site. Photographs of the site indicating the borehole locations are shown on Figure C.
