**GEOTECHNICAL RISK MANAGEMENT POLICY FOR PITTWATER
FORM NO. 1 – To be submitted with Development Application**

Report Title: Geotechnical Report 35 Norma Road, Palm Beach
Report Date: 8/9/23
Author: BEN WHITE
Author's Company/Organisation: WHITE GEOTECHNICAL GROUP PTY LTD

GEOTECHNICAL INVESTIGATION:

Alterations and Additions at 35 Norma Road, Palm Beach

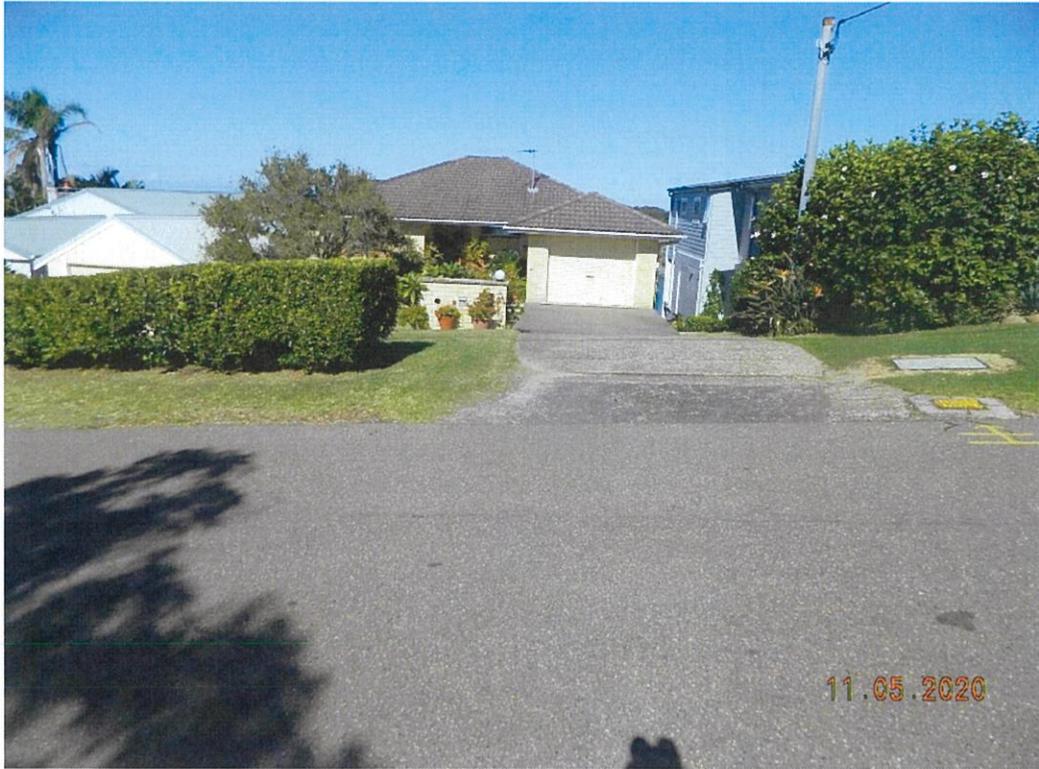
Photo 1

2.3 At the road frontage, a concrete driveway runs to a garage on the upper ground floor of the existing house (Photo 1). Between the road frontage and the house is a gently sloping lawn (Photo 2). E of the lawn is a concrete driveway and fibro garage that will be demolished as part of the proposed works (Photo 3). The cut for the driveway/garage is supported by a stable ~1.0m high sandstone dressed concrete retaining wall. The part two storey brick house is supported on brick walls (Photos 2 & 4). The external brick walls show no significant signs of movement.

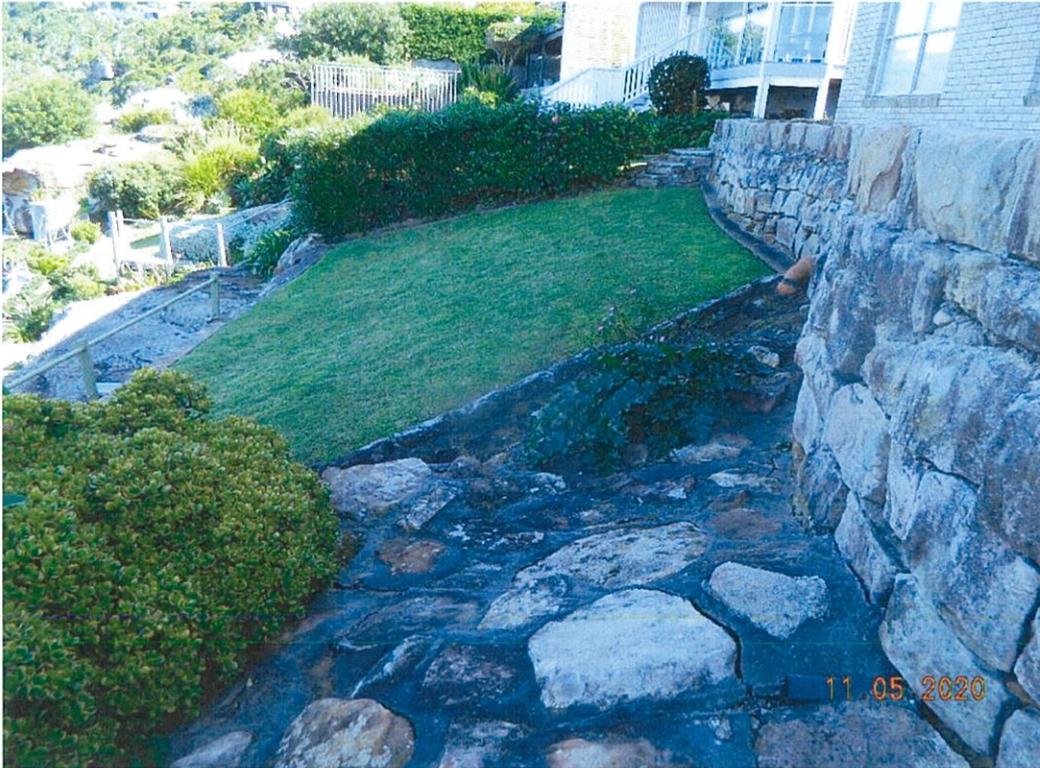
Photo 5

A sandstone pavement extends off the downhill side of the house. A stable sandstone block retaining wall up to ~1.6m high supports the fill underneath the pavement (Photo 5). A moderately sloping lawn extends downhill from the retaining wall. Fill at the SE corner of the lawn is supported by a ~1.3m high brick retaining wall in good condition. Sandstone bedrock is outcropping at the SW corner of the lawn (Photo 6). A portion of the rock is undercut ~1.5m (Photo 7). Given the thickness of the cantilever arm and no visible presence of defects in the arm, the undercut is considered to be stable. The outcropping sandstone bedrock steps down the property (Photos 8 & 9). A lawn extends from the bottom of the outcropping rock to a concrete block retaining wall (Photo 10). The retaining wall supports the lawn fill and is in good condition. Sandstone boulders around and on the lawn are considered to have come to rest in their current positions before the lawn area was developed. They are considered to be in stable positions. The overall slope across the property is considered stable.

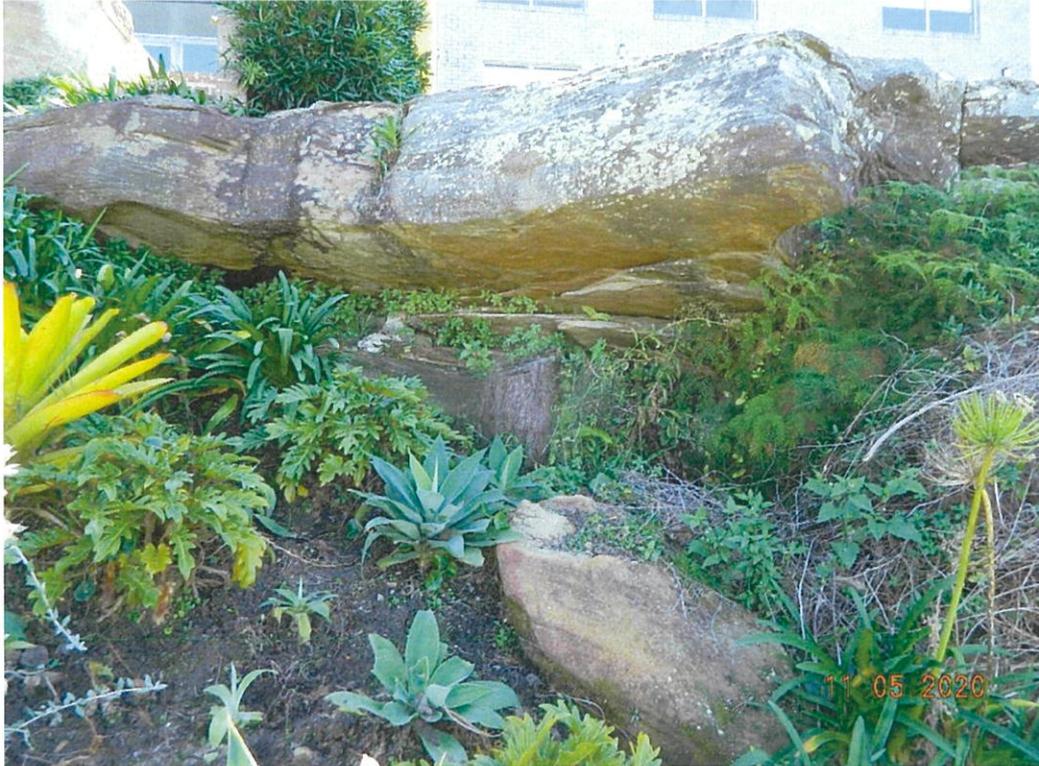
Photo 7

We estimate the foundations for the proposed retaining wall to support the fill on the downhill side of the property will be in the close vicinity to outcropping undercut rock immediately downslope (Photo 7). No foundations are to extend over undercut rock. If this can't be avoided the undercut rock is to be supported with blade walls designed by the structural engineer in consultation with the geotechnical consultant.

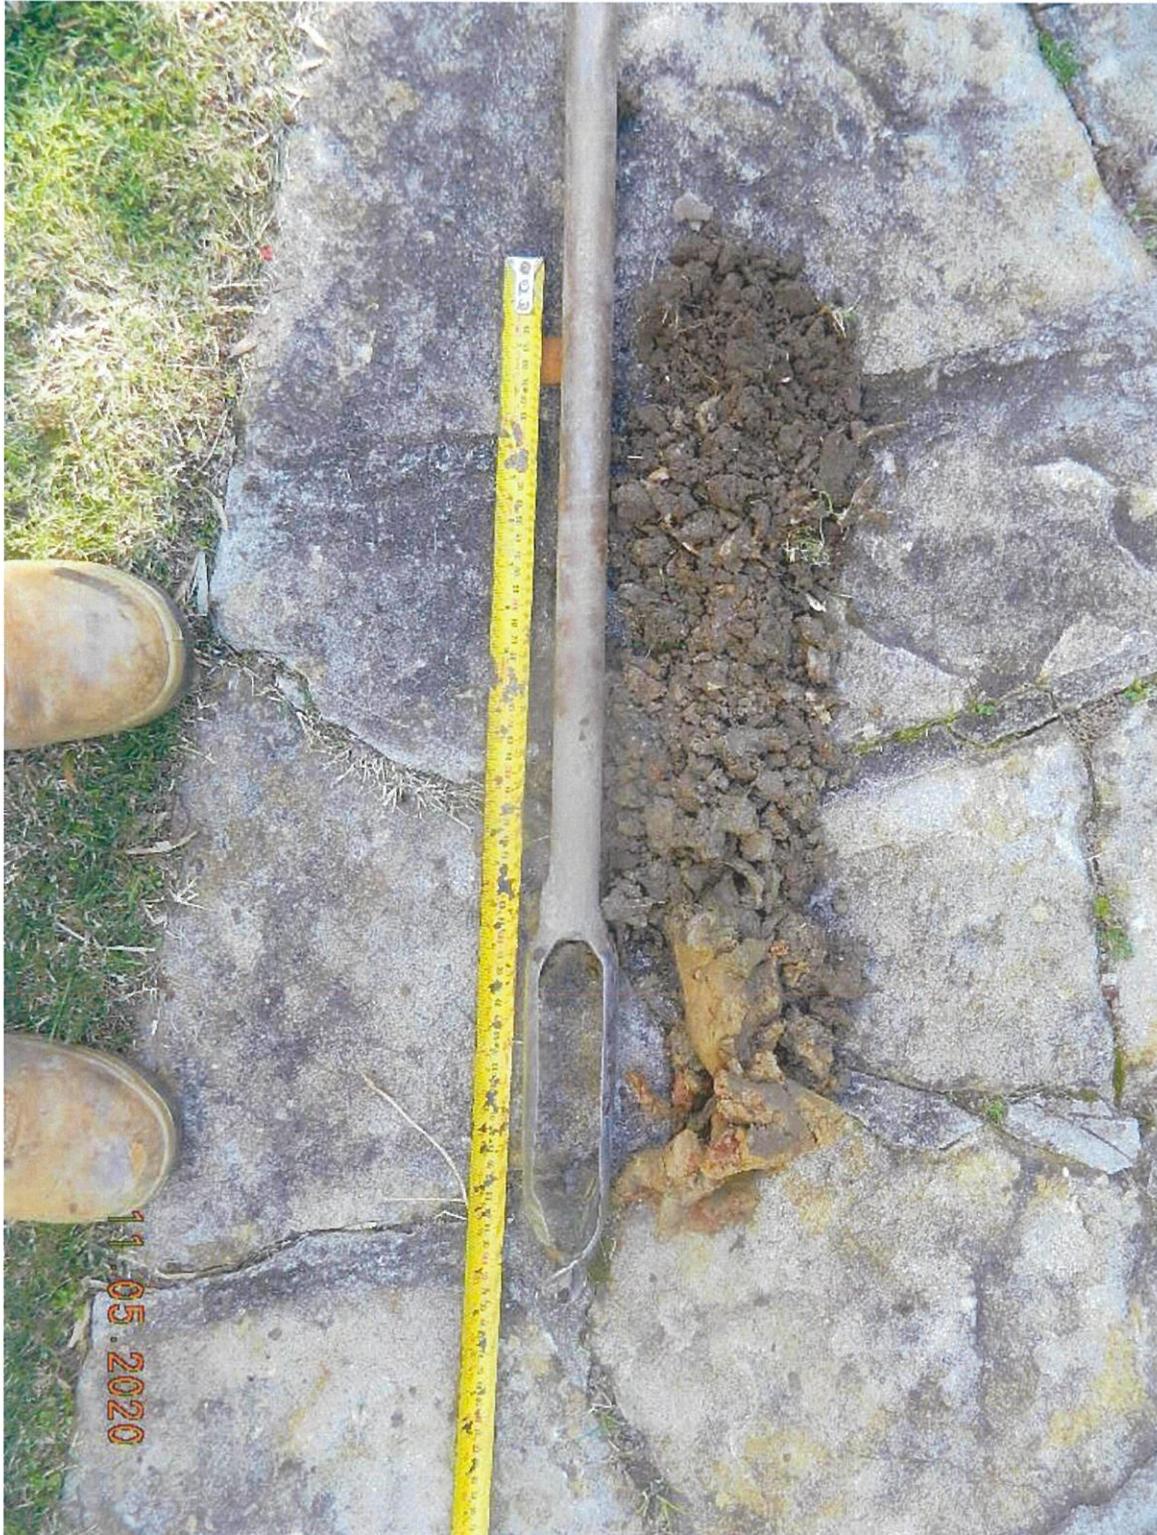
Photo 11: AH1 – Downhole is from top to bottom

AUGER HOLE 1 (~RL72.8) – AH1 (photo 11)

Depth (m)	Material Encountered
0.0 to 0.3	TOPSOIL , sandy soil, brown, damp, fine to medium grained with fine trace organic matter.
0.3 to 0.4	CLAYEY SAND , grey, damp, fine to medium grained.
0.4 to 0.6	CLAY , orange brown, firm to stiff, moist.

End of Test @ 0.6m in firm to stiff clay. No watertable encountered.

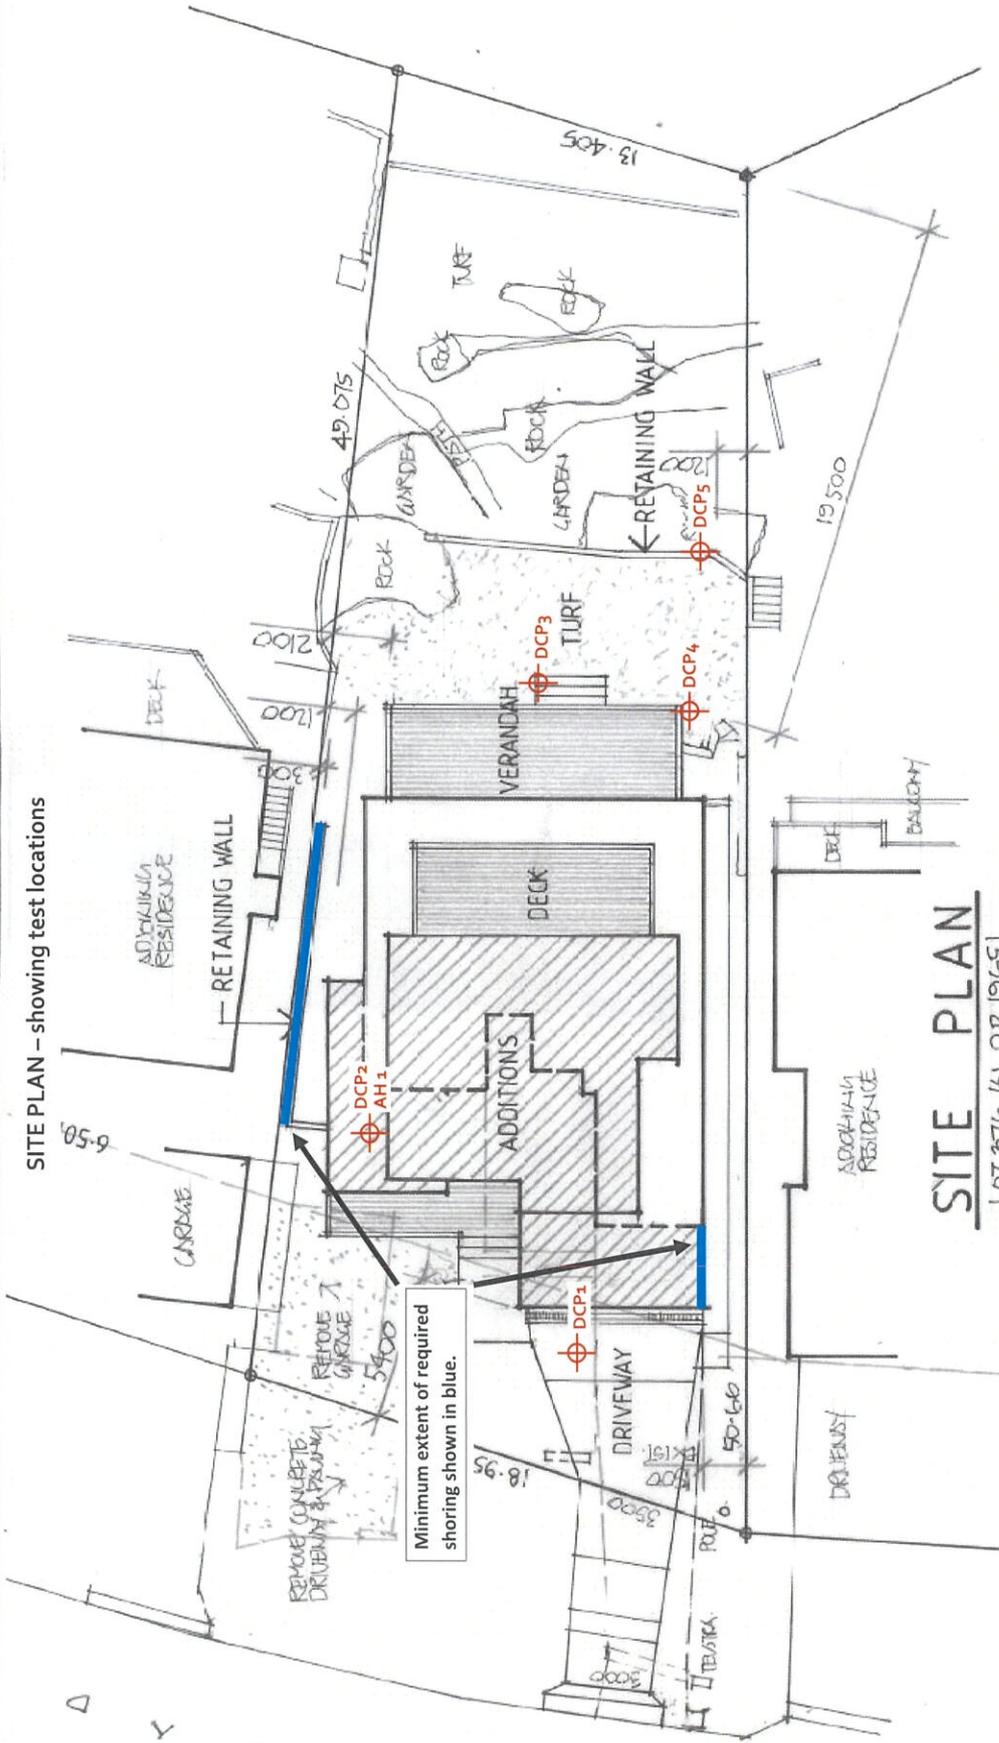
SITE PLAN - showing test locations

One auger hole (AH) was put down to identify the soil materials. Five Dynamic Cone Penetrometer (DCP) tests were put down to determine the relative density of the overlying soil and the depth to bedrock. The locations of the tests are shown on the site plan attached. It should be noted that a level of caution should be applied when interpreting DCP test results. The test will not pass through hard buried objects so in some instances it can be difficult to determine whether refusal has occurred on an obstruction in the profile or on the natural rock surface. This is not expected to be an issue for the testing on this site. But due to the possibility that the actual ground conditions vary from our interpretation there should be allowances in the excavation and foundation budget to account for this. We refer to the appended "Important Information about Your Report" to further clarify. The results are as follows:

Minimum extent of required shoring shown in blue.

excavation process in a staged manner, so cut batters through soil, sand, clay and rock up to Low Strength are not left unsupported. The support will need to be designed by the structural engineer. See the site plan attached for the minimum extent of the required shoring shown in blue.
