**REPORT ON GEOTECHNICAL SITE INVESTIGATION**

**PROPOSED ALTERATIONS AND ADDITIONS**

**18 – 20 STURDEE LANE, LOVETT BAY**

**Project No.: 2018-116.2**

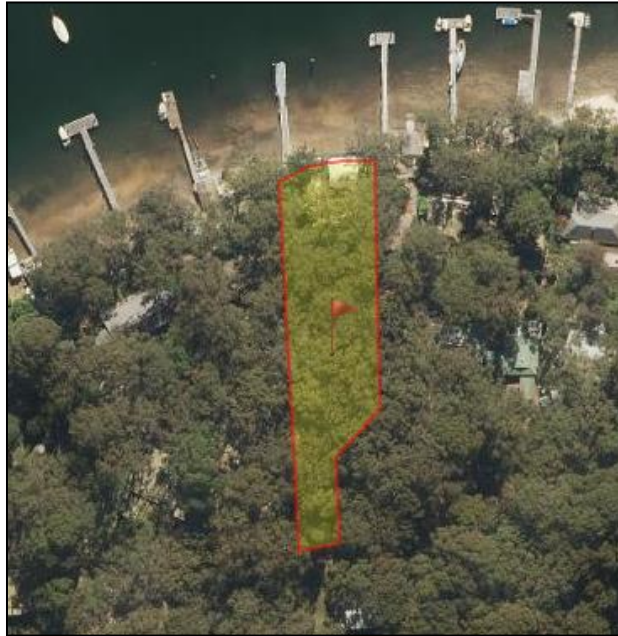
*Photograph 1: Aerial photo of site and surrounds*

An aerial photograph of the site and its surrounds is provided below (Photograph 1), as sourced from NSW Government Six Map spatial data.

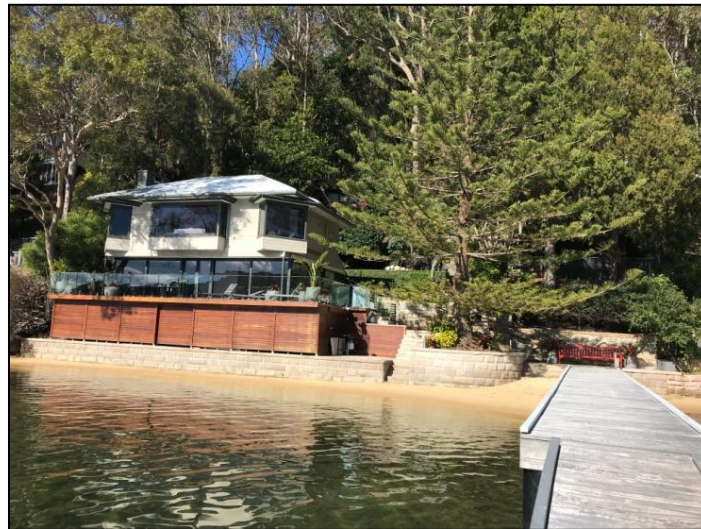
The site dwelling comprises a two storey weatherboard house with a one storey timber cabin at the rear and a jetty at the front. Two general views of the site are shown in Photograph 2 and Photograph 3.

*Photograph 2: View of the front of site looking south from the property jetty.*

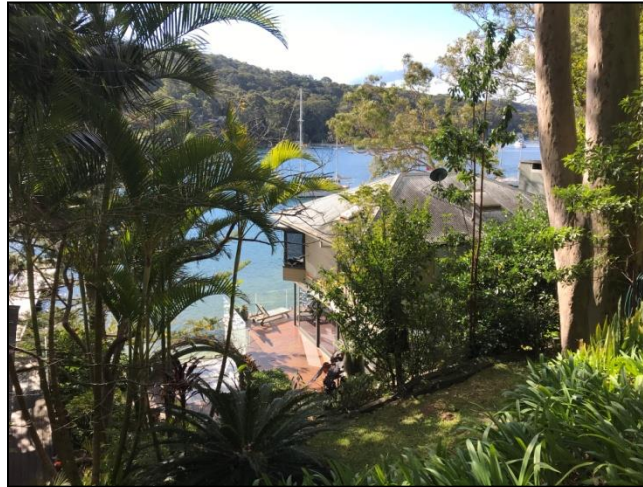
*Photograph 3: View of the rear of existing house, looking north.*

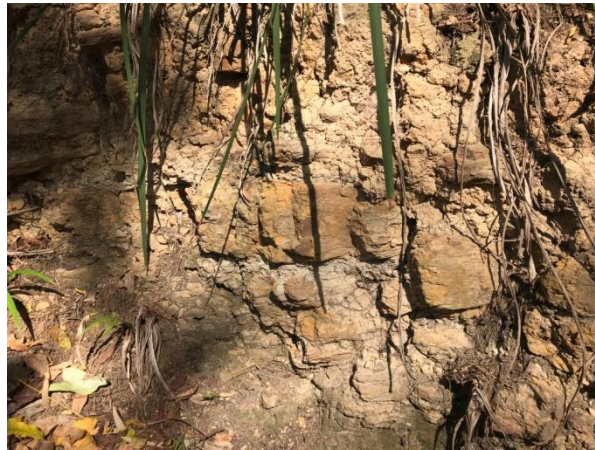
The front of the site contains a two storey weatherboard house that is in reasonable condition and does not display any obvious signs of cracking or distress. The timber cabin to the rear of the site residence is accessed via winding pathway that traverses the site adjacent to a number of gardens supported by retaining walls  $\leq 1.50\text{m}$  in height. Where the path has been cut into the existing stone, interbedded low strength sandstone and very low strength mudstone was observed (see Photograph 4 below).

*Photograph 4: Interbedded sandstone and shale adjacent to the pathway.*

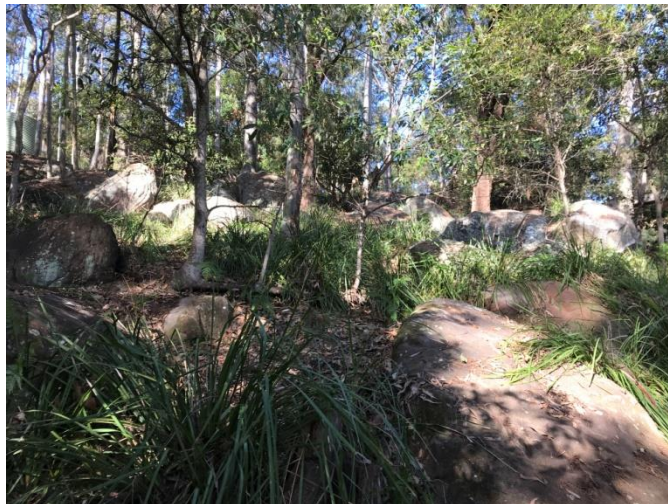
The remainder of the site contains a winding pathway, which leads to Sturdee Lane at the rear of the site, and gardens containing moderate levels of vegetation. Sandstone boulders are visible throughout the upper (south) end of the site however were not observed in the vicinity of the proposed excavation. (Photograph 5).

*Photograph 5: Sandstone boulders located in the upper south end of the site.*

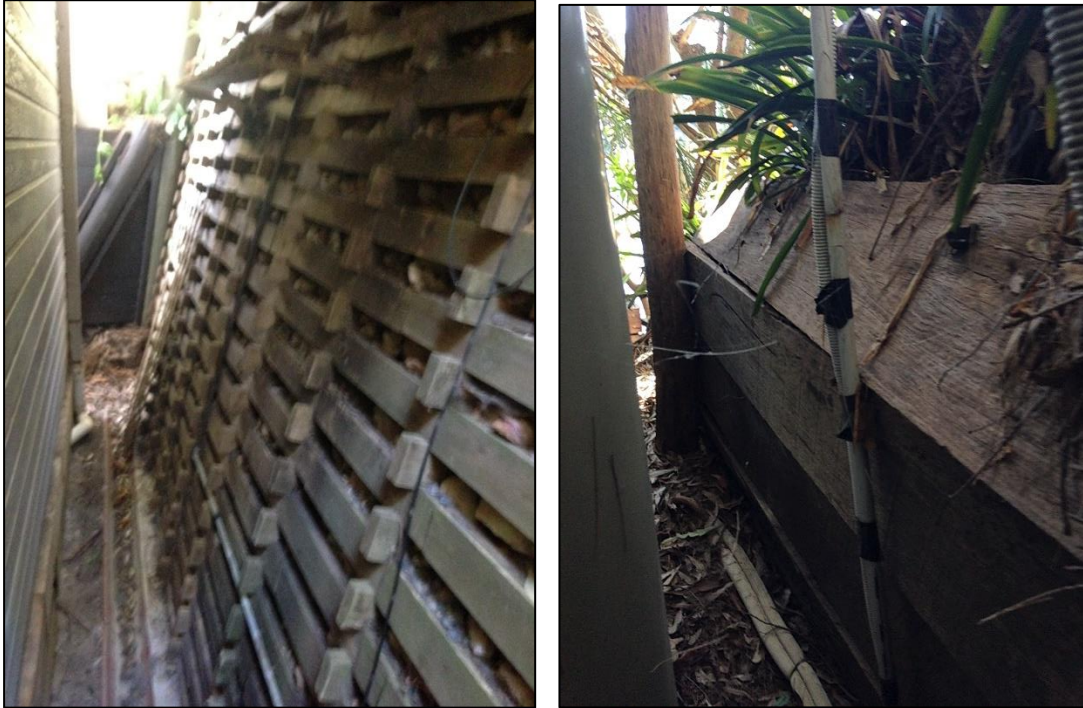
A timber crib retaining wall supports the first floor at the rear of the rear of the existing house which appears in good condition and did not display any signs of cracking or rotation and is shown in Photograph 6. Some degradation of a timber retaining wall to the east of the site was displaying some minor degradation (See Photograph 7).

*Photograph 6 and 7: Crib retaining wall below rear of existing residence (6) and timber retaining wall supporting the property to the east.*

4.3.3. Retaining Structures:	
Required	Replacement of existing retaining structures (or improvement of retaining wall footings may be required to as part of the proposed development.
Types	Steel reinforced concrete/concrete block walls post excavation, or installed progressively during excavation designed in accordance with Australian Standards AS4678-2002 Earth Retaining Structures.
Parameters for calculating pressures acting on retaining walls for the materials likely to be retained:

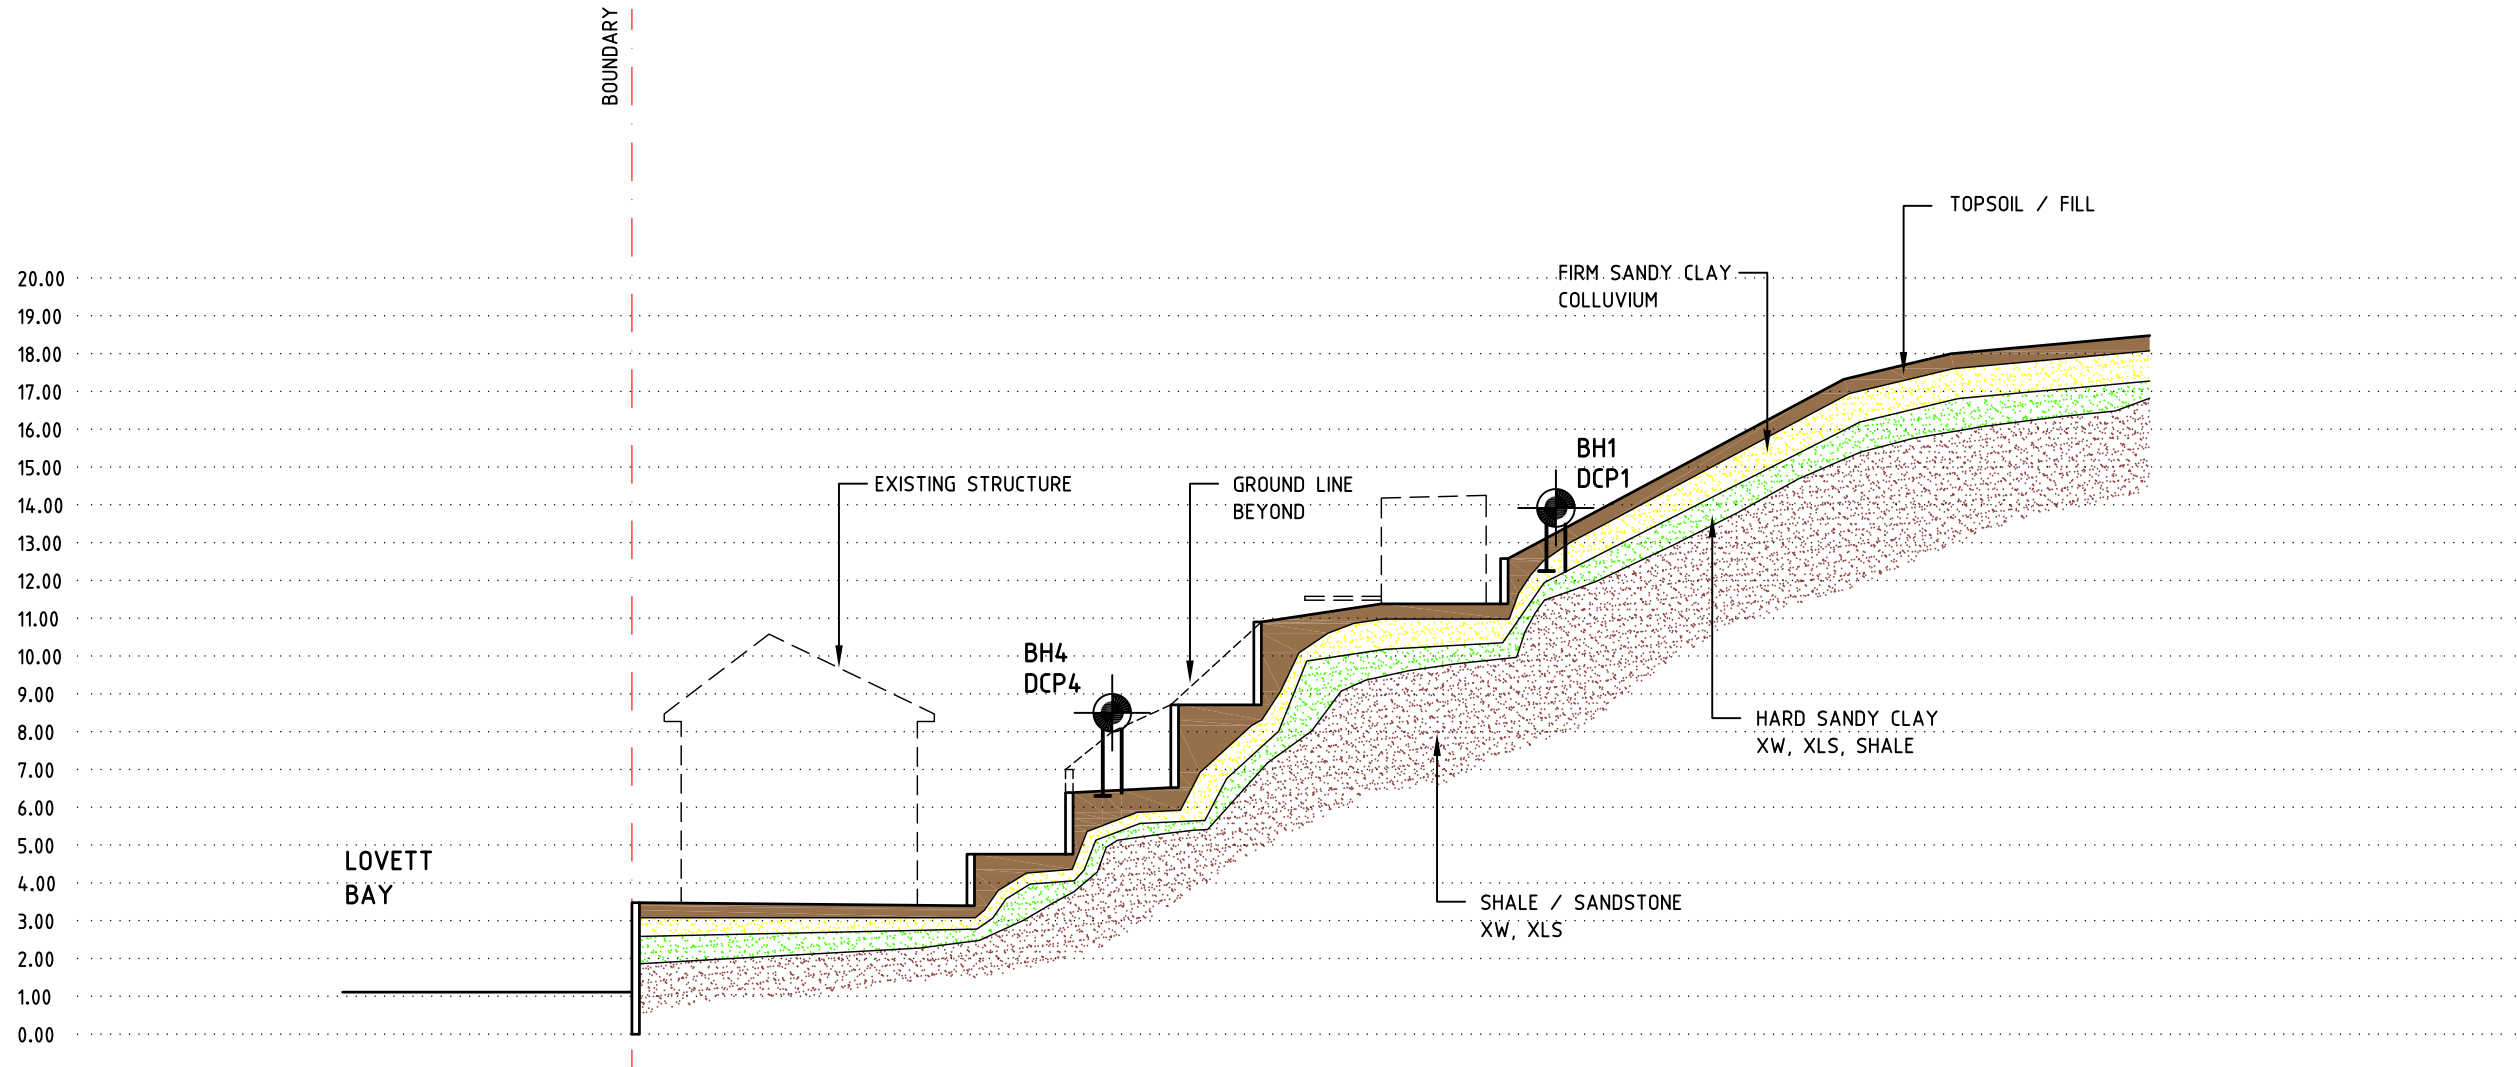
FIGURE 2

INTERBEDDED SHALE / SANDSTONE  
 VERY LOW STRENGTH /  
 LOW STRENGTH

GEOLOGICAL MODEL
