Report Title: Geotechnical Report 7 - 8 Coronation Street, Mona Vale
Report Date: 29/9/21

GEOTECHNICAL INVESTIGATION:

New Unit Building at **7 - 8 Coronation Street, Mona Vale**

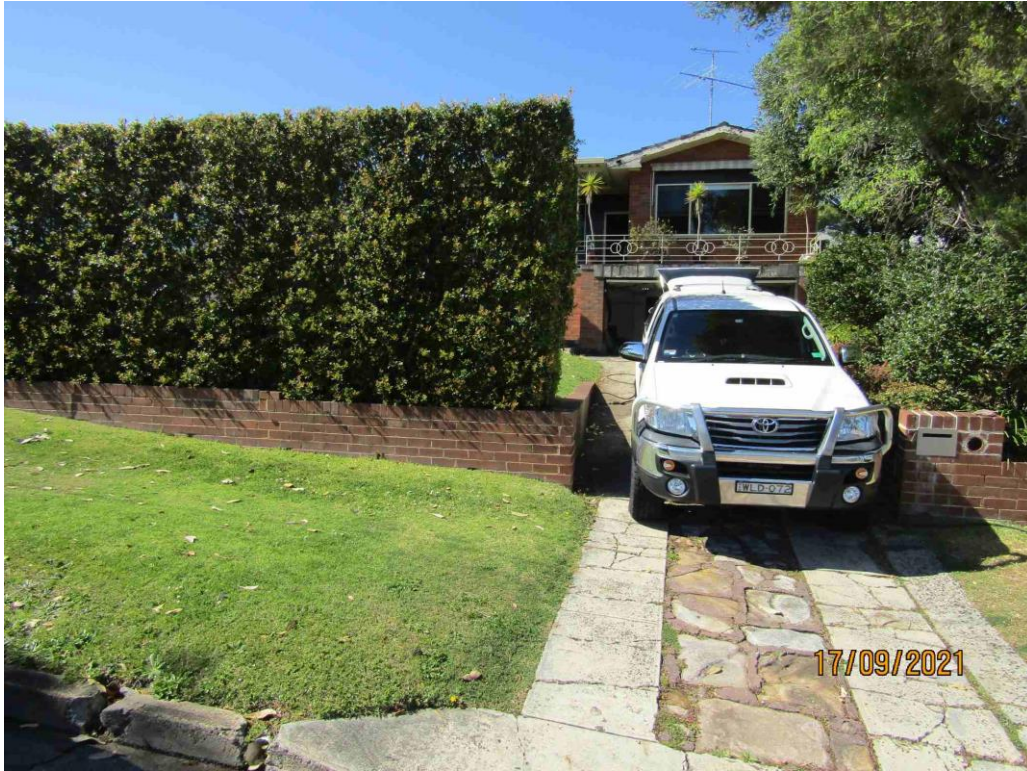
Photo 1

- 2.3 7 Coronation St, Mona Vale:** At the road frontage, a concrete driveway runs to a garage attached to the house (Photo 1). Between the road frontage and the house is a gently sloping lawn. The single storey brick house with garage below is supported by brick walls and brick piers (Photos 2 & 3). The external supporting walls show no significant signs of movement. A concrete driveway runs along the NE side of the house to a concrete parking area on the uphill side of the house (Photos 2 & 4). A pool

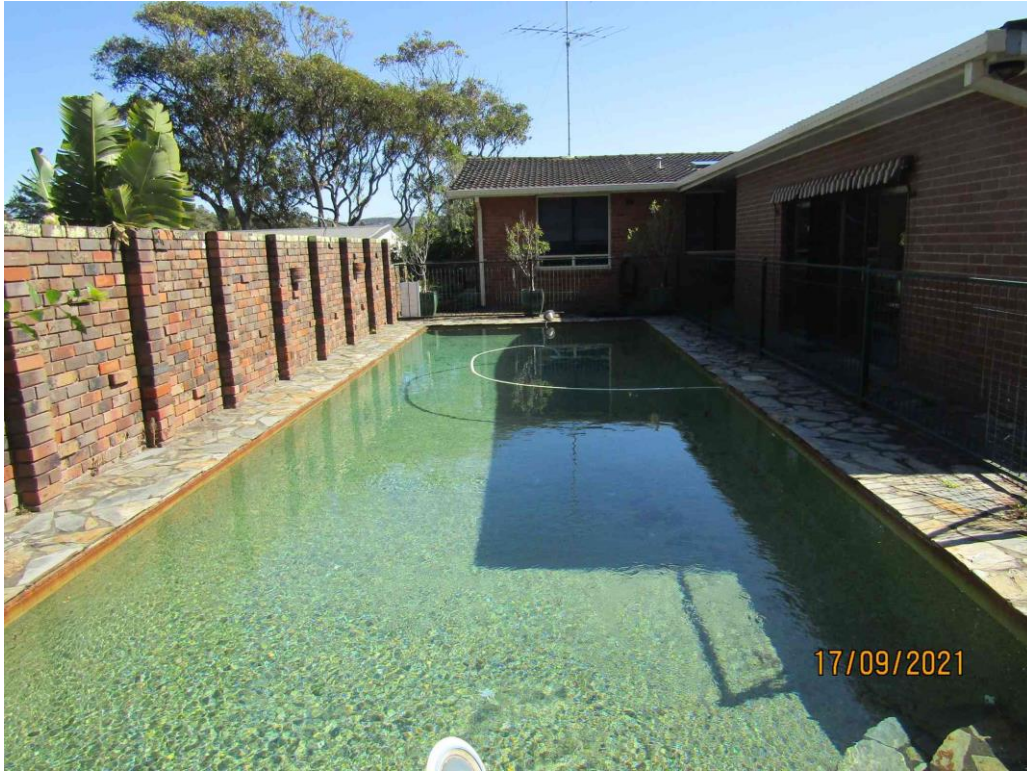
Photo 3

and paved area are located beside the parking area (Photo 3). A cut and a fill level the parking and paved area. Brick and concrete block retaining walls/fences up to ~3.0m high support the cut and fill for the paved area, and support fill on the uphill neighbouring property (Photos 3 & 4). The retaining portions of the walls are up to ~1.8m high. The NE and SE walls display vertical, horizontal and stepped cracks through the mortar. Part of the SE wall is tilting downslope slightly. The walls are currently braced with timber placed vertically against the walls and acrow props angled against the walls. The parking area, pool and pavement will be filled in as part of the proposed works and the upper fences will be demolished. The retaining portions of the walls will remain and be filled in on the downhill side and be buried as part of the proposed works. The adjoining neighbouring properties were observed to be in good order as seen from the street and subject property.

Excavation spoil from the proposed excavation will be placed to fill in the existing paved area (Photos 3 & 4), part of the existing pool (Photo 3) and will be placed directly above the uphill portion of the proposed basement to provide a lawn area.

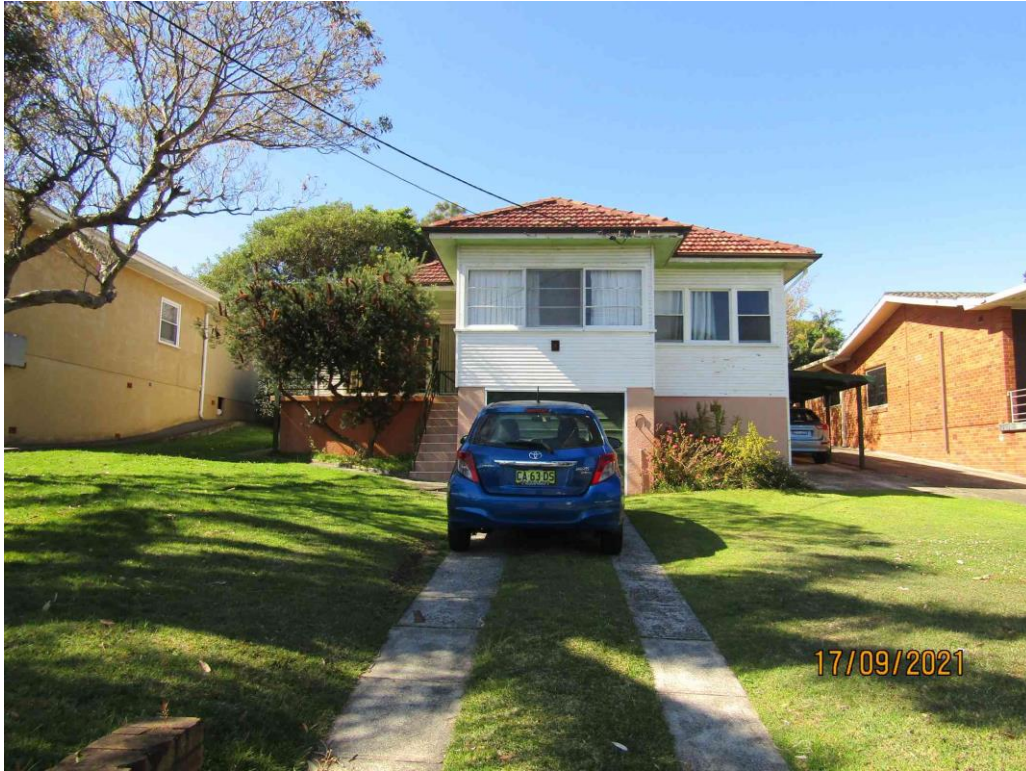
Photo 5

2.4 8 Coronation St, Mona Vale: At the road frontage, a concrete and concrete stripped driveway runs to a garage attached to the house (Photo 5). A concrete carport is located on the SW side of the house. Between the road frontage and the house is a gently sloping lawn. The single storey rendered masonry and vinyl clad house is supported by masonry walls (Photos 5 & 6). The external supporting walls show no significant signs of movement. A patio and gently sloping lawn extends off the uphill side of the house (Photos 6 & 7).

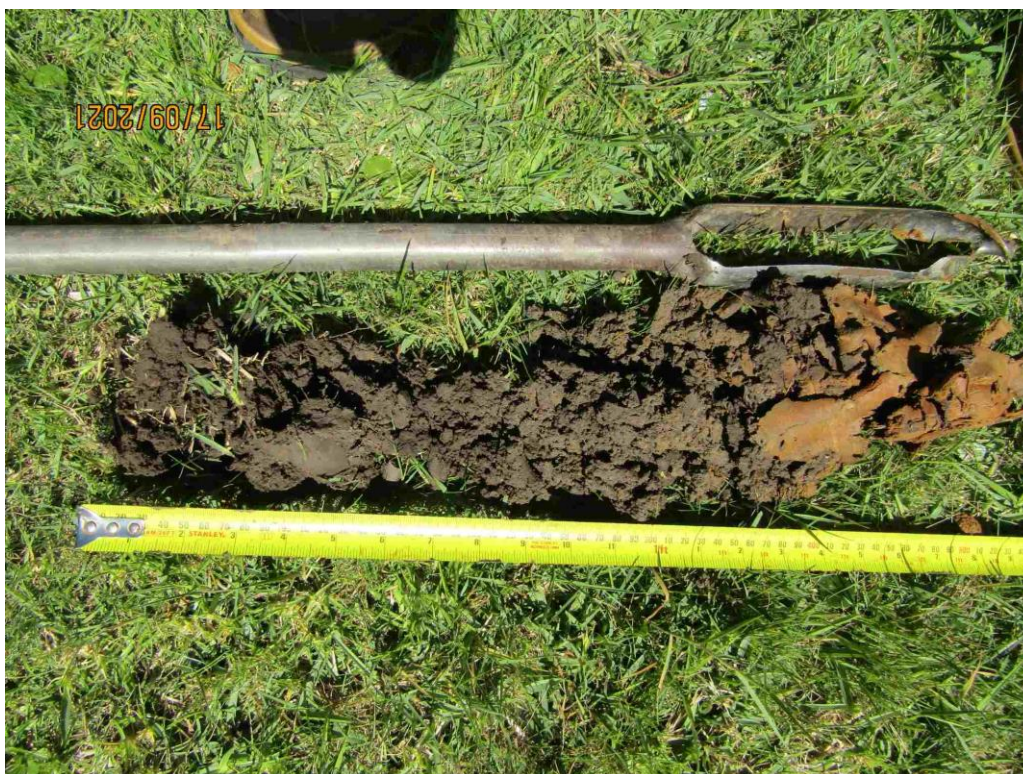
Photo 8

AUGER HOLE 1 (~RL28.0) – AH1 (photo 8)

Depth (m)	Material Encountered
0.0 to 0.4	TOPSOIL , sandy soil, dark brown, damp, fine to medium grained.
0.4 to 0.5	CLAY , orange, moist, firm to stiff.

End of hole @ 0.5m in firm to stiff clay. No watertable encountered.
