**TO
MOUNT PRITCHARD & DISTRICT COMMUNITY CLUB**

**ON
GEOTECHNICAL &
HYDROGEOLOGICAL INVESTIGATION**

**FOR
PROPOSED REDEVELOPMENT OF
HARBORD DIGGERS CLUB**

**AT
80 EVANS STREET, FRESHWATER, NSW**

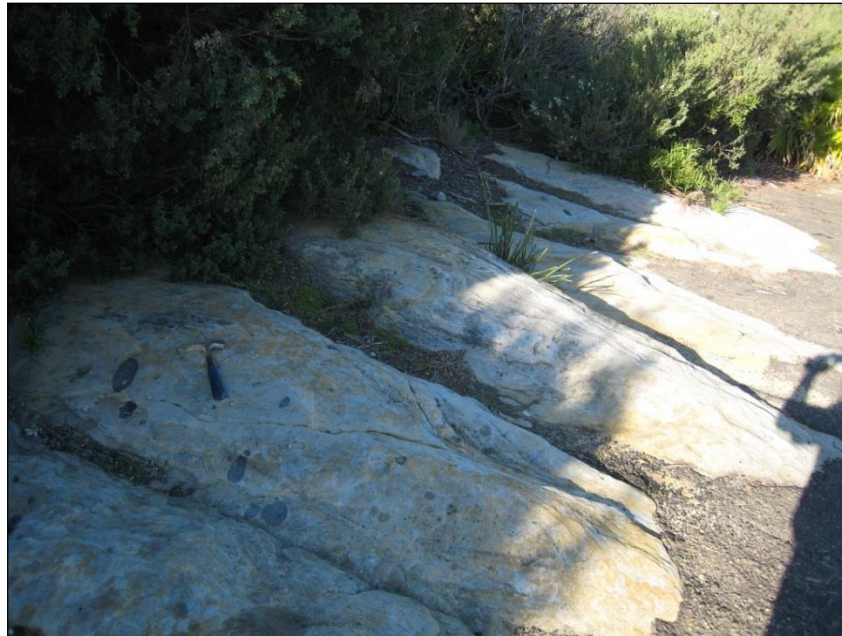
1. **Sandstone Outcrops:** At the south-eastern corner of the on-grade AC car park, outcrops of distinctly weathered sandstone bedrock of low and medium strength were visible. The sandstone outcrops contained inclusions of fine to coarse grained, sub-angular and sub-rounded quartz gravel. The surface of the sandstone was 'dry'. Refer to Plates 1a and 1b below.

Plate 1(a): Sandstone outcrops at south-eastern corner of AC car park

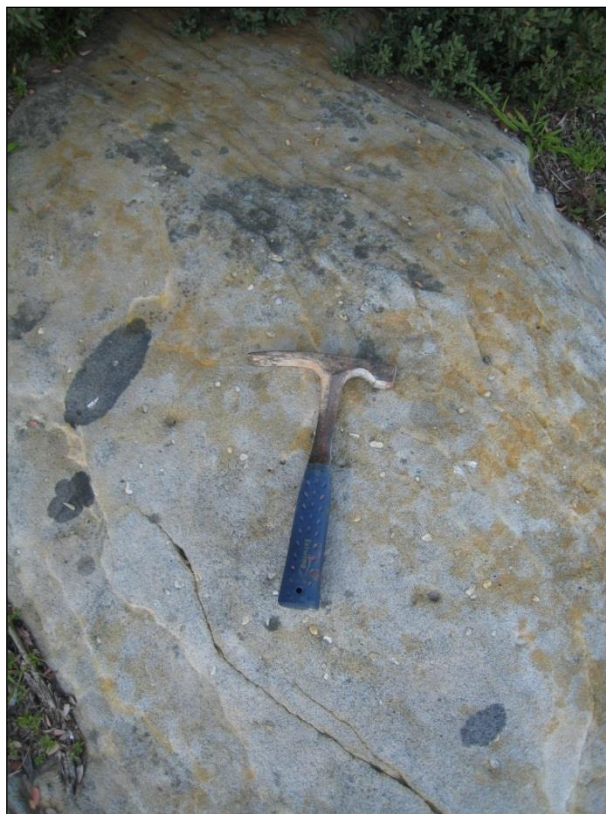
Plate 1(b): Close up view showing quartz gravel inclusions within the sandstone outcrops

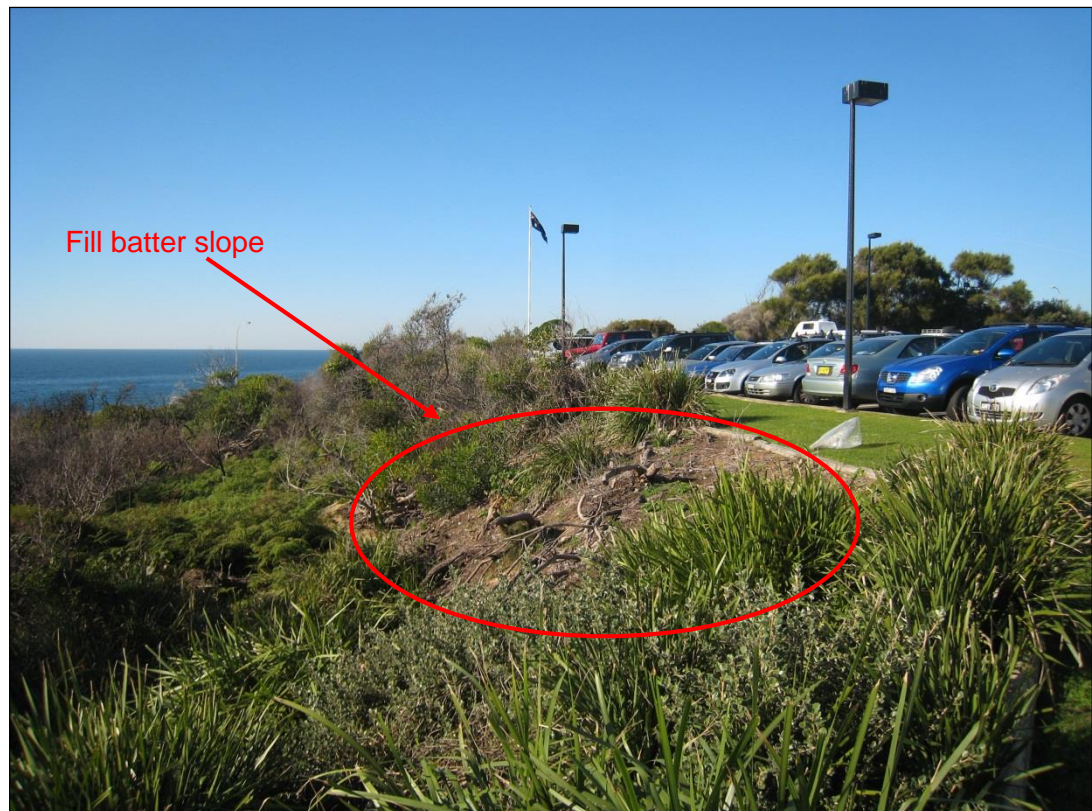
2. **Fill Batter Slope:** Along the northern side of the on-grade open air AC car park, there was a fill batter slope that was up to about 3m high. The fill batter slope graded between about 24° and 28° and was mostly vegetated. Where the vegetation cover was sparse, the fill batter slope surface exposed silty sand, with inclusions of sandstone gravel, cobbles and boulders. No evidence of deep seated slope instability (eg. landslides, bulging along the toe, tension cracks, etc.) were observed. Refer to Plate 2 below.

Plate 2: Fill batter slope along northern side of AC car park

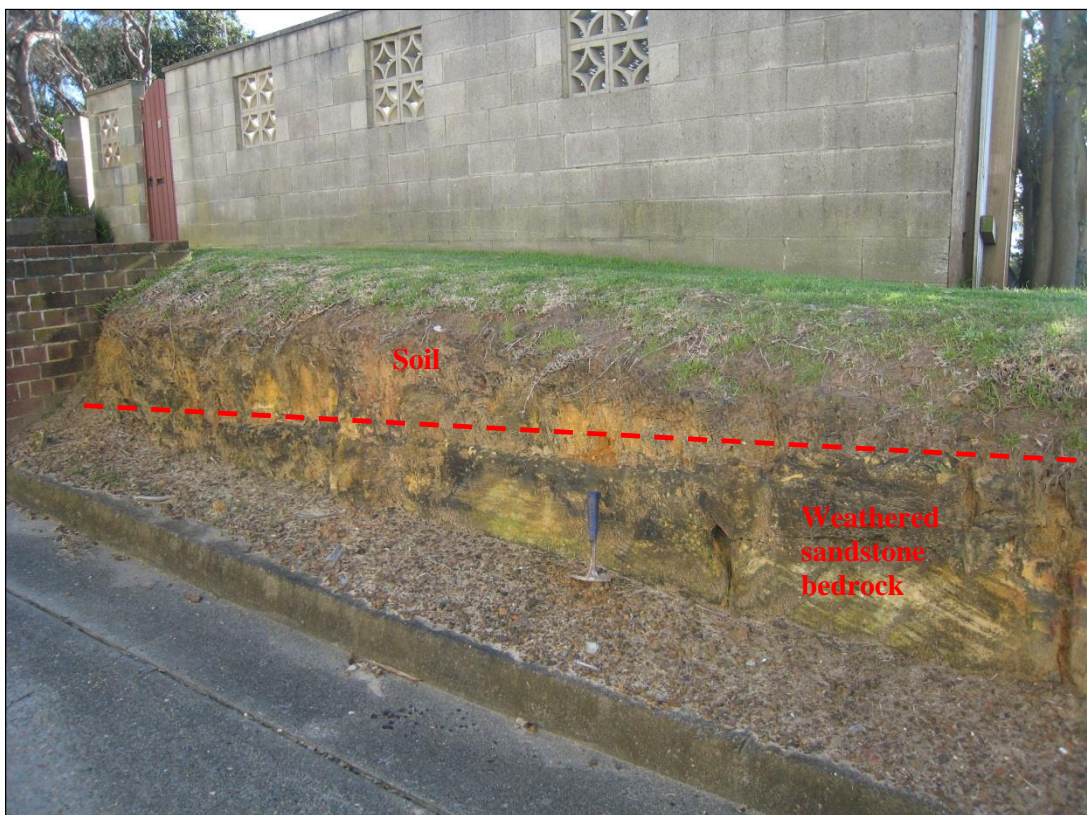
3. **Shallow Cutting:** Along the northern side of the existing Club building, there was an existing sub-vertical cut, which was less than about 1m deep. The cut exposed a shallow soil cover (generally less than about 0.5m thickness) overlying sub-horizontally bedded, distinctly weathered sandstone bedrock. The soil comprised mostly silty sand fill overlying a thin layer of residual clayey sand. The bedrock was assessed to be initially extremely weathered sandstone of extremely low strength grading into distinctly weathered sandstone and of very low, low and medium strength. There was no evidence of any groundwater seepage through the cut slope or of cut slope instability. Refer to Plate 3 below.

Plate 3: Shallow cutting along northern side of existing Club building.

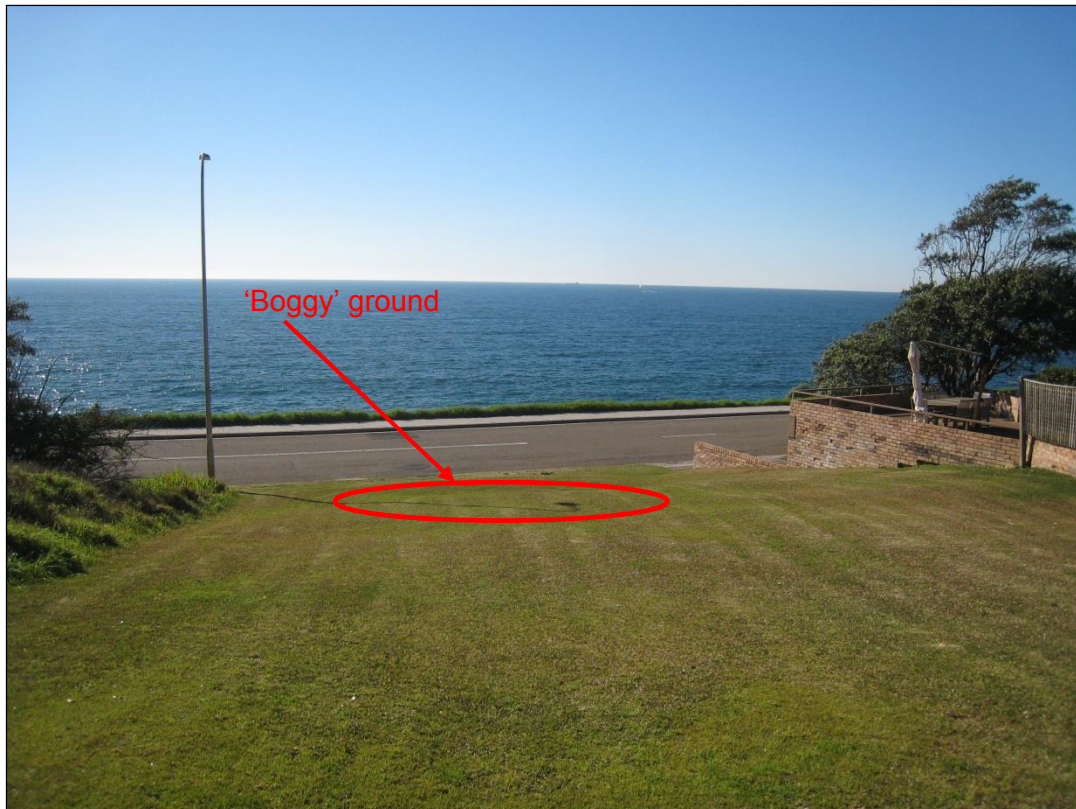
4. **'Boggy' Ground Surface:** During our walkover inspection in 2011, the ground surface at the toe of the grass covered slope at the north-western corner of the site was 'boggy' under foot. It is likely the soils had become saturated from wet weather at that time, as a result of seepage flows at the fill/natural soil interface. Refer to Plate 4 below.

We note that during the current fieldwork, however, the ground surface had dried out in that area and trafficability was good for the drill rig.

Plate 4: Area of 'boggy' ground (approximately indicated in 'red') at north-western corner of site (2011)

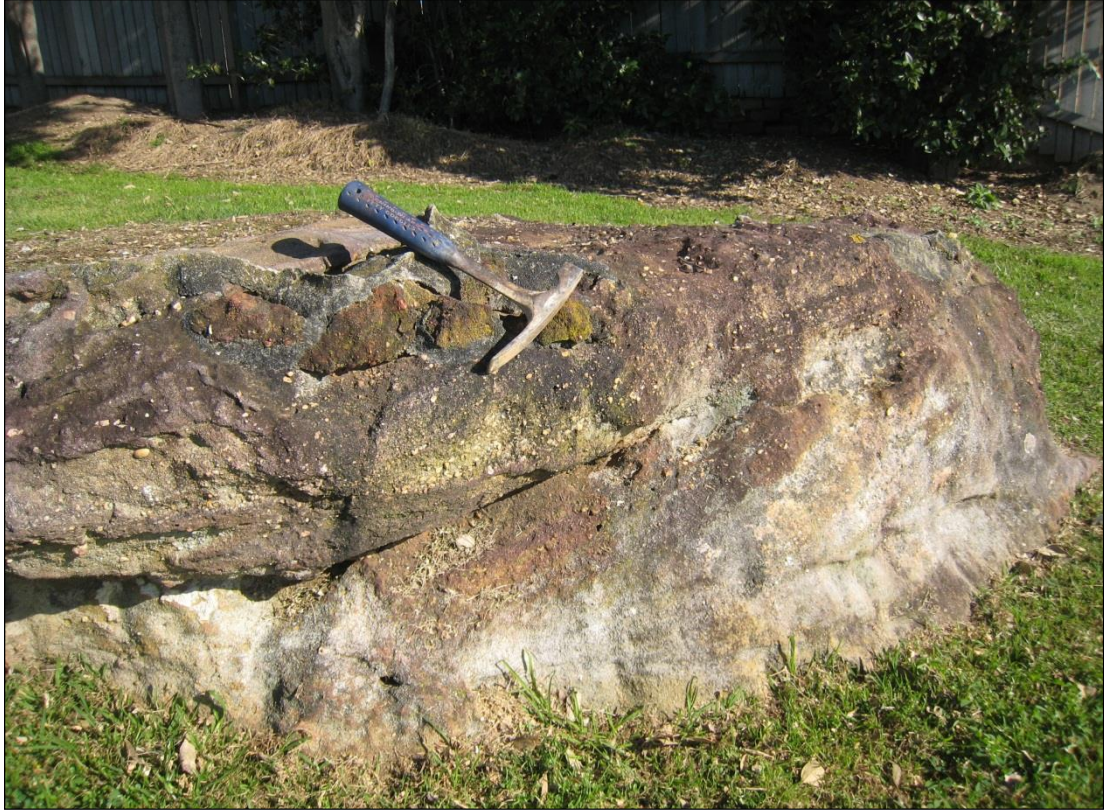
5. **Sandstone Outcrops:** On the eastern side of No 4A Lumsdaine Drive, an outcrop of distinctly weathered sandstone bedrock of medium and high strength, was visible. The sandstone contained inclusions of fine to coarse grained, sub-angular and sub-rounded quartz gravel. Refer to Plate 5 below.

Plate 5: Sandstone outcrops on the eastern side of No.4A Lumsdaine Drive

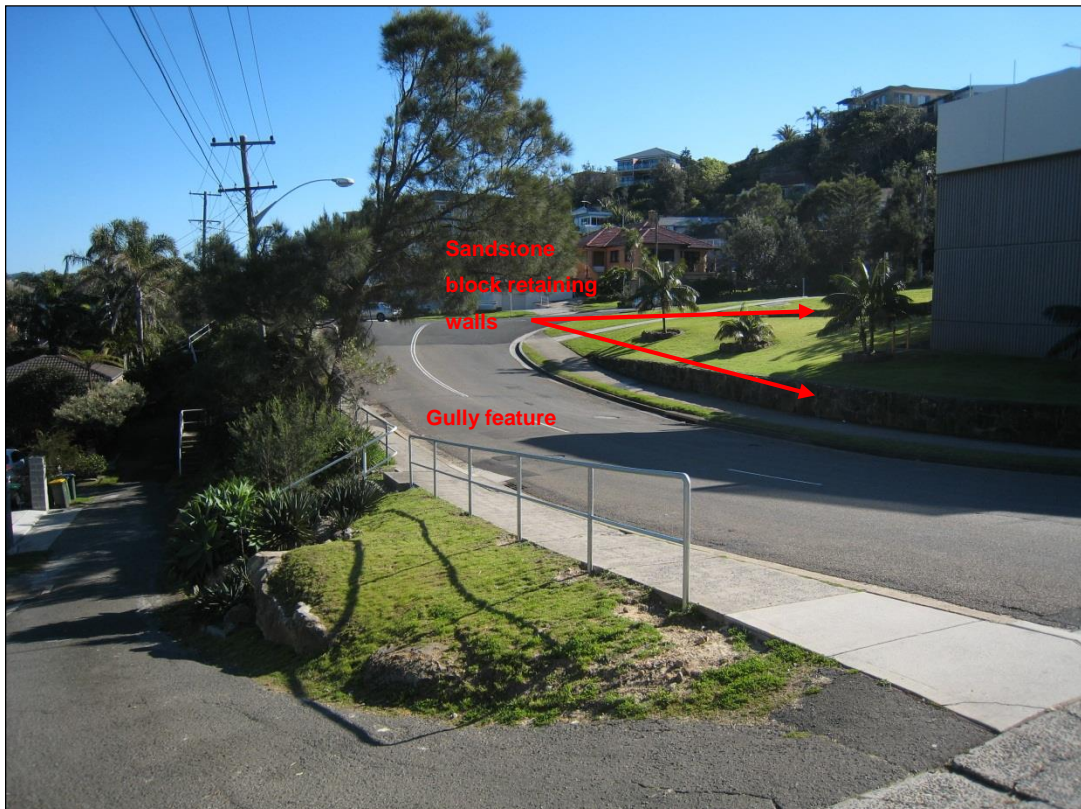
6. **Mortared Sandstone Block Retaining Walls:** At the south-western corner of the site, adjacent to the intersection of Carrington Parade and Evans Street, there were several mortared sandstone block retaining walls, which supported the subject site to a maximum height of about 1.1m. During our 2011 walkover inspection, groundwater seepage emanated from the base of the retaining wall, which ran along the Evans Street footpath. The retaining walls spanned a shallow gully feature. The retaining walls appeared to be in good condition. Distinctly weathered sandstone bedrock of at least medium strength outcropped along the sides of the gully feature. Refer to Plate 6 below.

Plate 6: View looking across Evans Street towards the south-western corner of the site, showing low height mortared sandstone block retaining walls and a shallow gully feature.

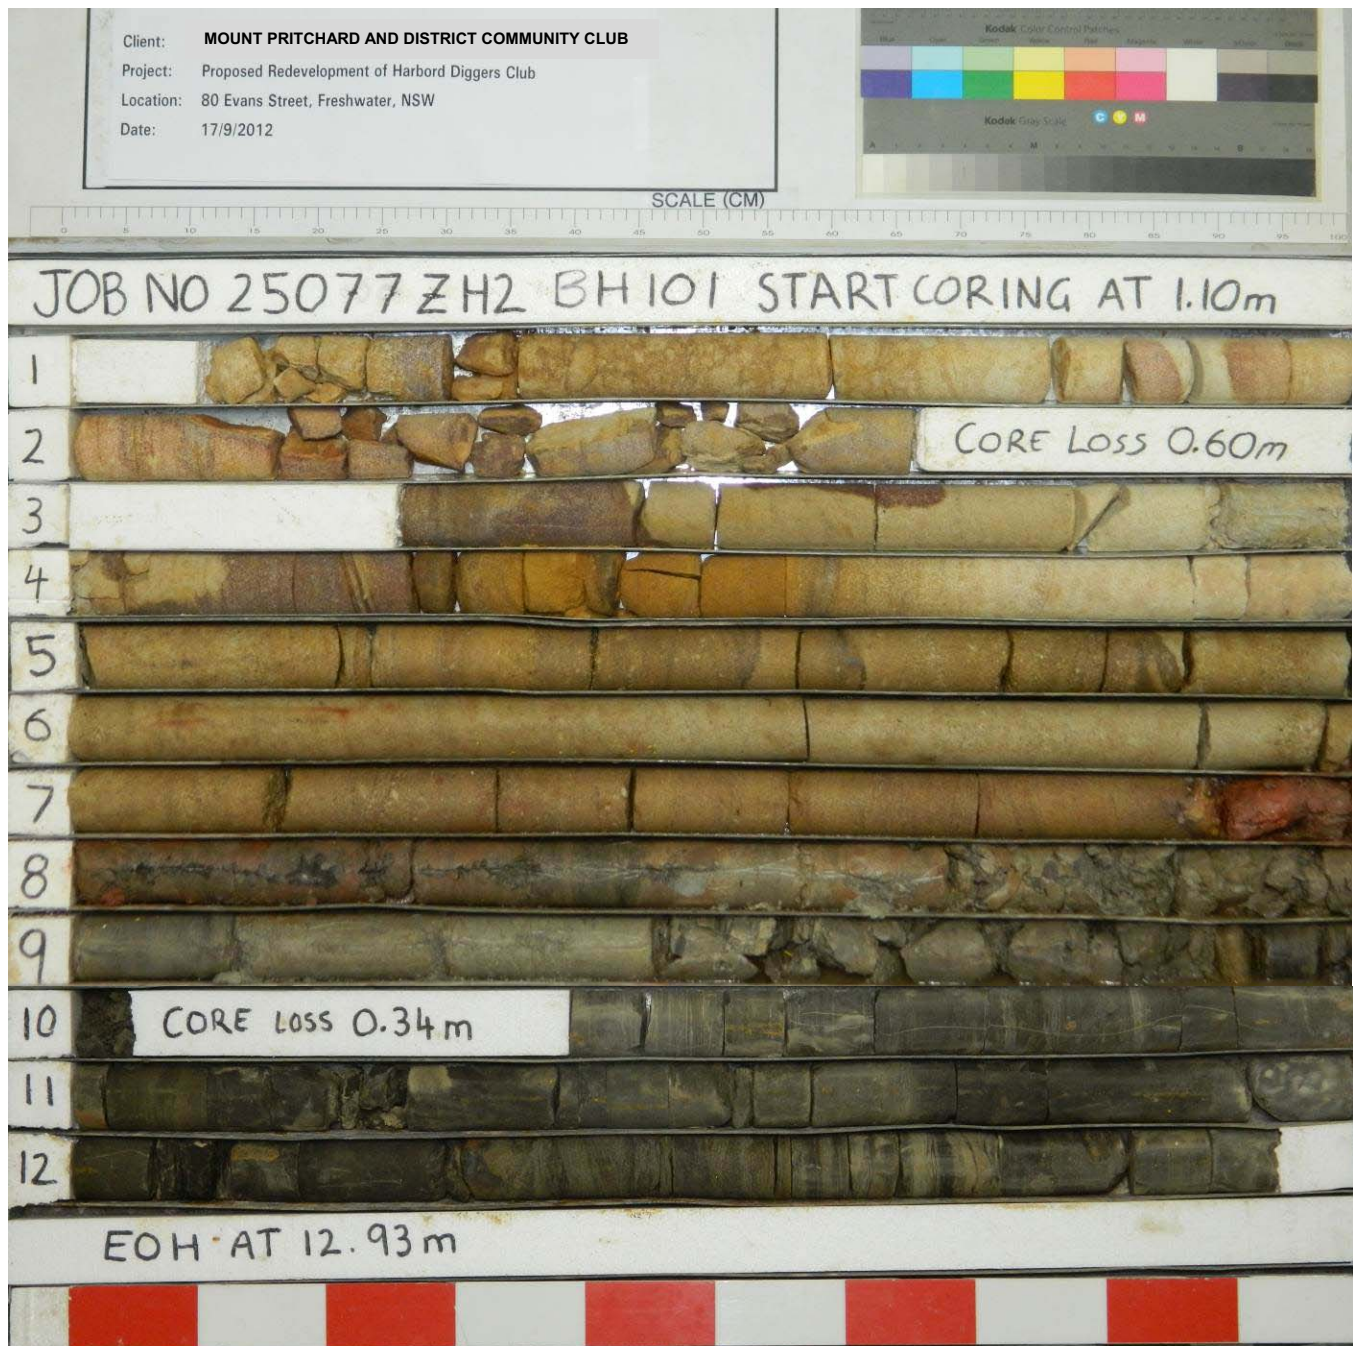
BOREHOLE LOG

Groundwater Record	SAMPLES				Field Tests	Depth (m)	Graphic Log	Unified Classification	DESCRIPTION	Moisture Condition/ Weathering	Strength/ Rel. Density	Hand Penetrometer Readings (kPa.)	Remarks
	ES	USO	DB	DS									
<div>ON COMPLETION OF CORING</div> <div>ON COMPLETION OF AUGERING</div>						0			FILL: Silty sand topsoil, fine to medium grained, dark brown, with roots.	M			GRASS COVER APPEARS WELL COMPACTED
				N = 18 5,9,9	1	FILL: Silty sand, fine to medium grained, light brown, trace of fine to medium grained ironstone and sandstone gravel.							
				N = 22 11,9,13	2	as above, but light brown and grey, trace of clay fines.							
					2	FILL: Silty sand, fine to medium grained, light grey and dark grey.							
				N = 9 4,2,7	3	SC	CLAYEY SAND: fine to medium grained, light grey and orange brown, trace of fine grained ironstone gravel.	M	L		RESIDUAL		
					4		-	SANDSTONE: fine to medium grained, light grey and orange brown.	DW	L-M		LOW TO MODERATE 'TC' BIT RESISTANCE

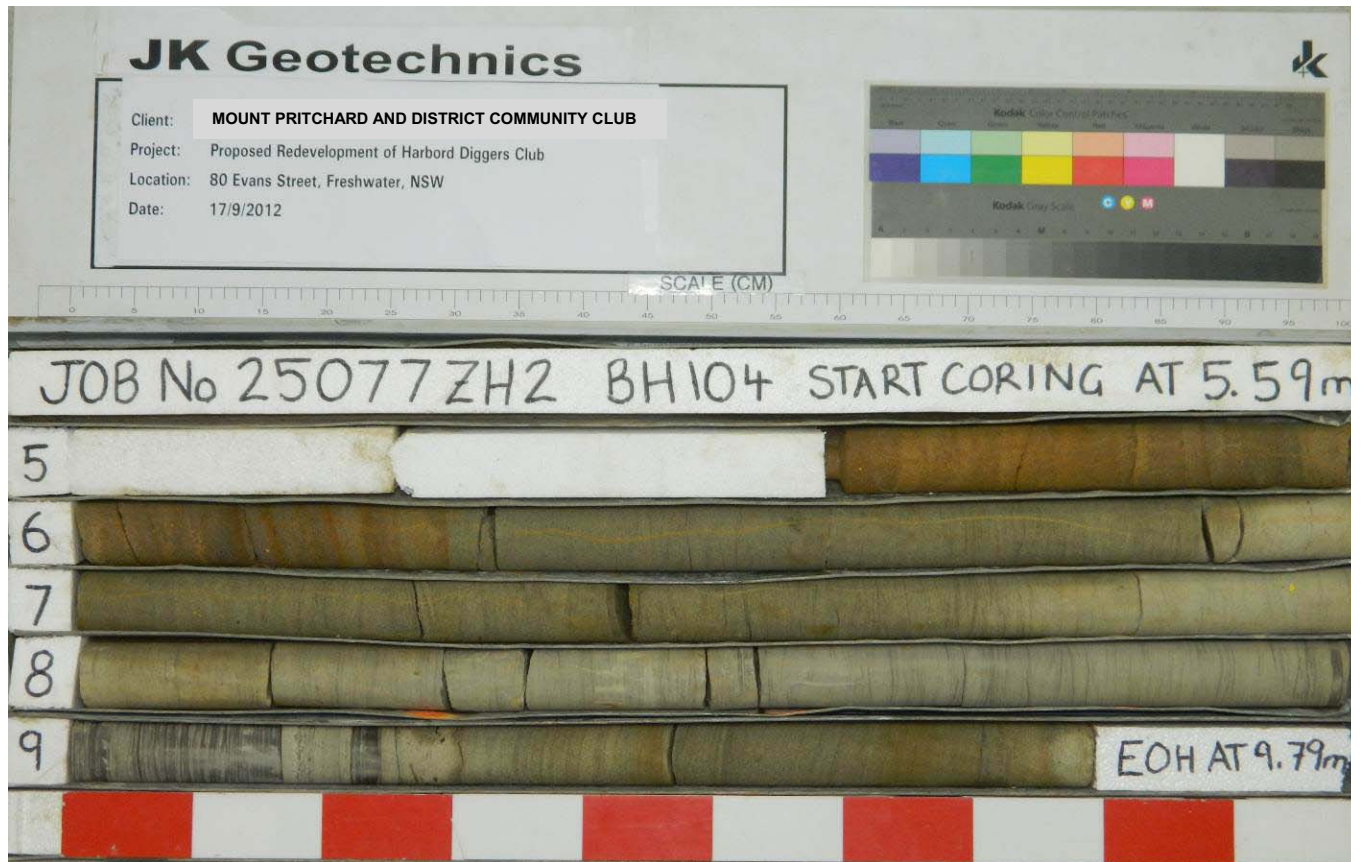
BOREHOLE LOG

SHALE: dark grey, with fine grained sandstone laminae and seams, bedded at 0-5°.																		
		10		END OF BOREHOLE AT 9.79m																		
		11
