15 JUBILEE PTY LTD

Geotechnical Investigation

15 Jubilee Avenue, Warriewood

E24716.G03_Rev3
7 May 2021

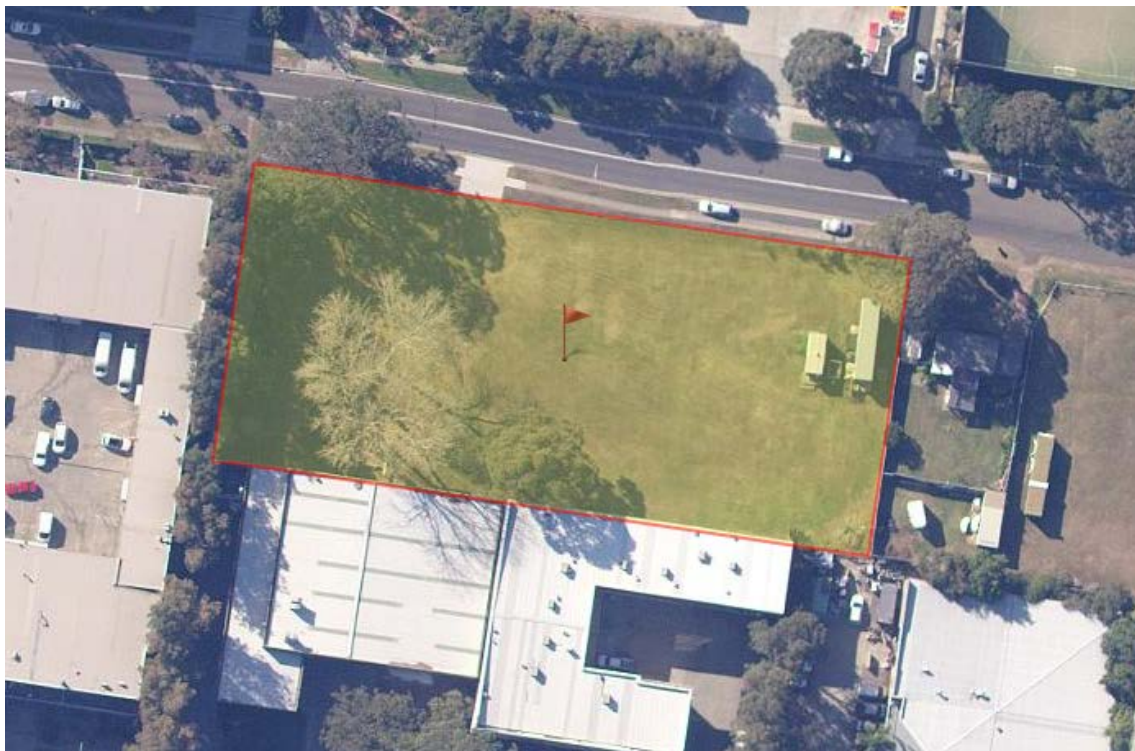
Plate 1: Aerial photograph of the site (source: Six Maps, accessed 30 June 2020)

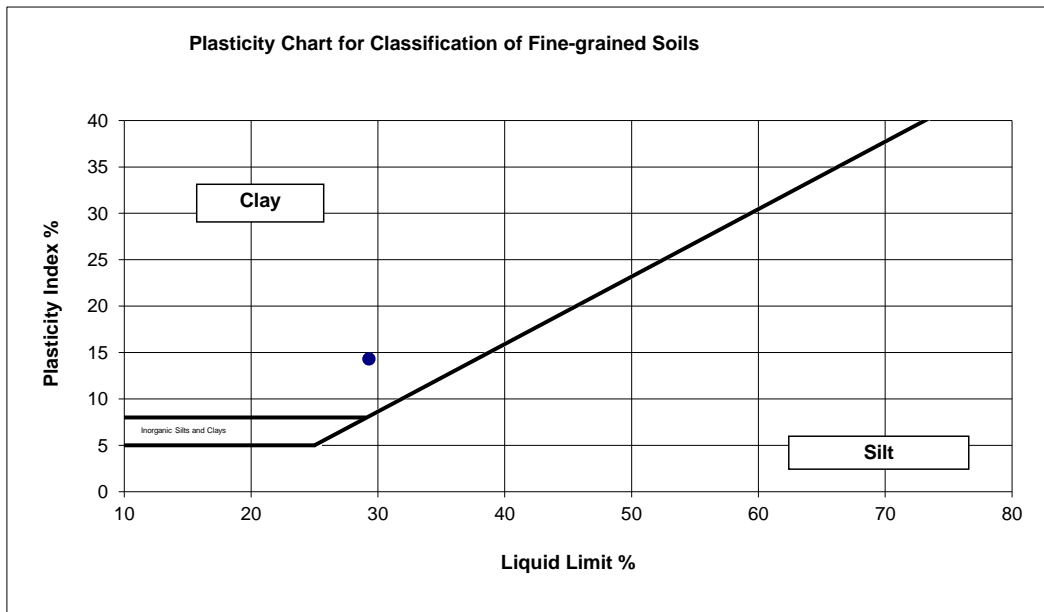
Liquid Limit (%) <input style="width: 50px;" type="text" value="29"/>	Linear Shrinkage (%) <input style="width: 50px;" type="text" value="9.0"/>
Plastic Limit (%) <input style="width: 50px;" type="text" value="15"/>	Plasticity Index <input style="width: 50px;" type="text" value="14"/>
