## **REPORT ON GEOTECHNICAL INVESTIGATION**

### **PROPOSED NEW DEVELOPMENT**

**154 – 158 PACIFIC PARADE, DEE WHY**

**Project No.: 2024-193**

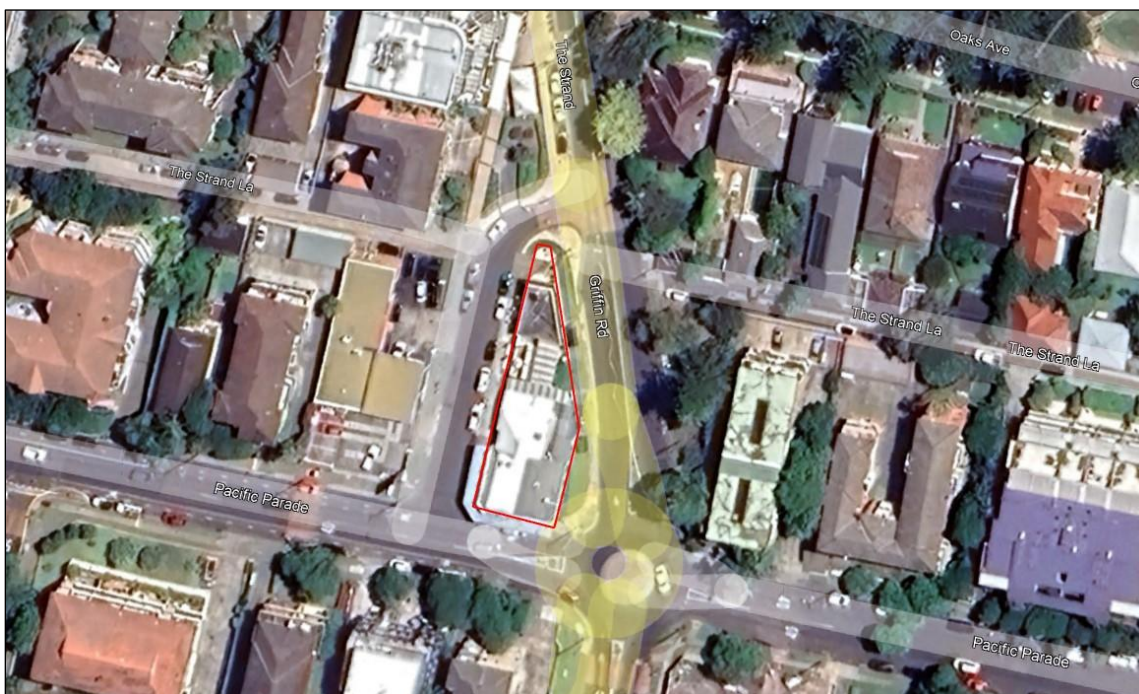
*Photograph 1: Aerial view of site (outlined red) and surrounds*

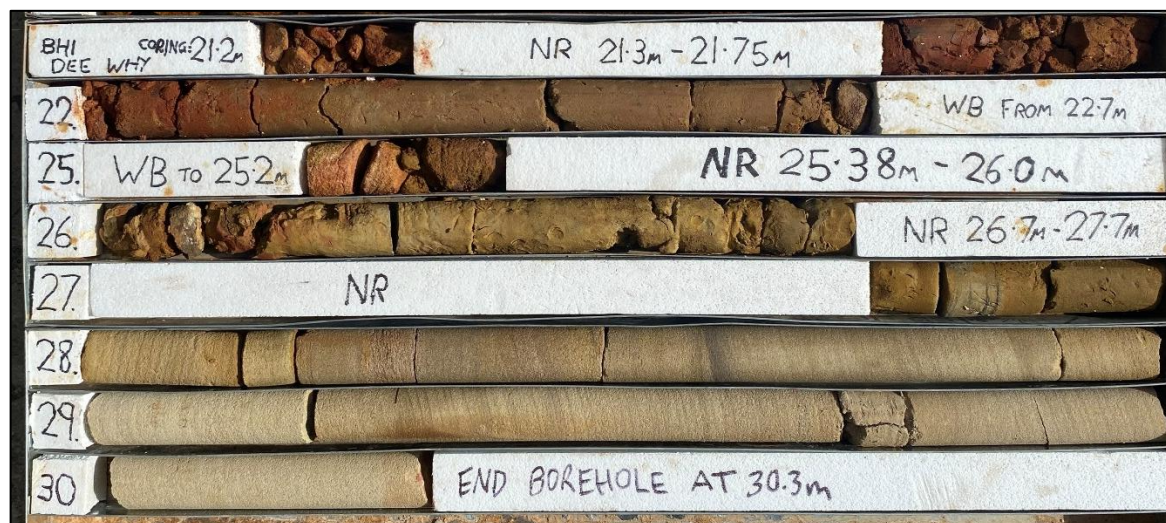
Borehole 1: 21.2m to 30.30m depth

| Strata | m to base | Description |
|---|---|---|
| Sandstone | – | Underlying the soils, bedrock was encountered within BH1 only at a depth of 28.0m. The unit initially comprised a horizon of extremely weathered very low strength strata which rapidly became uniform, medium strength sandstone below 28.2m depth and was relatively defect free. |

Photograph 2 shows the core recovered during the field investigation which should be viewed in conjunction with the relevant borehole log sheet.
