RE: 6 Monthly Groundwater Testing Results – Dec 2022
Ultra Manly Service Station – 207-217 Pittwater Rd, Manly, NSW

GROUNDWATER MONITORING TEST RECORD SHEET - 6 MTH VISUAL INSPECTION - DEC 2022

USTRAMANLY SITE PLAN

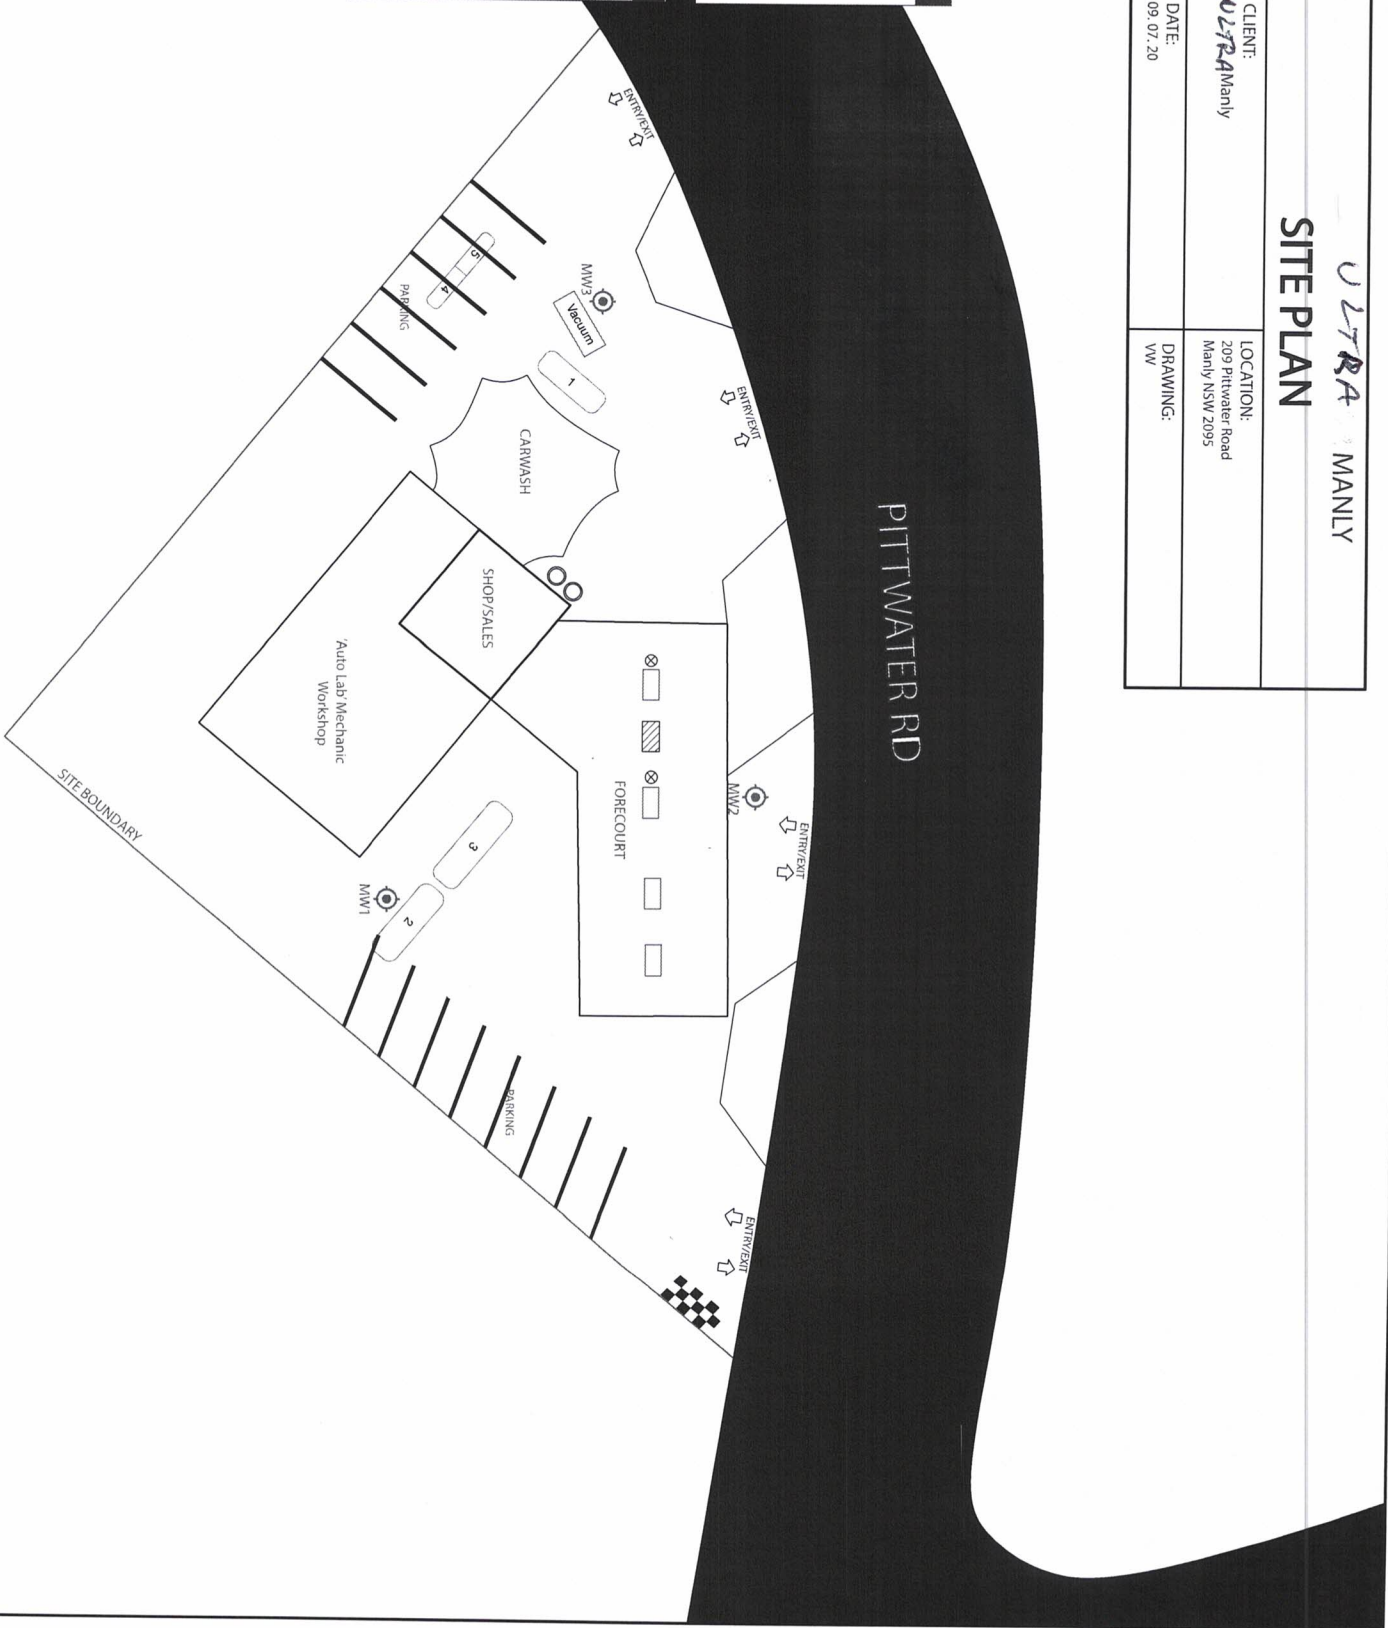
USTR MANLY
SITE PLAN

The site plan showing the locations of the groundwater monitoring wells is shown on **Figure 1** attached.

All gauging and visual inspection data has been attached to this letter, including a site plan indicating the location of the wells within the site.
