## **PRELIMINARY ASSESSMENT: Acid Sulfate**

New House and Pool at **73 Wimbledon Avenue, North Narrabeen**

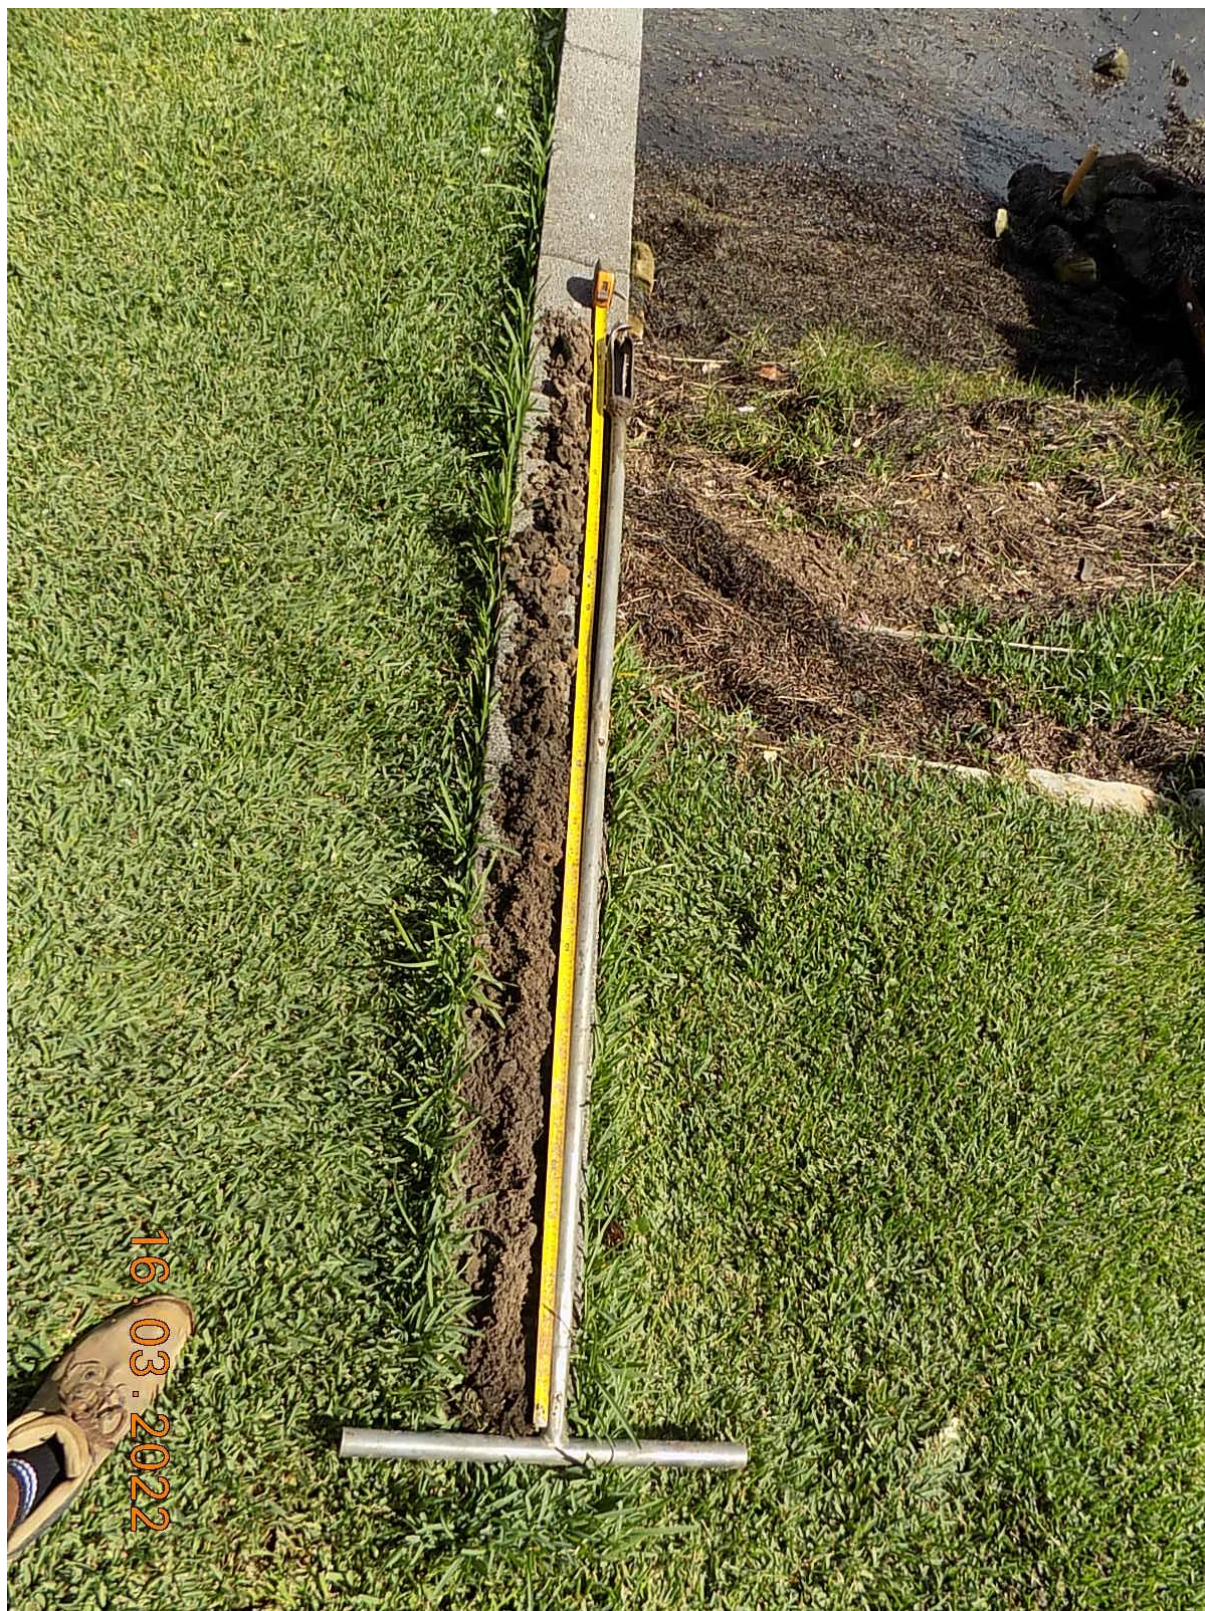
Photo 1: AH1 – Downhole is from bottom to top.

### AUGER HOLE 1 (~RL1.6) – AH1 (Photo 1)

Depth (m)	Material Encountered
0.0 to 0.1	<b>TOPSOIL</b> , dark brown sandy soil, dry, fine to medium grained with fine trace organic matter.
0.1 to 0.7	<b>SAND</b> , light brown and grey, dry, medium grained.
0.7 to 1.3	<b>SAND</b> , yellow and grey, damp, medium grained.
1.3 to 1.9	<b>SAND</b> , white and grey, wet, medium grained.

End of Hole @ 1.9m in sand. Water table encountered at ~1.2m.

TEST: AH1	FIELD pH & PEROXIDE RESULTS				
Sample depth (m)	pH <sub>F</sub>	30% Peroxide reaction	pH <sub>FOX</sub>	pH <sub>F</sub> - pH <sub>FOX</sub>	SS=Shell J=Jarosite R=Roots
0.3	7.2	-	7.2	0	R
0.7	7.2	L	7.4	-0.2	-
1.3	7.4	L	7.5	-0.1	-
1.9	7.4	L	7.5	-0.1	-

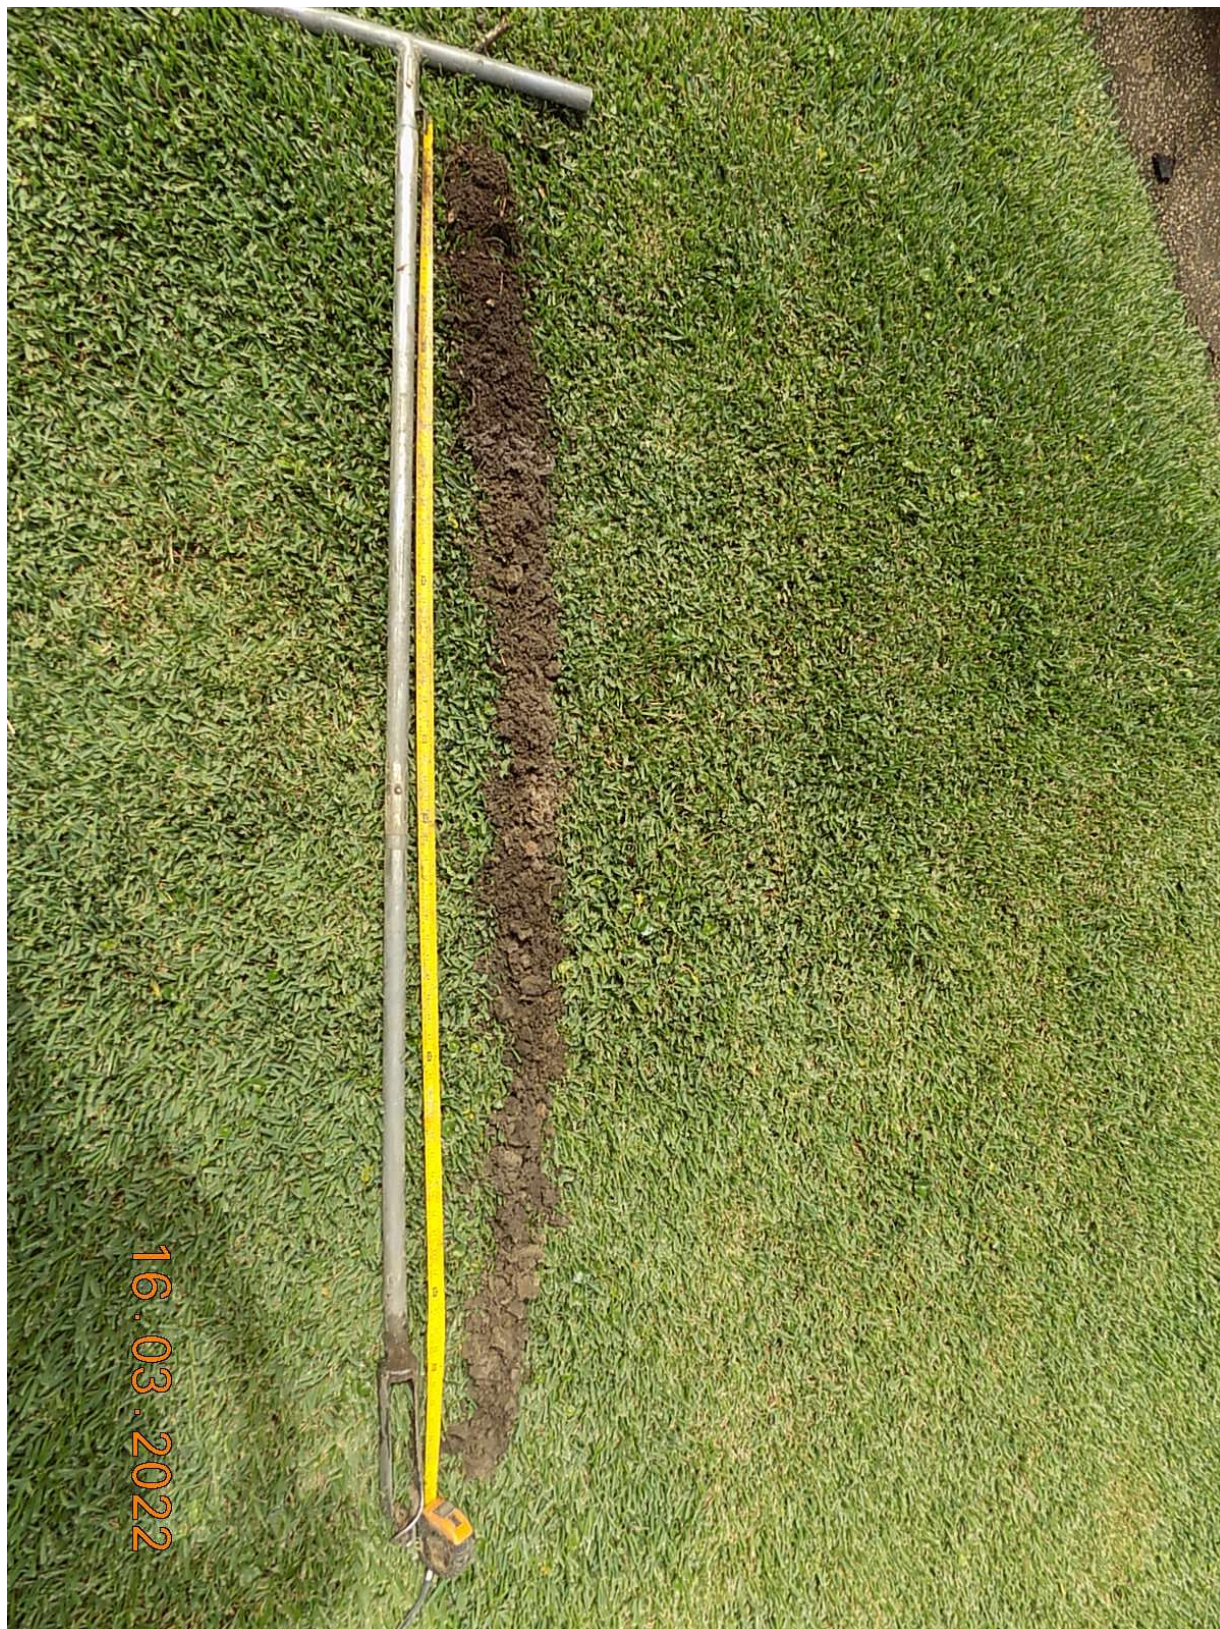
Photo 2: AH2 – Downhole is from top to bottom.

## AUGER HOLE 2 (~RL1.7) – AH2 (Photo 2)

Depth (m)	Material Encountered
0.0 to 0.4	<b>TOPSOIL</b> , dark brown, sandy, dry, fine to medium grained with fine trace organic matter.
0.4 to 0.9	<b>SAND</b> , grey and brown, dry, medium grained.
0.9 to 1.3	<b>SAND</b> , yellow and grey, damp, medium grained.
1.3 to 1.8	<b>SAND</b> , white, grey, and yellow, wet, medium to coarse grained.

End of Hole @ 1.8m in sand. Water table encountered at ~1.3m.

TEST: AH2	FIELD pH & PEROXIDE RESULTS				
Sample depth (m)	pH <sub>F</sub>	30% Peroxide reaction	pH <sub>FOX</sub>	pH <sub>F</sub> - pH <sub>FOX</sub>	SS=Shell J=Jarosite R=Roots
0.3	6.3	-	6.3	0	R
0.7	7.4	-	7.5	-0.1	-
1.3	7.3	-	7.4	-0.1	-
1.8	7.3	-	7.4	-0.1	-

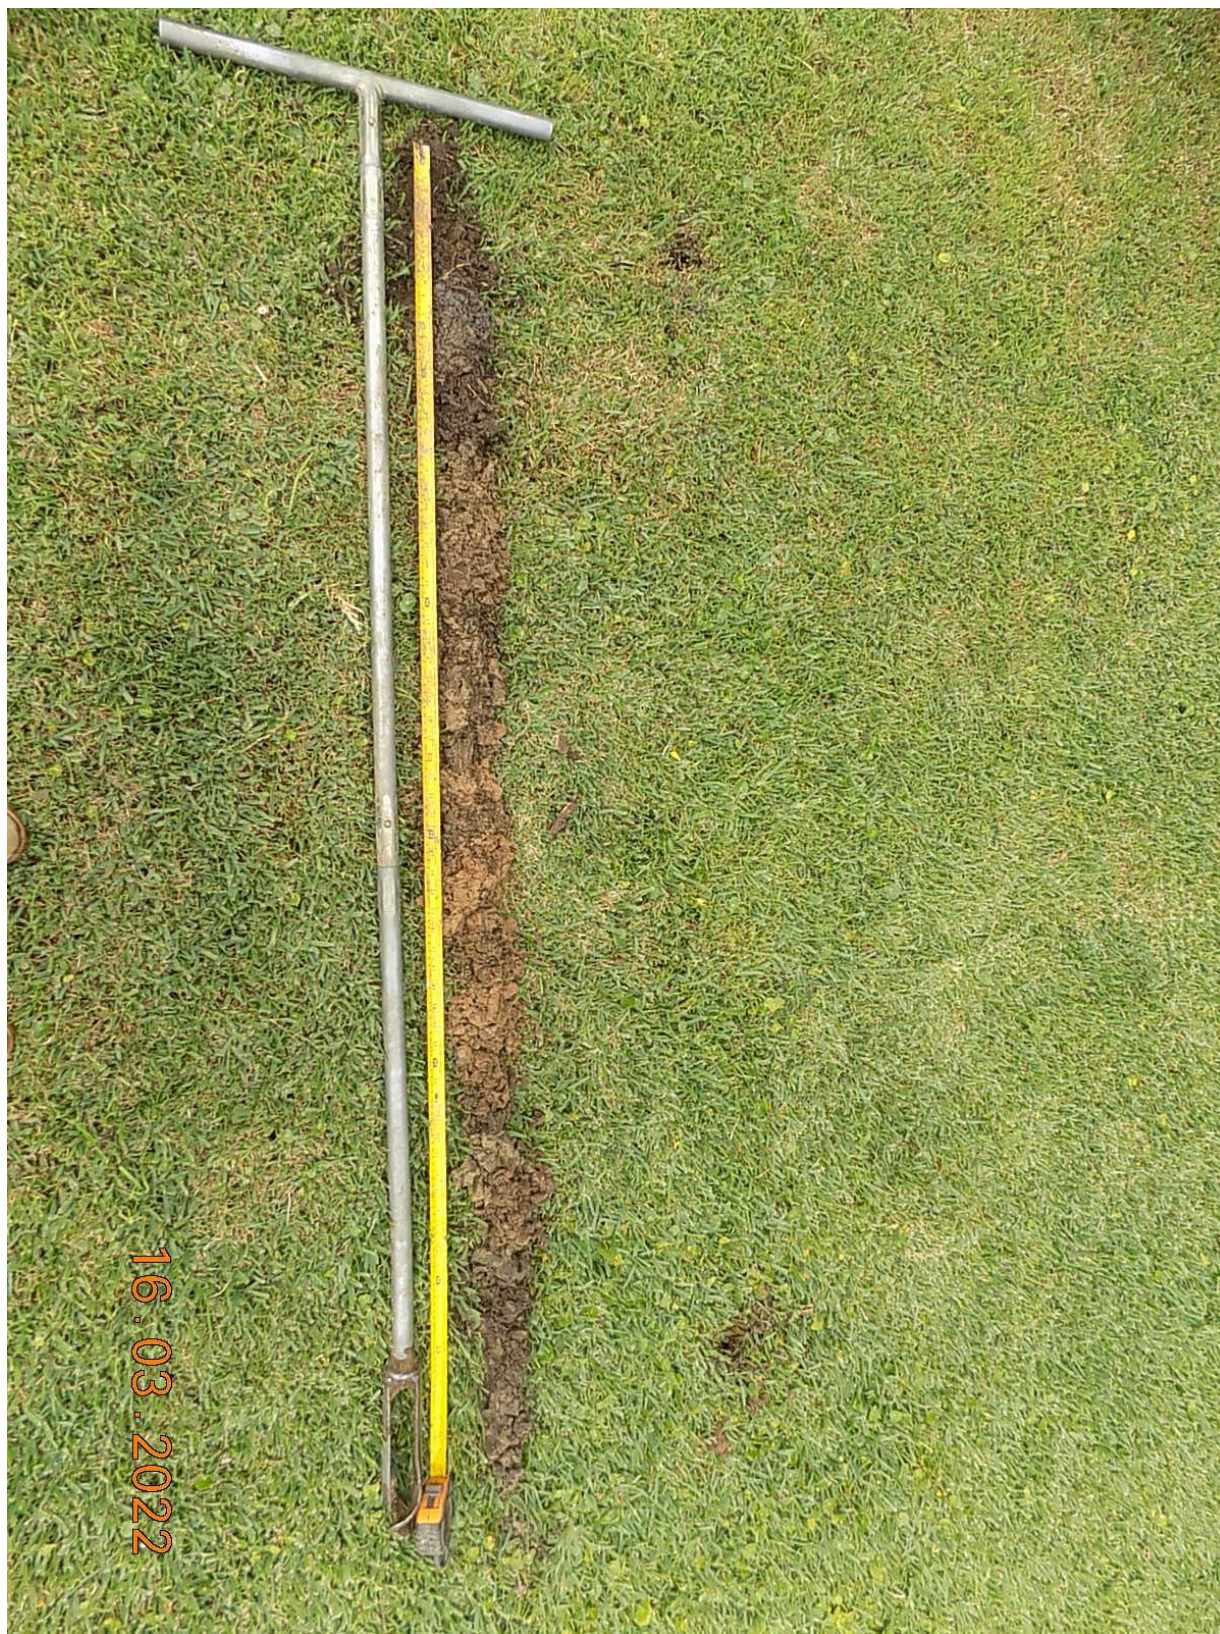
Photo 3: AH3 – Downhole is from top to bottom.

## AUGER HOLE 3 (~RL2.0) – AH3 (Photo 3)

Depth (m)	Material Encountered
0.0 to 0.4	<b>TOPSOIL</b> , dark brown and grey, sandy, dry, fine to medium grained with fine trace organic matter.
0.4 to 0.8	<b>SAND</b> , white and grey, dry, medium grained.
0.8 to 1.5	<b>SAND</b> , yellow and brown, dry, fine to coarse grained.
1.5 to 1.8	<b>SAND</b> , grey, wet, medium grained.

End of hole @ 1.8m in sand. Water table encountered at ~1.5m.

TEST: AH3	FIELD pH & PEROXIDE RESULTS				
Sample depth (m)	pH <sub>F</sub>	30% Peroxide reaction	pH <sub>FOX</sub>	pH <sub>F</sub> - pH <sub>FOX</sub>	SS=Shell J=Jarosite R=Roots
0.3	6.3	-	6.4	-0.1	R
0.9	7.7	-	7.7	0	-
1.3	7.9	-	7.8	0.1	-
1.8	7.3	-	7.5	-0.2	-

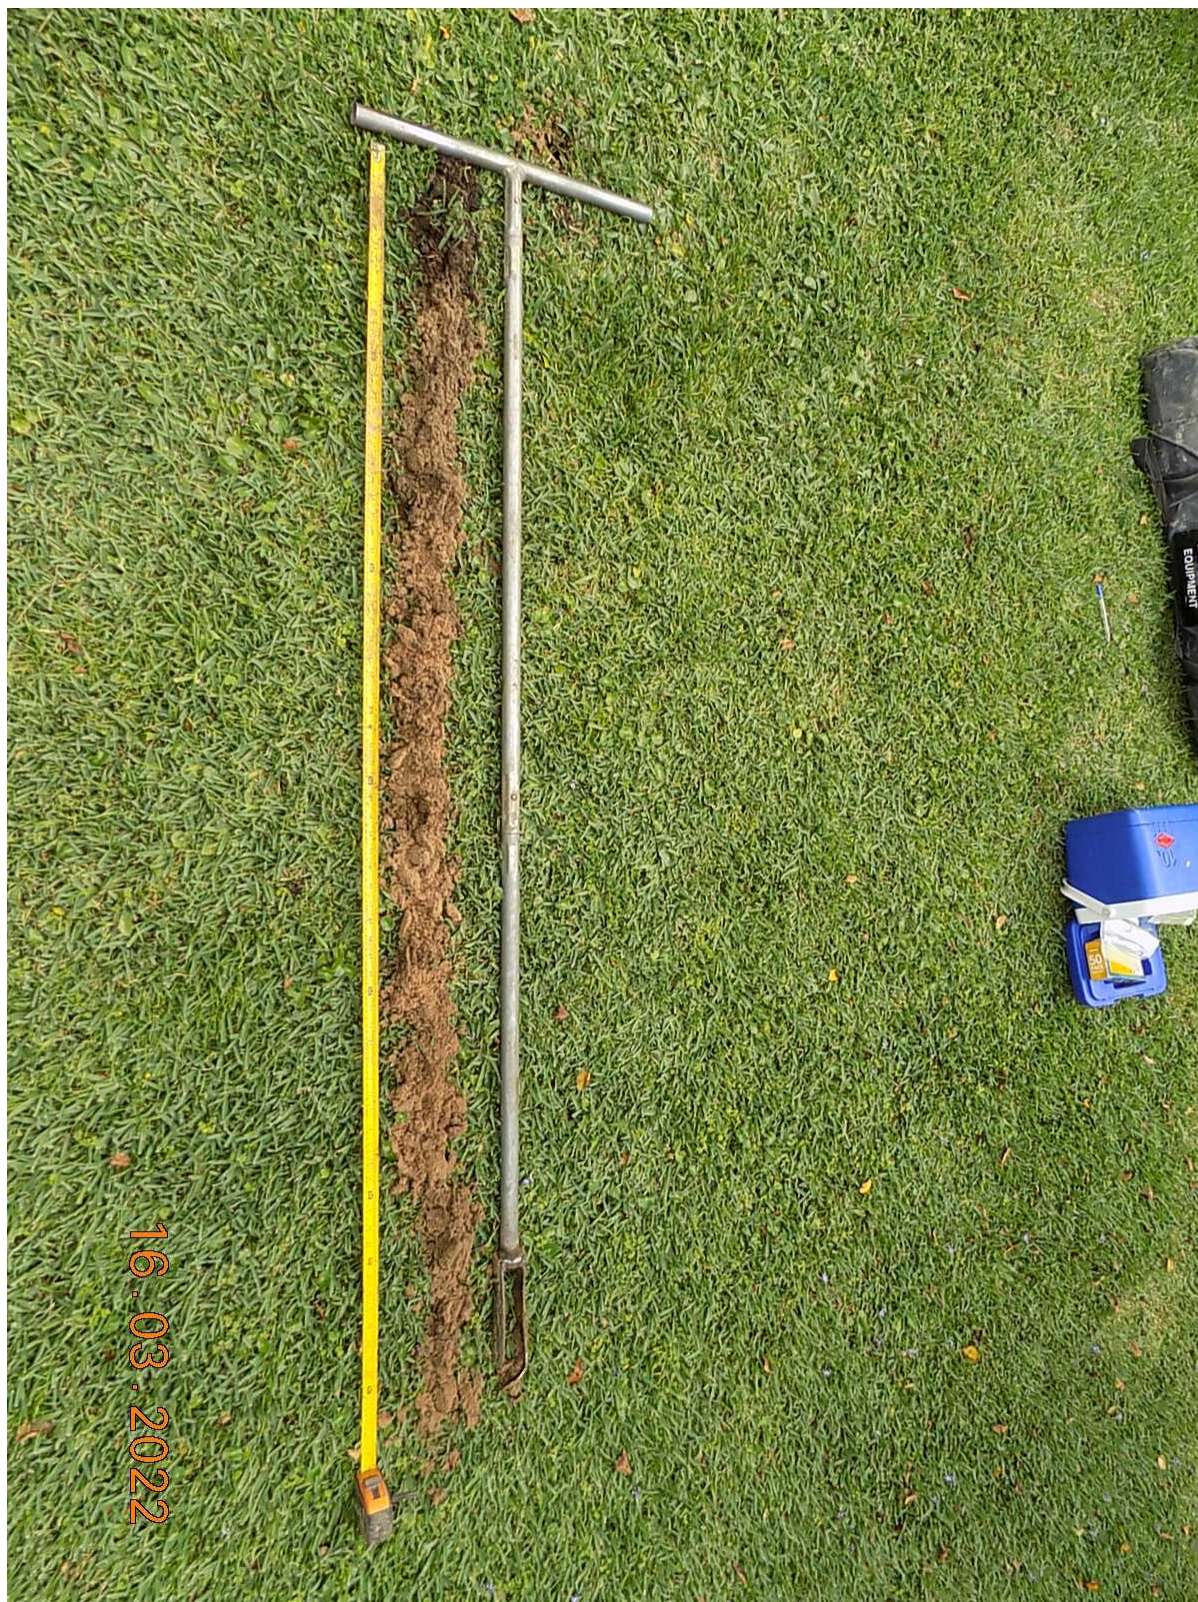
Photo 4: AH4 – Downhole is from bottom to top.

## AUGER HOLE 4 (~RL2.2) – AH4 (Photo 4)

Depth (m)	Material Encountered
0.0 to 0.2	<b>TOPSOIL</b> , dark brown, sandy, dry, fine to medium grained with fine trace organic matter.
0.2 to 1.5	<b>SAND</b> , light brown and orange, dry, medium grained.
1.5 to 1.8	<b>SAND</b> , light brown and orange, wet, medium grained.

End of Hole @ 1.8m in sand. Water table encountered at 1.6m.

TEST: AH4	FIELD pH & PEROXIDE RESULTS				
Sample depth (m)	pH <sub>F</sub>	30% Peroxide reaction	pH <sub>FOX</sub>	pH <sub>F</sub> - pH <sub>FOX</sub>	SS=Shell J=Jarosite R=Roots
0.3	7.0	-	7.0	0	R
1.0	7.3	-	7.2	0.1	-
1.5	7.5	-	7.6	-0.1	-
1.8	7.4	-	7.5	-0.1	-

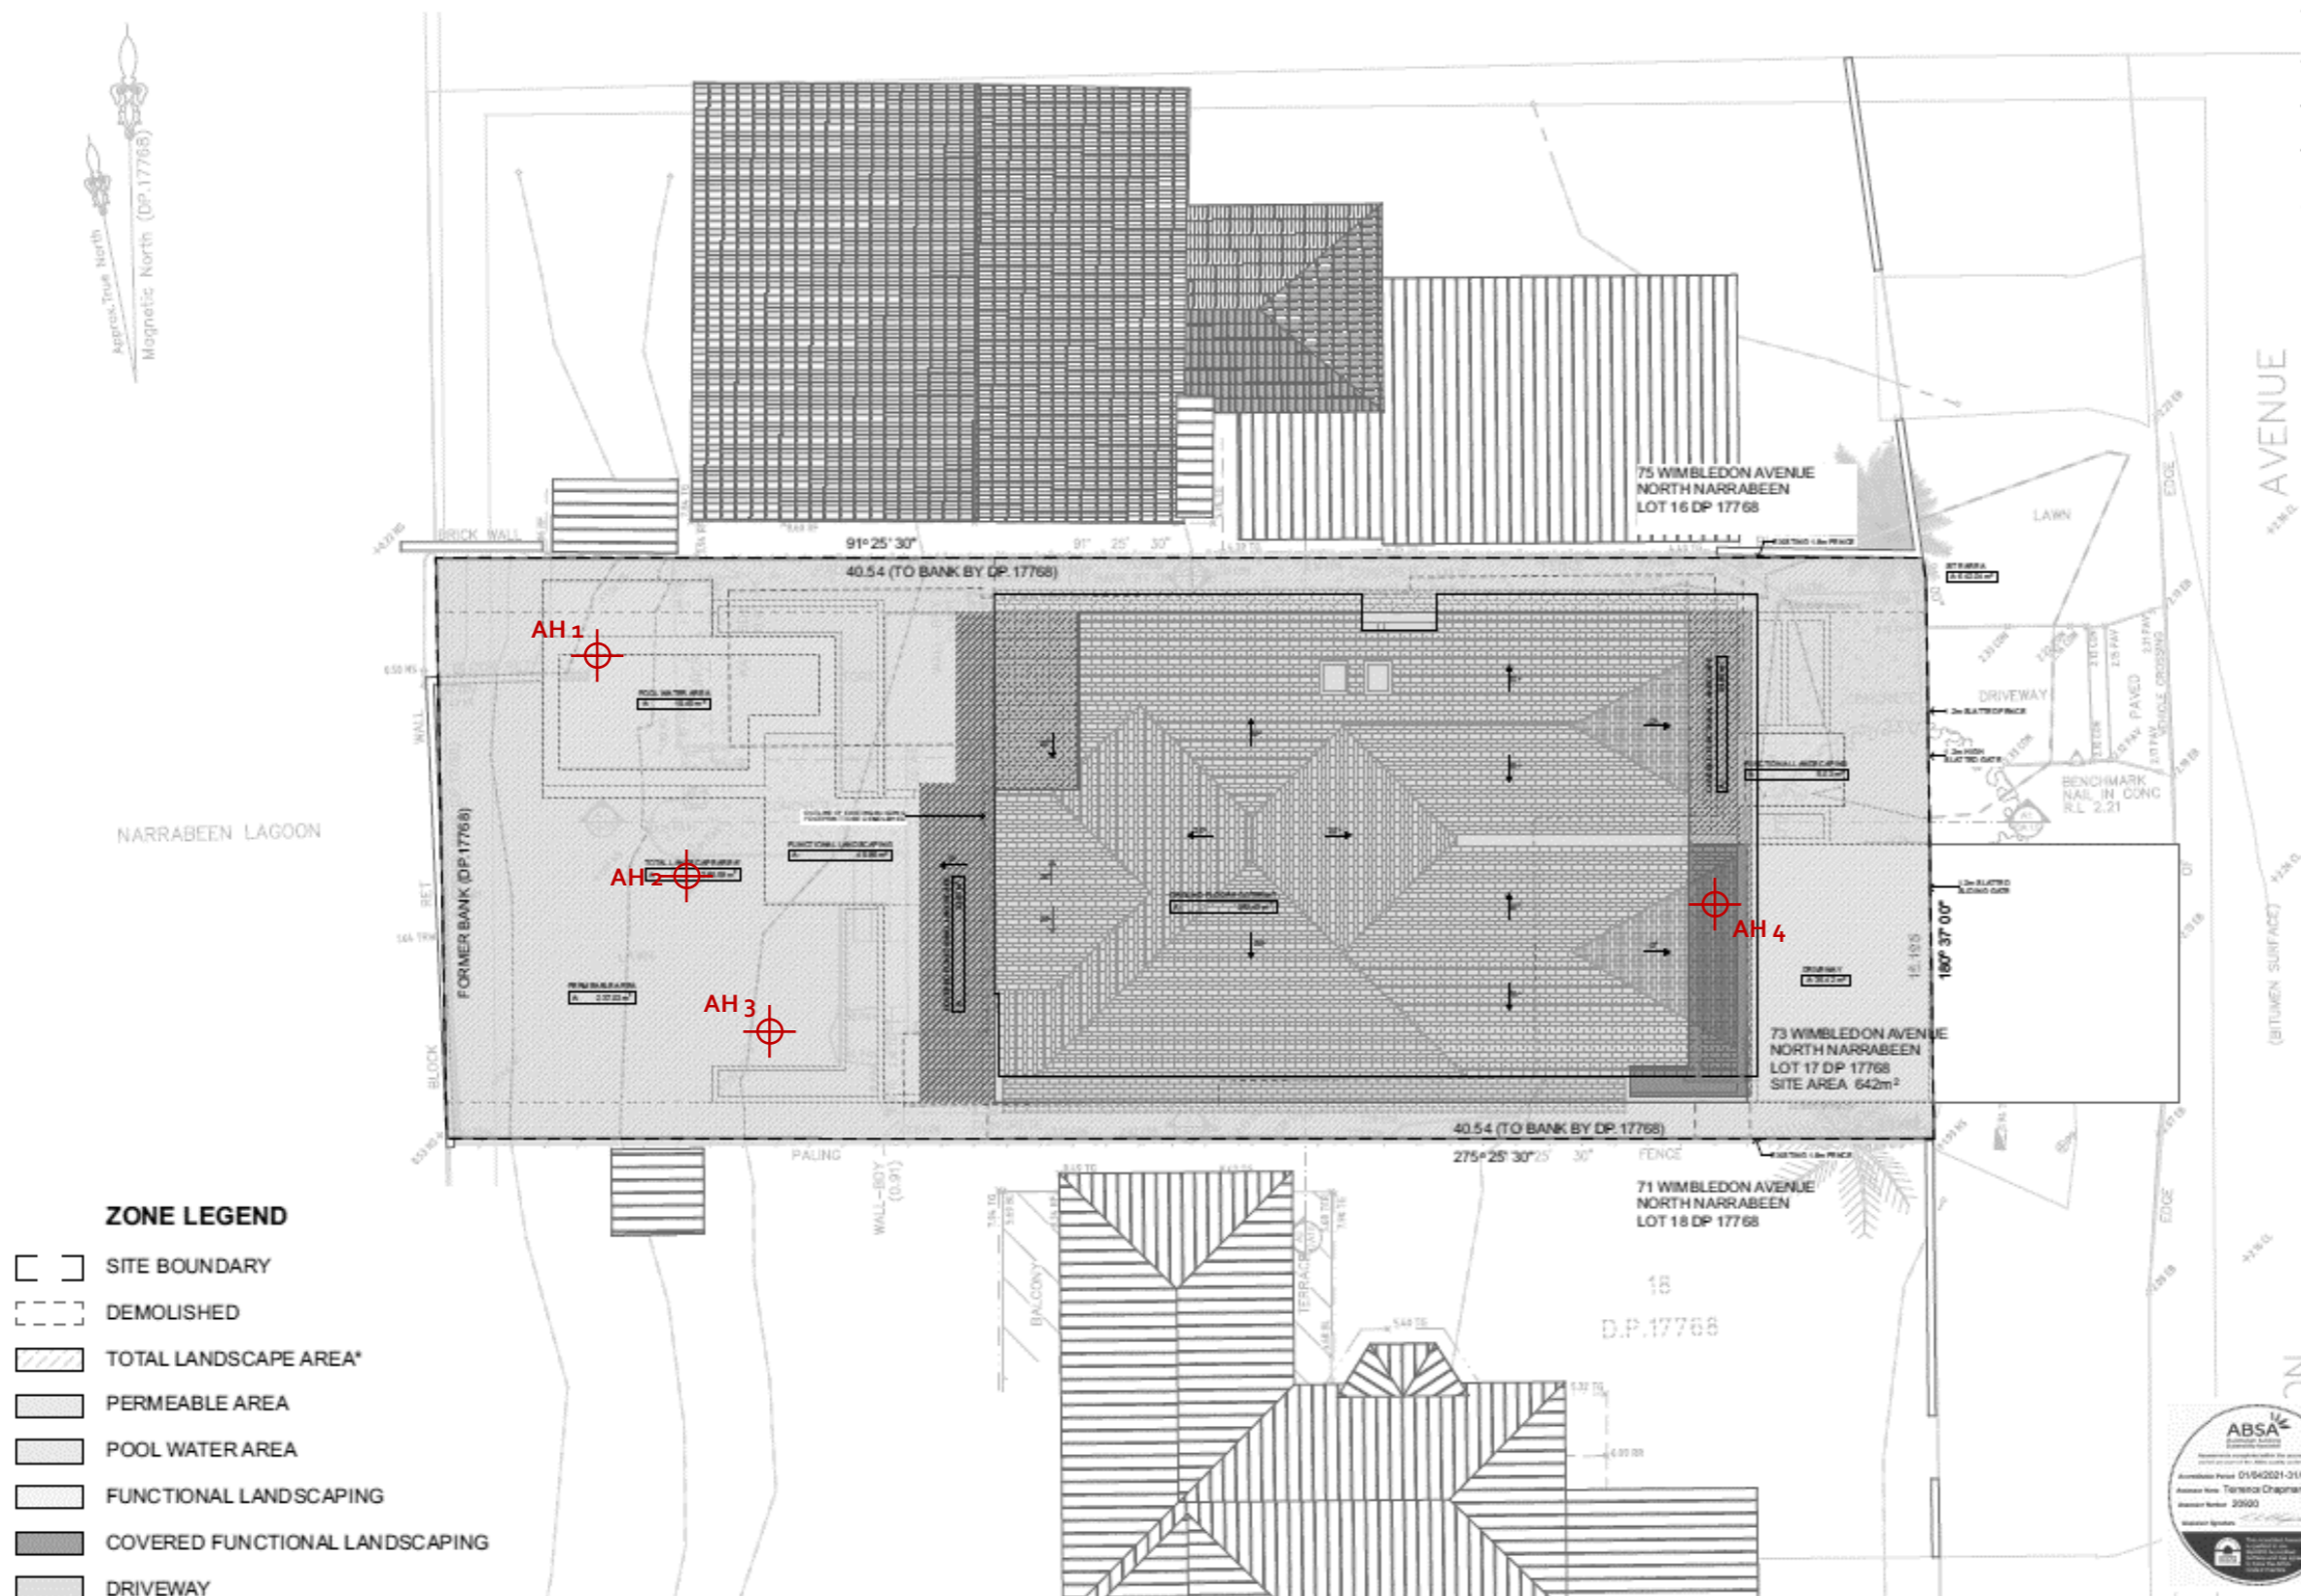
### SITE PLAN – showing test locations

Four hand Auger Holes (AH) were put down in the locations shown on the site plan attached. Field pH and peroxide testing was carried out on samples taken from the auger holes at regular intervals. The logs of the auger holes and the test results are as follows. The soil reaction rating scale for the pH<sub>FOX</sub> test is shown in Appendix 1.
