325 Whale Beach Road, Palm Beach

Updated Plans

Comments on Updates to Plans

Report Title: Geotechnical Report 325 Whale Beach Road, Palm Beach

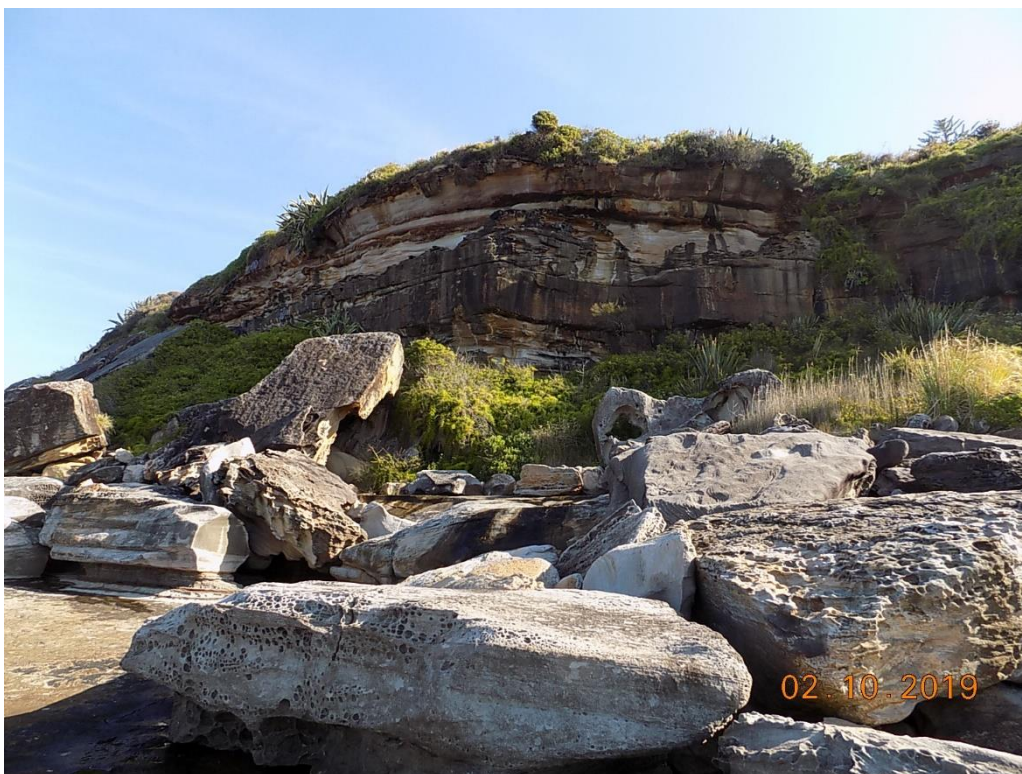
Photo 6

well-vegetated garden at the cliff-top (Photos 4 & 5). A ~15m high sea cliff falls from near the lower boundary to a rock platform below (Photo 6). It consists of competent Medium Strength Sandstone. The cliff face displays no significant undercutting or serious geological defects that could affect its stability. The rock platform has a covering of dislodged sandstone boulders at the cliff base. Some of the boulders were observed to be greater than 3m in diameter and effectively armour the cliff base from the erosional forces of storm surf.

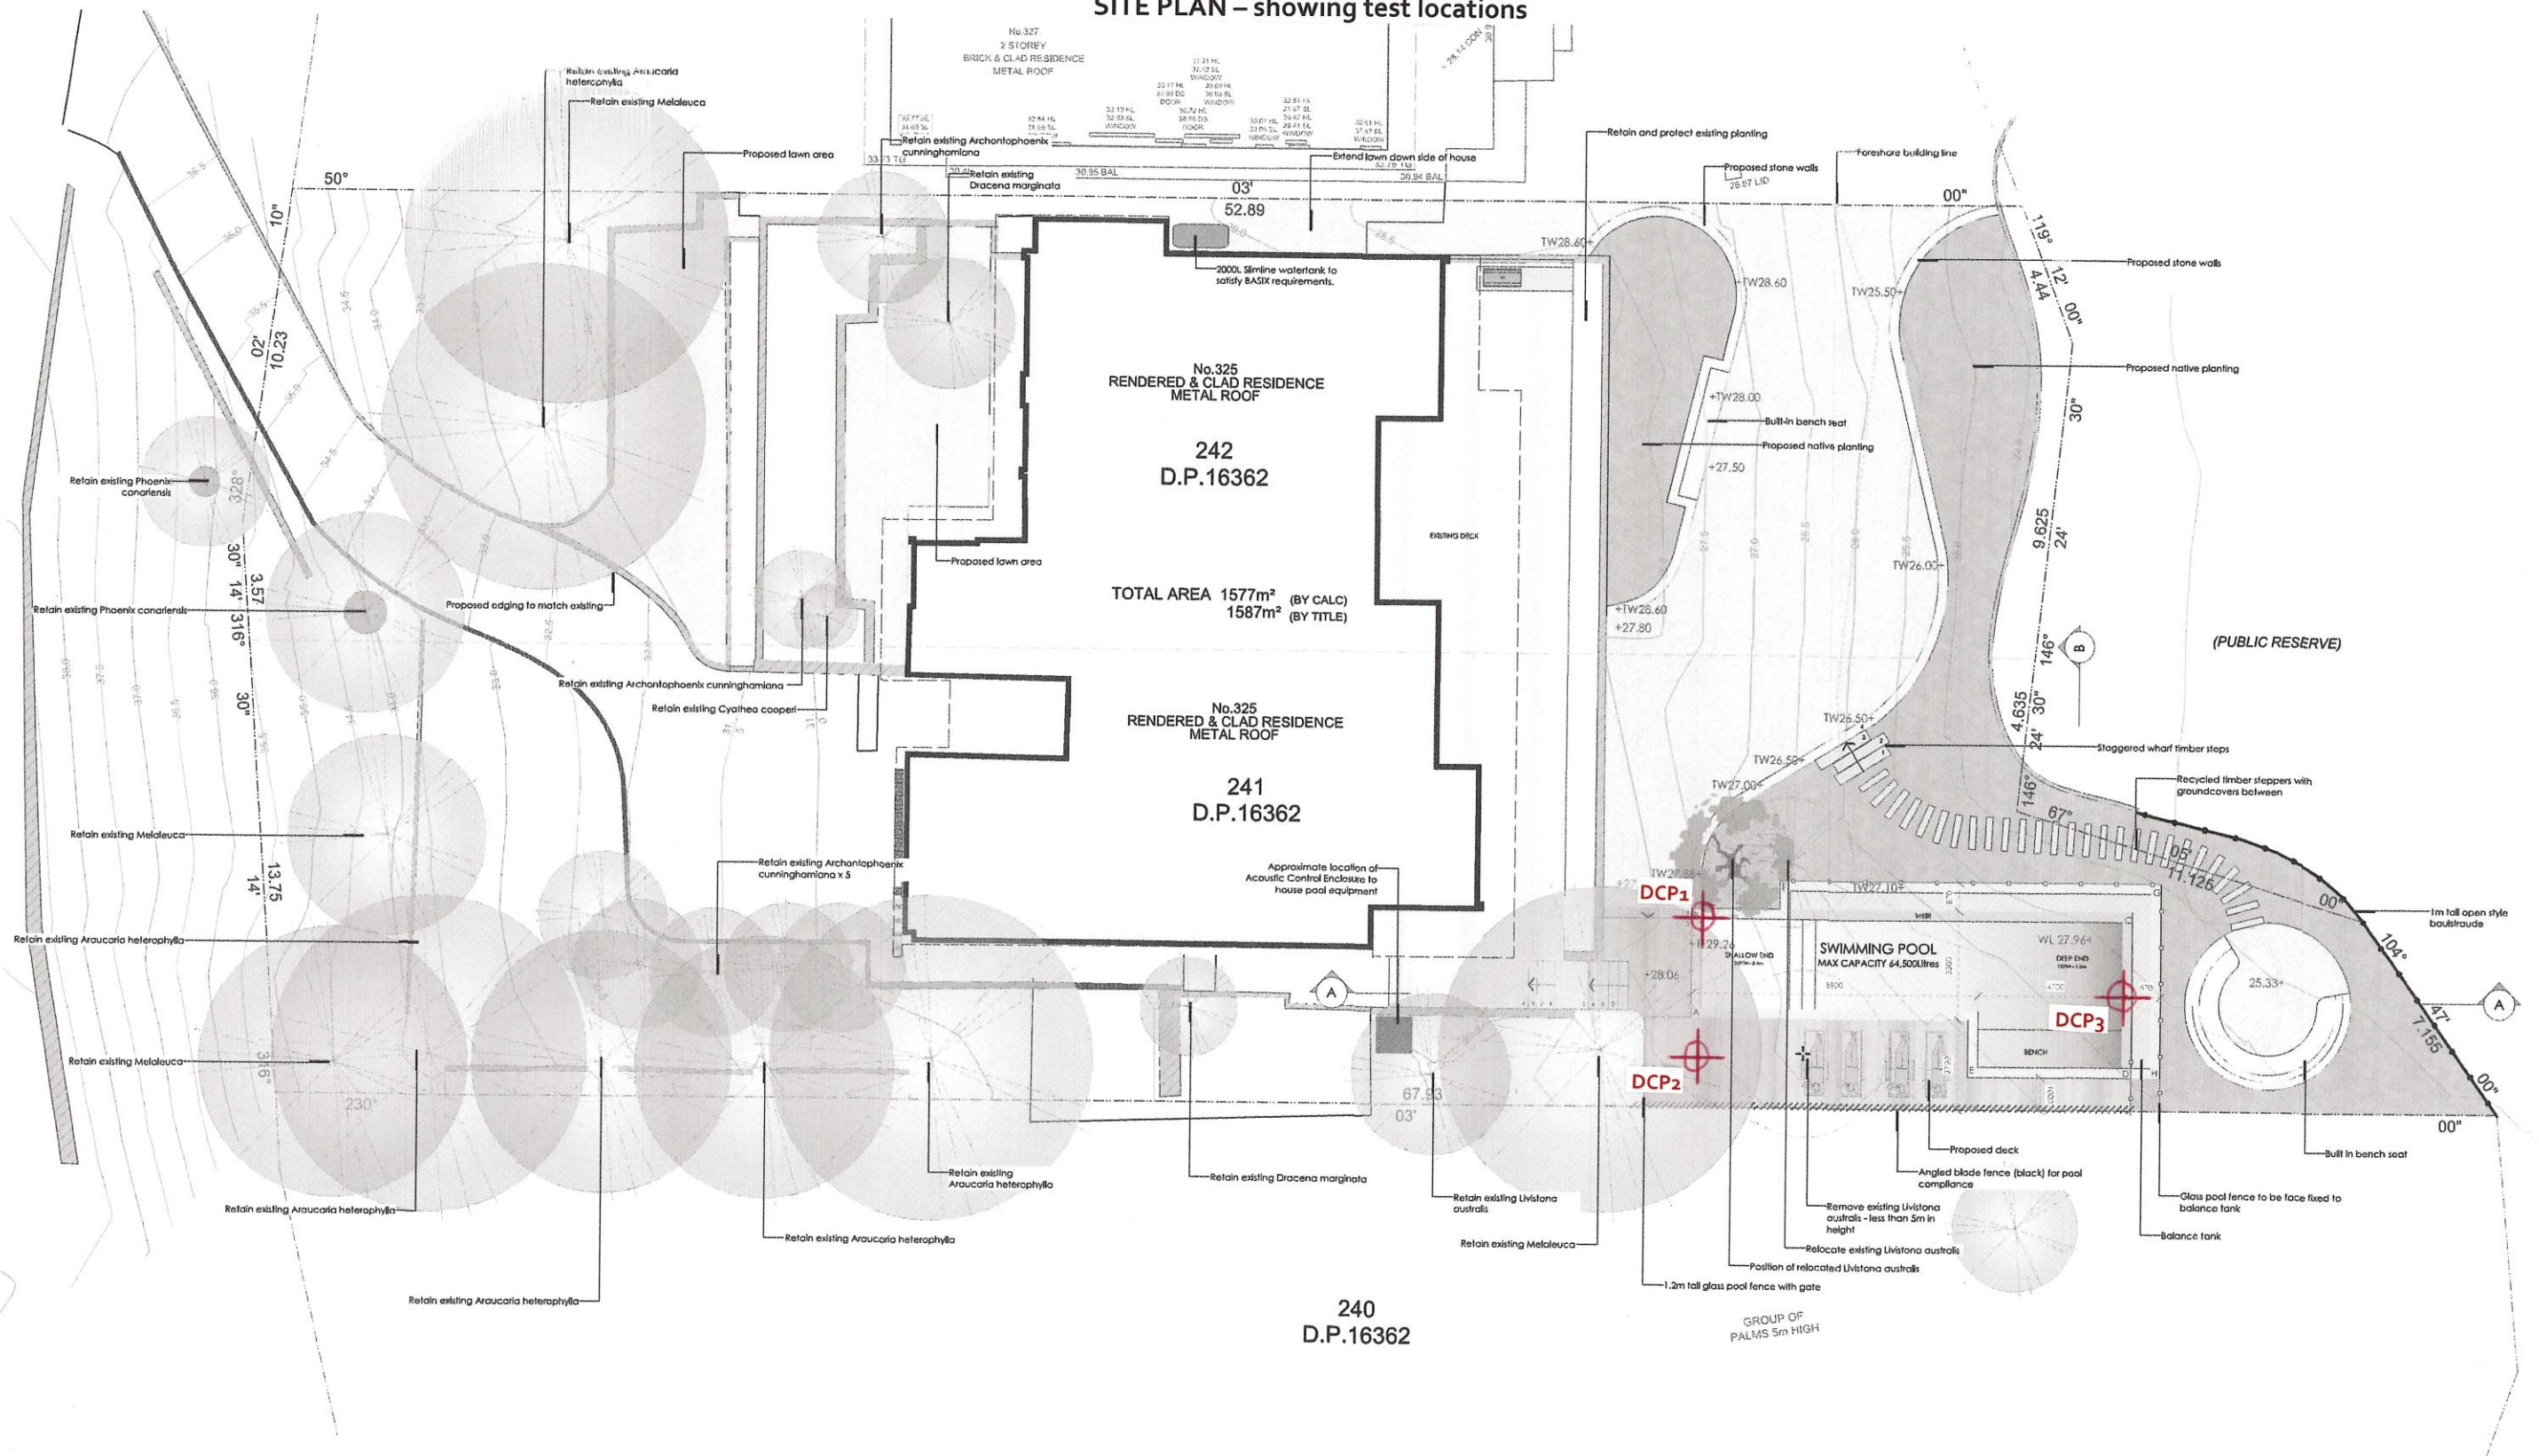
SITE PLAN – showing test locations

Three Dynamic Cone Penetrometer (DCP) tests were put down to determine the relative density of the overlying soil and the depth to weathered rock. The locations of the tests are shown on the site plan. It should be noted that a level of caution should be applied when interpreting DCP test results. The test will not pass through hard buried objects so in some instances it can be difficult to determine whether refusal has occurred on an obstruction in the profile or on the natural rock surface. This is expected to have occurred in DCP1:

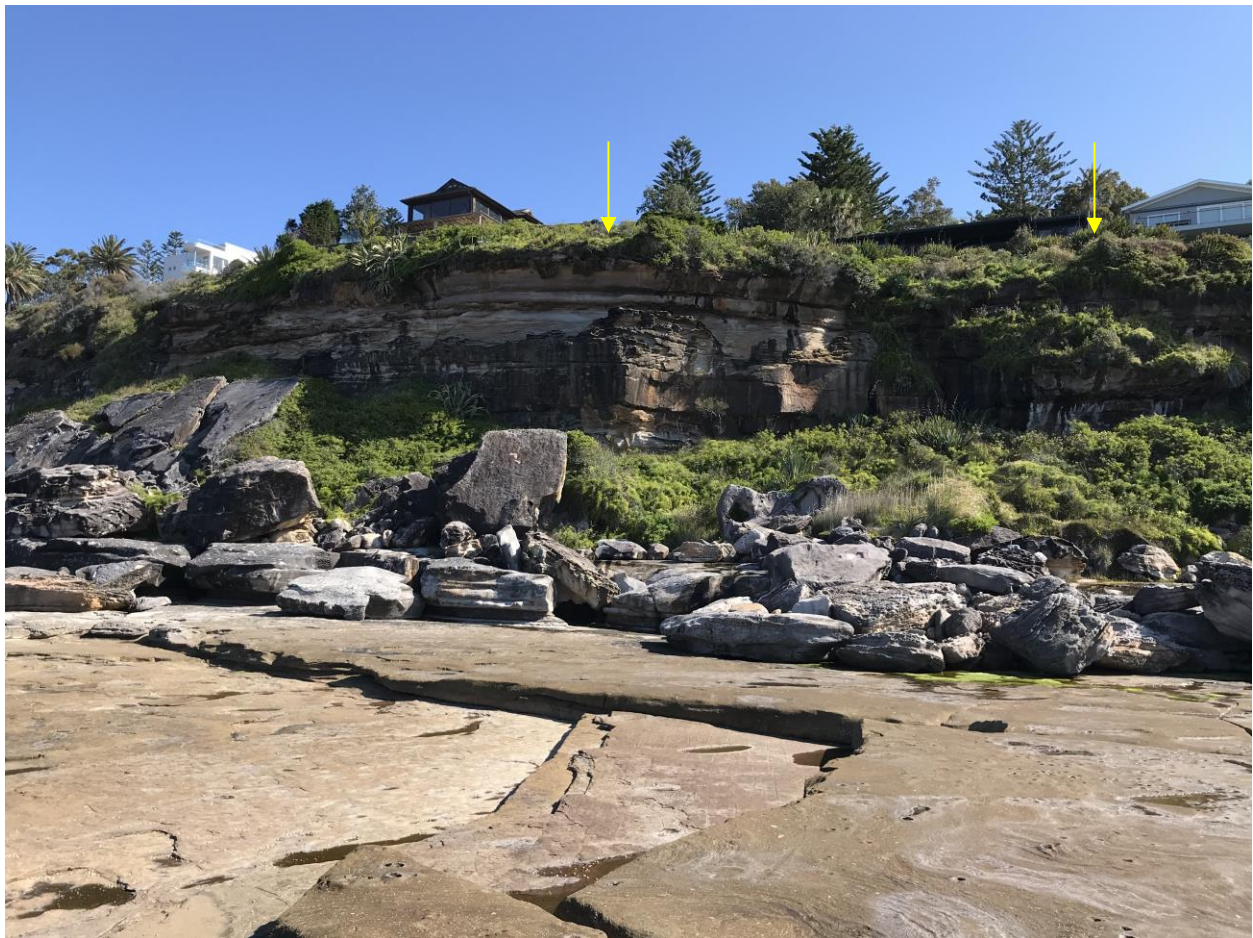
Figure 1: View of cliff face at subject property (approximate extent between arrows) from rock platform on 28 September 2019, looking SSW

The subject property is located on a rocky cliff headland known as Little Head, which extends north of the sandy Whale Beach. A photograph of the property from the rock platform seaward of the property is provided in Figure 1. An aerial view of the property is provided in Figure 2, along with a section location (denoted as Section A) and the location of the proposed pool².

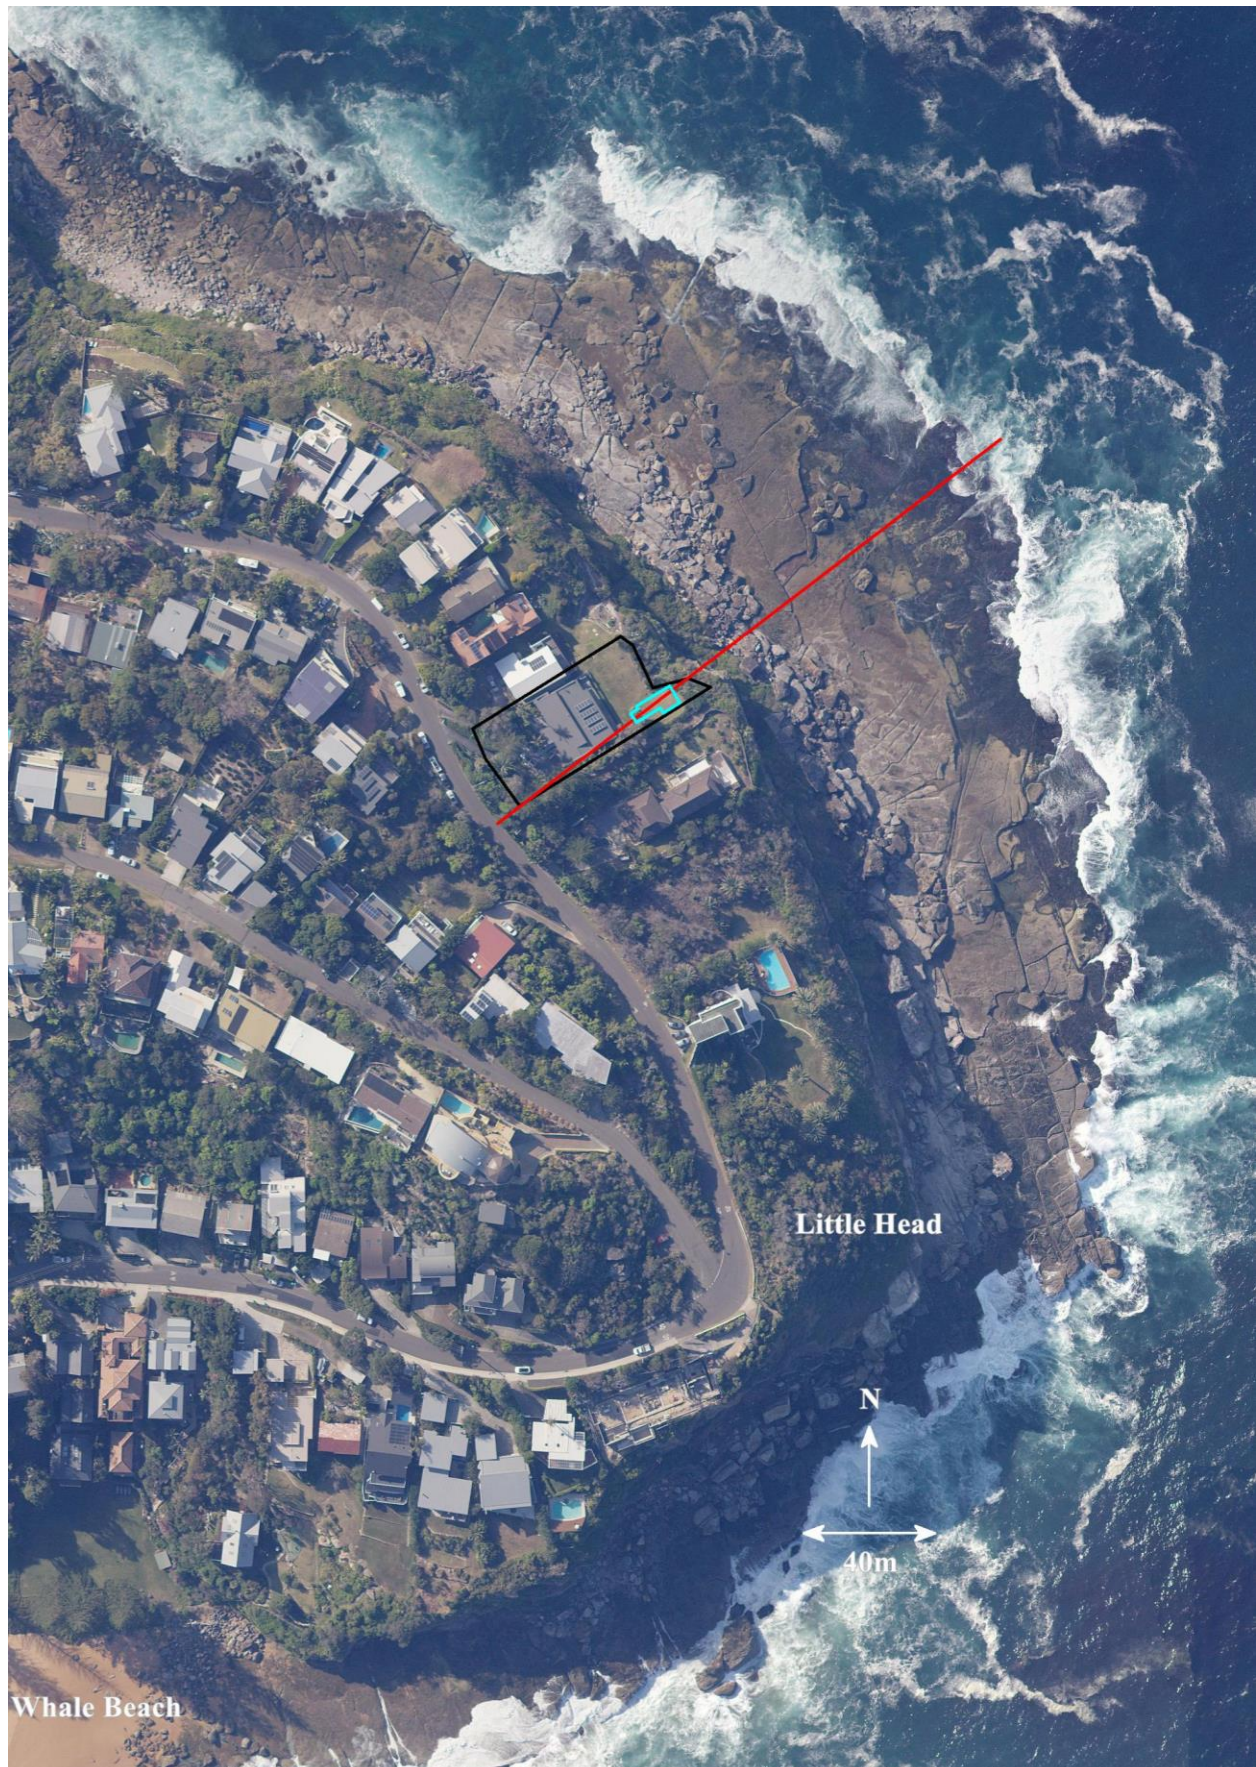
Figure 2: Aerial view of subject property (black) on 30 August 2018, with Section A location (red) and proposed pool location (blue) shown

² Note that the property boundary depicted in Figure 2 is not survey accurate, being derived from approximate NSW Government GIS cadastral data.

It is proposed to construct a pool at the location shown in Figure 2, and undertake landscaping in surrounding areas. As noted in Section 3, the seaward edge of the proposed pool is located about 12.4m from the top of cliff.
