GEOTECHNICAL INVESTIGATION:

New Apartment Block and Basement Carpark at 3 Berith Street, Wheeler Heights

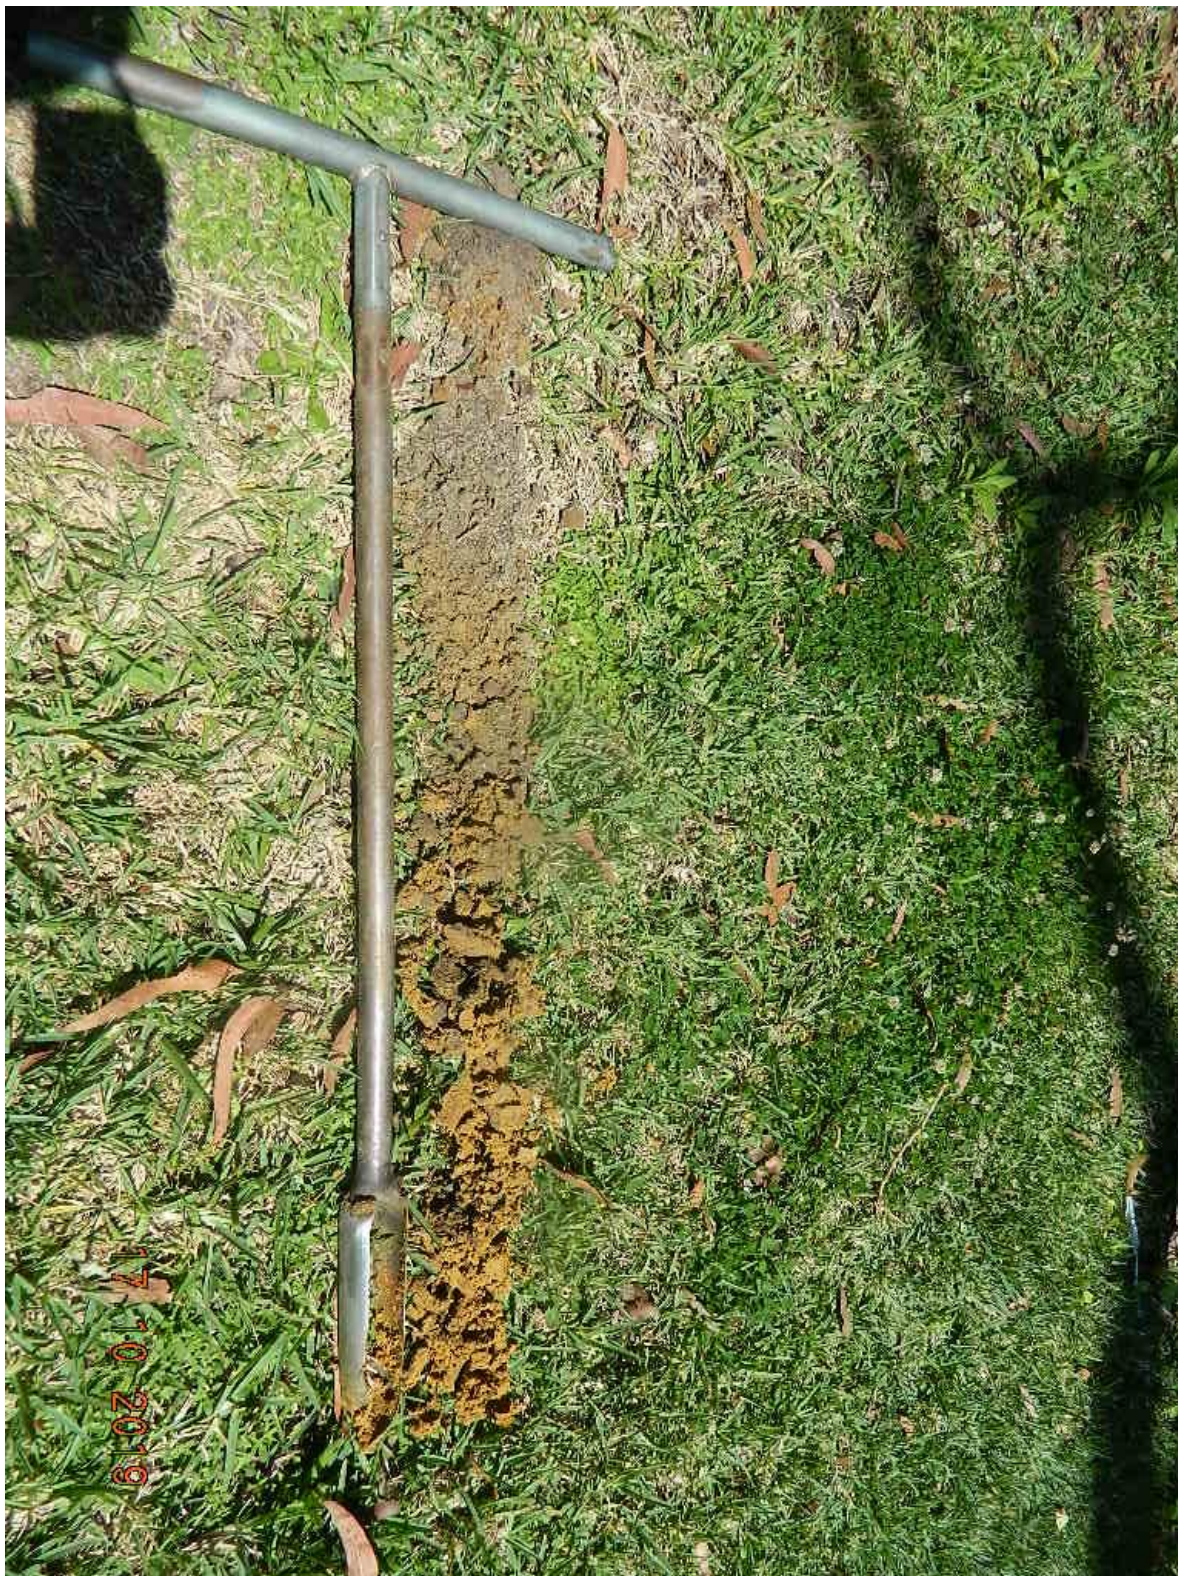
Photo 5 – AH1

AUGER HOLE 1 (~RL76.0) – AH1 (Photo 5)

Depth (m)	Material Encountered
0.0 to 0.5	TOP SOIL , sandy soil, dark brown medium grained with trace organic matter.
0.5 to 1.0	SANDY CLAY , brown, medium to coarse grained with rock fragments.

Refusal @ 1.0m in rock fragments. No watertable encountered.

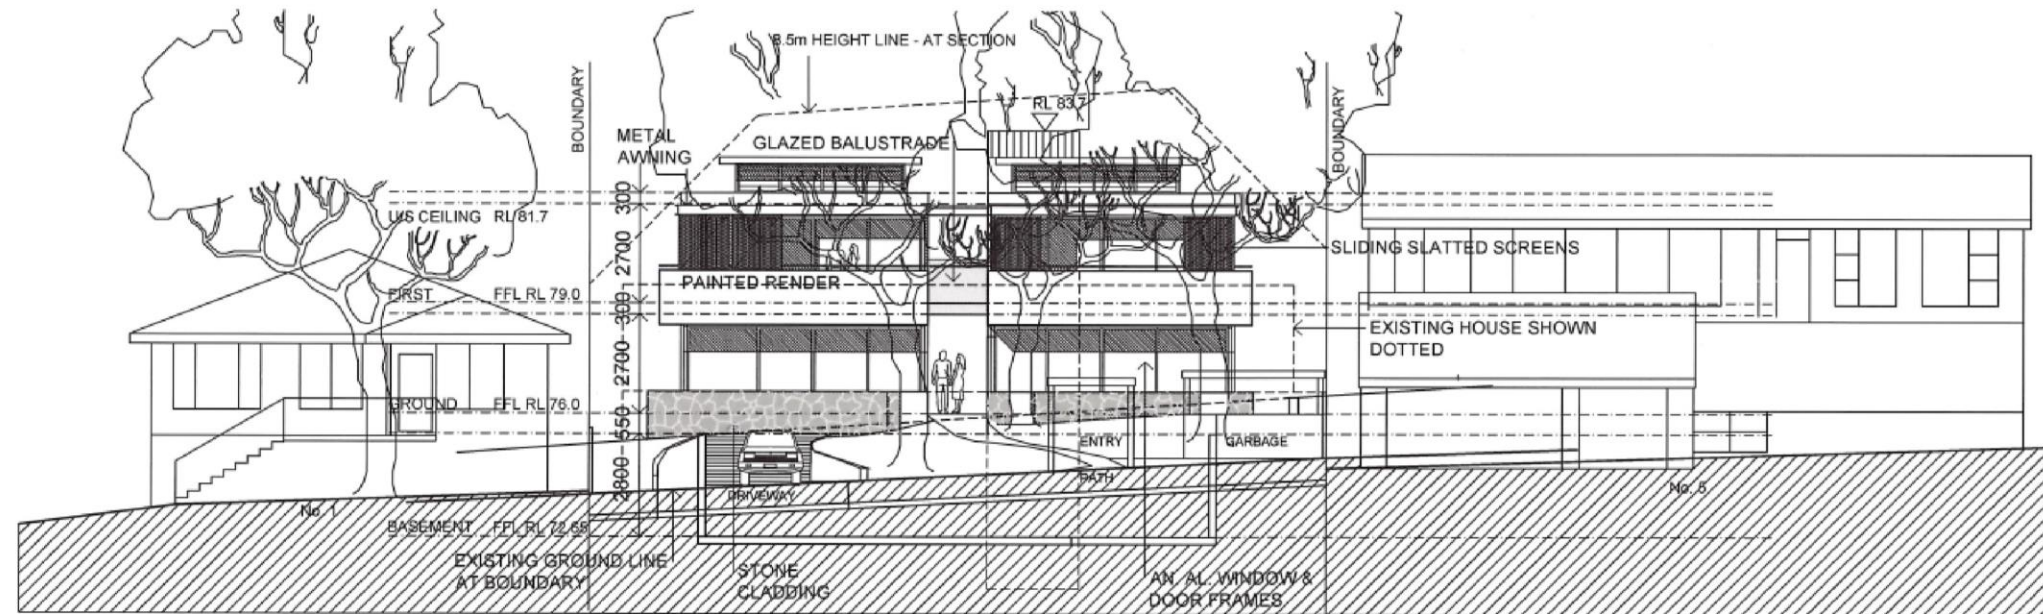
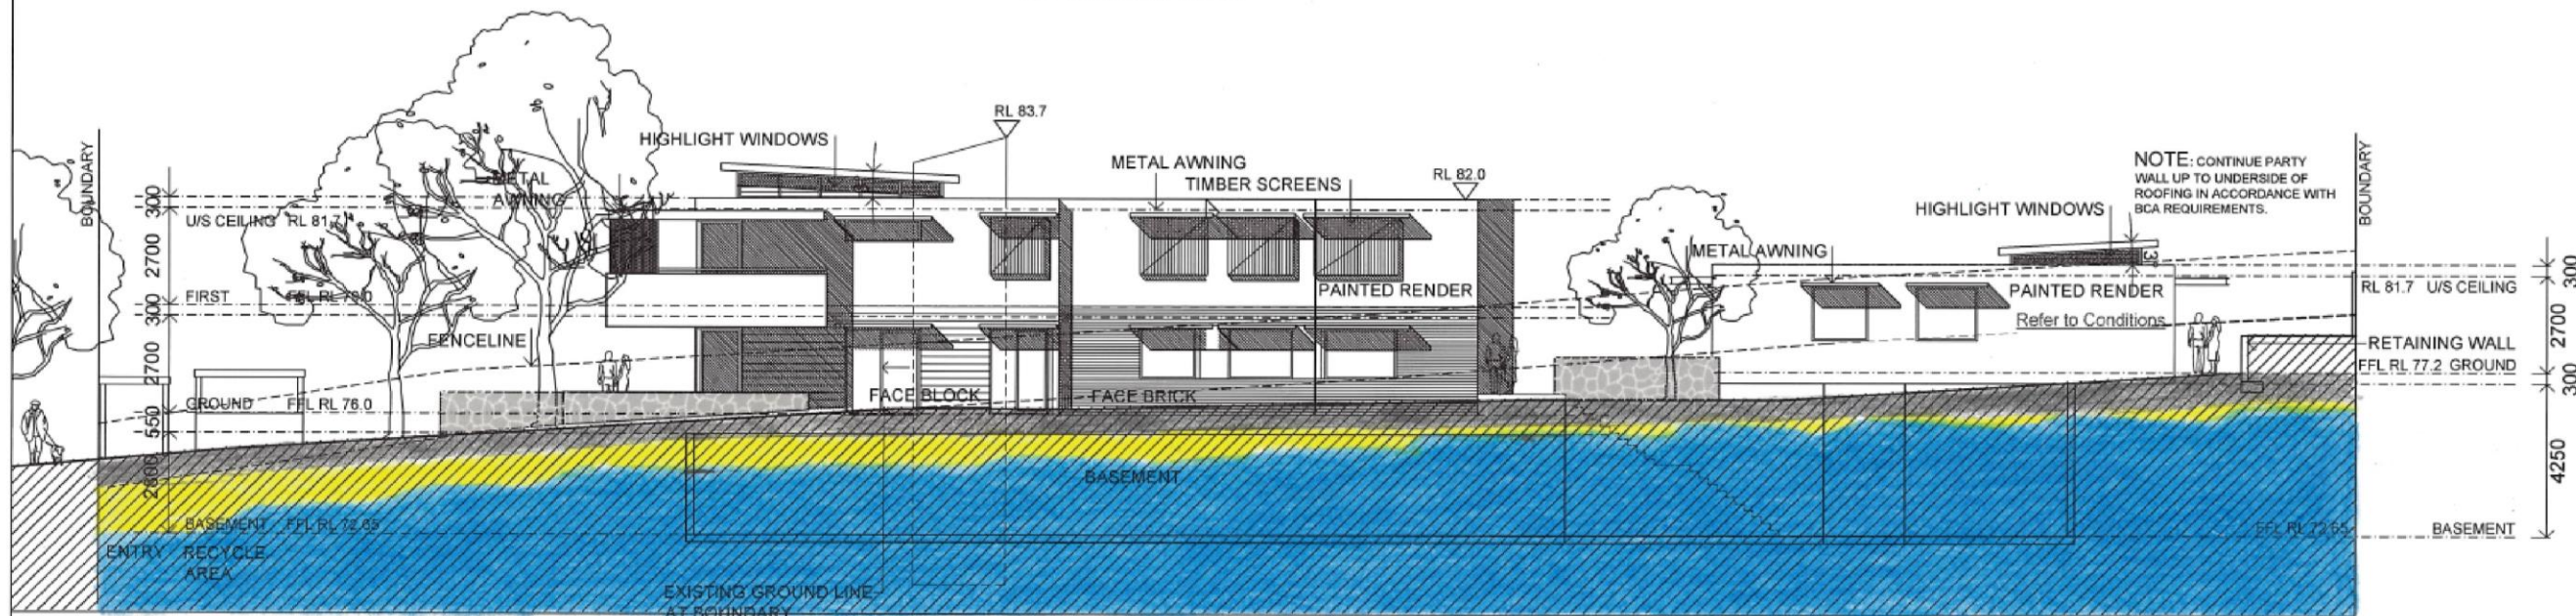
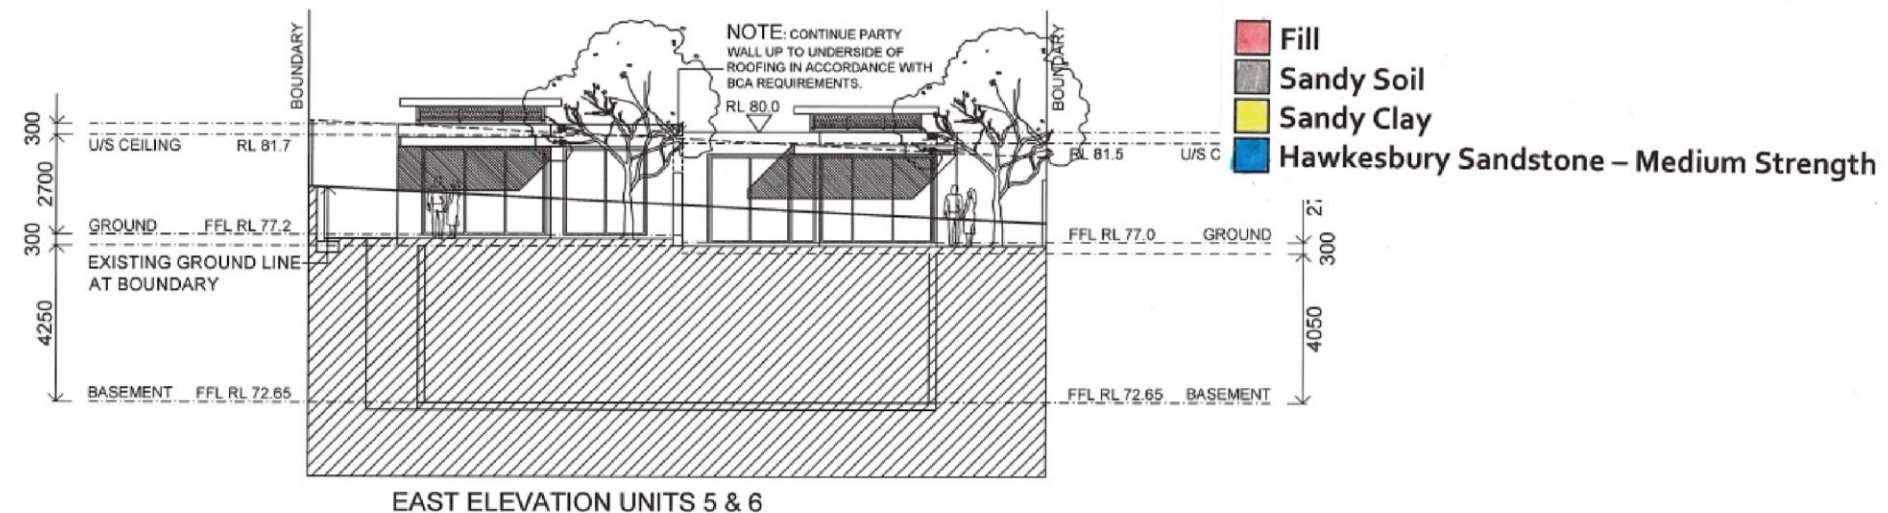
TYPE SECTION – Diagrammatical Interpretation of expected Ground Materials

The surface features of the block are controlled by the underlying sandstone bedrock that steps down the property forming sub-horizontal benches between the steps. Where the grade is steeper, the steps are larger, and the benches narrower. Where the slope eases, the opposite is true. Where the rock is not exposed, it is overlain by natural sandy soils and firm to stiff sandy clays that fill the bench step formation. In the test locations rock was encountered at depths of between 0.6 to 1.5m below the current surface. See Type Section attached for a diagrammatical representation of the expected ground materials.

- Fill
- Sandy Soil
- Sandy Clay
- Hawkesbury Sandstone – Medium Strength
