Marine Habitat Survey

Address | 16 Addison Road, Manly

Job Number 19-030-04

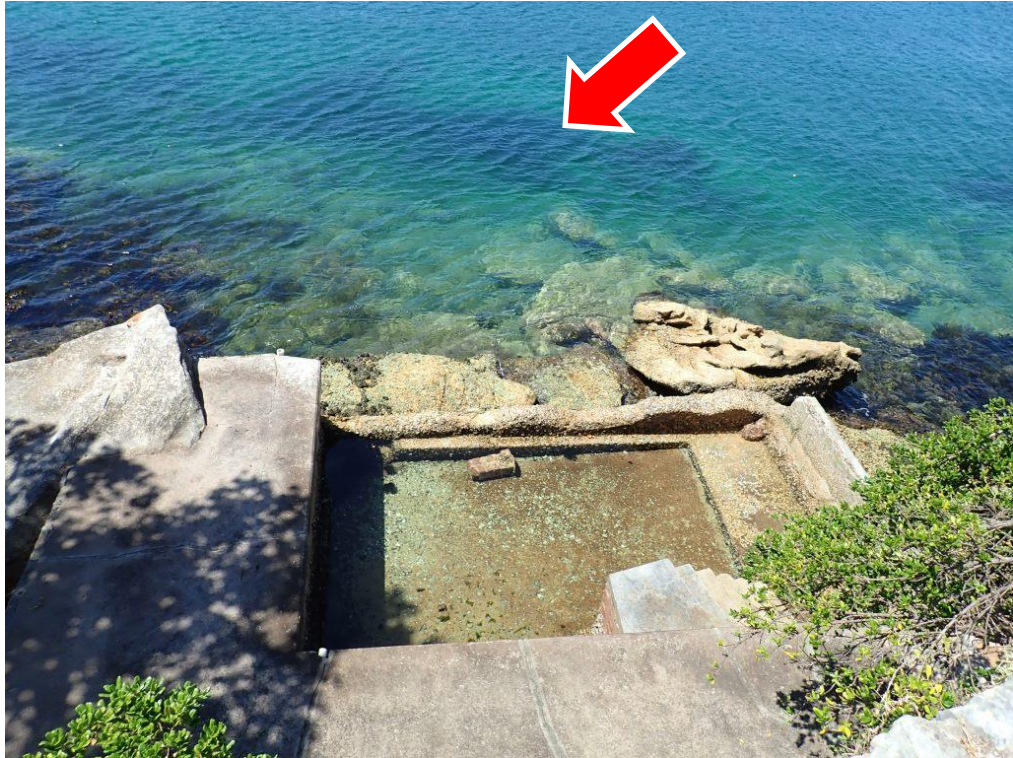
There was a bed of high density *Zostera* located 8.8 m seaward of the edge of the intertidal rock platform, which is 10.3 m away from the nearest building works (arrowed in Photo 1).

Photo 1. Existing concrete swimming pool and concrete platform at The Property. The red arrow indicates the *Zostera* seagrass bed 10.3 m off the pool wall.

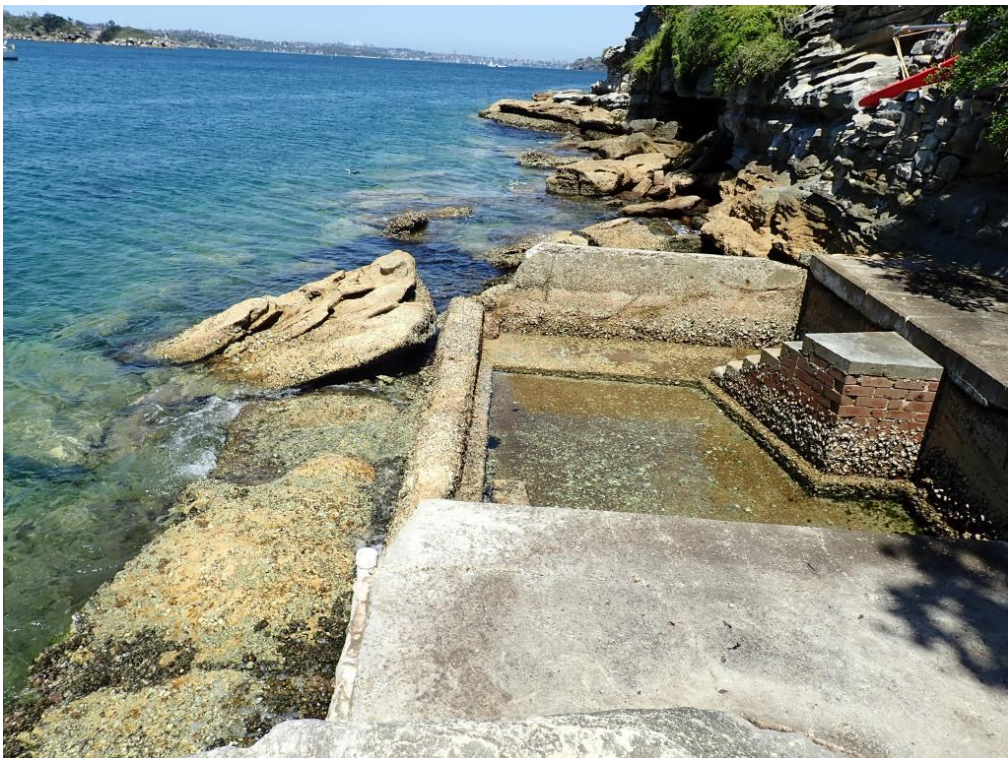
The intertidal zone within the on-site survey area of The Property consisted of natural and artificial habitats. A natural tall rock face was fronted by a concrete reclamation area which surrounded the northern and landward sides of a concrete and brick swimming pool (Photos 1 - 4). Seaward of the outer pool wall was a 1.5 m wide natural rock platform (Photos 2 and 6).

Photo 2. Existing swimming pool (viewed looking south), fronted by a natural intertidal rock platform and rocky subtidal seabed.

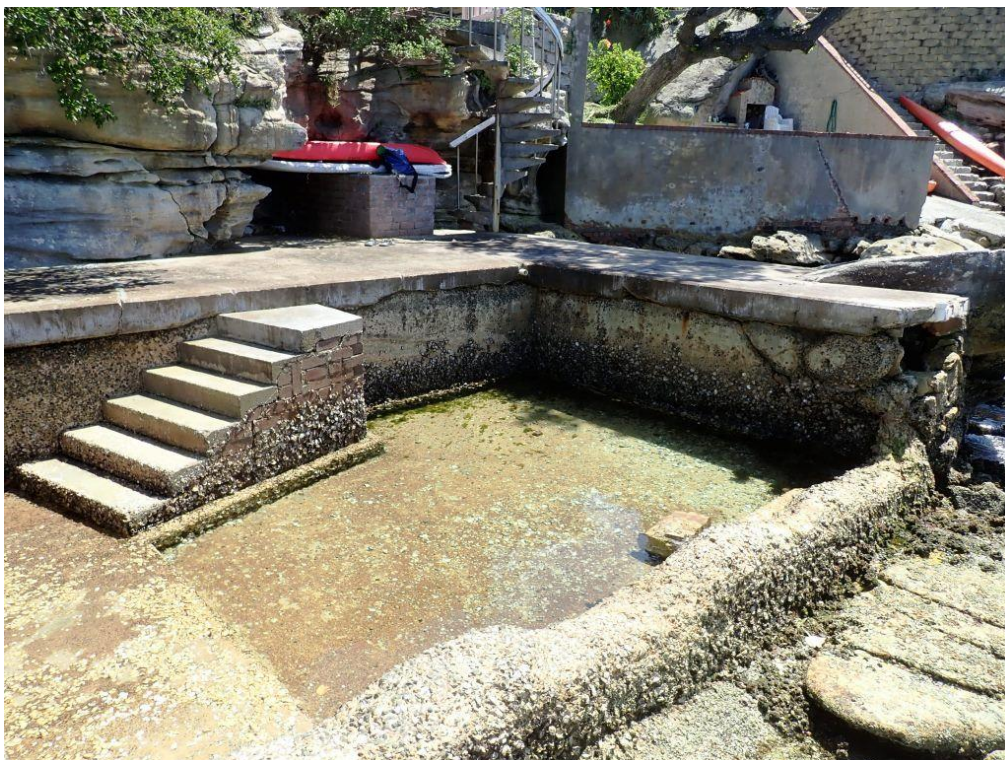
Photo 3. Intertidal habitats present in the swimming pool include the inner pool walls and stairs, and the outer pool wall.

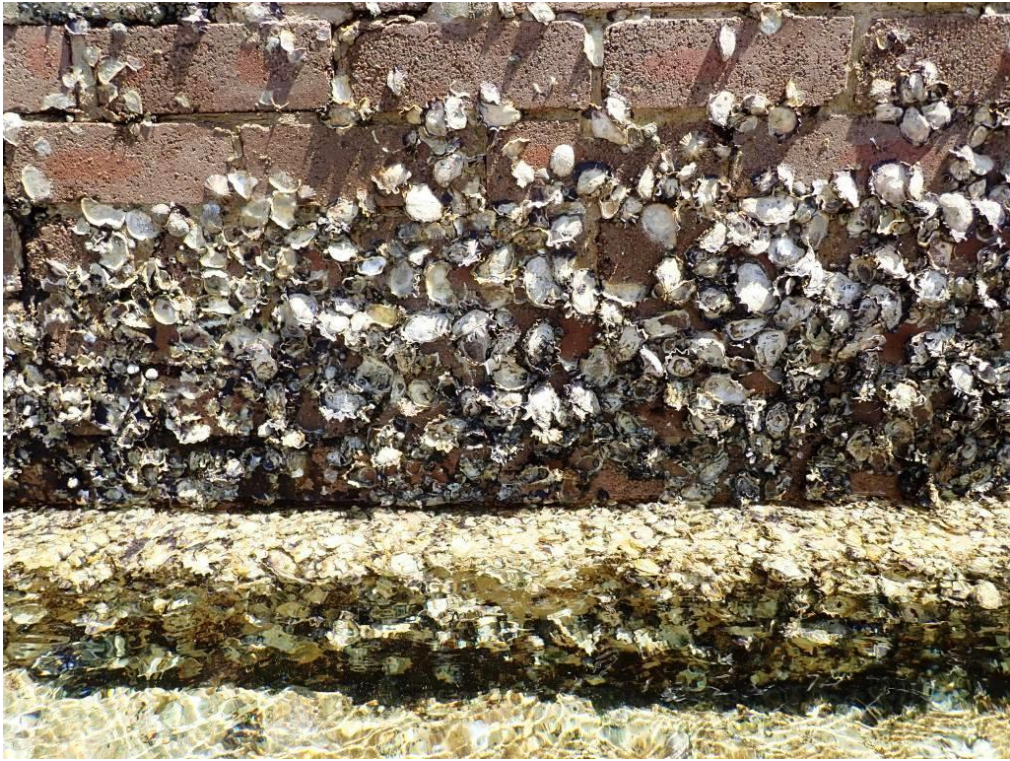
The internal pool walls and outer pool wall were colonised by a medium density cover of Sydney rock oysters (*Saccostrea glomerata*; Photo 5), along with periwinkles (*Austrocochlea porcata* and *Bembicium nanum*), limpets (*Cellana tramoserica* and *Siphonaria denticulata*) and mulberry whelks (*Morula marginalba*). The seaward natural rock platform was colonised by a diverse high density cover of biota (Photo 6) including brown algae (encrusting *Ralfsia verrucosa* and turfing filamentous), red coralline algae (*Amphiroa anceps* and *Corallina officinalis*), green filamentous alga, barnacles (*Chthamalus antennatus* and *Tesseropora rosea*), cunjevoi (*Pyura stolonifera*) and calcareous tube worms (*Galeolaria caespitosa*).

Photo 5. Medium density cover of Sydney rock oysters colonising the swimming pool stairs.

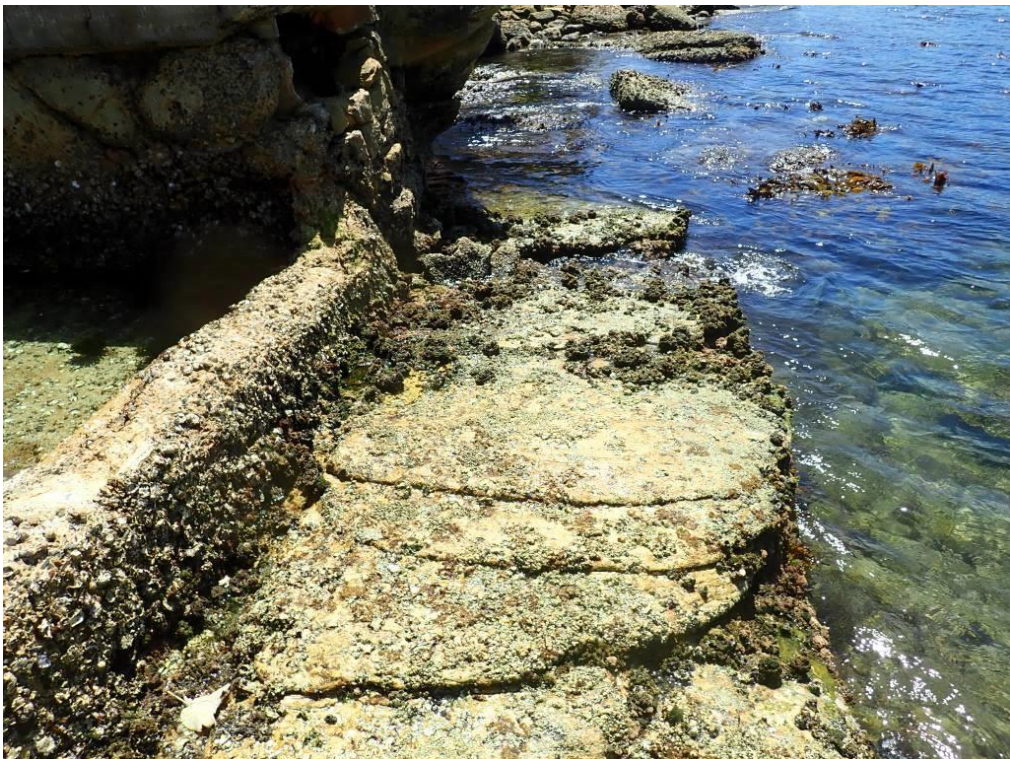
Photo 6. Oysters colonising the low pool wall and a diverse assemblage of biota colonising the rock platform in front.

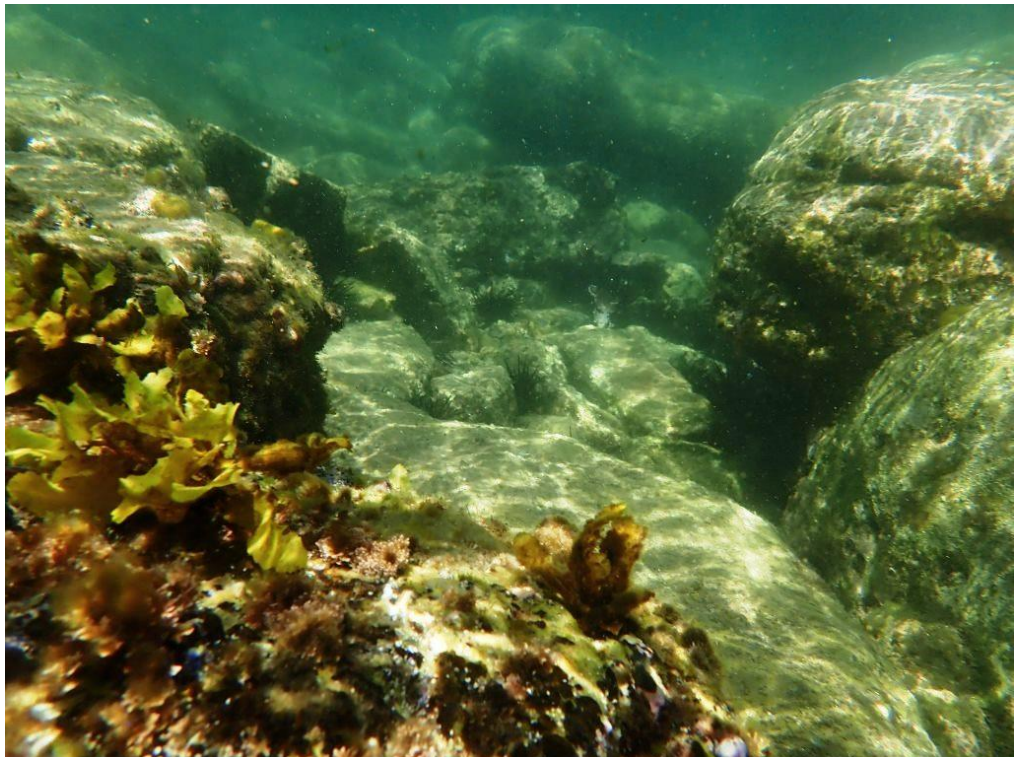
The subtidal zone within the on-site survey area of The Property consisted of artificial and natural habitats. The floor of the swimming pool provided an artificial subtidal habitat (Photo 7). The natural subtidal seabed off the edge of the intertidal rock platform consisted of moderately sloping boulders that transitioned onto sand 8.5 m off the rock platform (Photos 1, 2 and 8).

Photo 8. Brown macroalgae colonising the shallow boulders of the subtidal seabed.
