## **REPORT ON GEOTECHNICAL INVESTIGATION**

### **PROPOSED NEW DWELLING**

**2 WYADRA AVENUE, CURL CURL, NSW**

**Project No.: 2020-229.1**

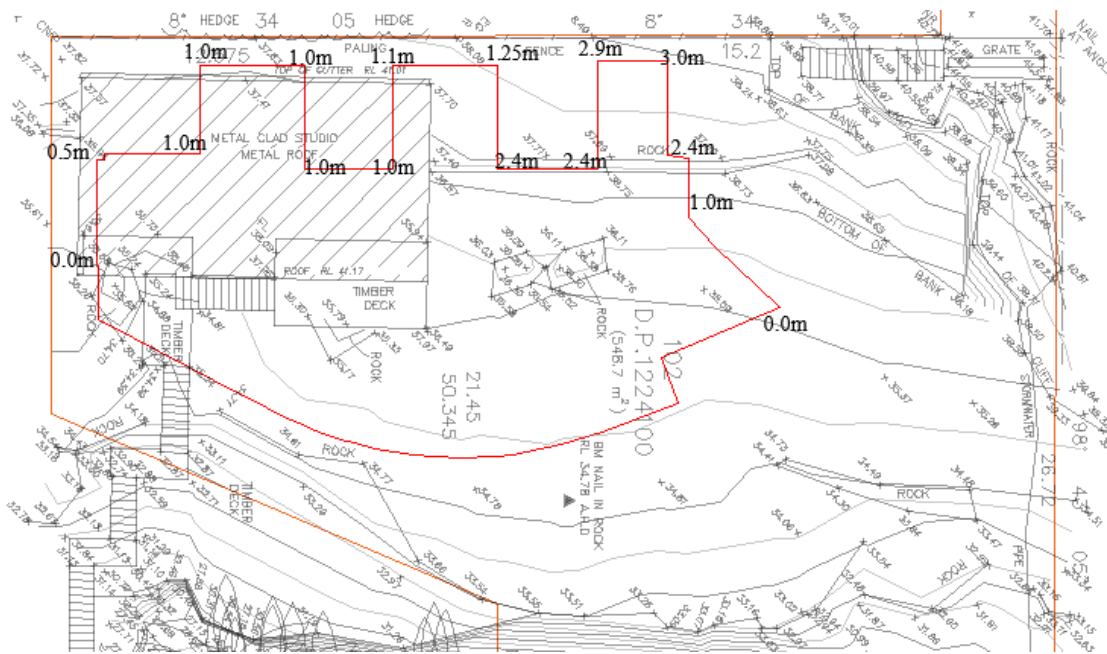
Figure 1: Outline of proposed works with approximate excavation depths

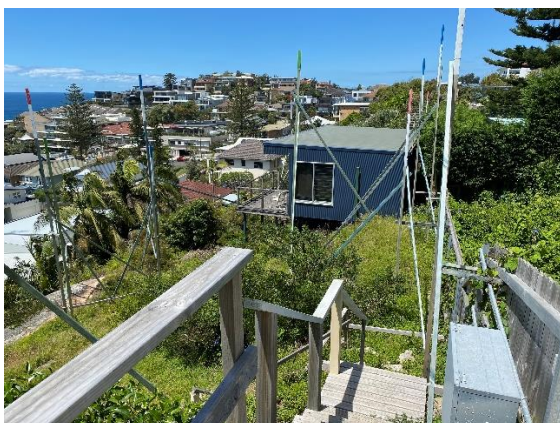
View of site (No. 2) from access driveway

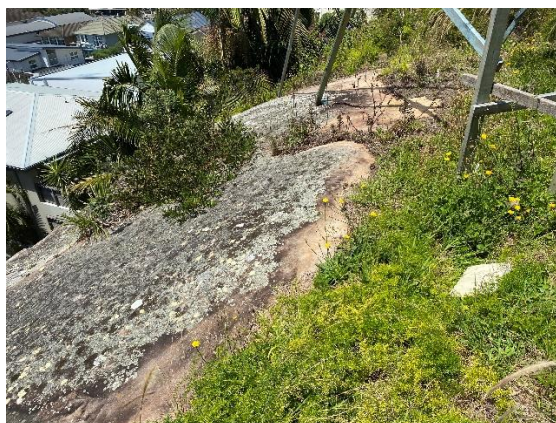
Outcrop along eastern side of block

The cliff is up to 8.0m in height and formed through generally massive sandstone with few bedding or joint defects in the upper portion and with more bedding defects in the lower 3.0m. An undercut is formed at the base of the upper cliff, that extends up to 4.0m laterally into the cliff face towards the east. Some spalling at face of the cliff has also separated some small sections of rock.

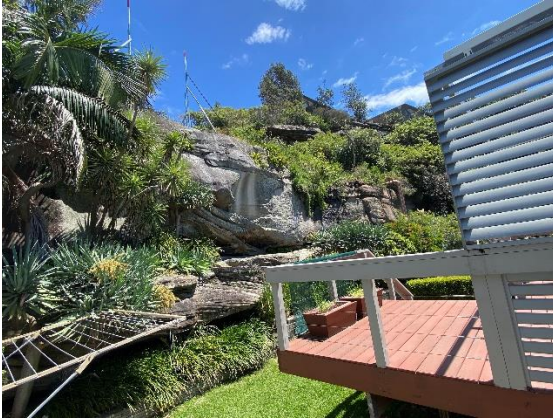
Rear of No. 16 showing cliff line at rear of No. 2

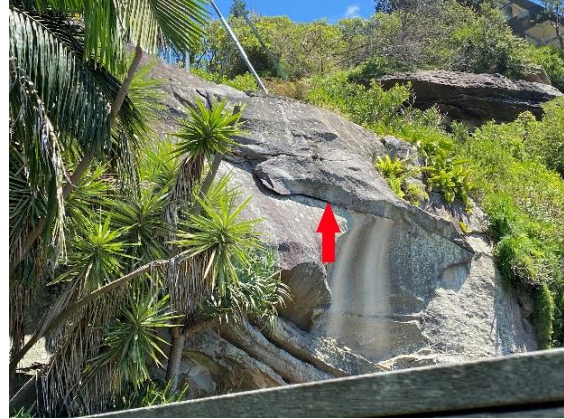
Spalling and fractured rock near cliff crest.

when assessed against the criteria of the AGS 2007. However, these hazards are considered without the implementation of the recommendations of this report. Therefore, where geotechnical inspection and installation of support systems along with the removal of the spalled rock occur, the risk levels will reduce significantly.

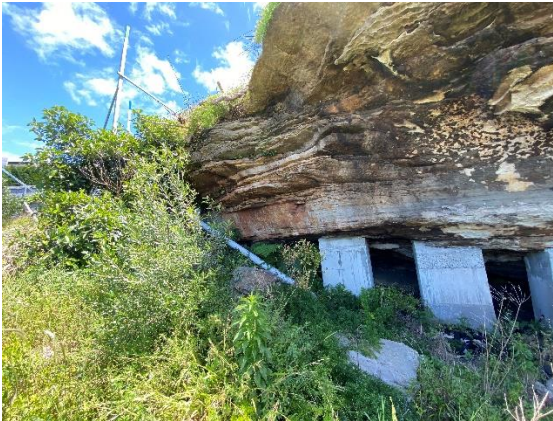
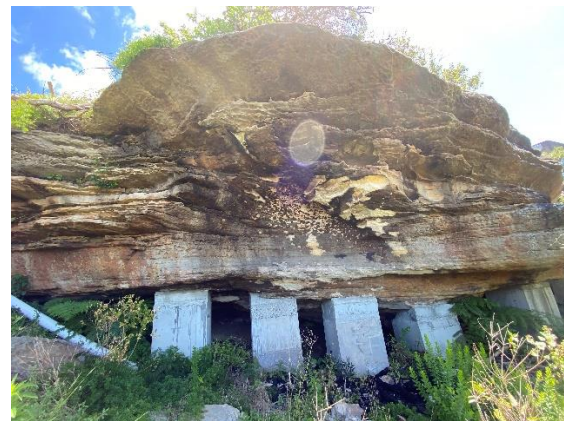
At the rear north-west corner of the property there is another 4.0 – 5.0m high cliff line that extends from the northern neighbouring property to the sites north-west corner. This cliff contains a large overhang in the corner of the site which has been previously underpinned via several large mass concrete underpinning blocks. From this overhang the cliff curves to strike west and reduces in height with low cliffs and terraces stepping down in a southerly direction into the site.

Outcrop cliff and underpinning at north-west corner of No. 2

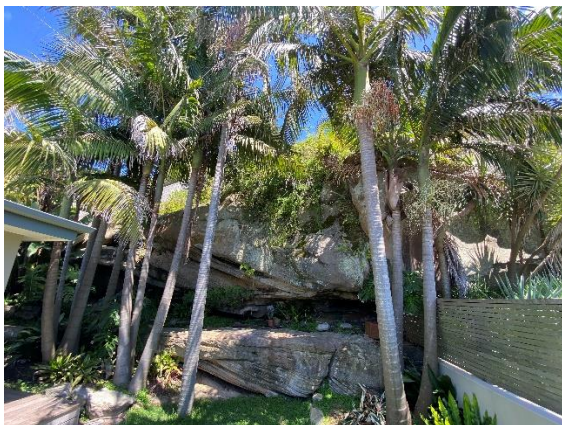
Cliff to rear of No. 14

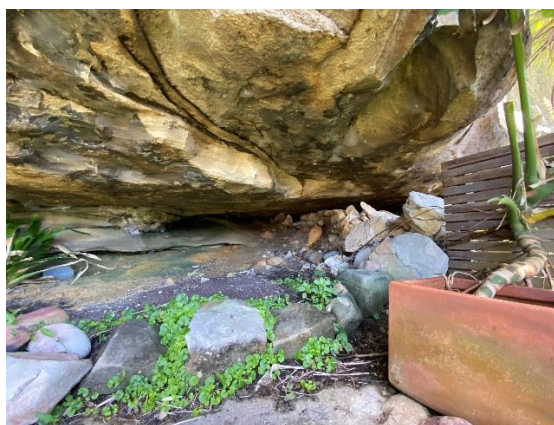
Undercut below cliff face as viewed from No. 14

Whilst the risk assessment identified some of the risk levels as being marginally “Acceptable” when compared to the AGS criteria, it is recommended that an underpinning system be implemented to the overhang based on future detailed geotechnical inspection. Provided this occurs and the excavation/construction inspections detailed within this report the risk from all hazards will be well within the “Acceptable” risk level for the life span of the proposed development, taken as 100 years.
